## Inspection Photos

Location: QB ENERGY PUCKETT-67S97W/1SE14N (PUCKETT 22B-1 PAD)

Location ID: 324253

Date: 12/3/2024

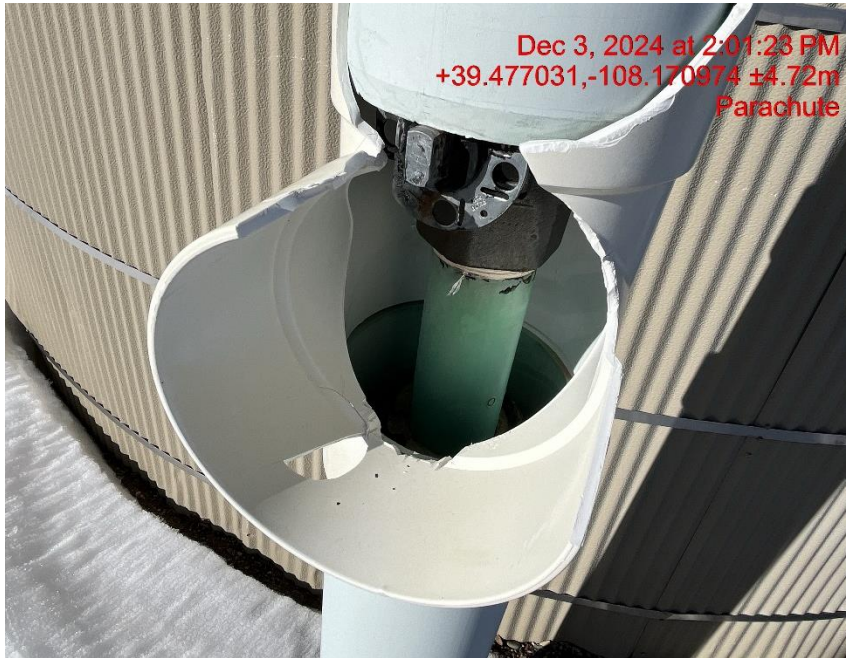
**Photo # 0203 Flow line heating insulation open ended/wildlife hazard available for entry by wildlife**

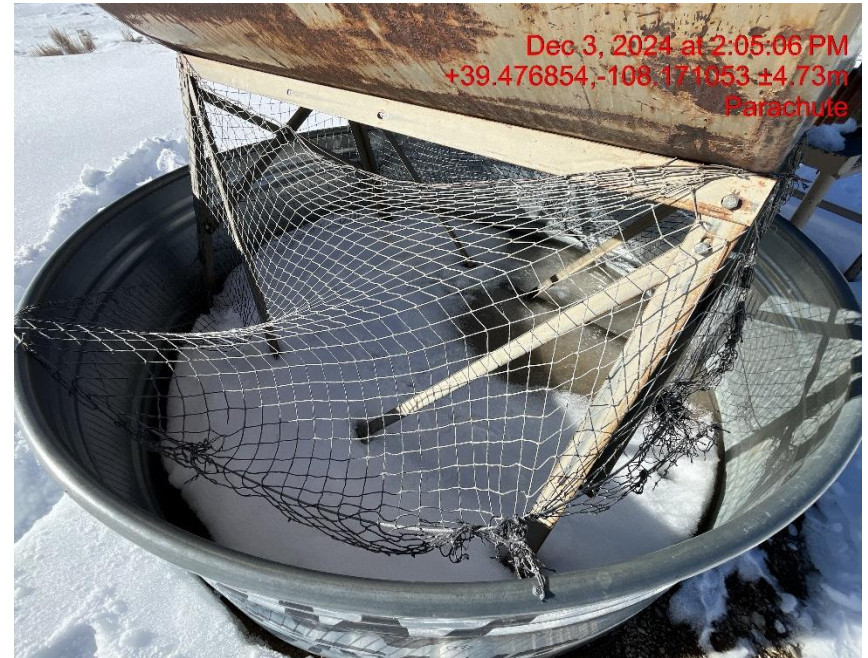
**Photo # 0209 Wildlife protection for Methanol tank containment needs maintenance/netting is damaged and open to wildlife**

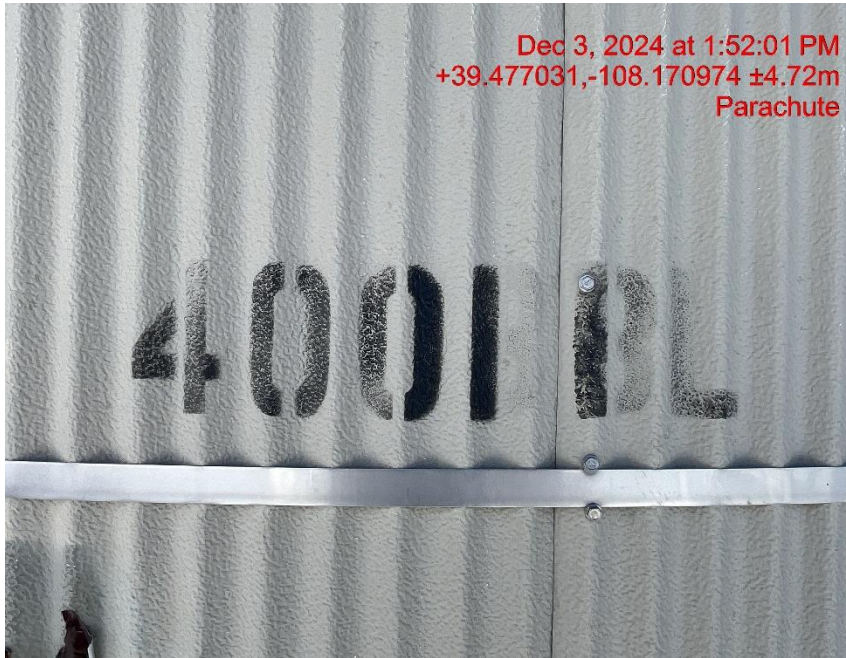
Photo # 0192 Capacity on condensate tank is weathered and becoming illegible

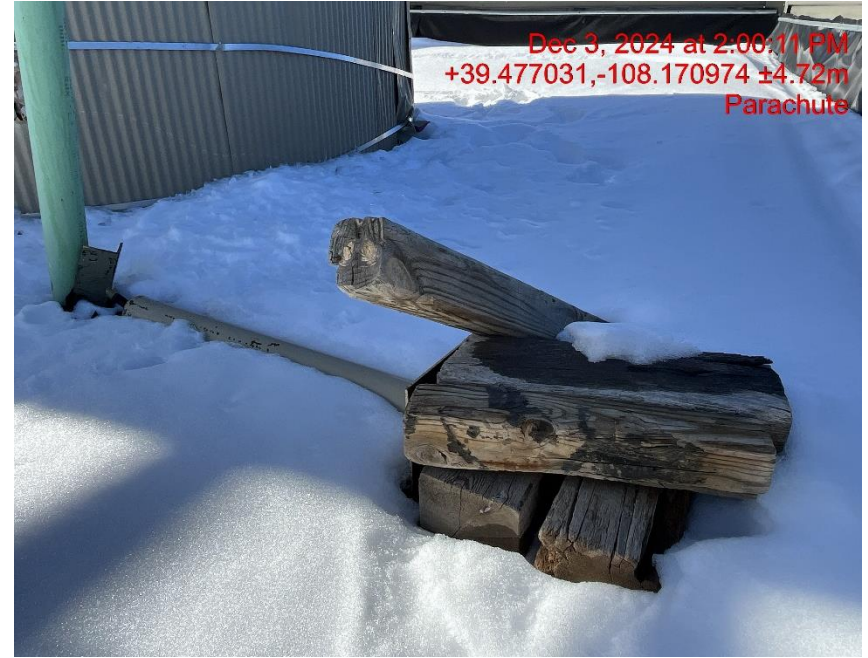
Photo # 0200 Debris

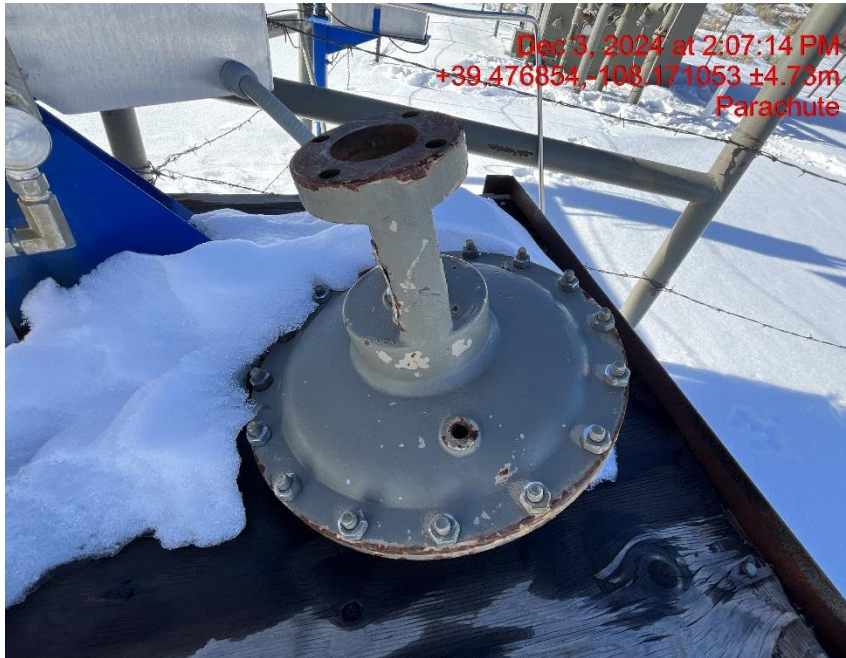
Photo # 0214 Debris

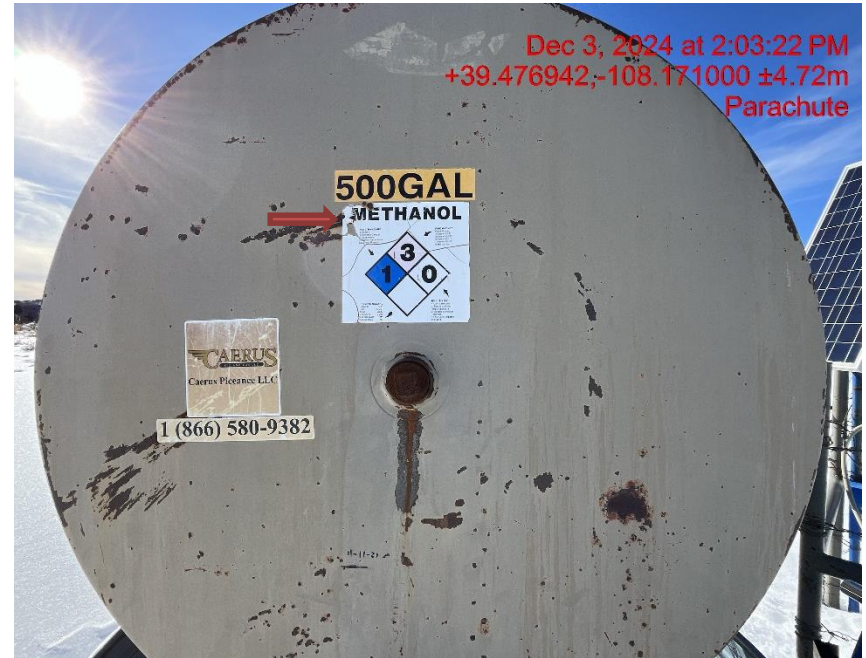
Photo # 0206 Some information on methanol tank is peeling and becoming illegible
