Inspection Photos

Location: QB ENERGY CHEVRON/TEXACO-66S97W/12SESE (GARDEN GULCH 5 696)

Location ID: 335776

Date: 12/3/2024

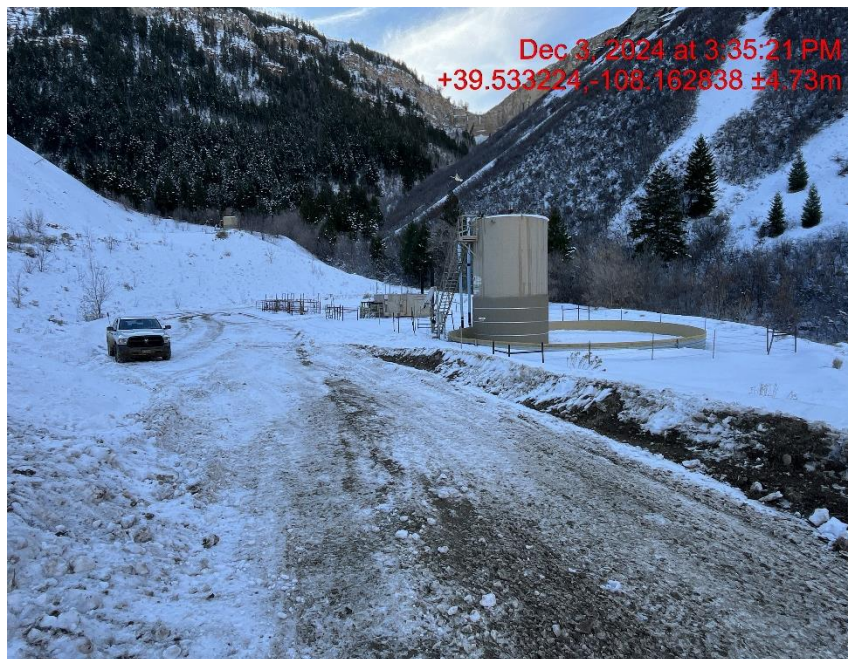
Photo # 0245 Entrance to location

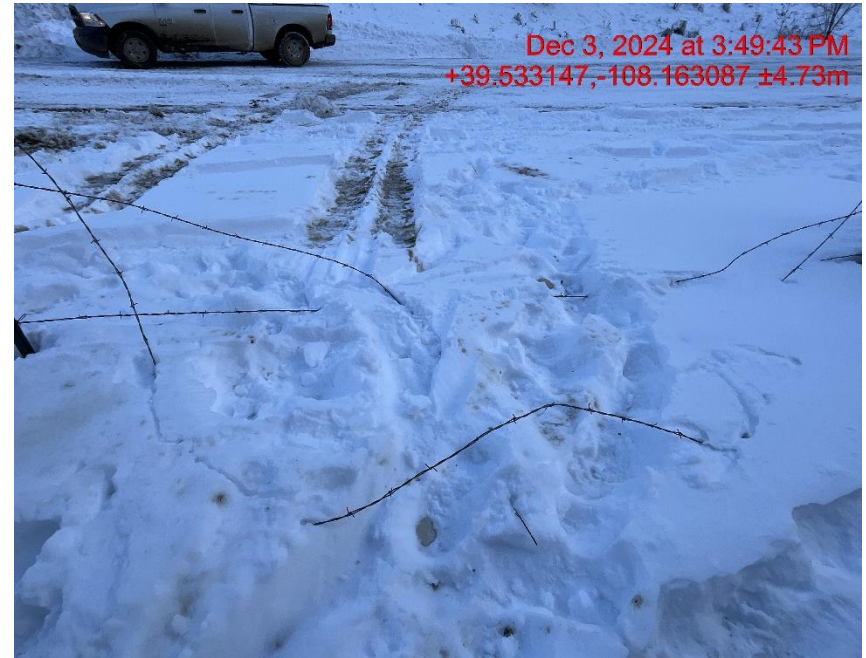
Photo # 0265 Loose barbed wire fencing/wildlife hazard

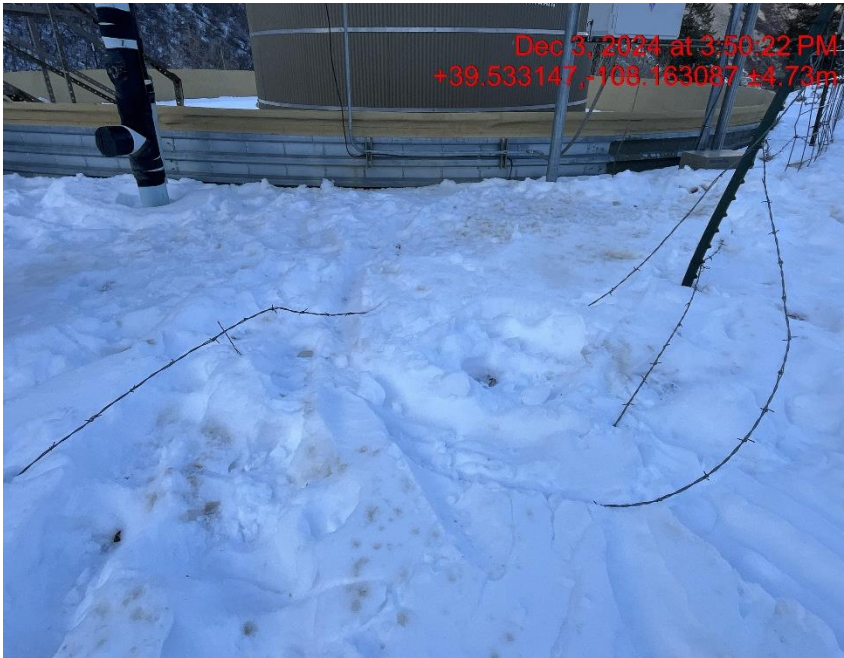
Photo # 0267 Loose barbed wire fencing/wildlife hazard

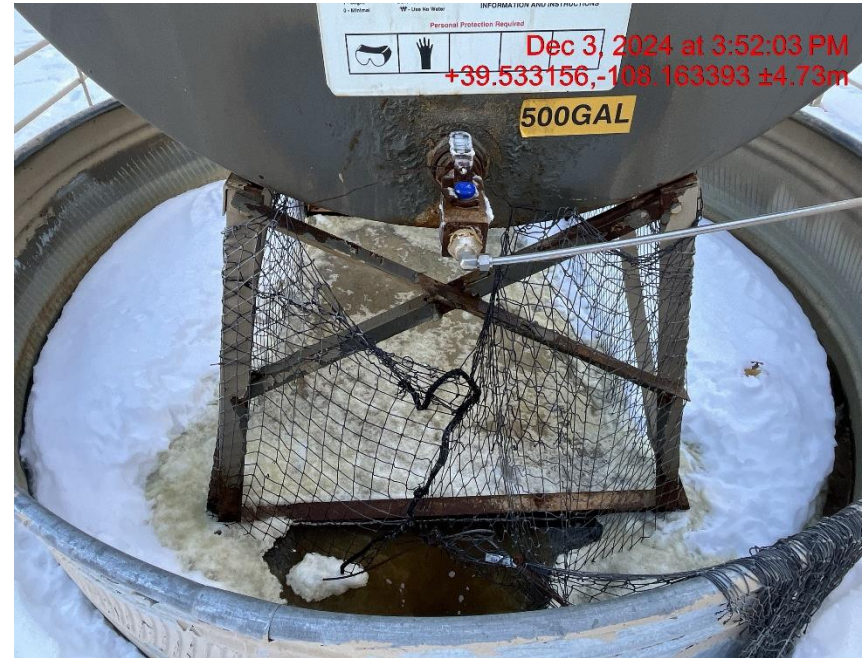
Photo # 0270 Wildlife protection for Methanol tank containment needs maintenance/netting is damaged and open to wildlife

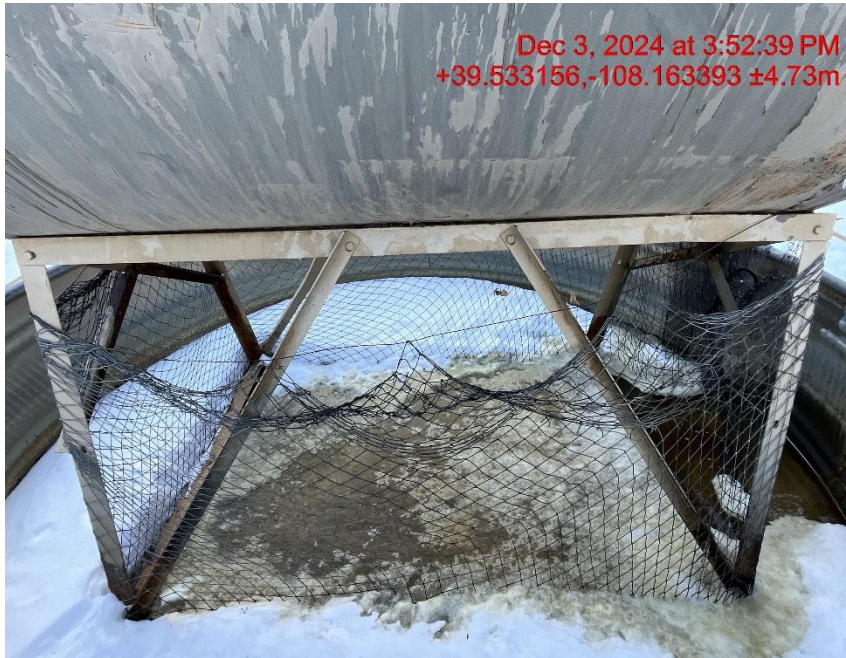
Photo # 0273 Wildlife protection for Methanol tank containment needs maintenance/netting is damaged and open to wildlife

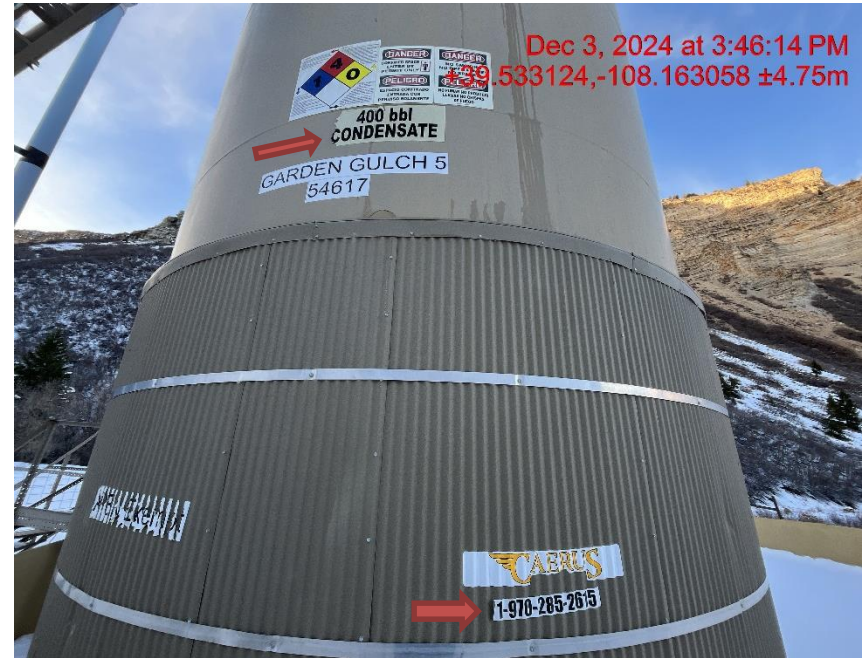
Photo # 0257 Some information on condensate tank is peeling

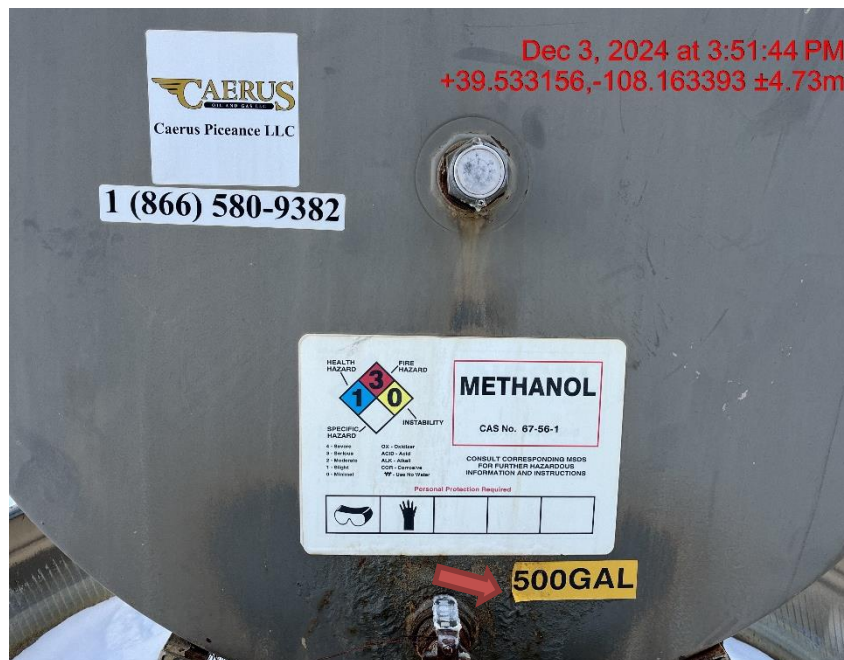
Photo # 0269 Capacity label is peeling on methanol tank
