## Inspection Photos

Location Name: TEP ROCKY MOUNTAIN LLC CIRCLE B LAND 24B-35-692 Pad

Location ID: 334695

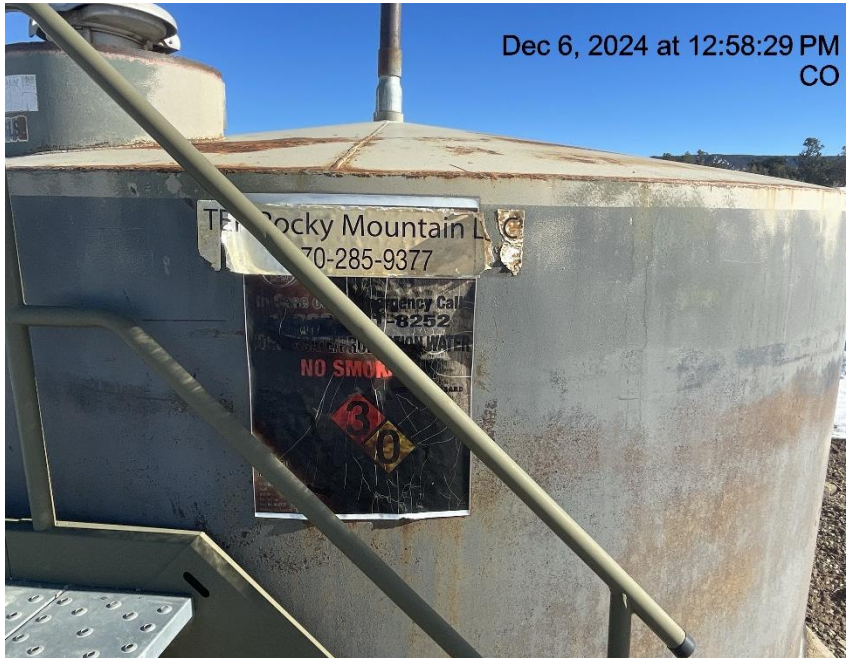
**Photo # 2573 Blowdown tank label weathered & illegible /does not comply with CECMC rules. Additionally capacity on tank label is also incorrect**

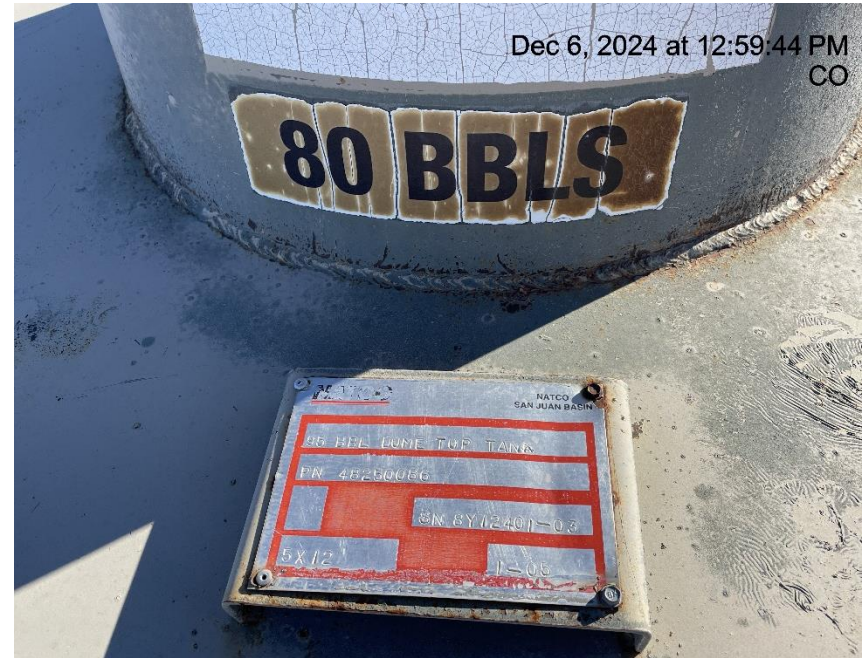
**Photo # 2574 Capacity on tank label for blowdown tank is incorrect/does not comply with CECMC rules**

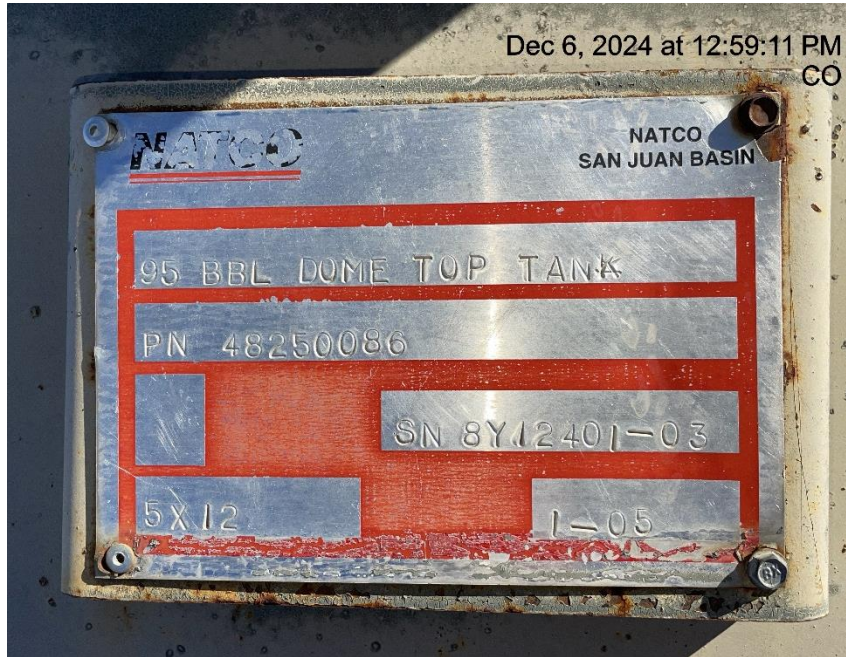
Photo # 2575 Correct tank capacity

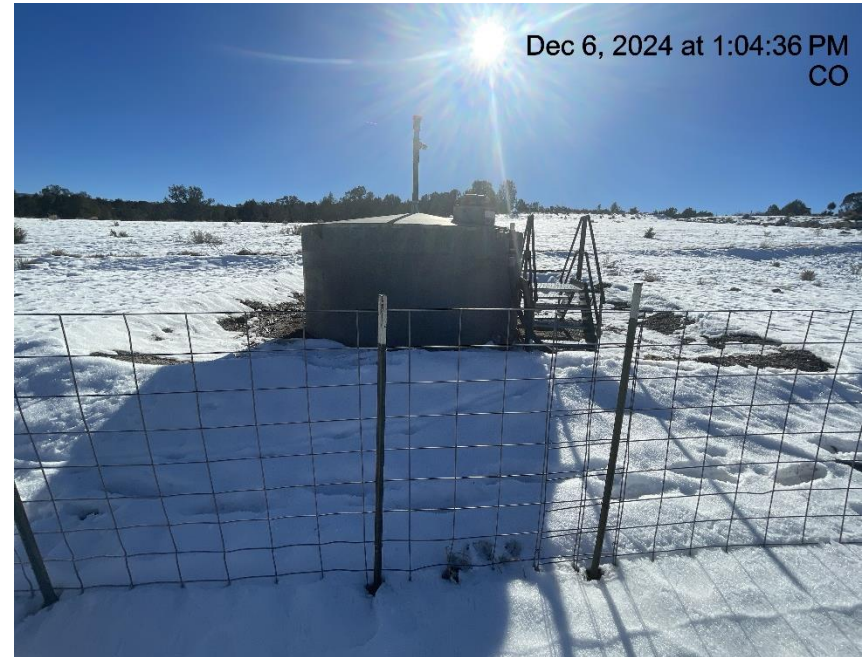
Photo # 2576 Secondary containment insufficient/does not comply with CECMC rules

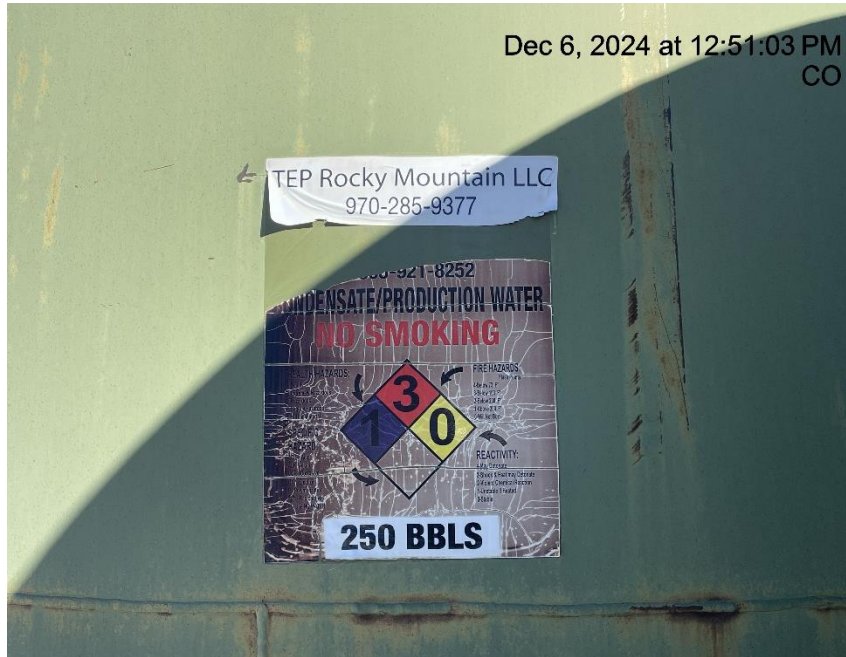
Photo # 2577 Tank label weathered & damaged

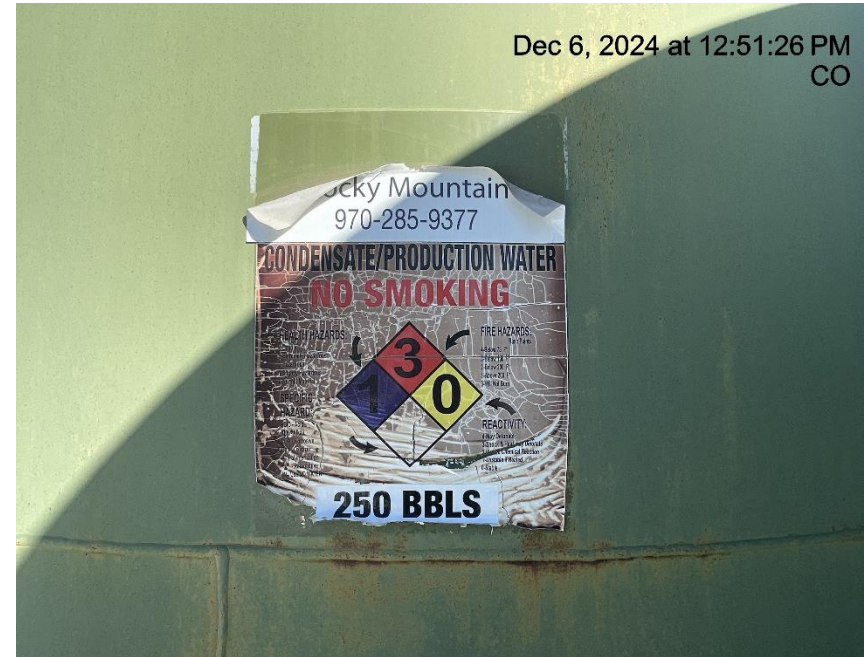
Photo # 2578 Tank label weathered & damaged

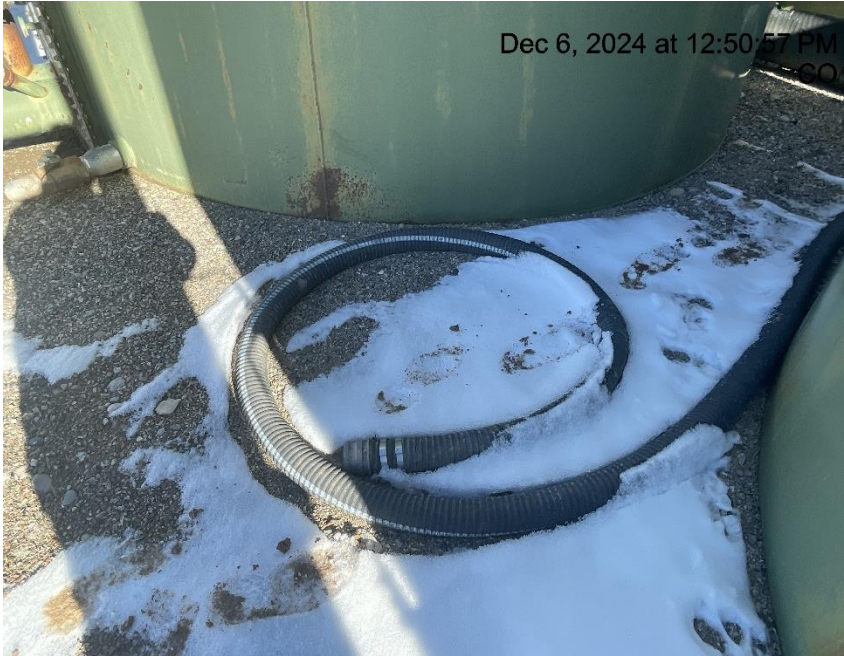
**Photo # 2579 Unused hose in secondary containment**

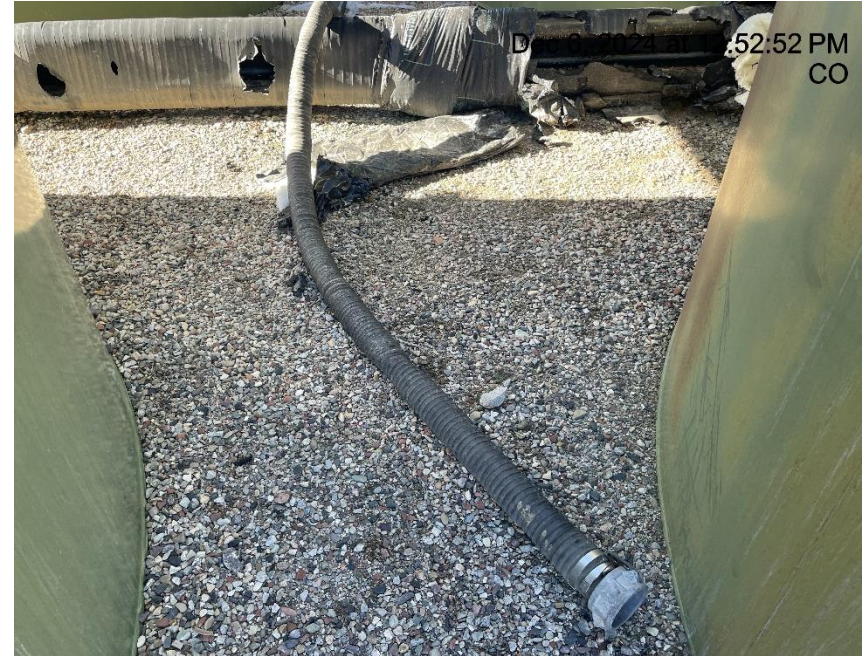
**Photo # 2580 Unused hose & small amount of debris in secondary containment**

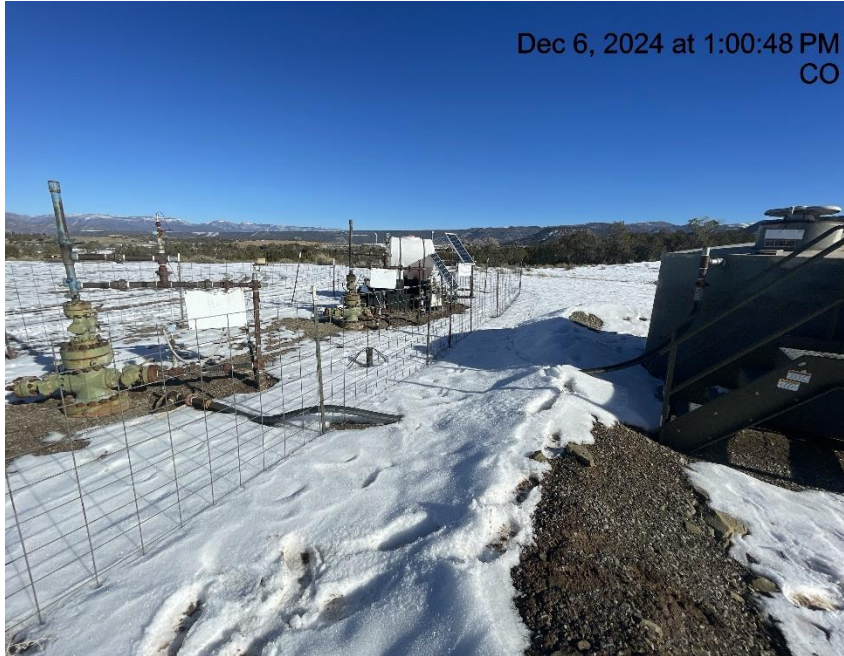
**Photo # 2581 CIRCLE B LAND 14C-35-692 well bradenhead line connected to blowdown tank**

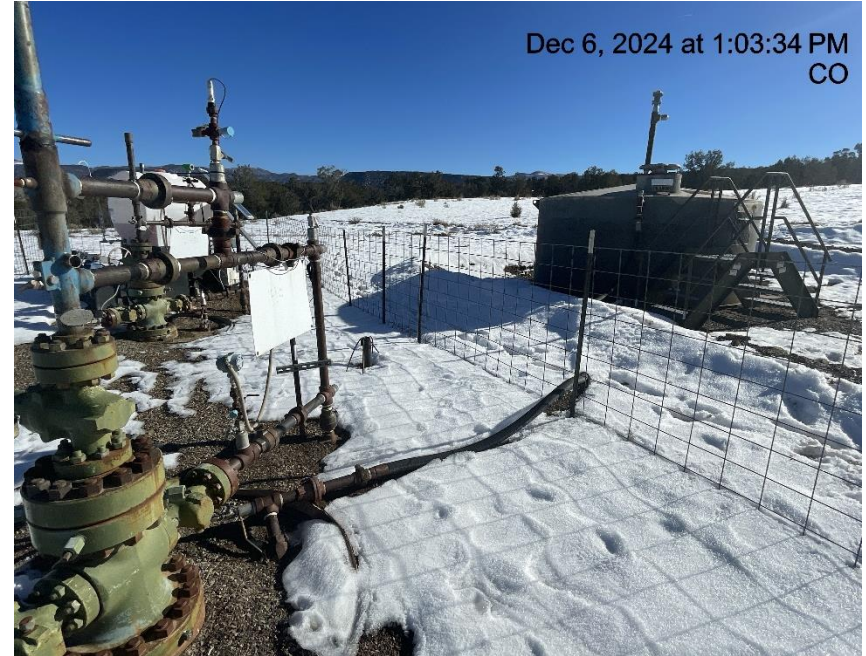
**Photo # 2582 CIRCLE B LAND 14C-35-692 well bradenhead line connected to blowdown tank**

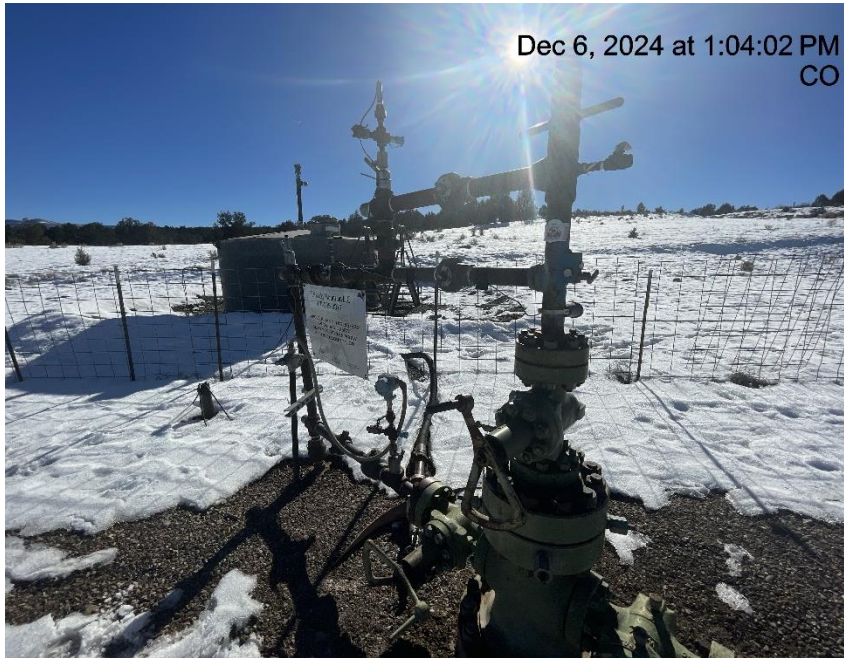
**Photo # 2583 CIRCLE B LAND 14C-35-692 well bradenhead  
line connected to blowdown tank**
