Inspection Photos

Location: TEP ROCKY MOUNTAIN LLC UNOCAL-67S96W/1NWSW (GM 14-1 PAD)

Location ID: 334925

Date: 12/5/2024

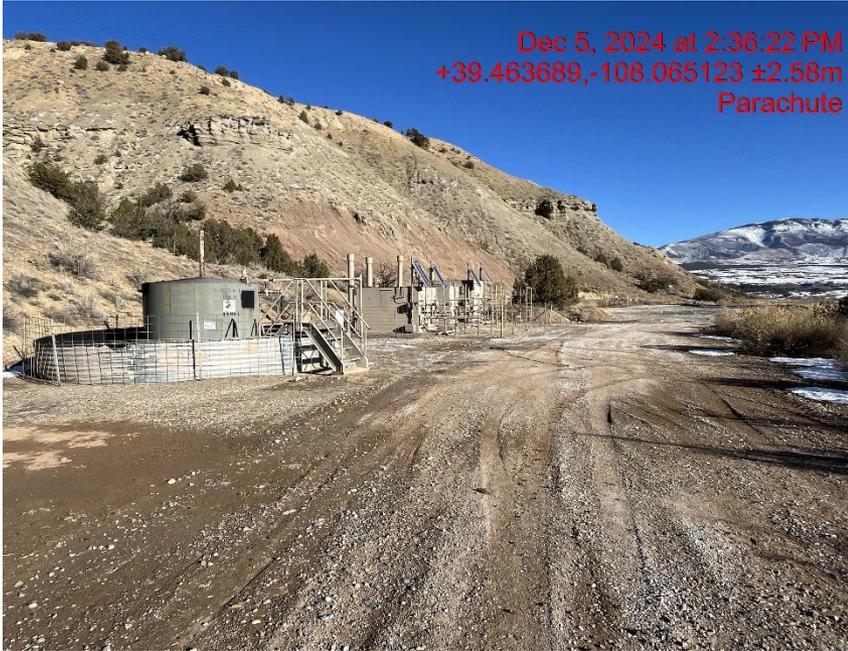
Photo # 0305 Entrance to location

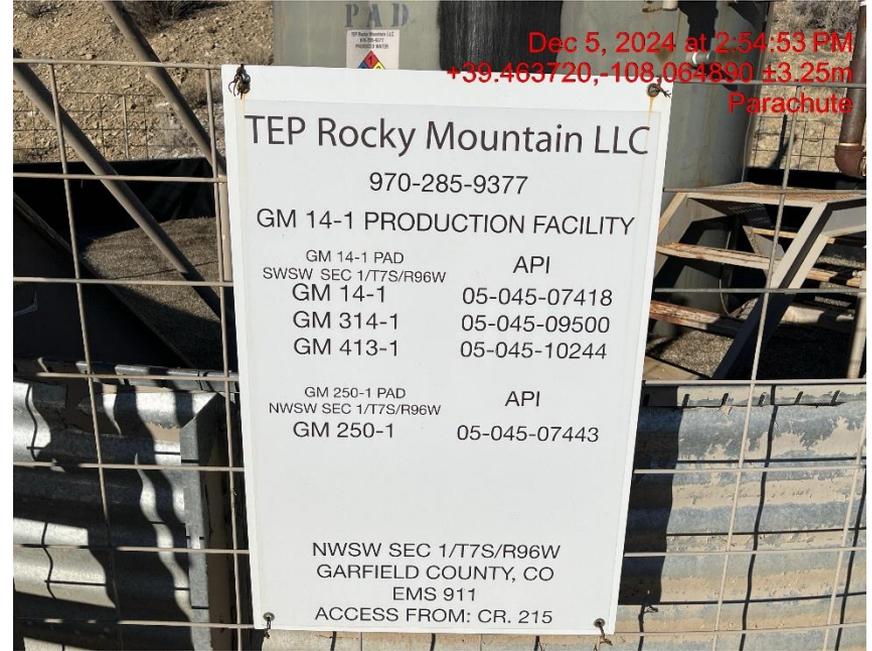
Photo # 0332 Location

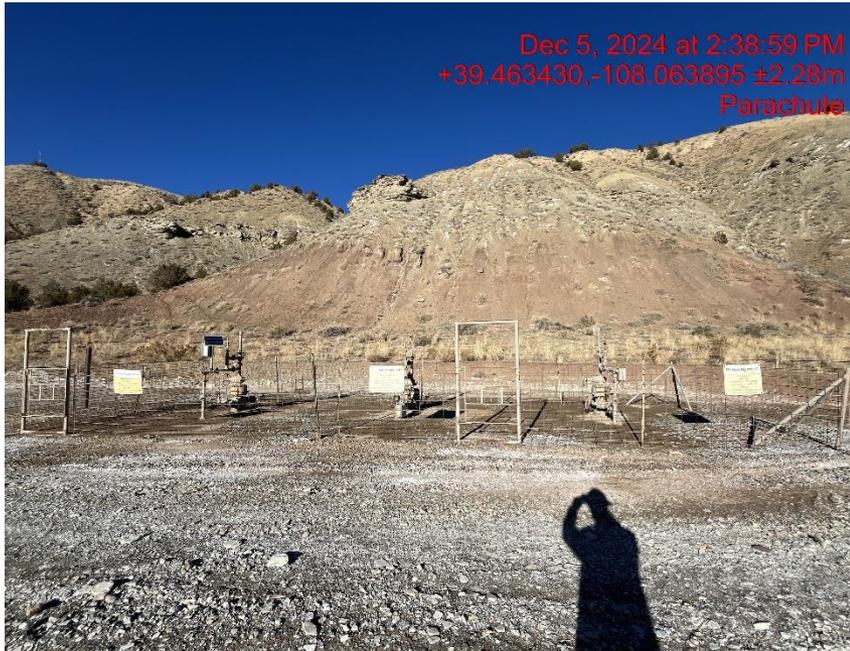
Photo # 0306 Location

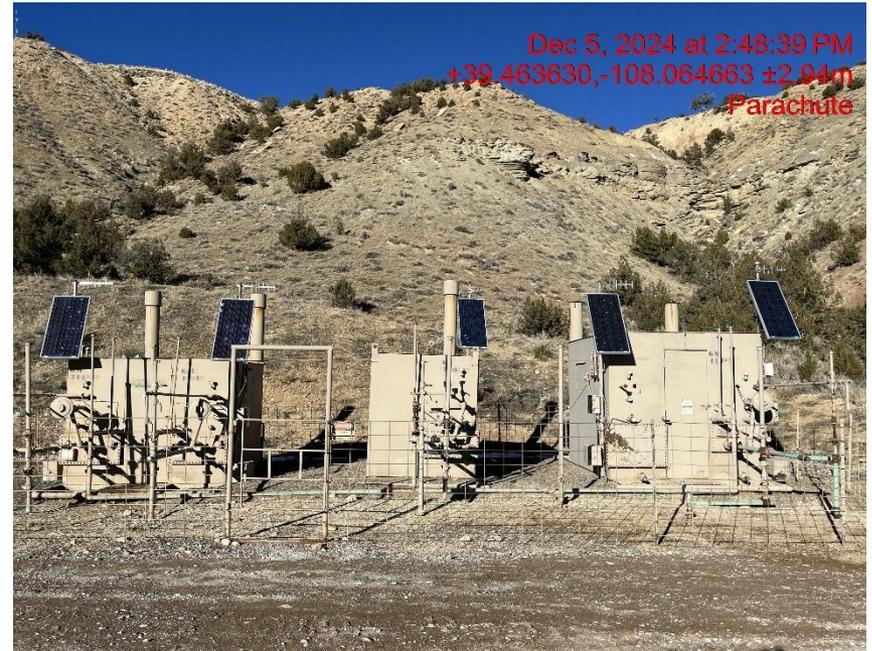
Photo # 0319 Location

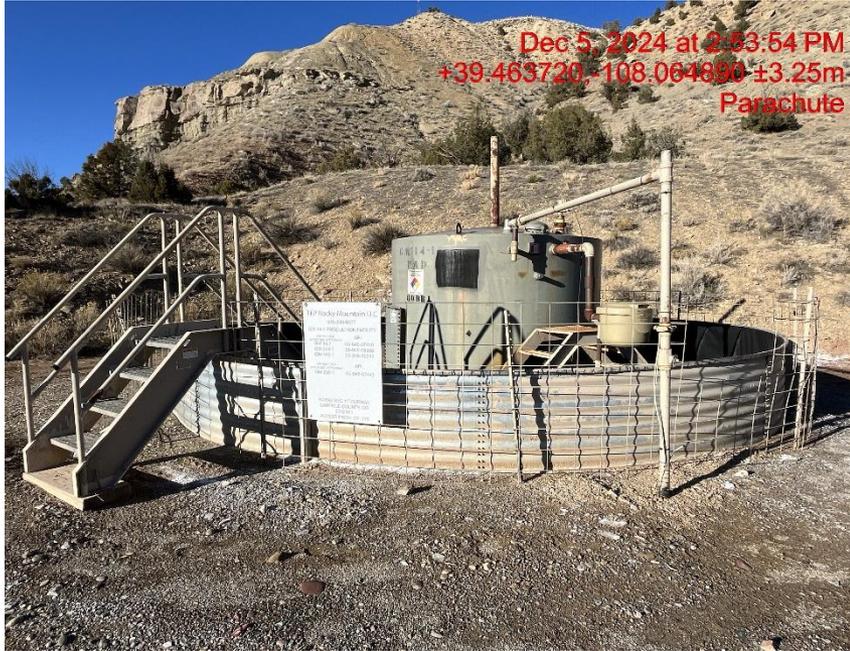
Photo # 0330 Location

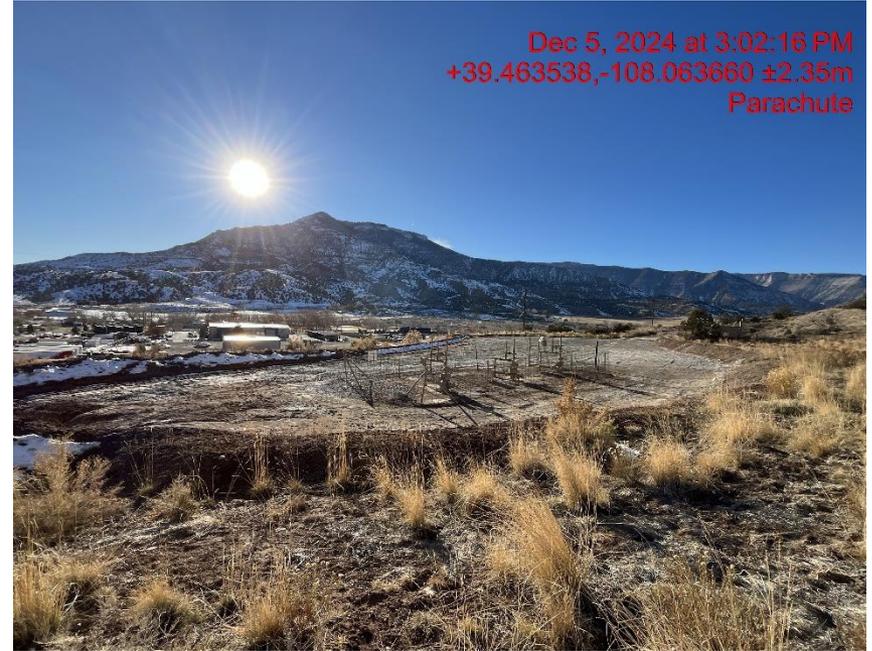
Photo # 0341 NE corner of location

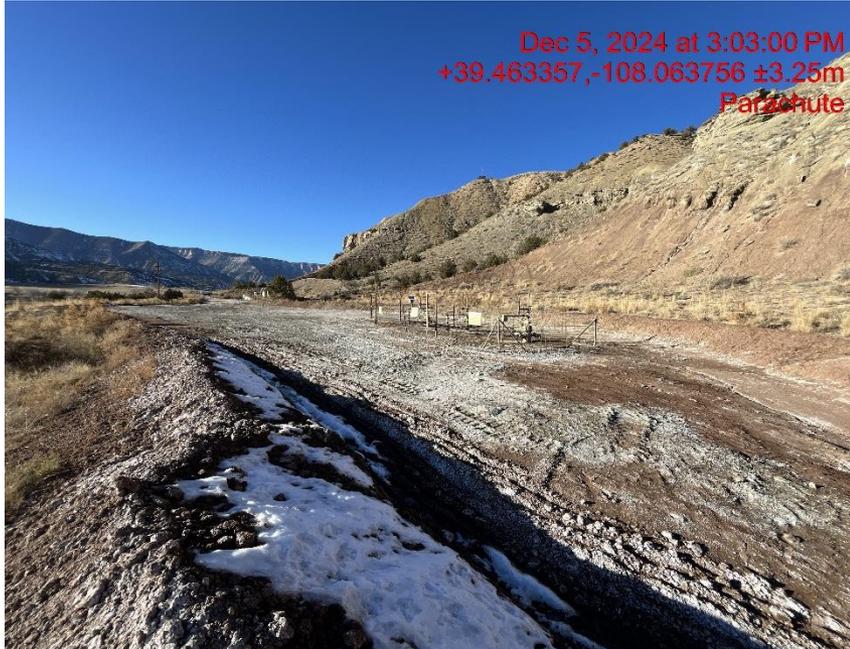
Photo # 0342 SE corner of location

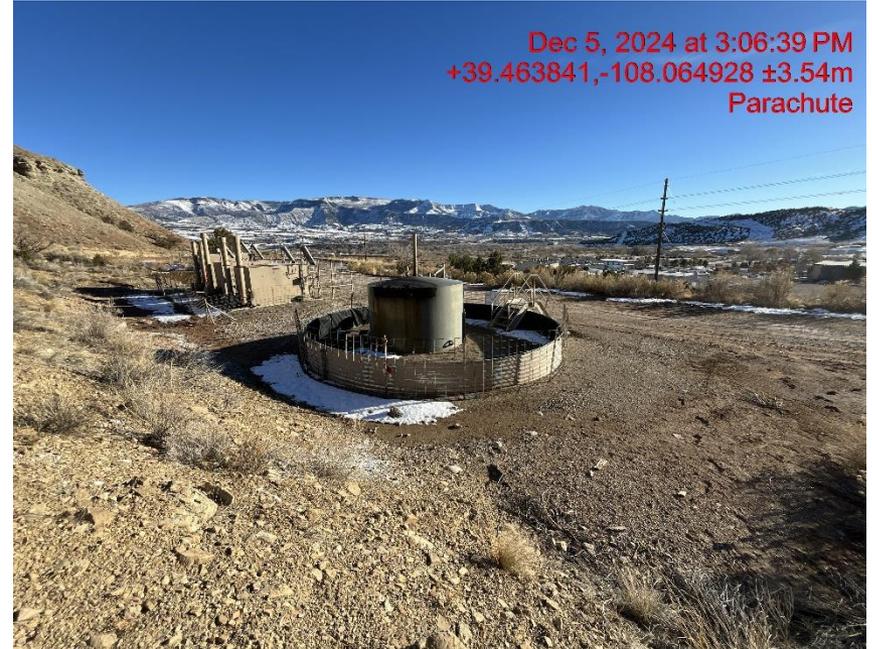
Photo # 0348 NW corner of location

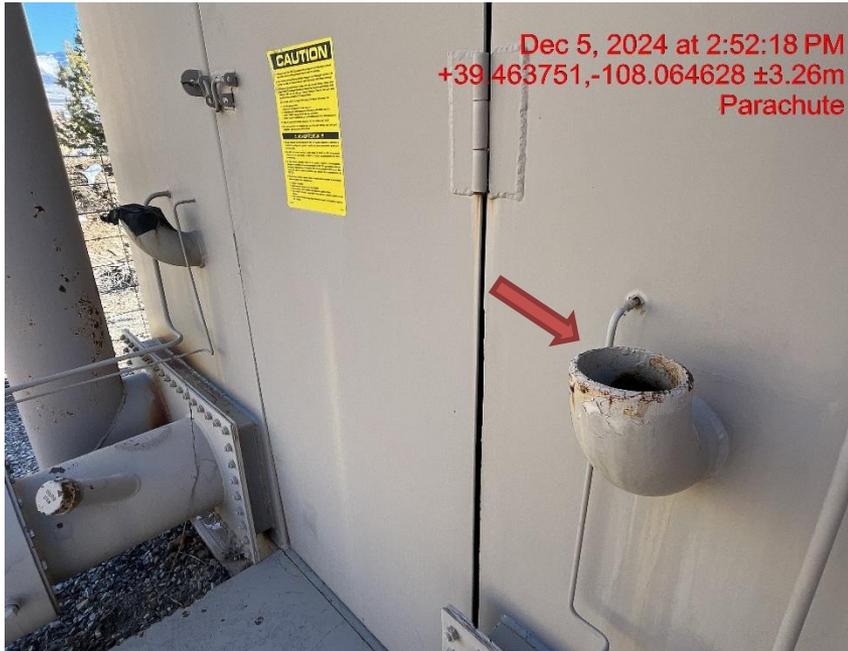
Photo # 0326 Open ended piping/wildlife hazard/ available for entry by wildlife

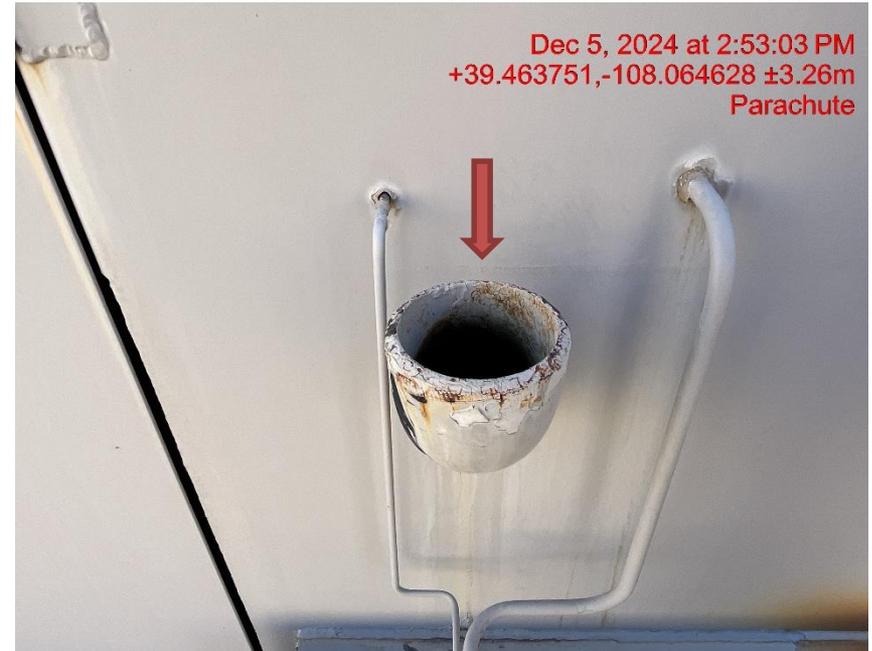
Photo # 0329 Open ended piping/wildlife hazard/ available for entry by wildlife

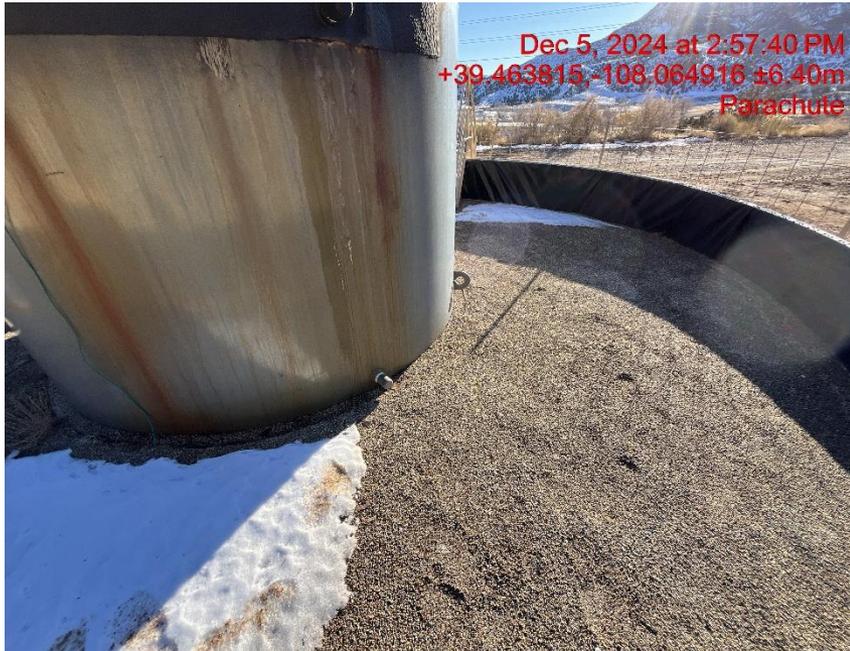
Photo # 0335 Suspected leaks on production tank/tank appears to lack integrity

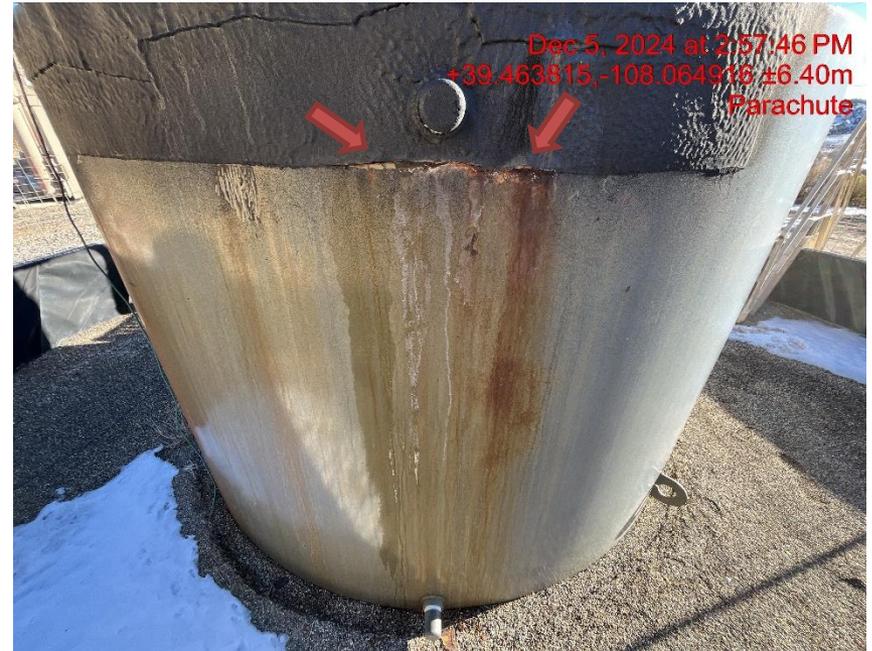
Photo # 0336 Suspected leaks on production tank/tank appears to lack integrity

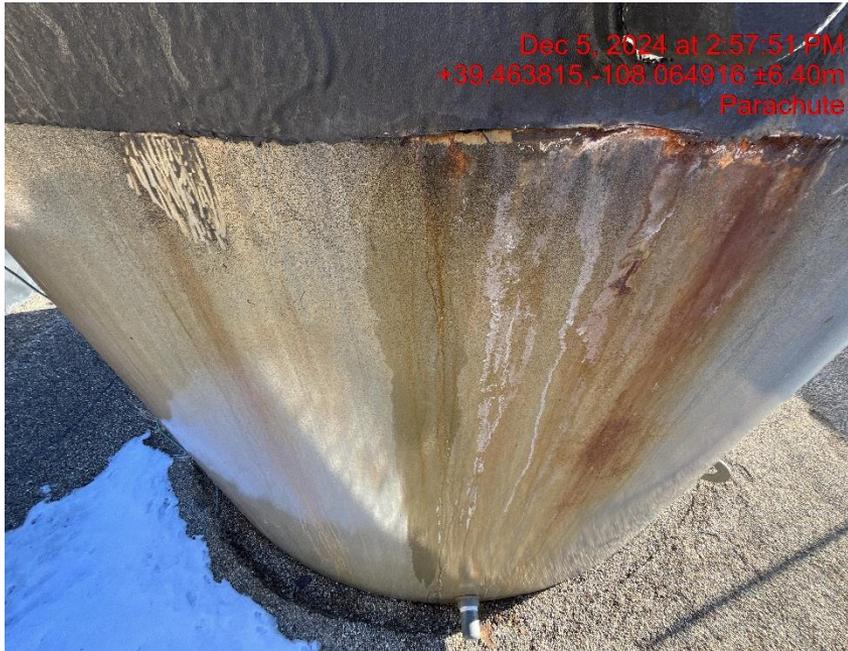
Photo # 0337 Suspected leaks on production tank/tank appears to lack integrity

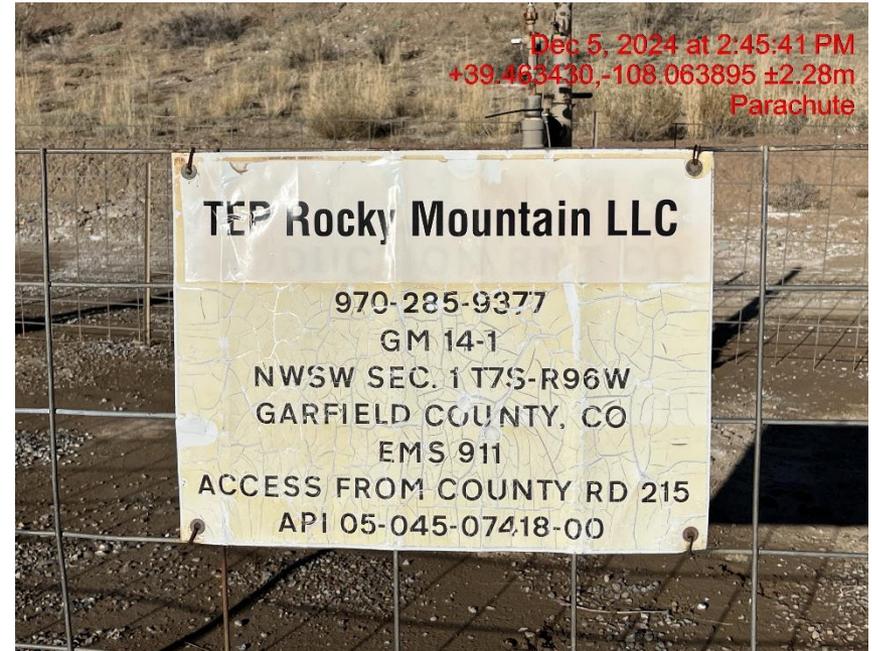
Photo # 0313 Wellhead signs are weathered & cracked and becoming illegible

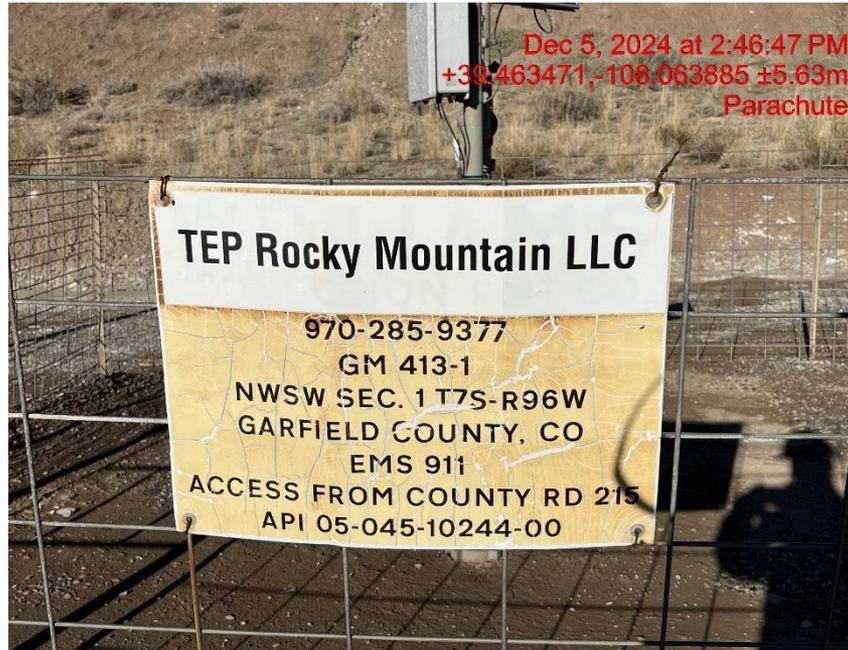
Photo # 0317 Wellhead signs are weathered & cracked and becoming illegible
