Inspection Photos

Location Name: TEP ROCKY MOUNTAIN LLC, GM-66S96W/27SWSE

Location ID: 324239

Date: 12/6/2024

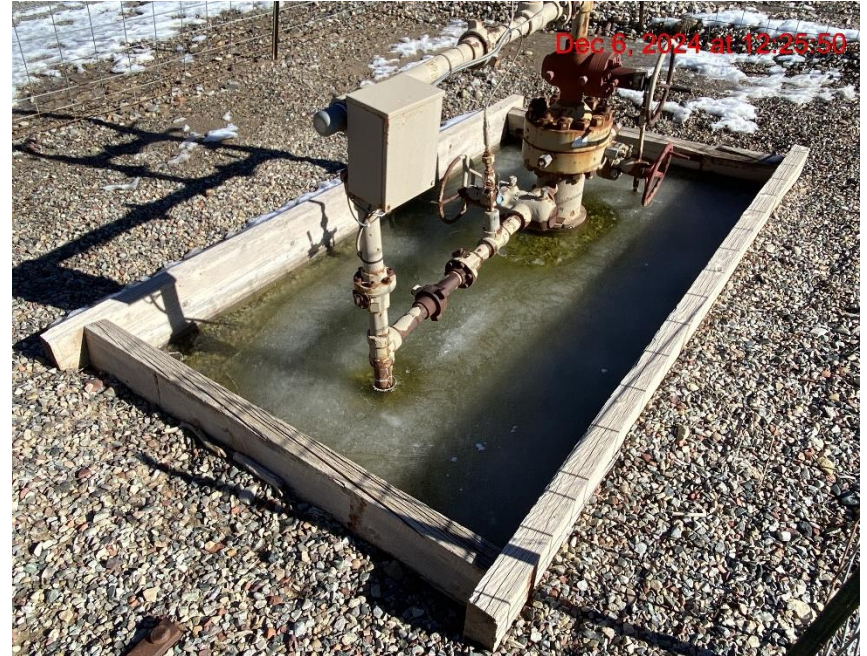
Open Wellhead Cellar/No Wildlife Egress – Photo #05191

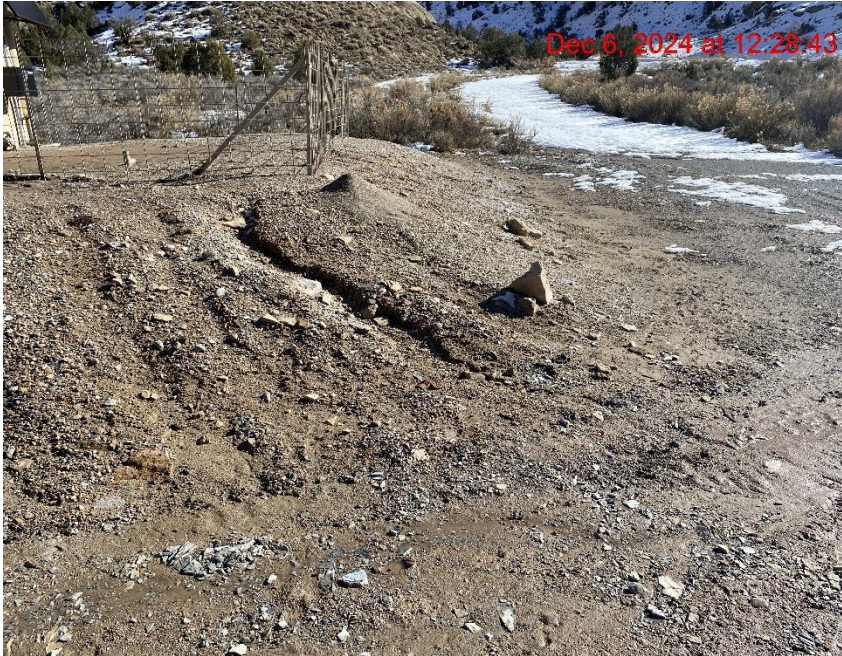
Insufficient Erosion Control – Photo #05195

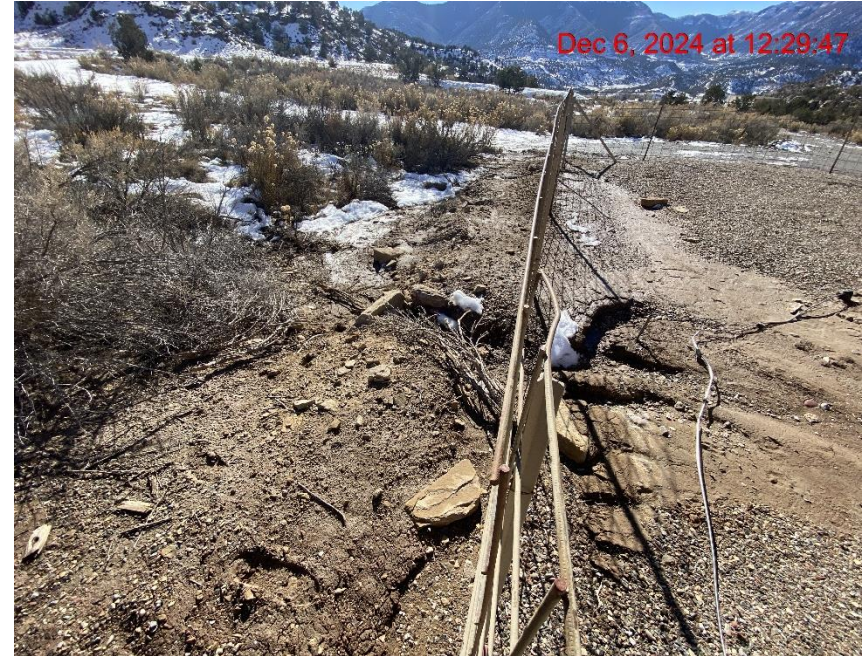
Sediment Transport Off Site – Photo #05198

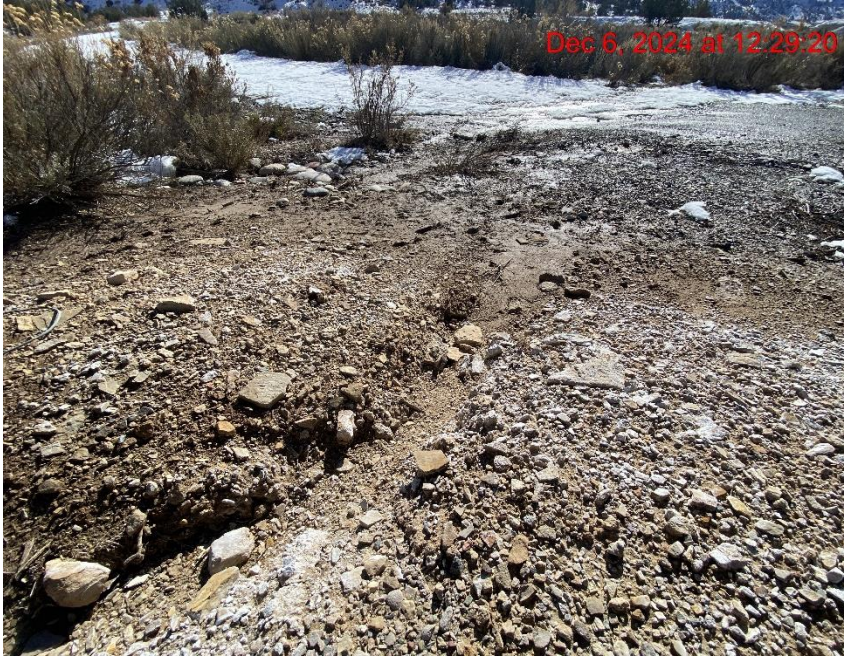
Sediment Transport Off Site – Photo #05197
