Inspection Photos

Location Name: TEP ROCKY MOUNTAIN LLC, GM-66S96W/27SWSE

Location ID: 335398

Date: 12/6/2024

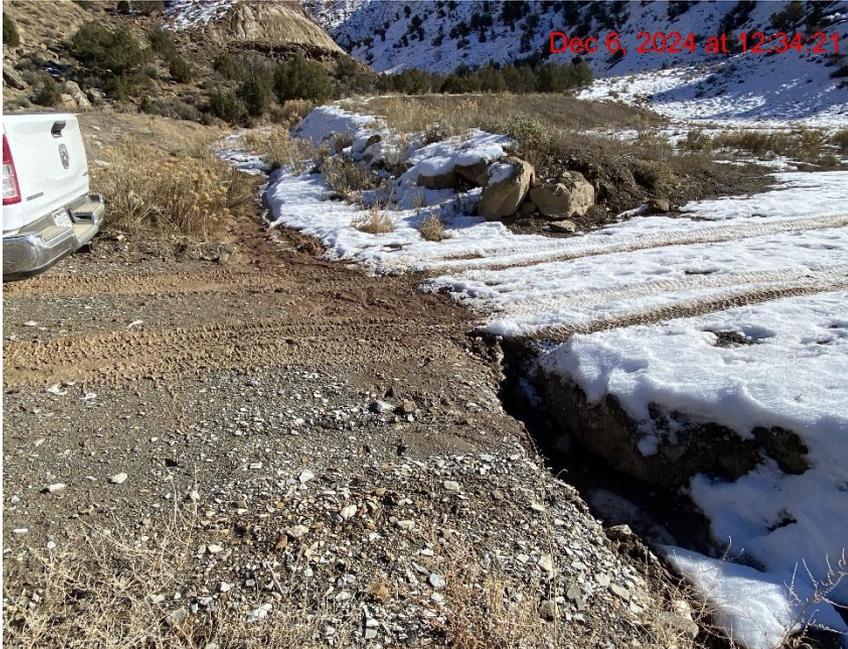
Insufficient Erosion Control/Degradation – Photo #05205

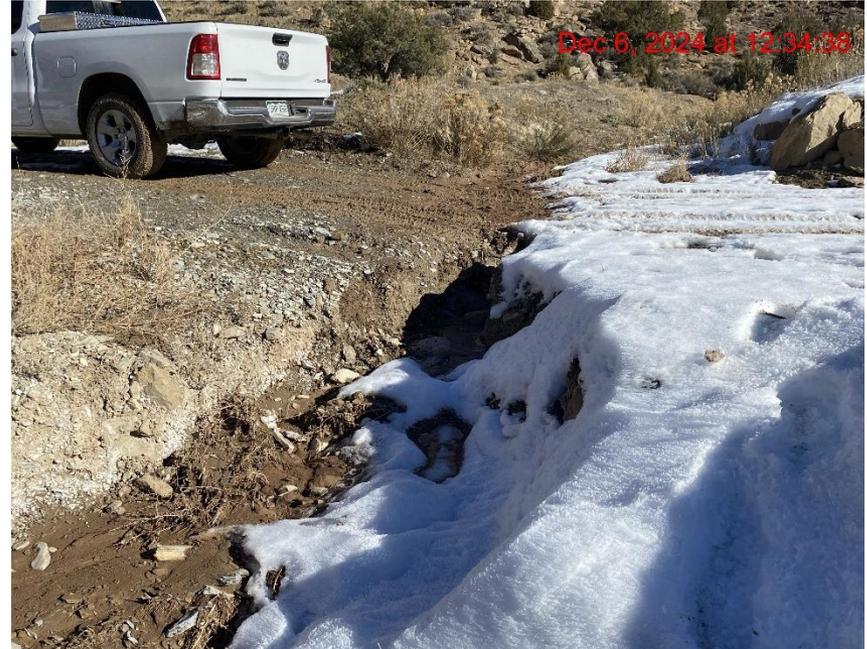
Insufficient Erosion Control/Degradation – Photo #05206

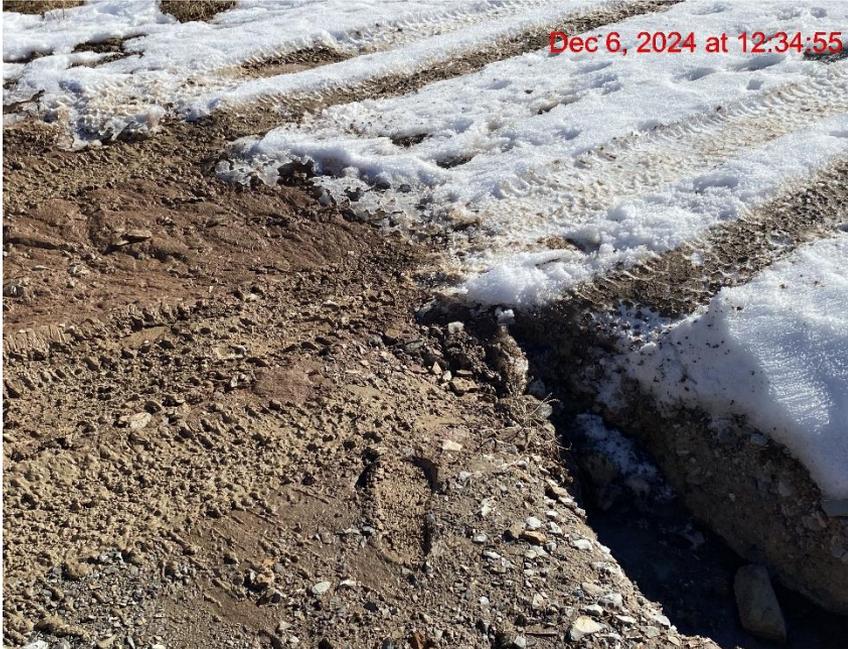
Insufficient Erosion Control/Degradation – Photo #05207

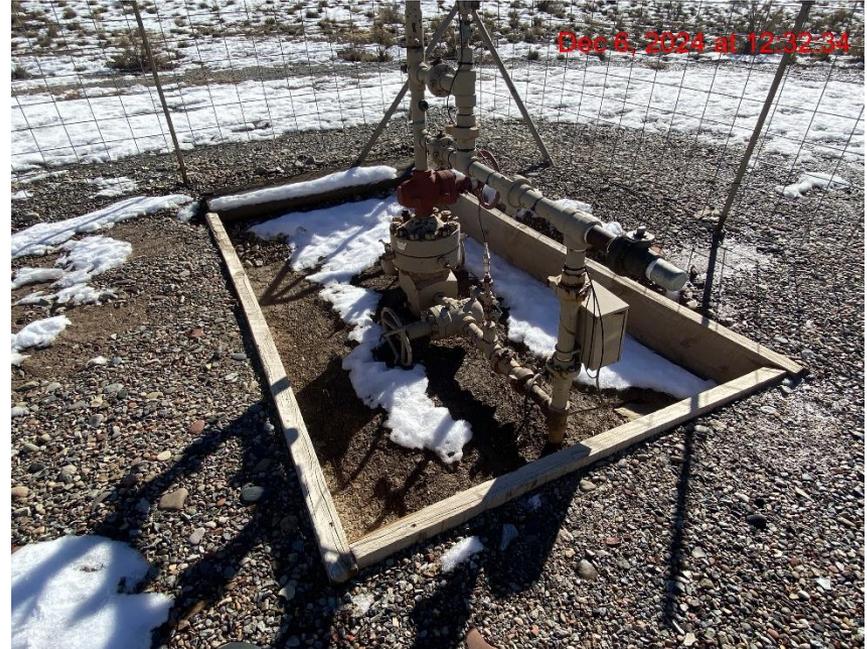
Open Wellhead Cellar/No Wildlife Egress – Photo #05202
