Inspection Photos
Location Name: Reliance E 23-79HN Econode
Location: 435930

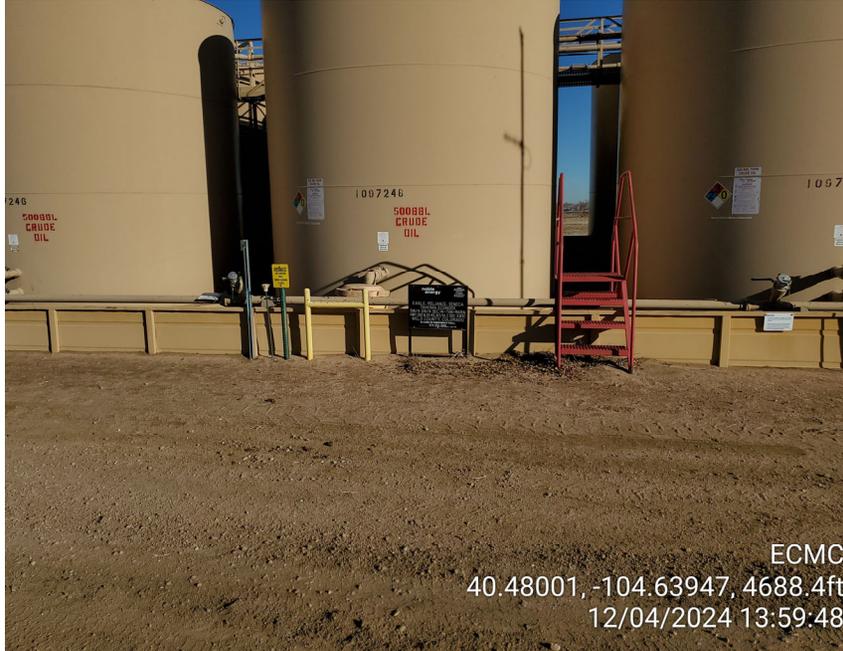
Photo 1: Location Sign at AST battery

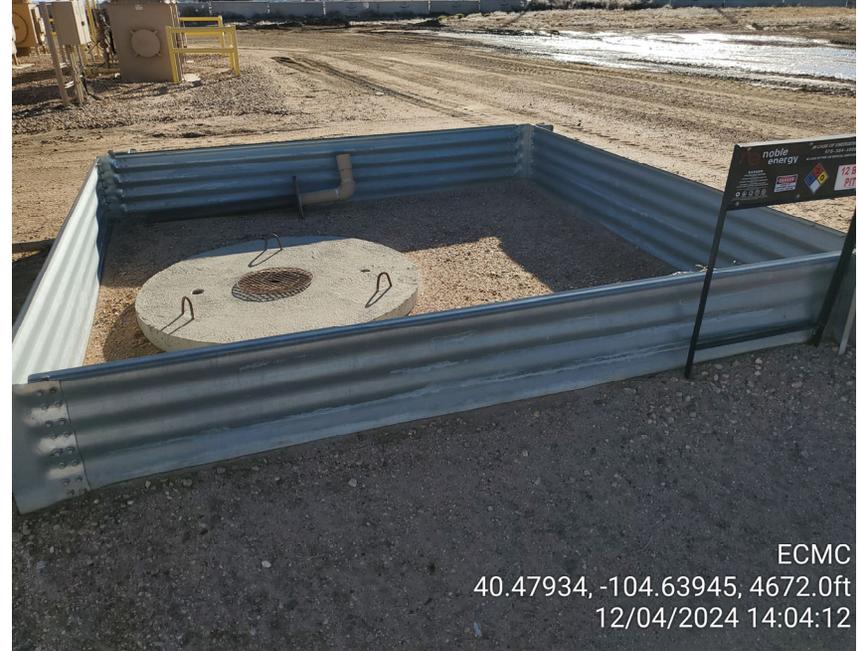
Photo 2: Partially buried vault/condensate drain near compressor

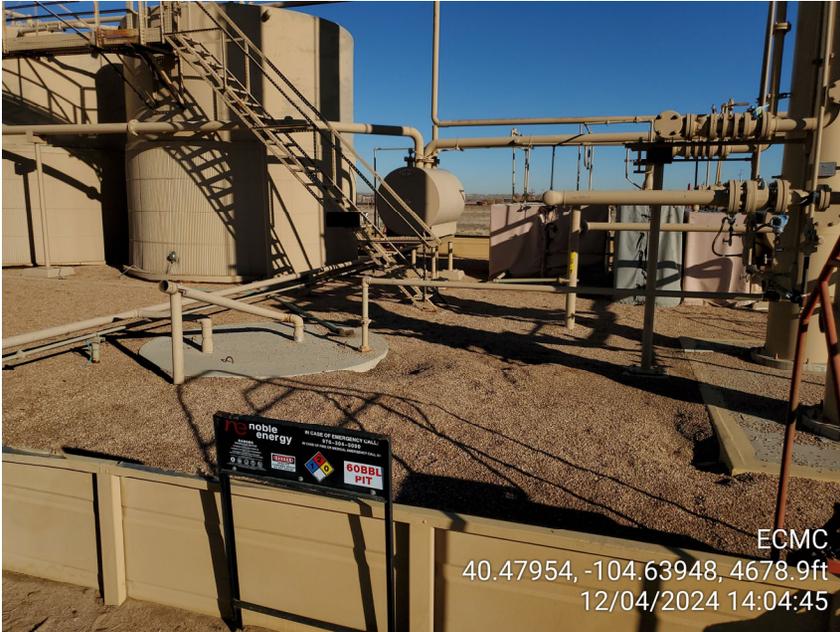
Photo 3: Buried produced water vessel and ancillary piping

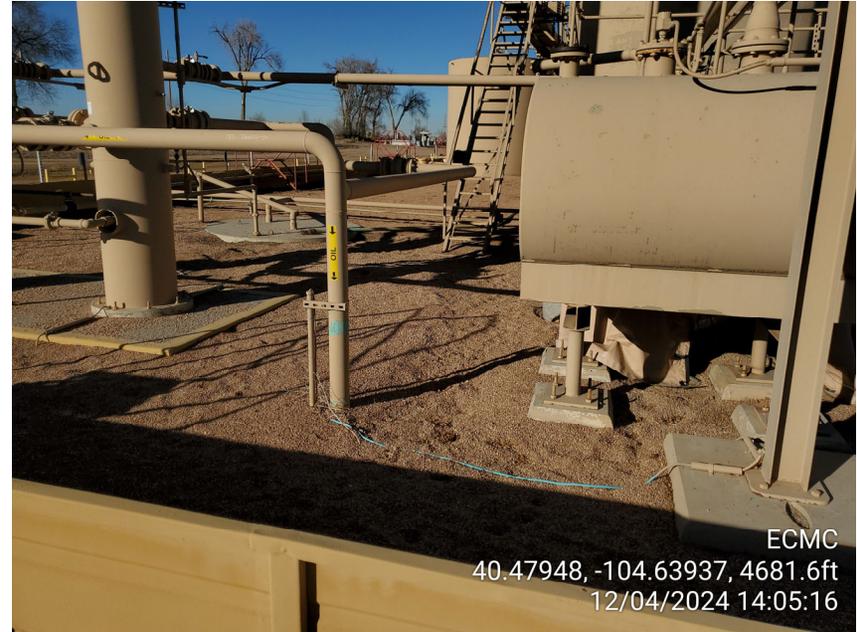
Photo 4: Ancillary piping and equipment within AST containment

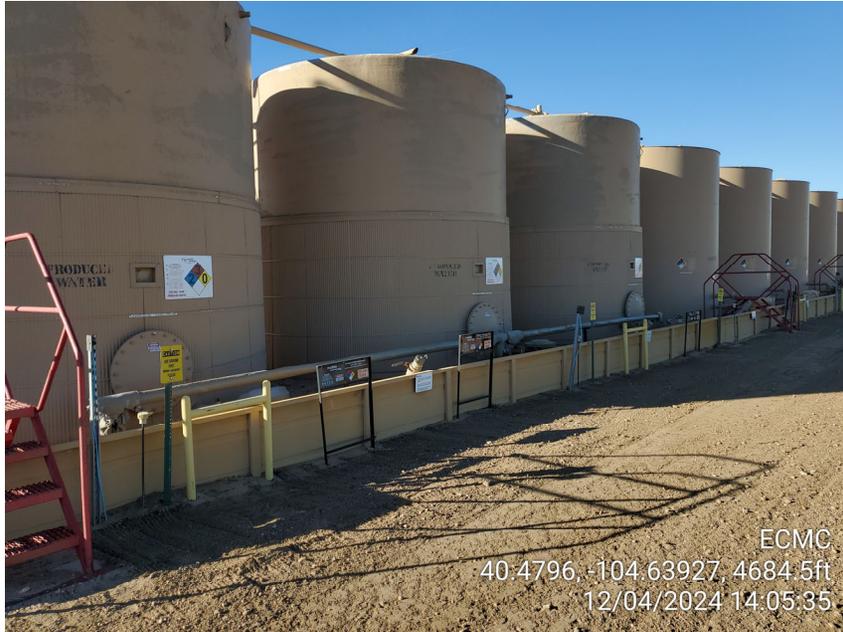
Photo 5: Above ground storage tank battery

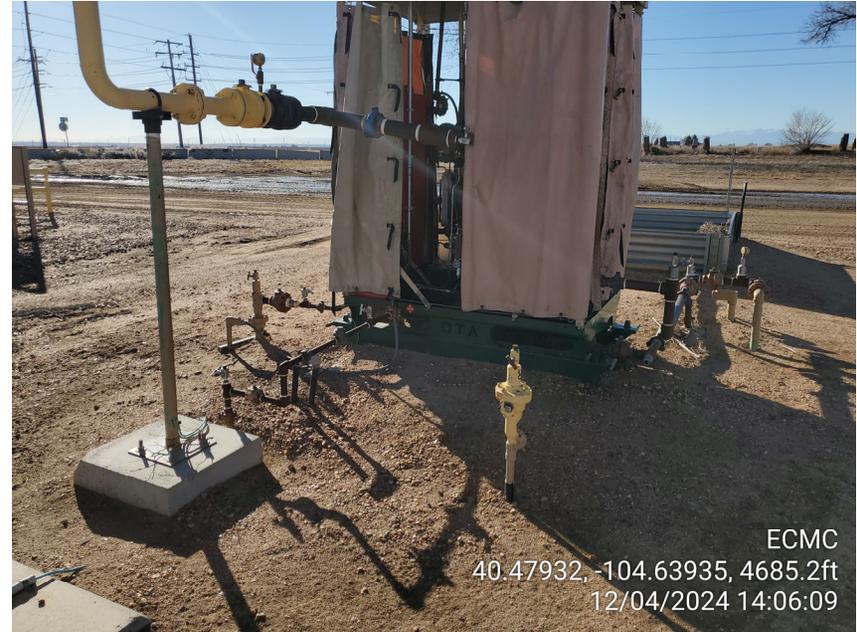
Photo 6: Process piping example

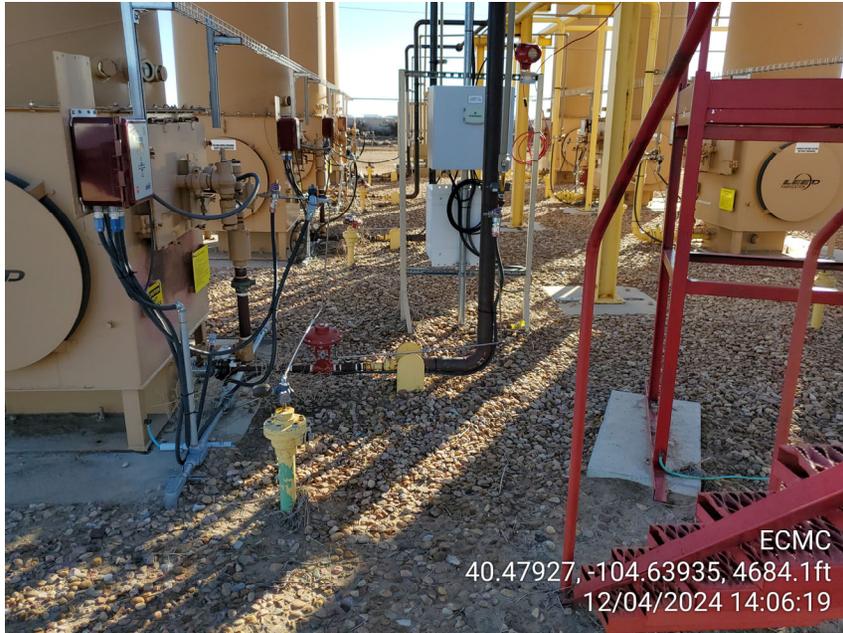
Photo 7: Process piping examples: stub ups near Emission Control Devices

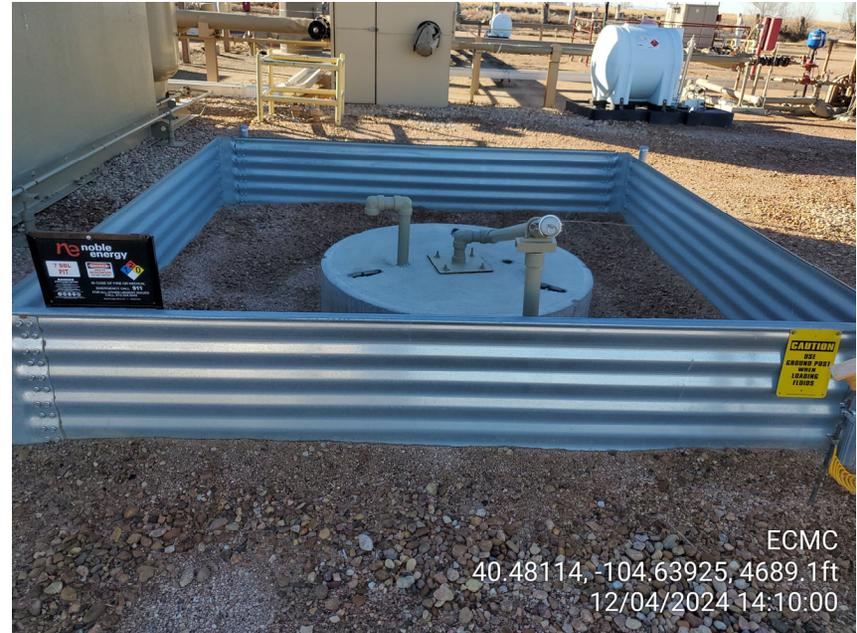
Photo 8: Concrete buried vessel near LACT

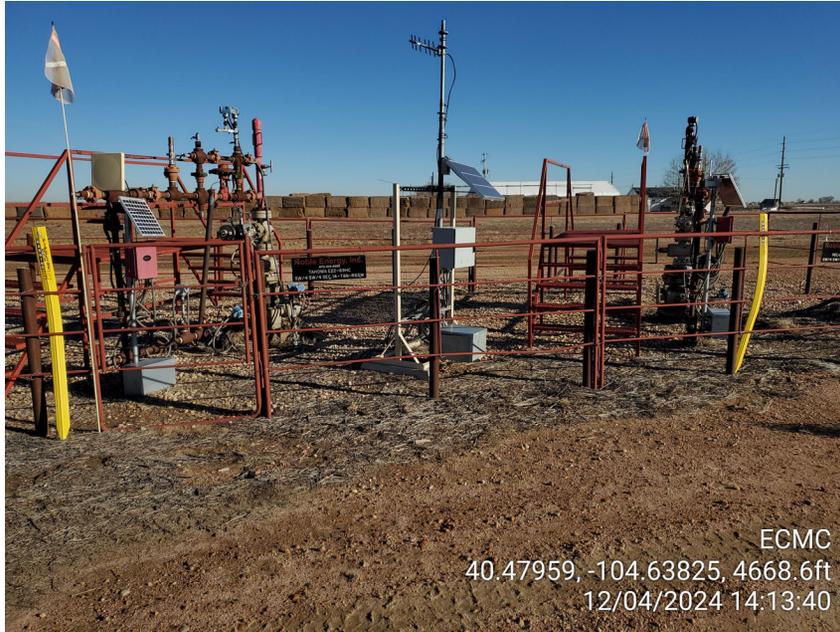
Photo 9: Tahoma E 22-69HC and Reliance E23-79HN wells

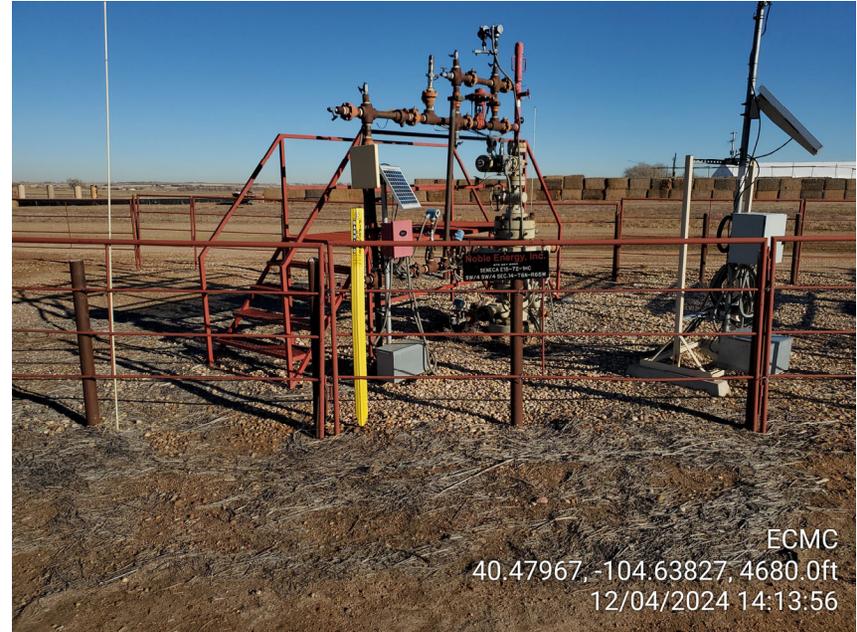
Photo 10: Seneca E15-72-1HC well

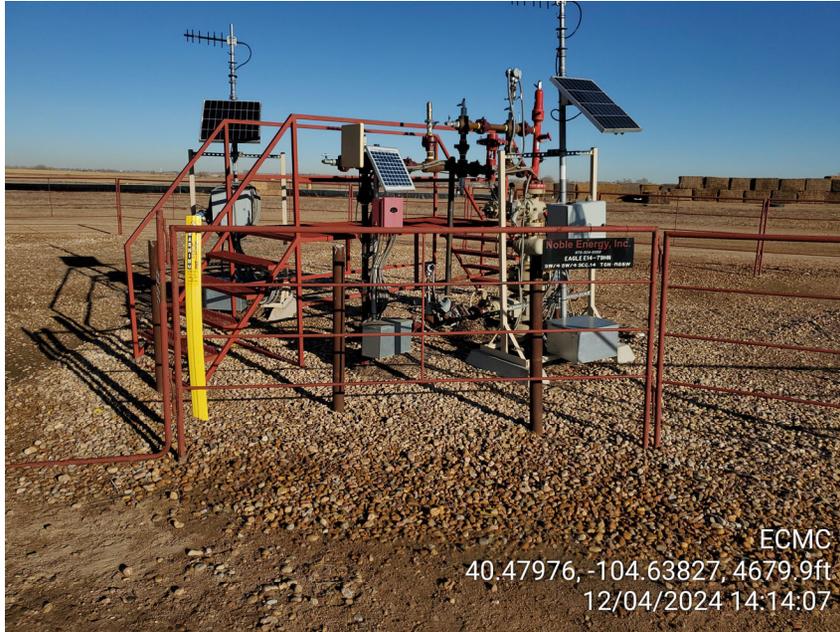
Photo 11: Eagle E14-79HN well

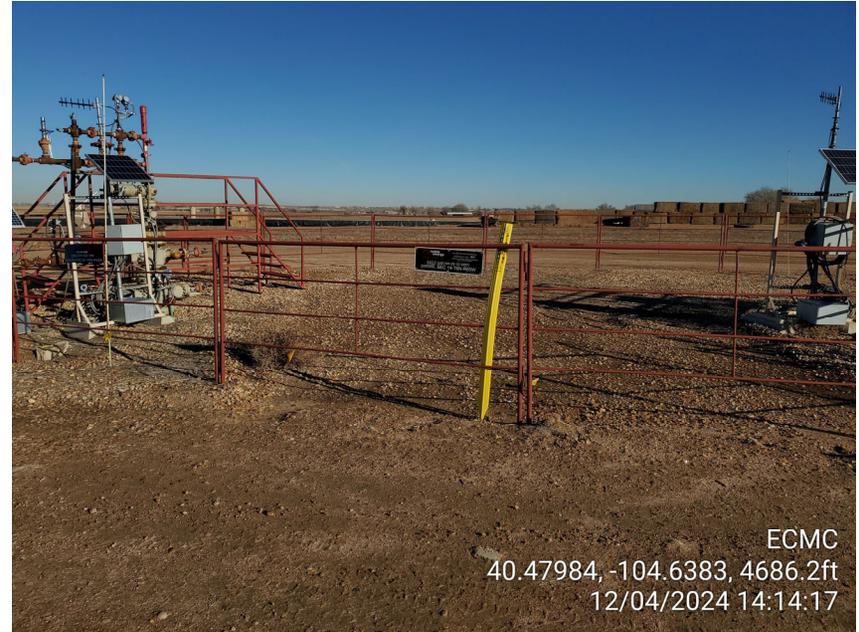
Photo 12: Eagle 14-62-1HN well site (P&A) (Remediation Project 30834)
