Inspection Photos

API: 071-09013

Operator: WAPITI OPERATING LLC

Inspection Date: 12/9/2024

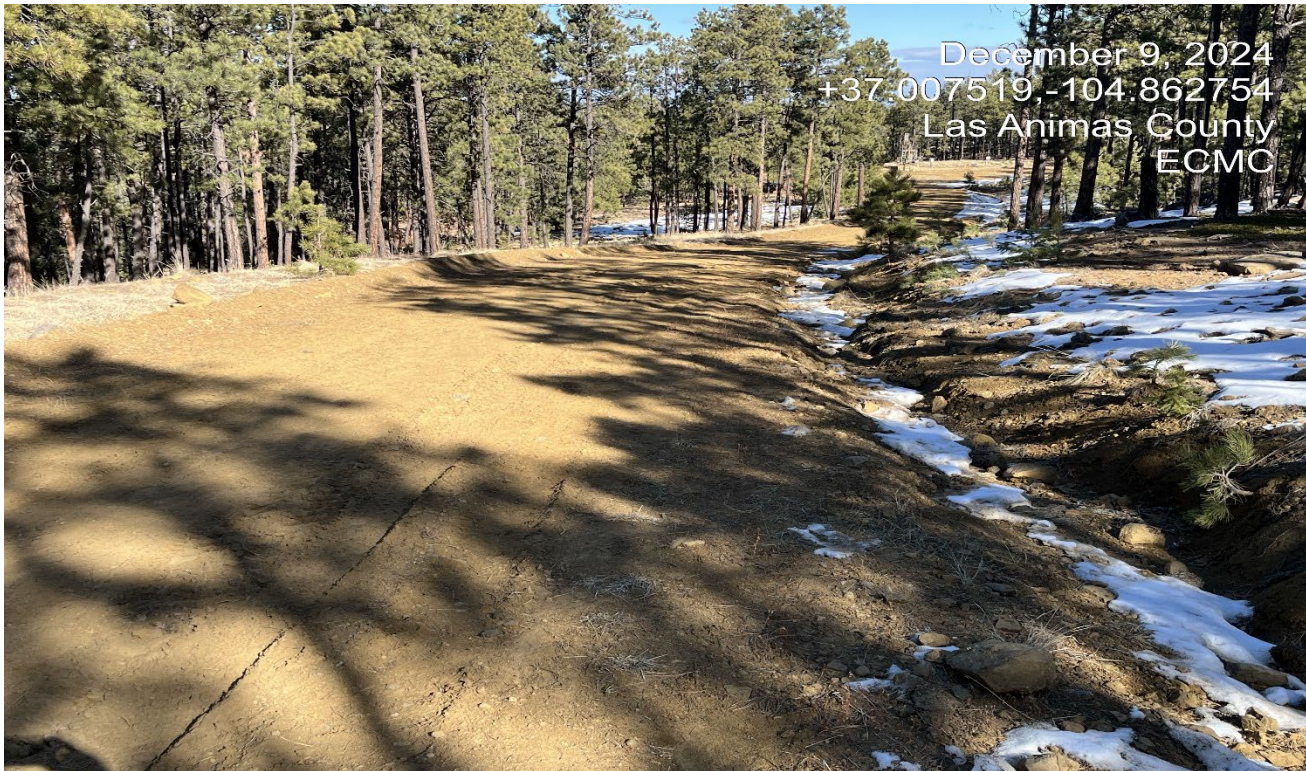
Photo 1. Facing northeast along the access road. There is insufficient BMP's installed along the roadside to prevent erosion.

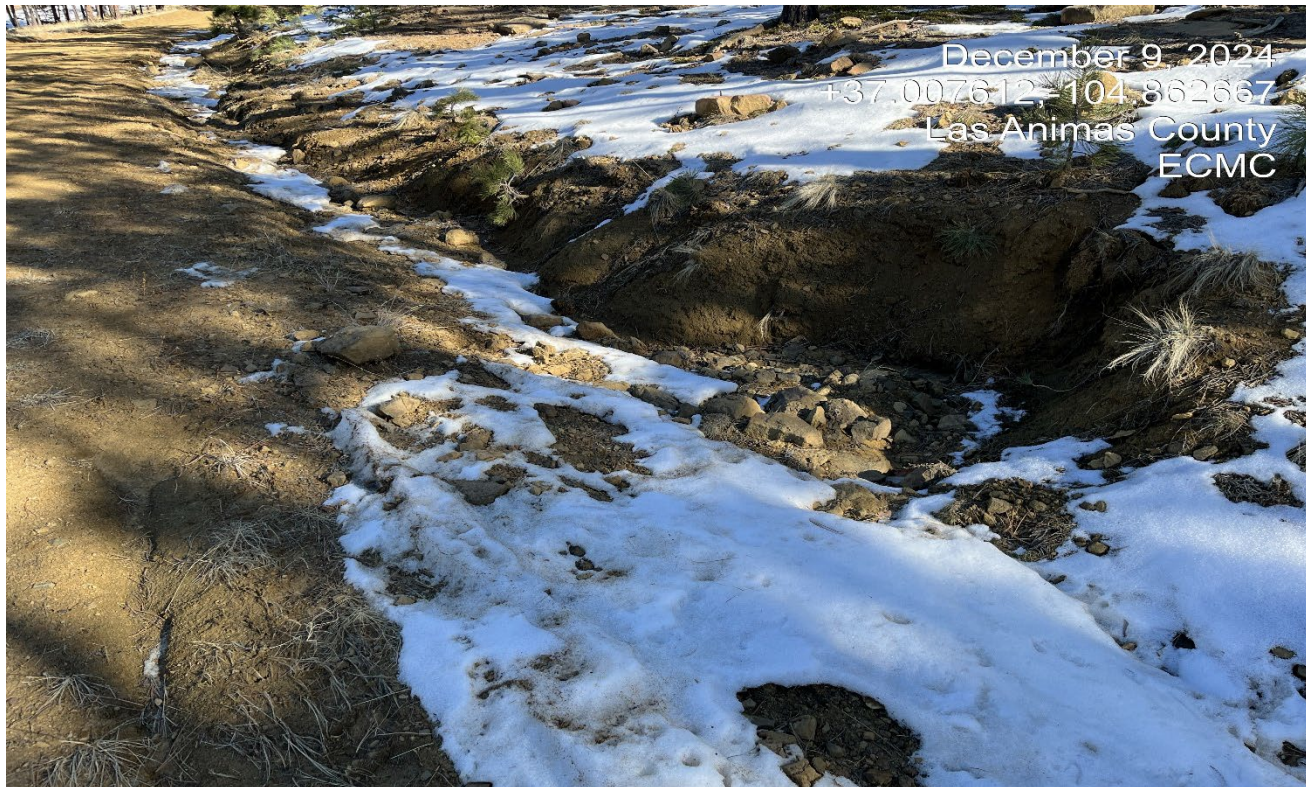
Photo 2. The erosion along the road side has insufficient BMP's to prevent continued erosion.

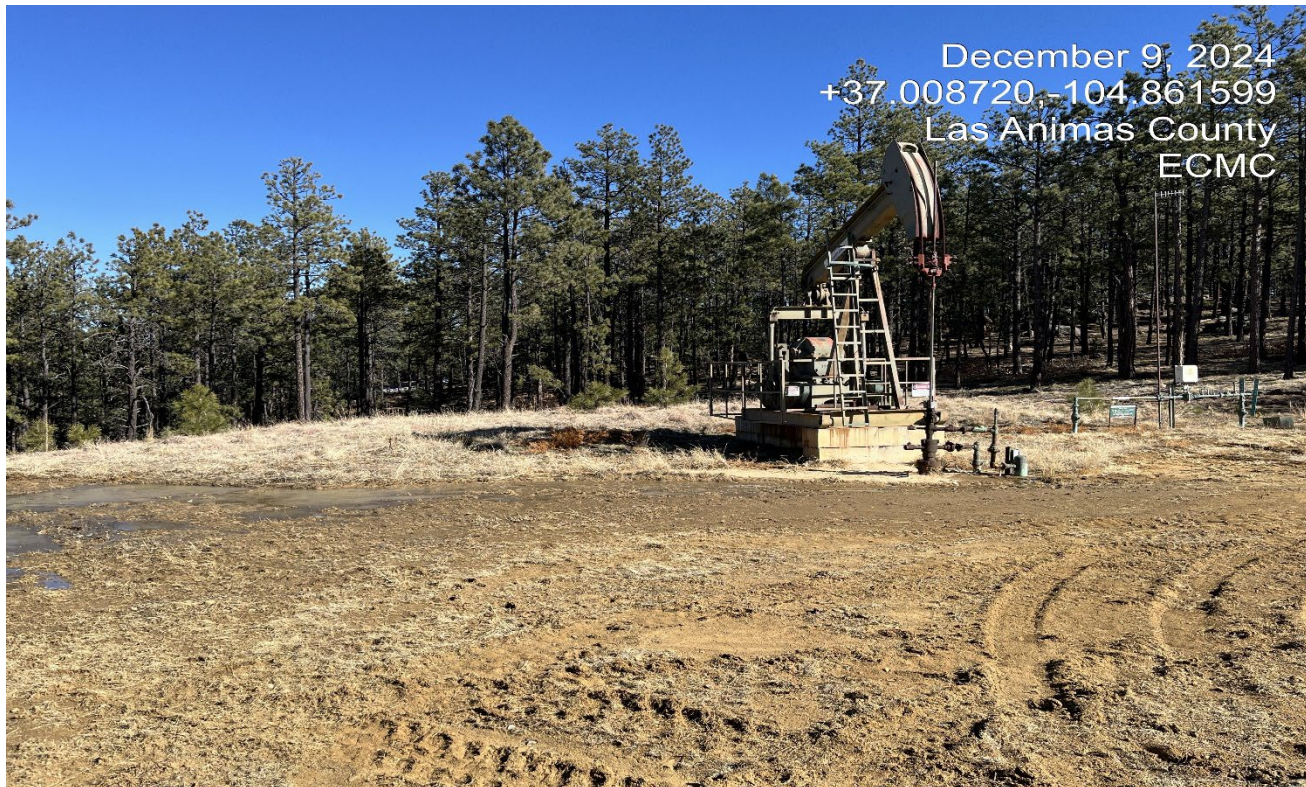
Photo 3. Facing toward the wellsite. There was a water leak at the wellhead which flowed to the northwest side of the location. Operator was immediately notified.

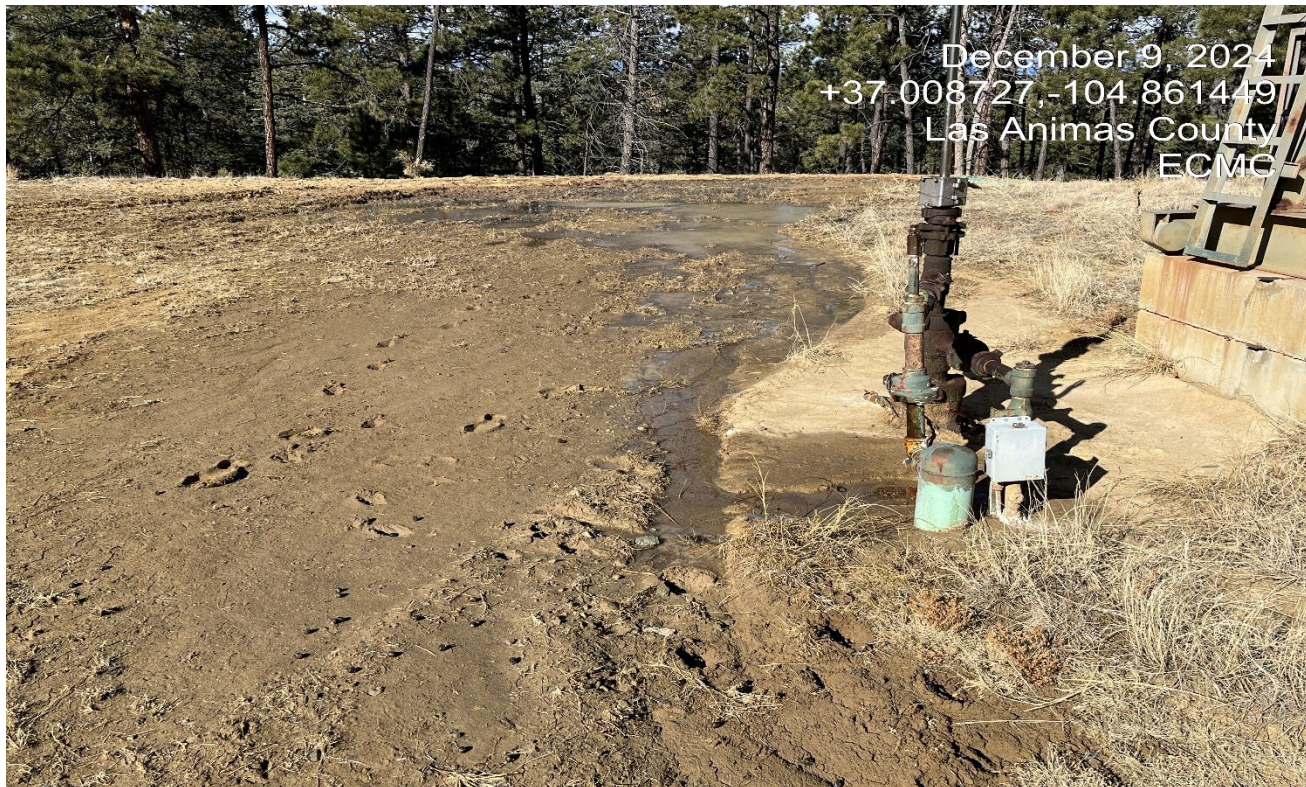
Photo 4. The water was leak out steadily from the wellhead which prompted immediate notification. Operator was seen traveling to the site for repair.

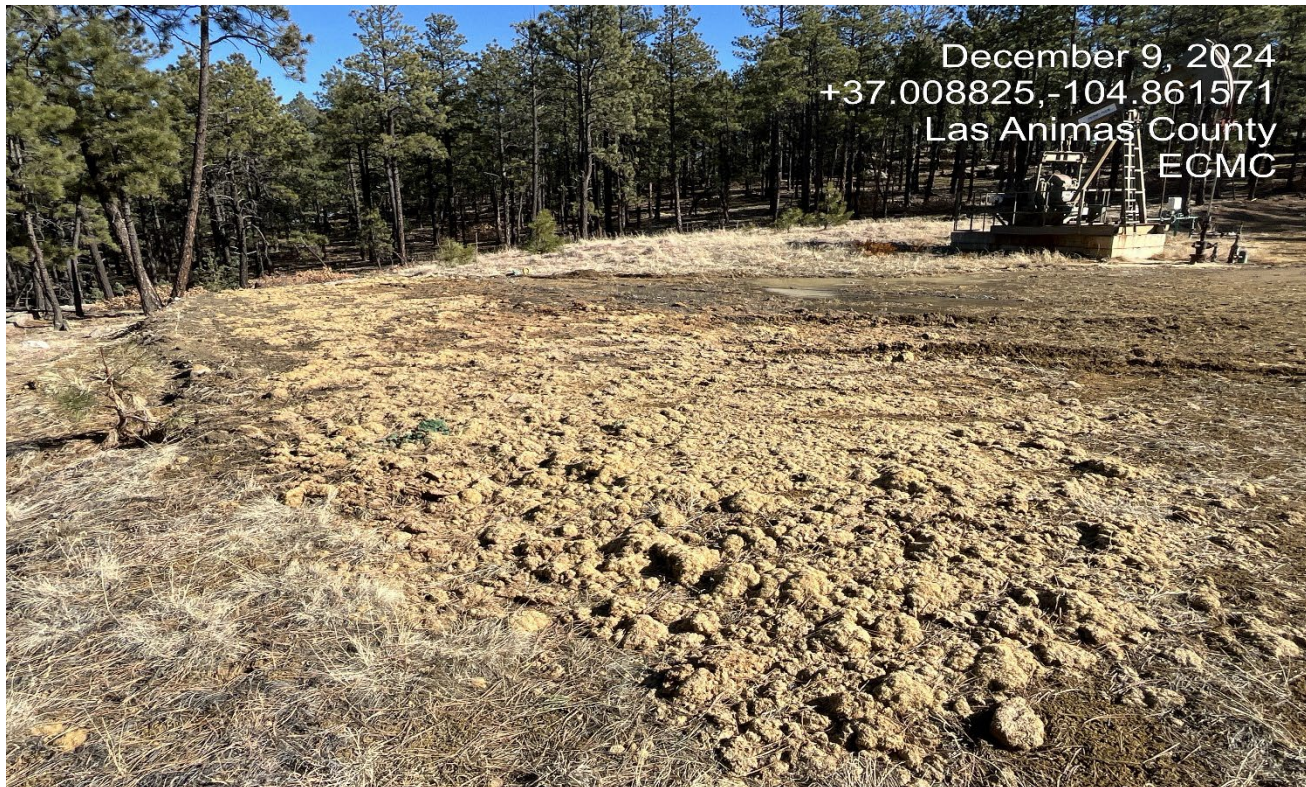
Photo 5. Facing toward the northwest side where erosion had occurred. This area was previously vegetated but soils were pushed to fill in the erosion. The hydro-mulch applied was clumpy with uneven coverage.

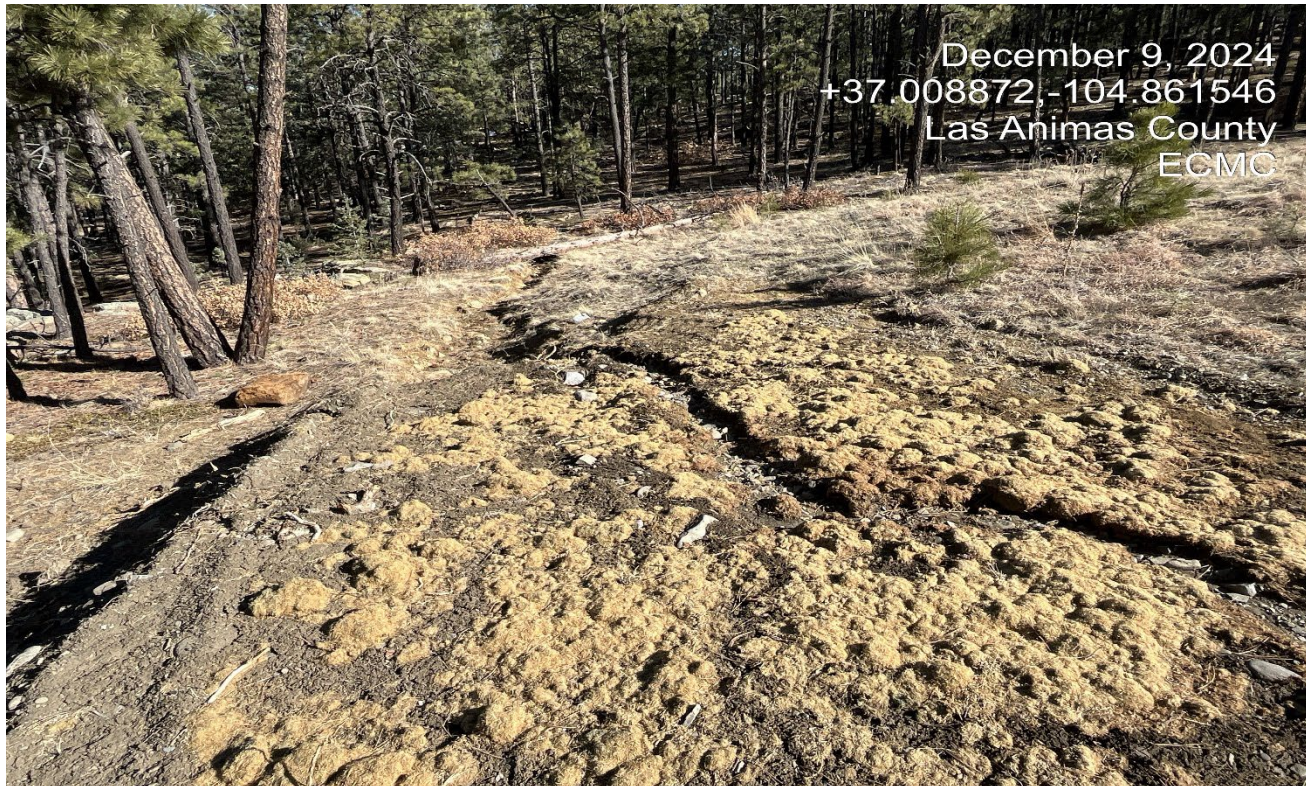
Photo 6. There is erosion already occurring where soils were pushed out to fill in the previously observed erosion channel.

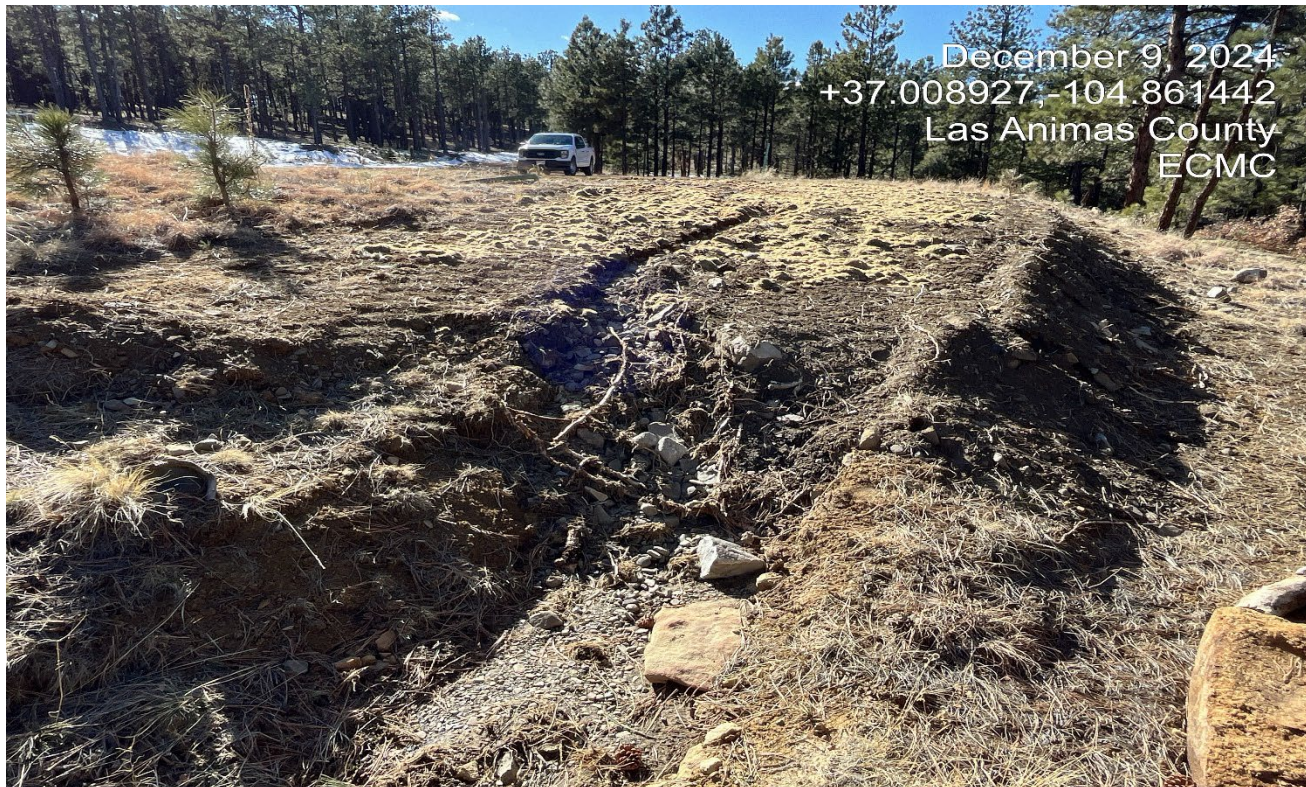
Photo 7. Facing southwest at the location. The loose soils pushed out to this area are susceptible to erosion. A new erosion channel has already developed.
