Inspection Photos
Location Name: QB Energy LAZIER (P23B) Pad
Location #: 335320

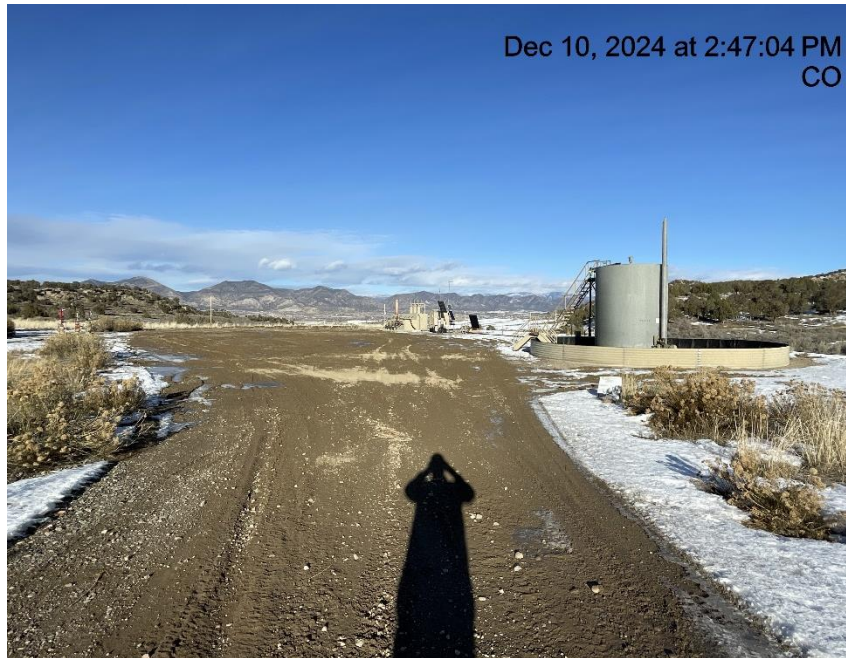
Photo # 2904 From entrance to location

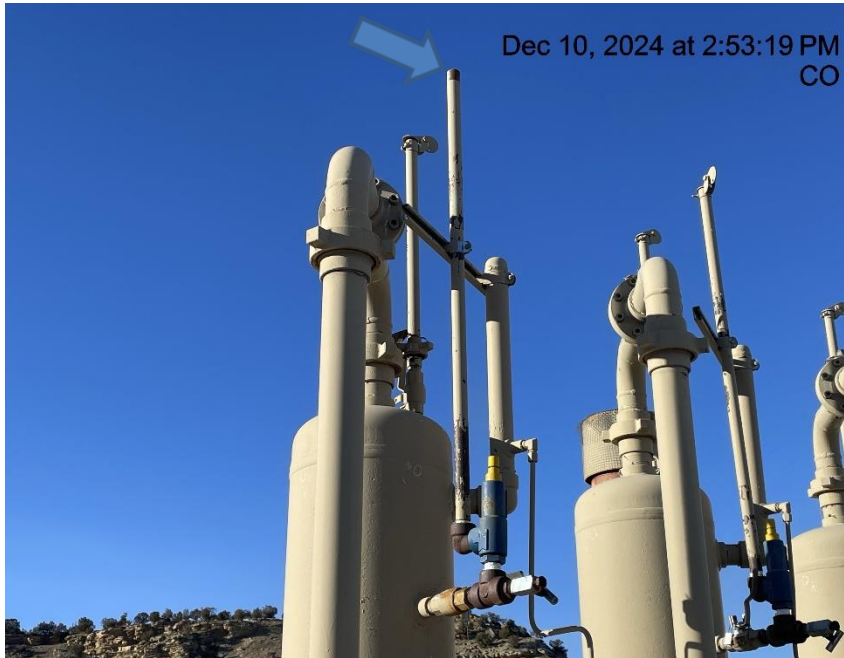
Photo # 2910 PRV vent line does not comply with CECMC pressure safety device rules

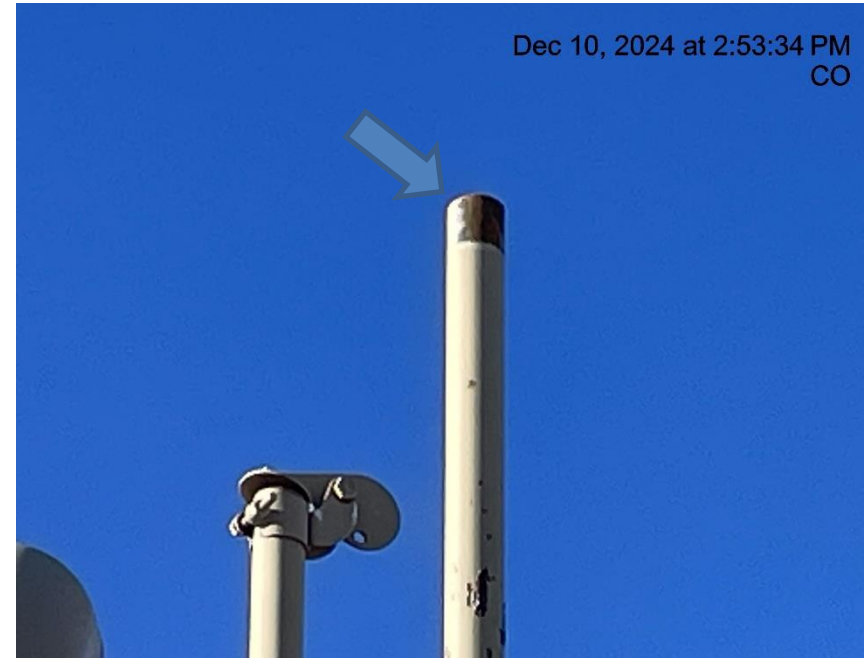
Photo # 2911 PRV vent line does not comply with CECMC pressure safety device rules
