Inspection Photos

Loc: 307766

Operator: WAPITI OPERATING LLC

Inspection Date: 12/9/2024

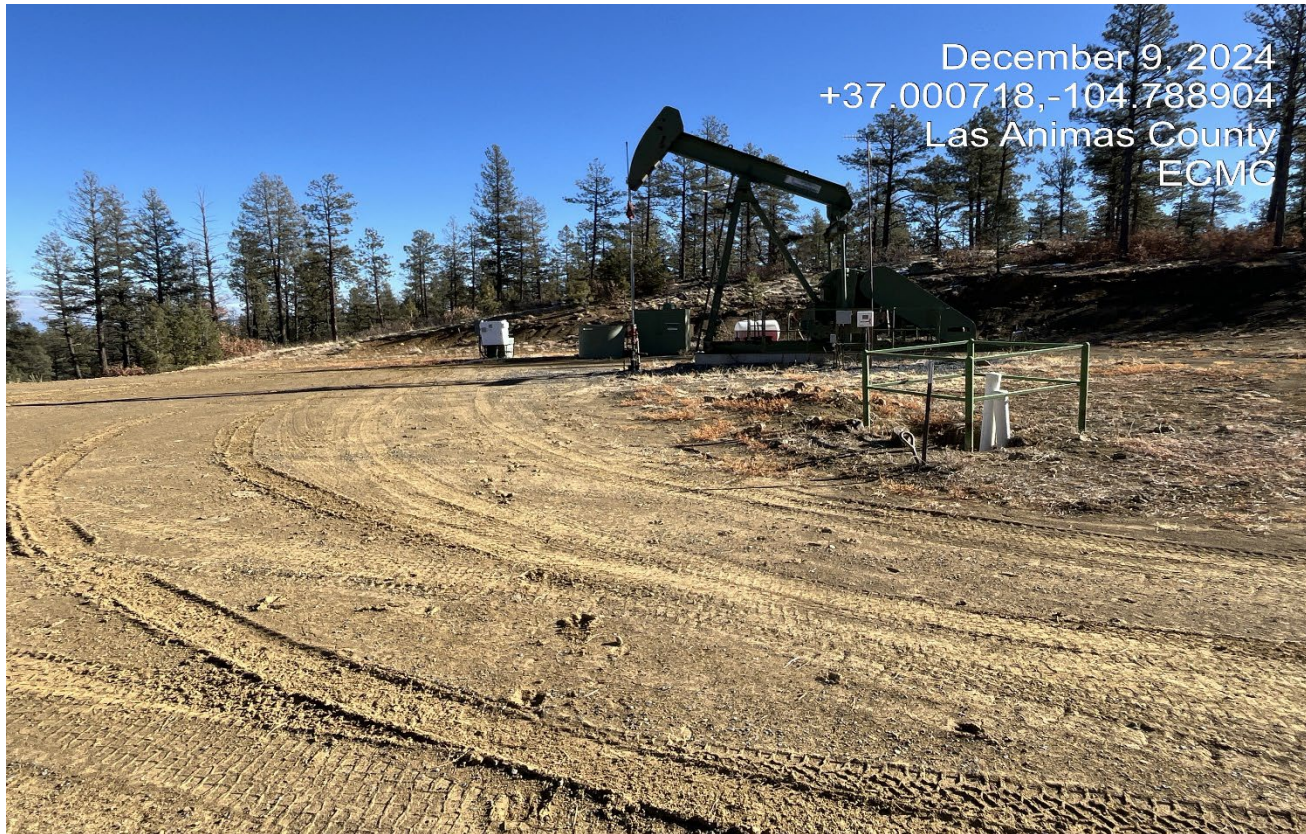
Photo 1. Facing east toward the wellsite.

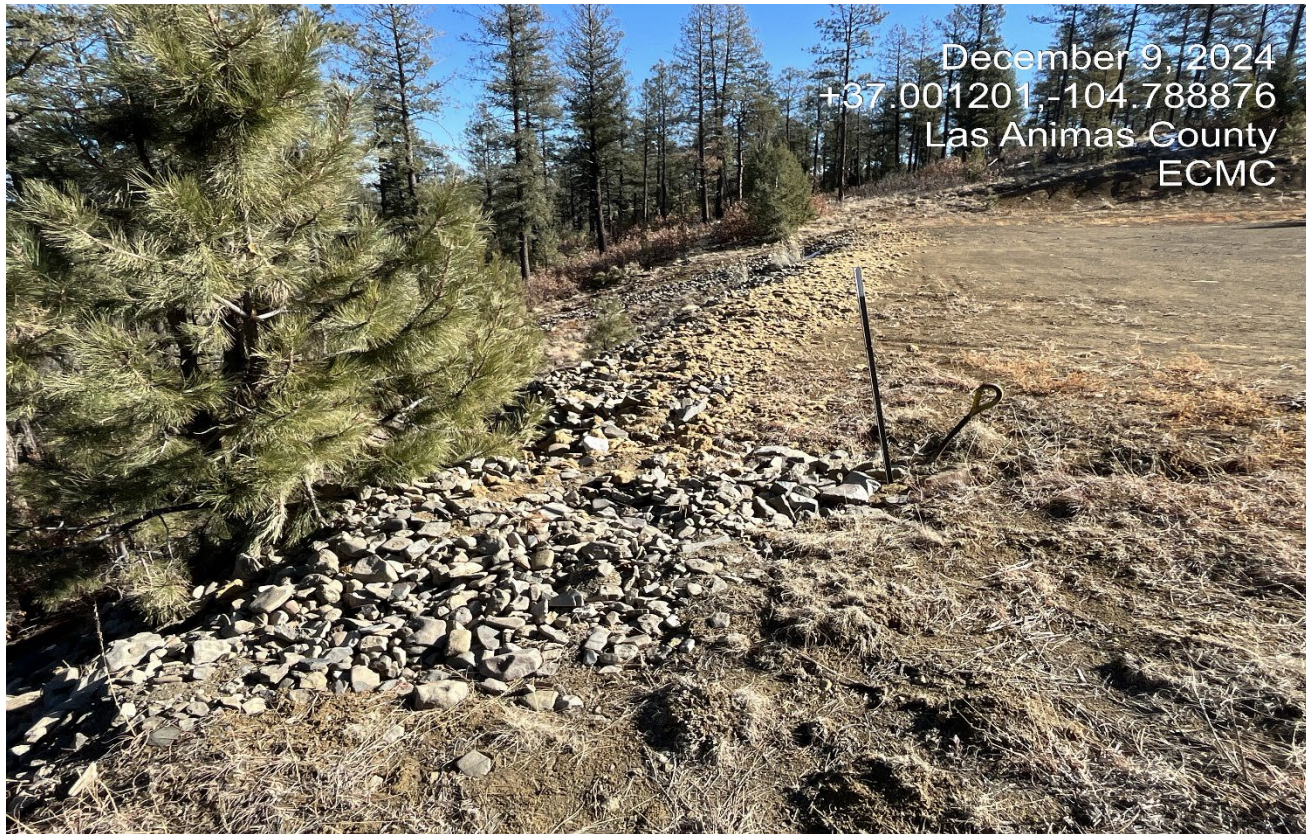
Photo 2. The erosion channels along the fill slope have been filled in with rock.

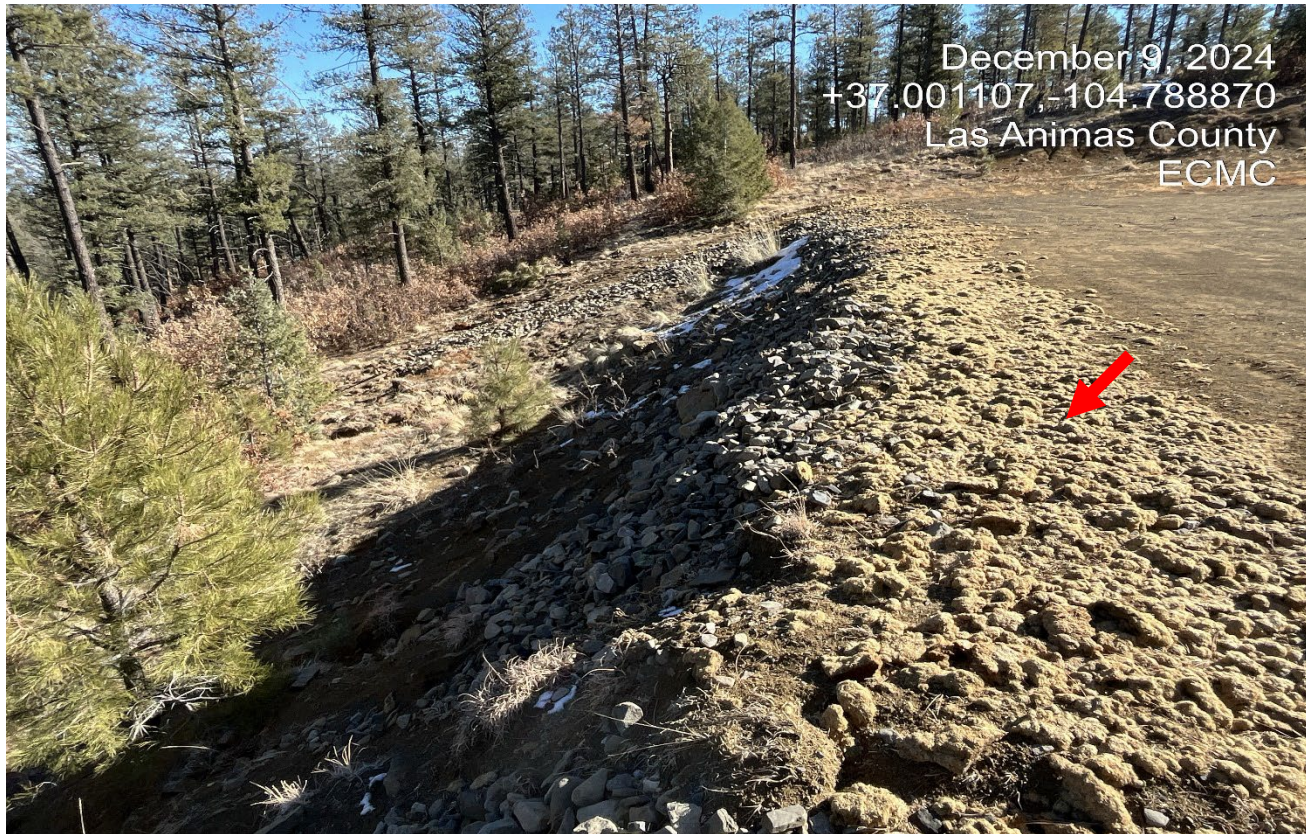
Photo 3. The fill slope was filled in with rock and some hydromulch was spread along area of the red arrow.

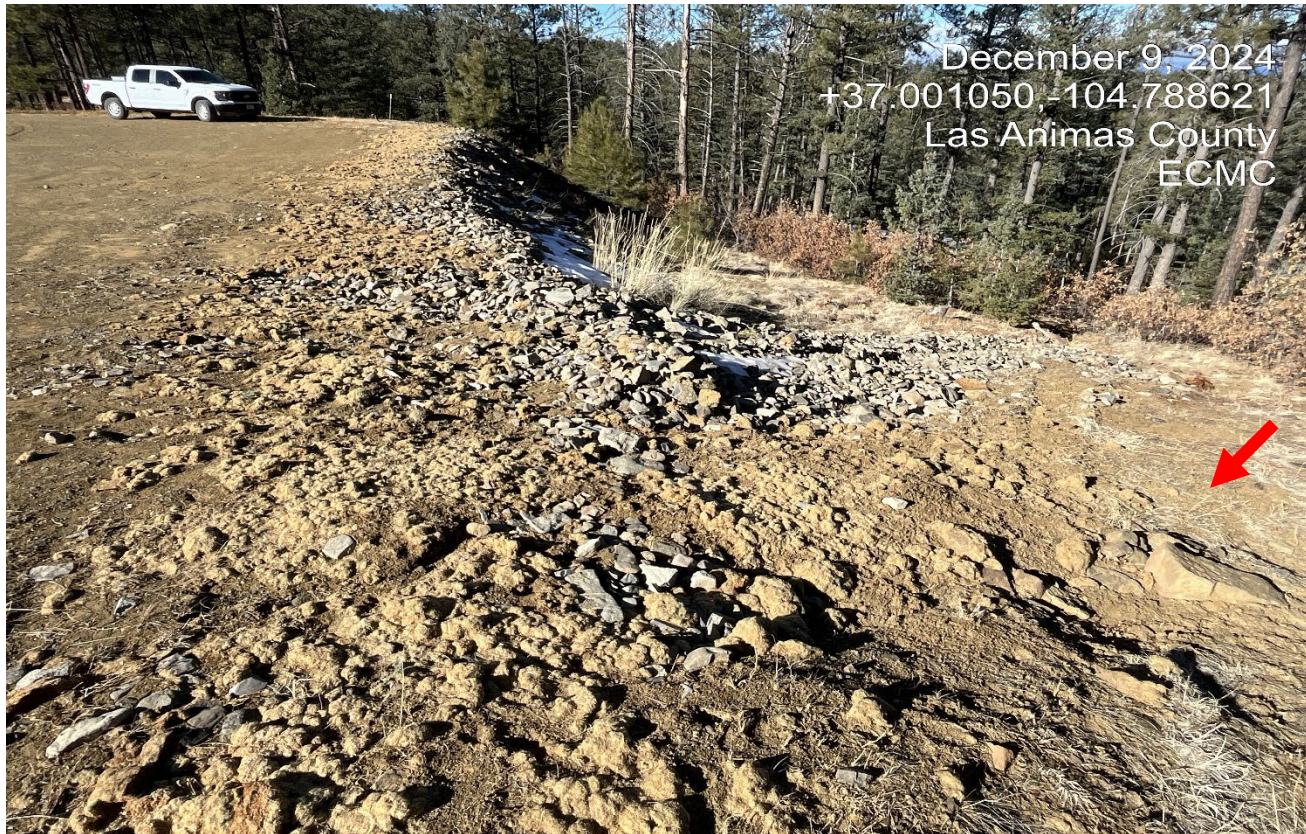
Photo 4. Northeast side of the location facing west. The erosion channels were filled in with rock. Stormwater will find least resistant pathway would could create erosion toward area of red arrow.

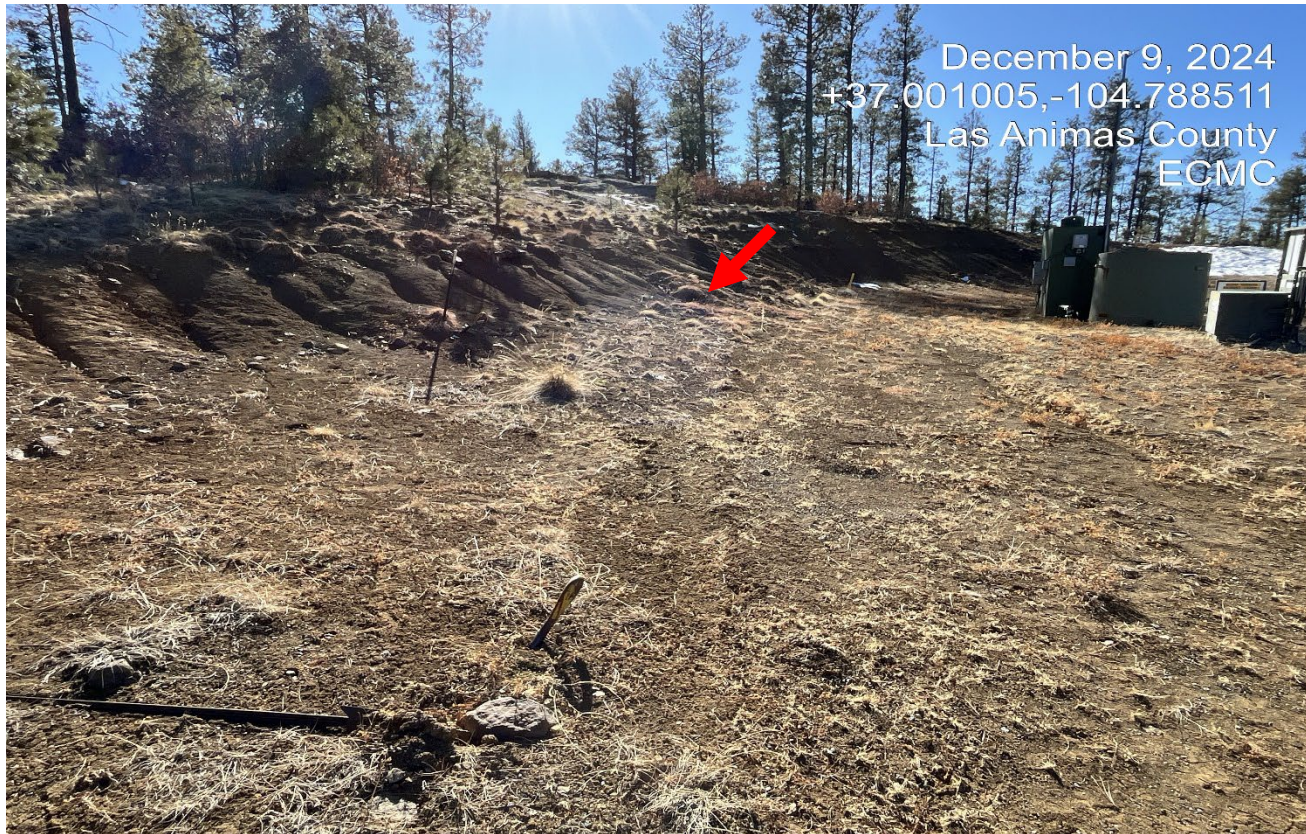
Photo 5. Facing toward the cu slope. There is erosion along the cut slope that needs to be regraded and seeded.

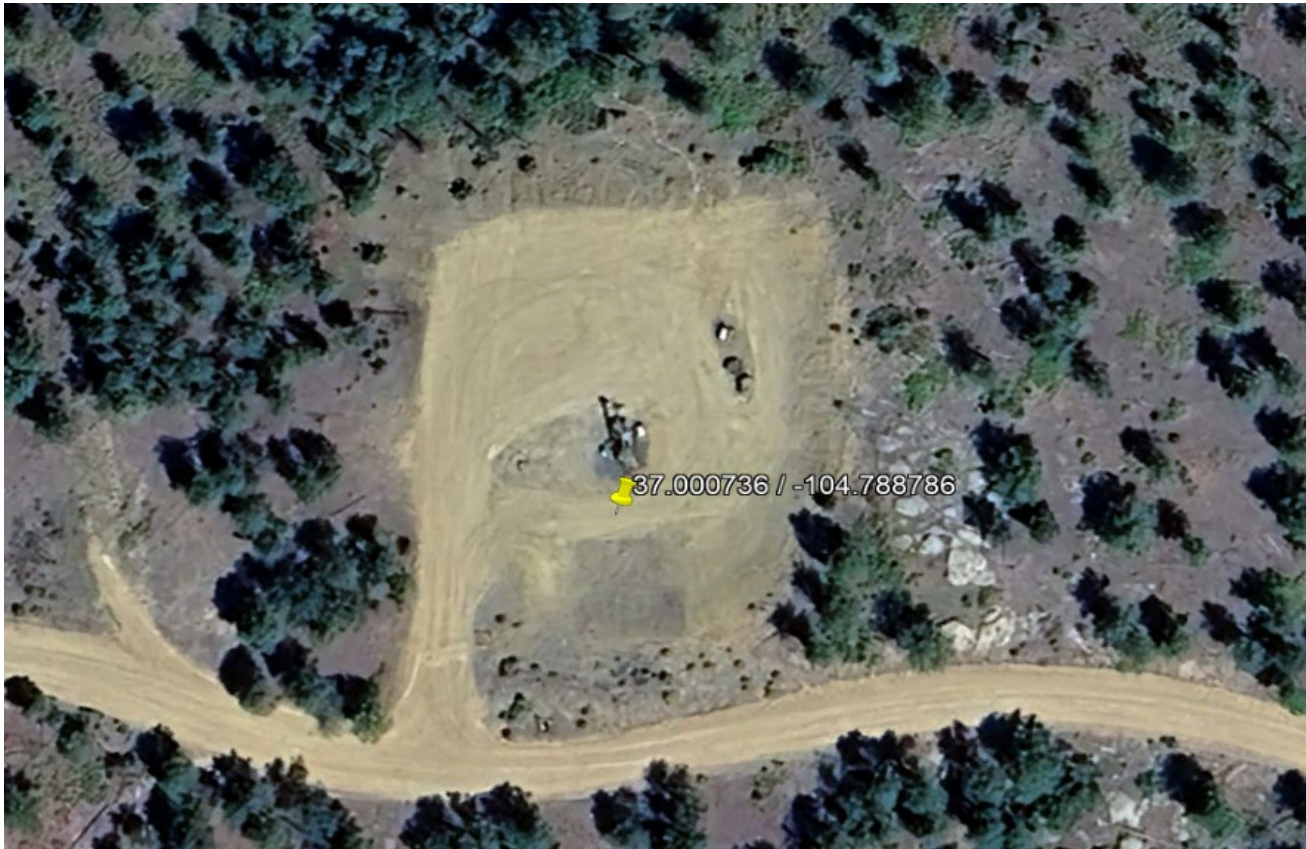
Photo 6. 2024 aerial imagery of the location shows unused areas at the north side of the location will need to be revegetated.
