Inspection Photos

API: 071-06970

Operator: WAPITI OPERATING LLC

Inspection Date: 12/9/2024

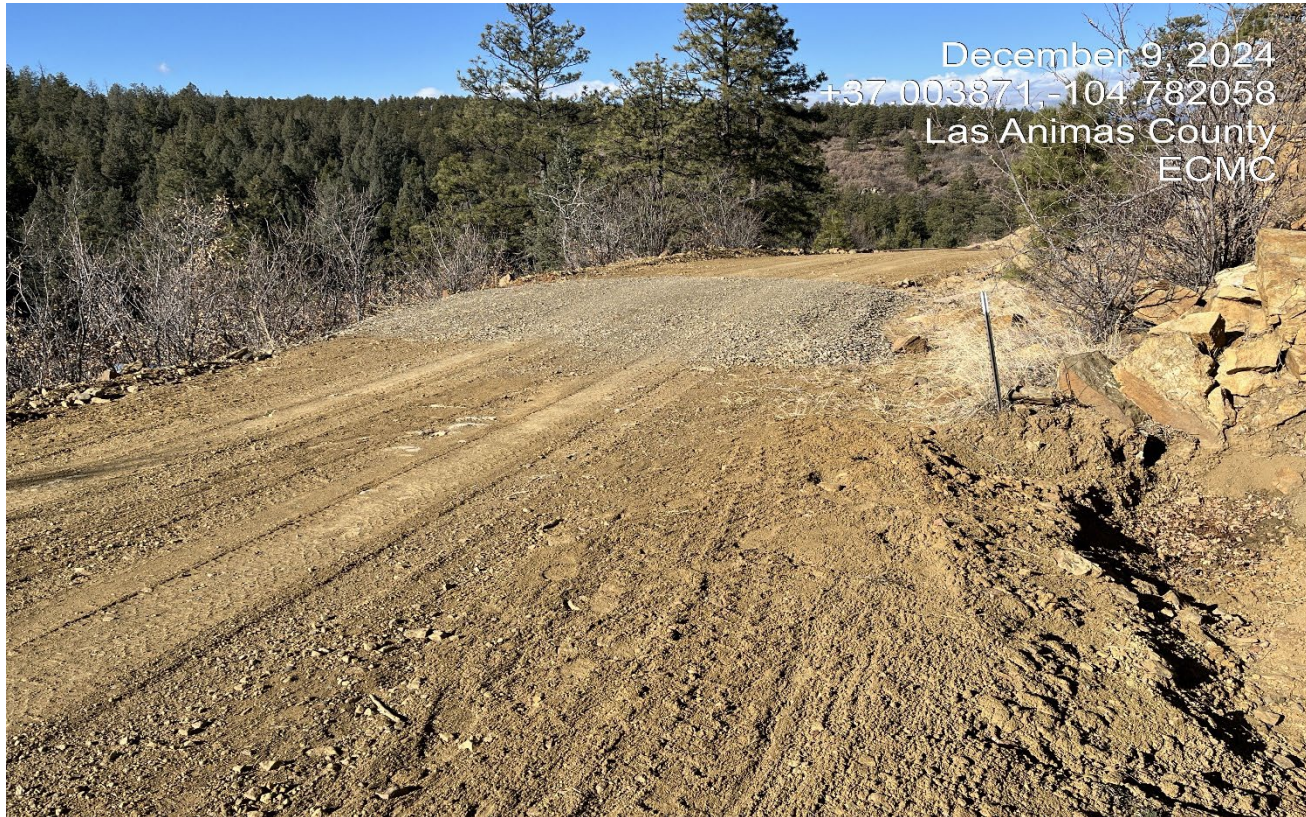
Photo 1. Facing northwest along the access road. The culvert has been cleaned out.

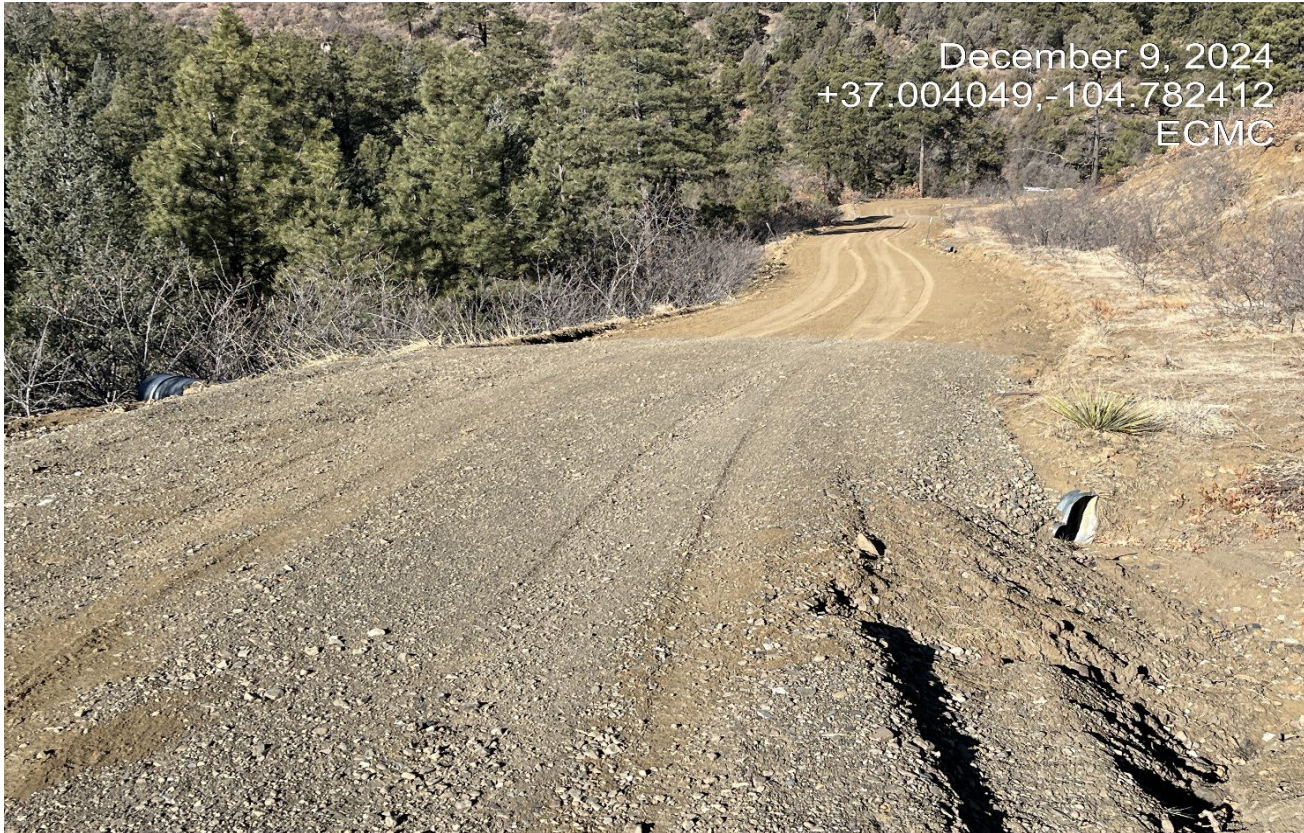
Photo 2. Facing northwest along the road. The culvert has been cleaned out and road base was added to promote drainage off the road.

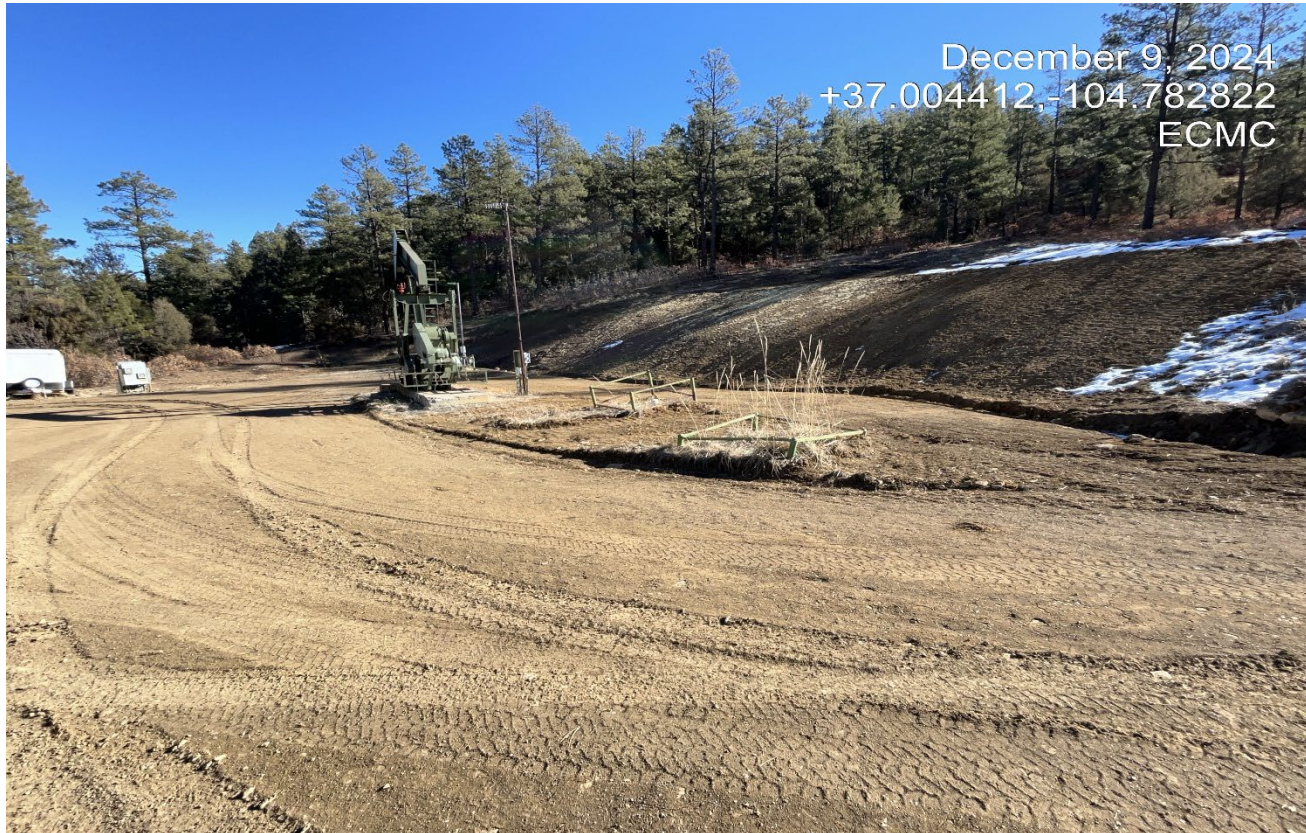
Photo 3. Facing east toward the wellsite.

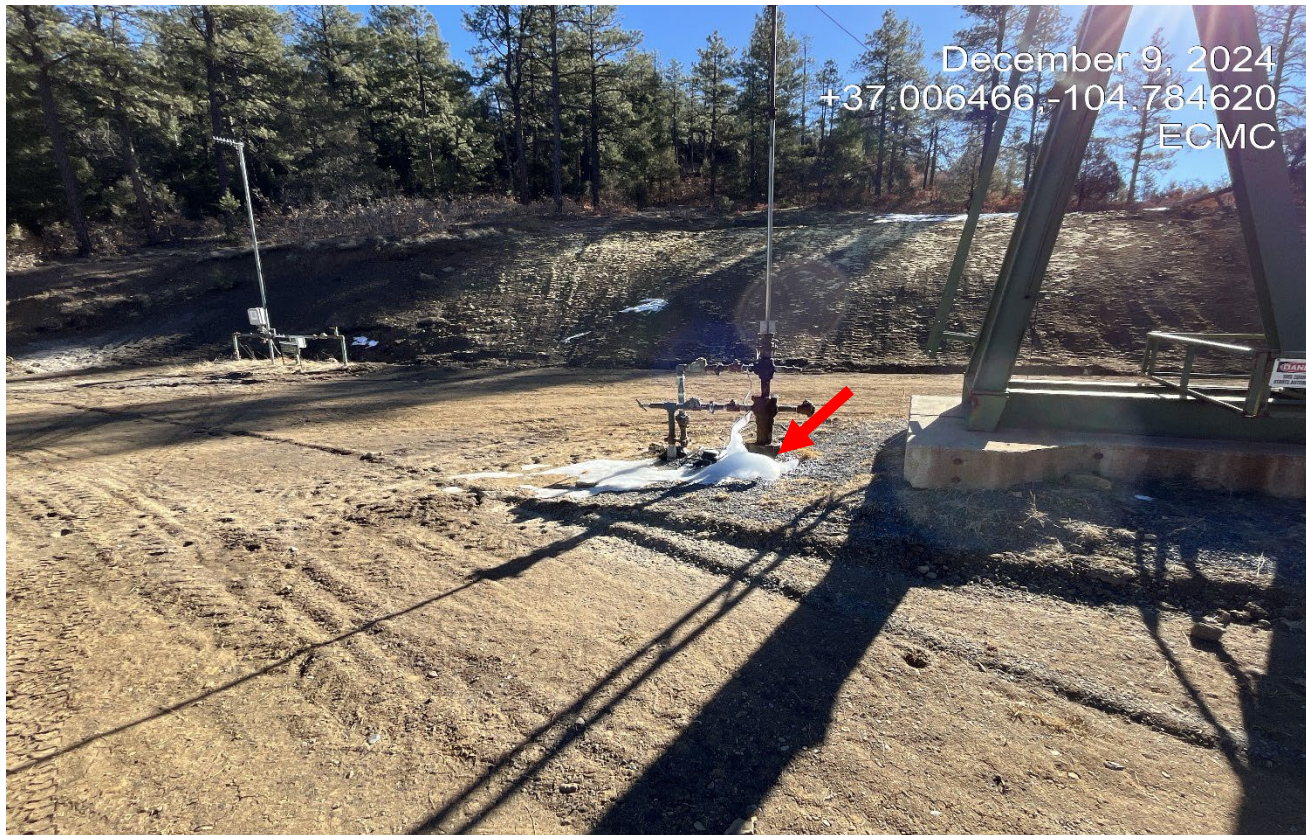
Photo 4. There is ice build up of a slight water leak at the wellhead.

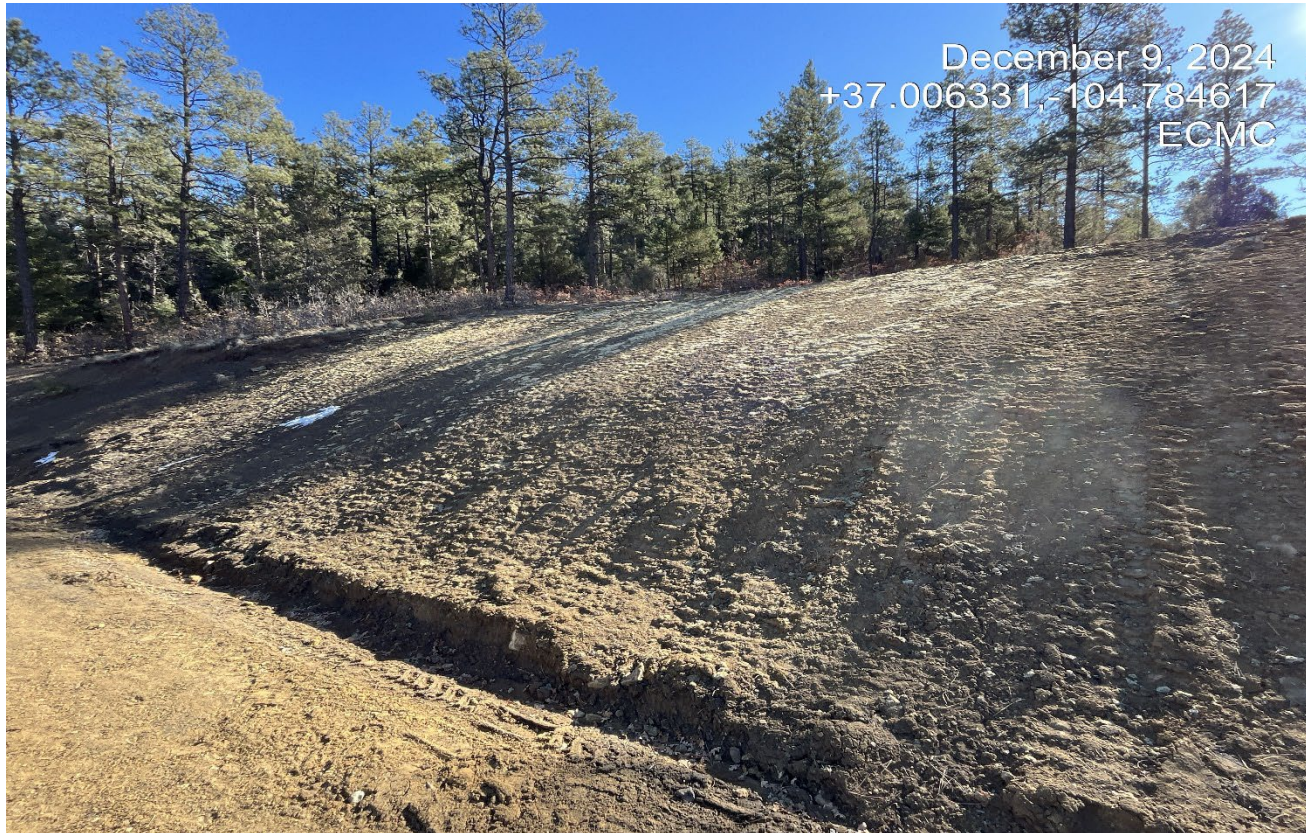
Photo 5. Facing toward the cut slope which has been tracked for temporary stabilization.

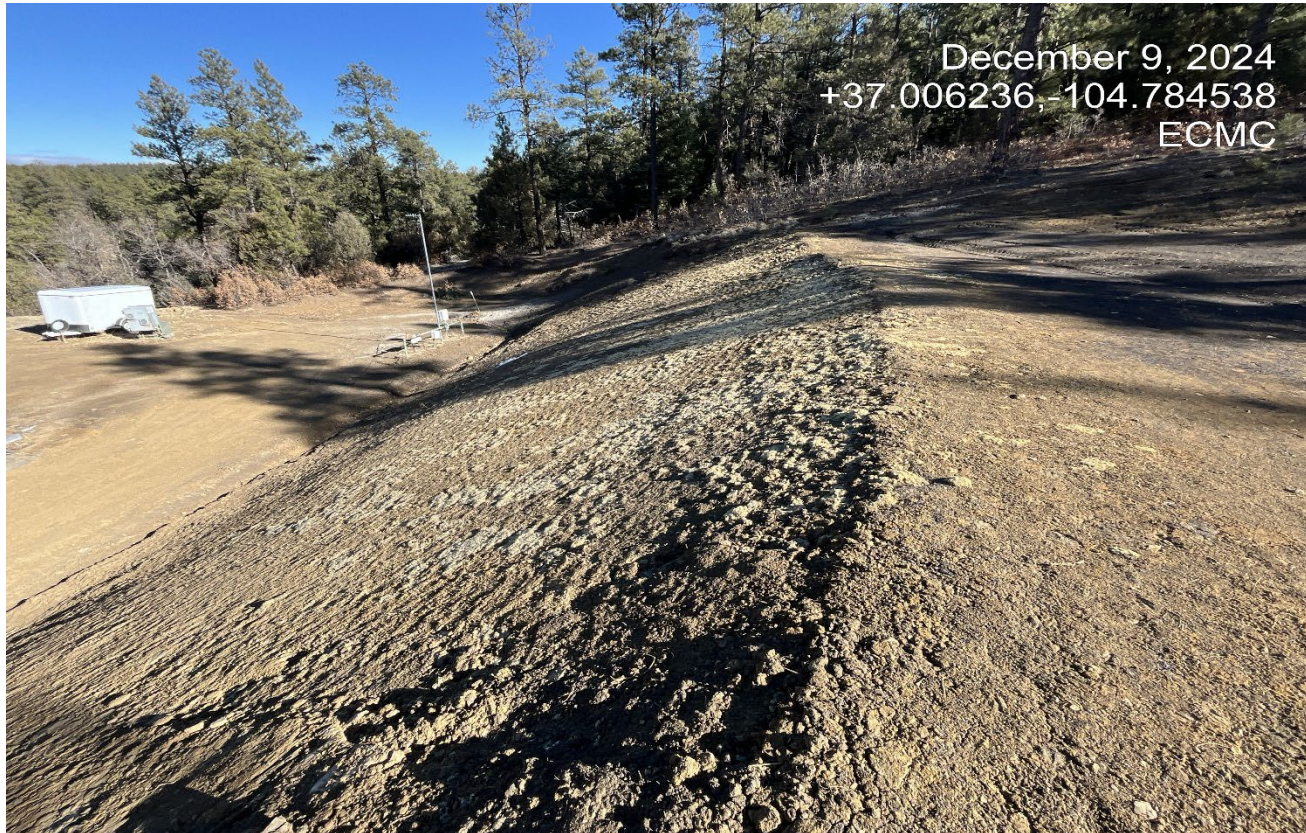
Photo 6. Facing down toward the cut slope. There was some sparse hydromulch spread. It appears work is still in process however hydromulch must be uniformly spread with complete coverage for proper stabilization.

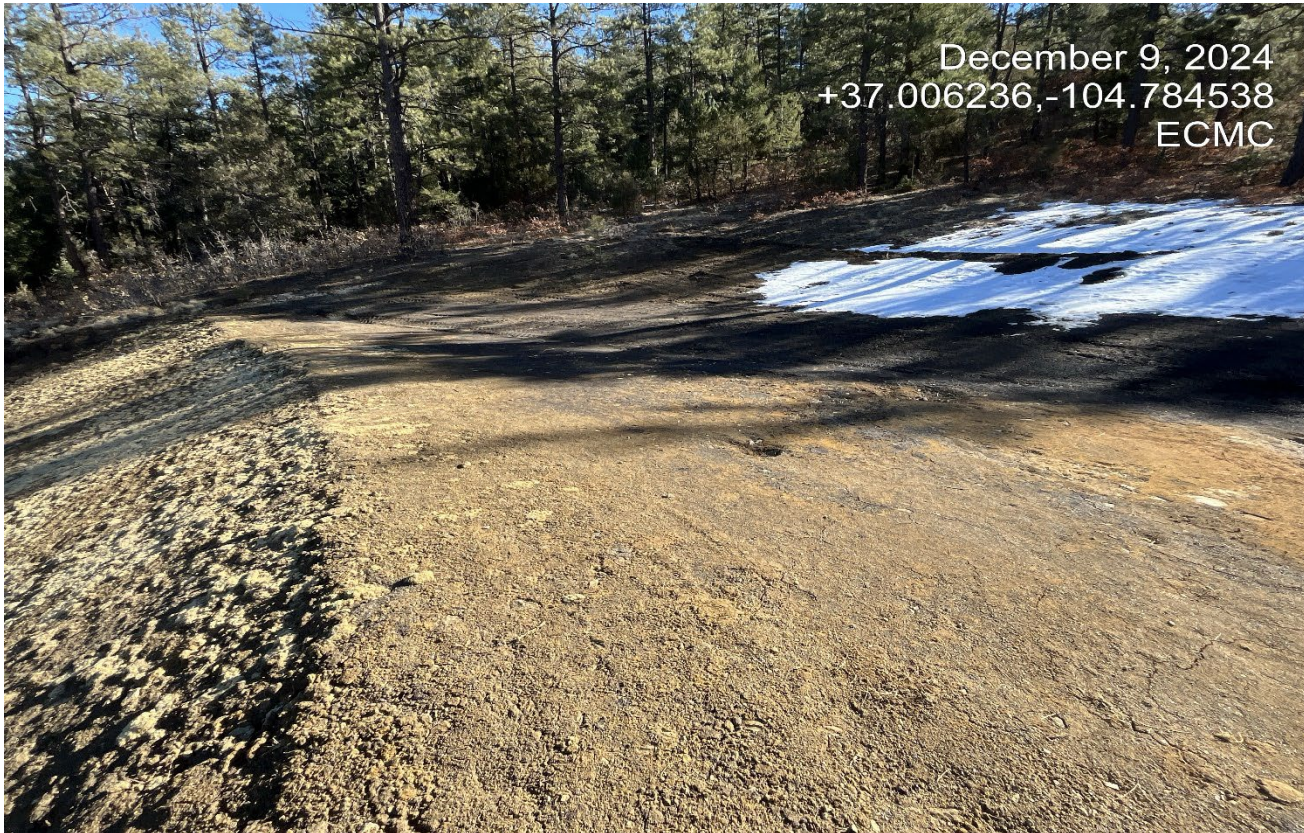
Photo 7. Facing toward the top portion of the cut slope.
