Inspection Photos

API: 071-09051

Operator: WAPITI OPERATING LLC

Inspection Date: 12/9/2024

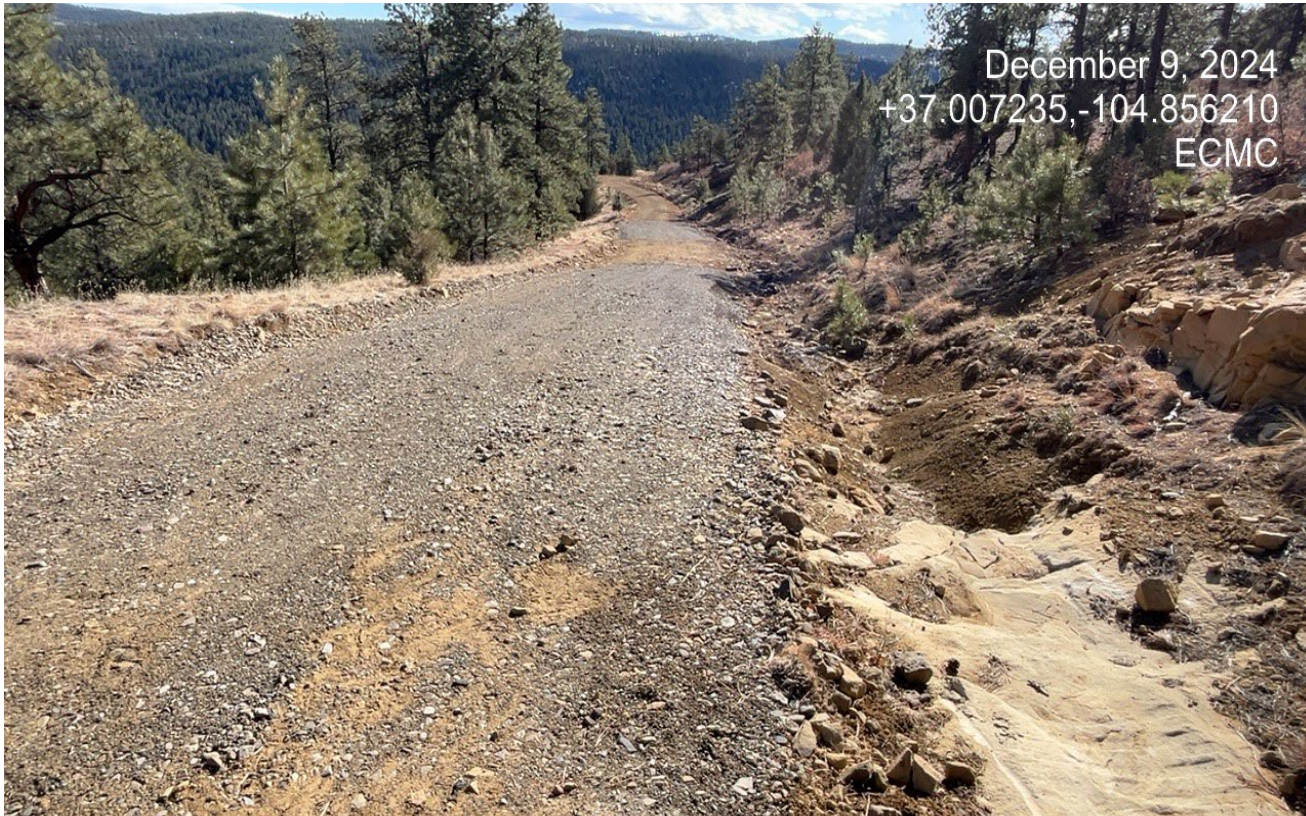
Photo 1. Facing southeast along the access roads. More BMP's need to be installed up along the road to slow down or divert stormwater off the road..

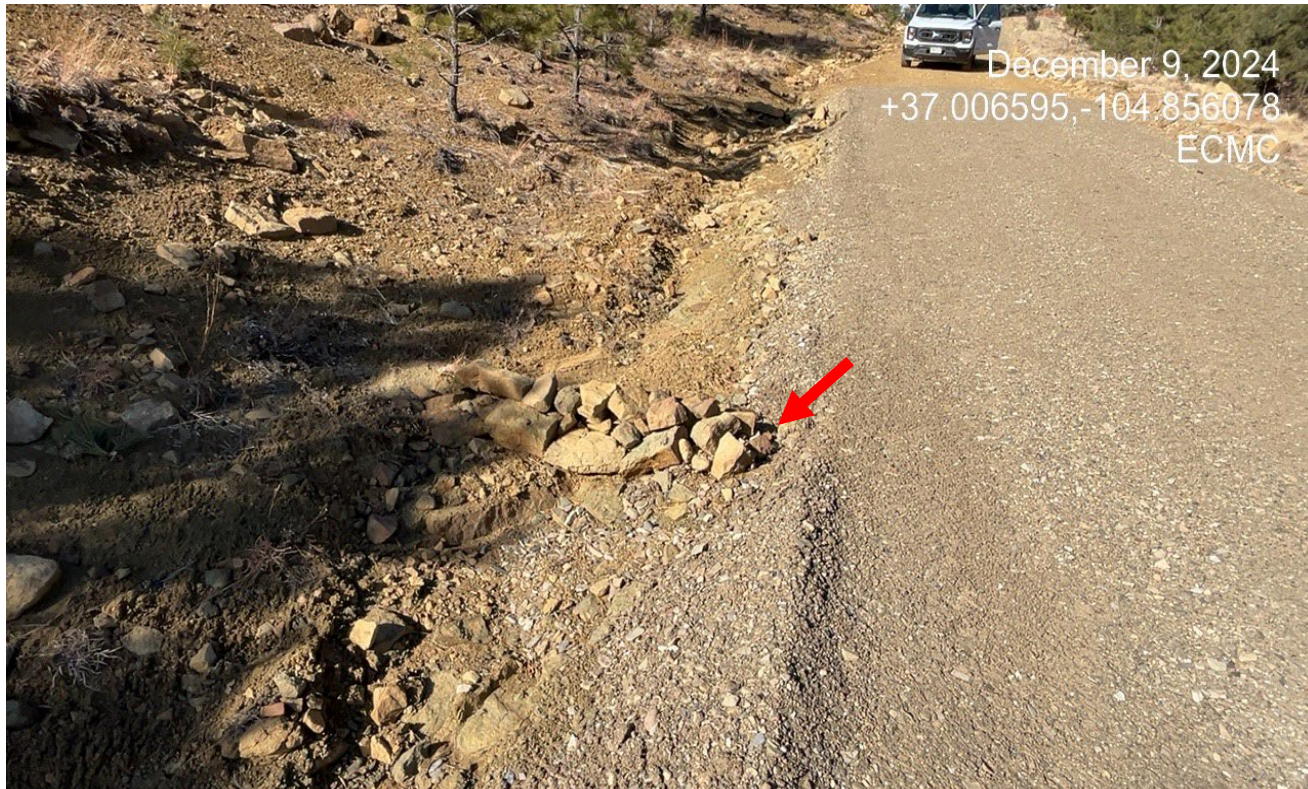
Photo 2. Facing There are some rock check dams installed but stormwater has already eroded around the out side.

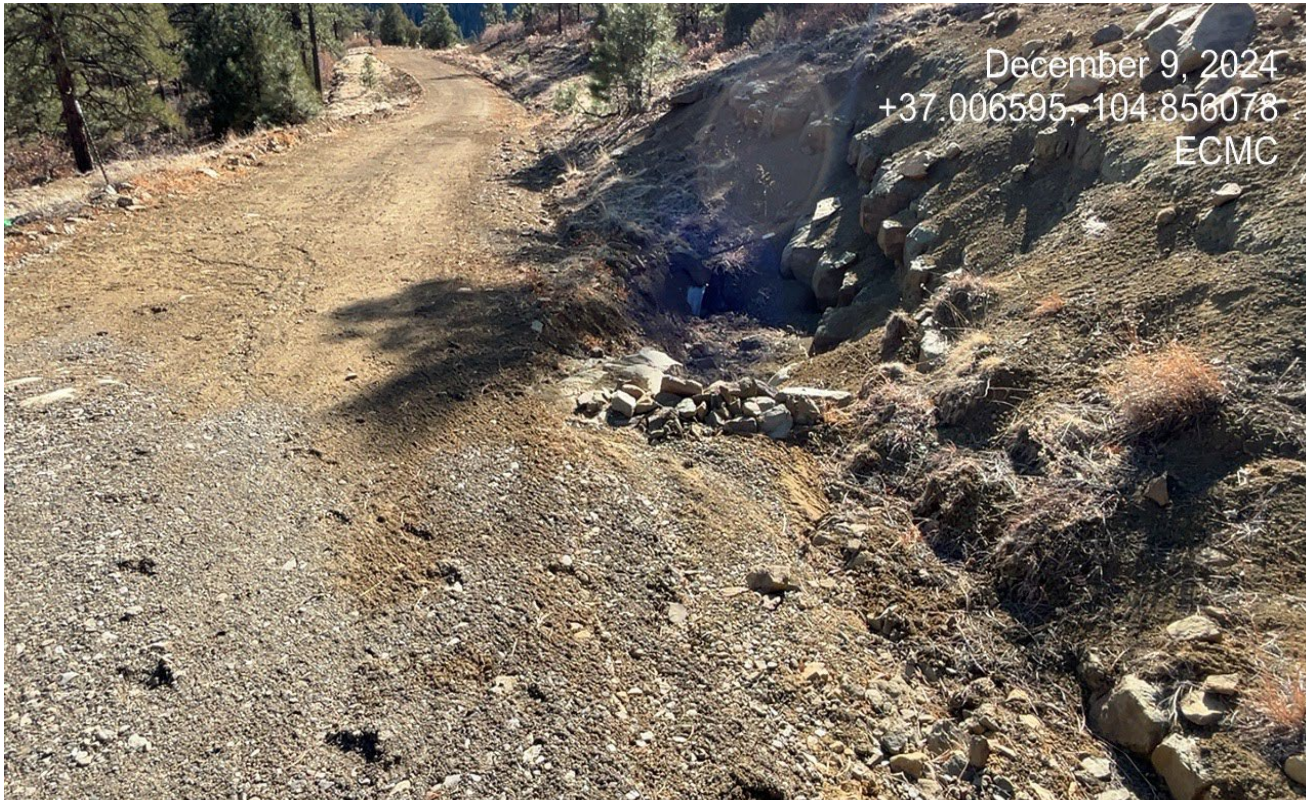
Photo 3. The culvert is cleaned out and this check dams has held back a lot of sediment. The check dam will need to be cleaned out and sediment control further up the road should be installed.

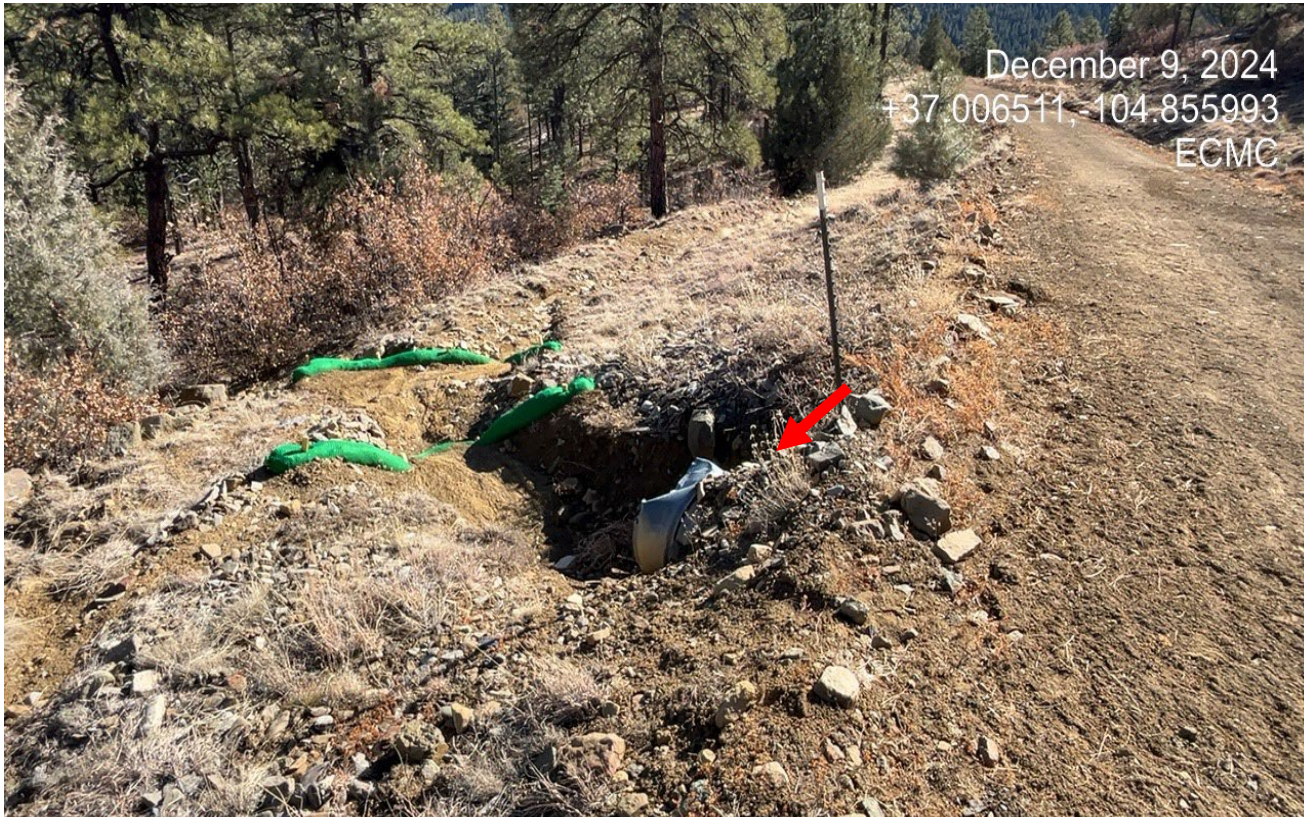
Photo 4. The green wattles were installed at the culvert outlet which has already filled in with sediment. The wattles will need to be cleaned out and sediment control further up the road should be installed.
