Inspection Photos

API: 071-06299

Operator: OGRIS OPERATING LLC

Inspection Date: 12/9/2024

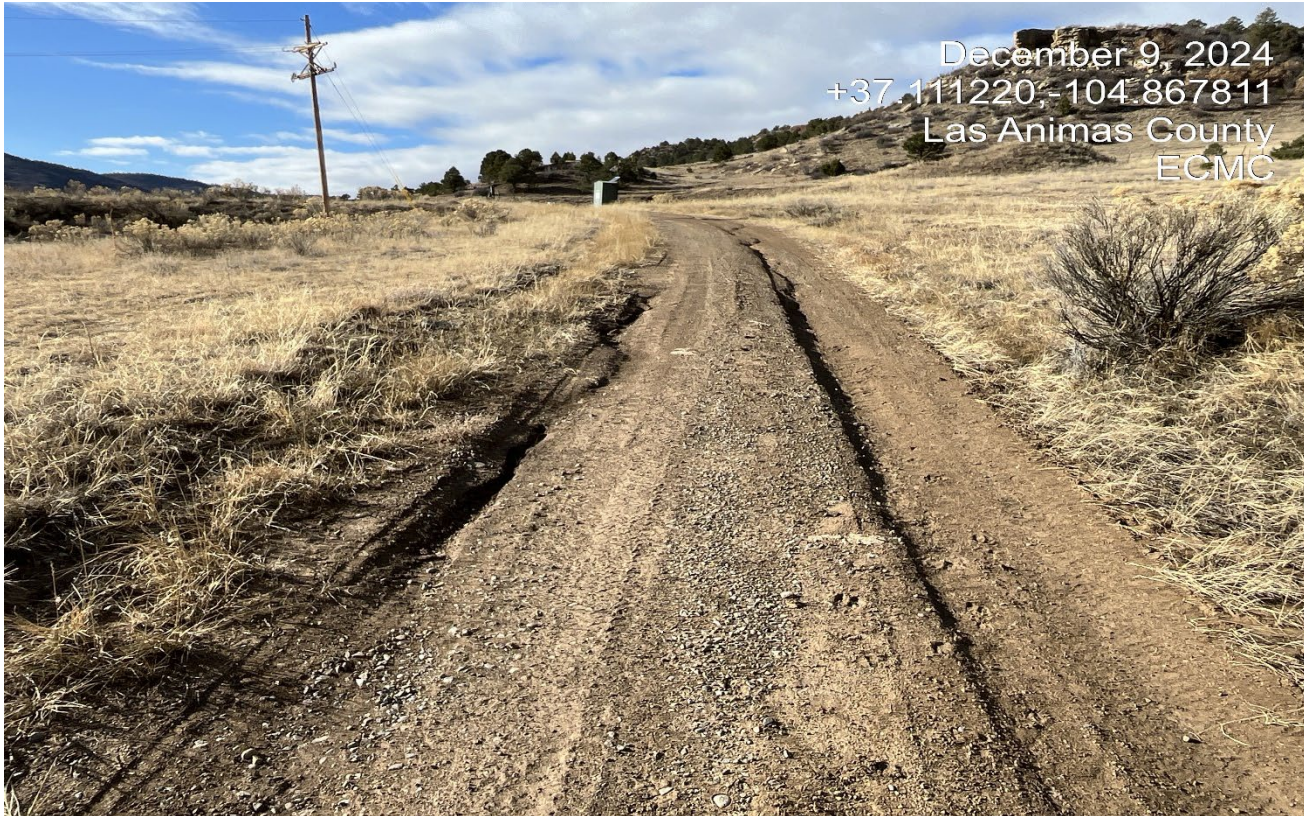
Photo 1. Facing southwest along the access road. There is erosion along the road that needs to be repaired.

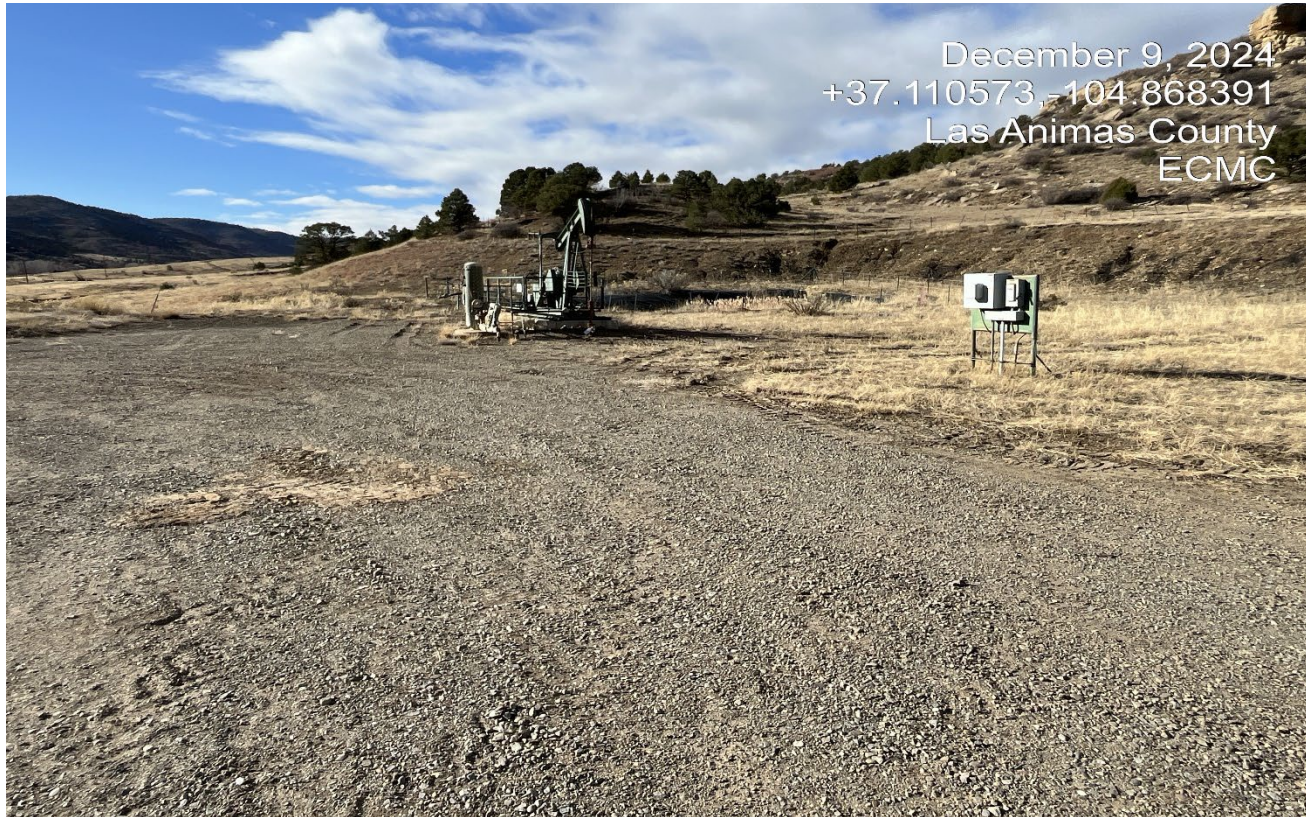
Photo 2. Facing southwest toward the location.

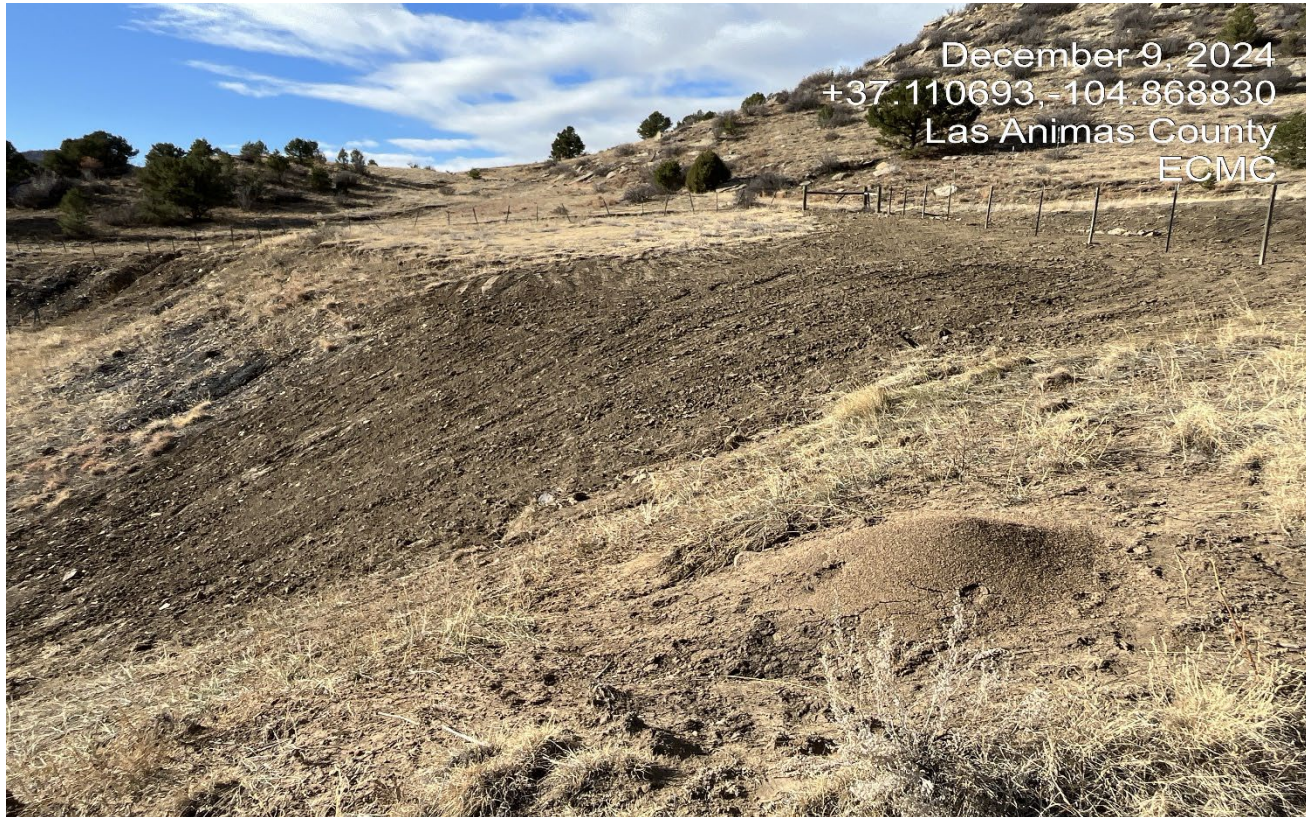
Photo 3. The erosion gully along the cut slope has been repaired.

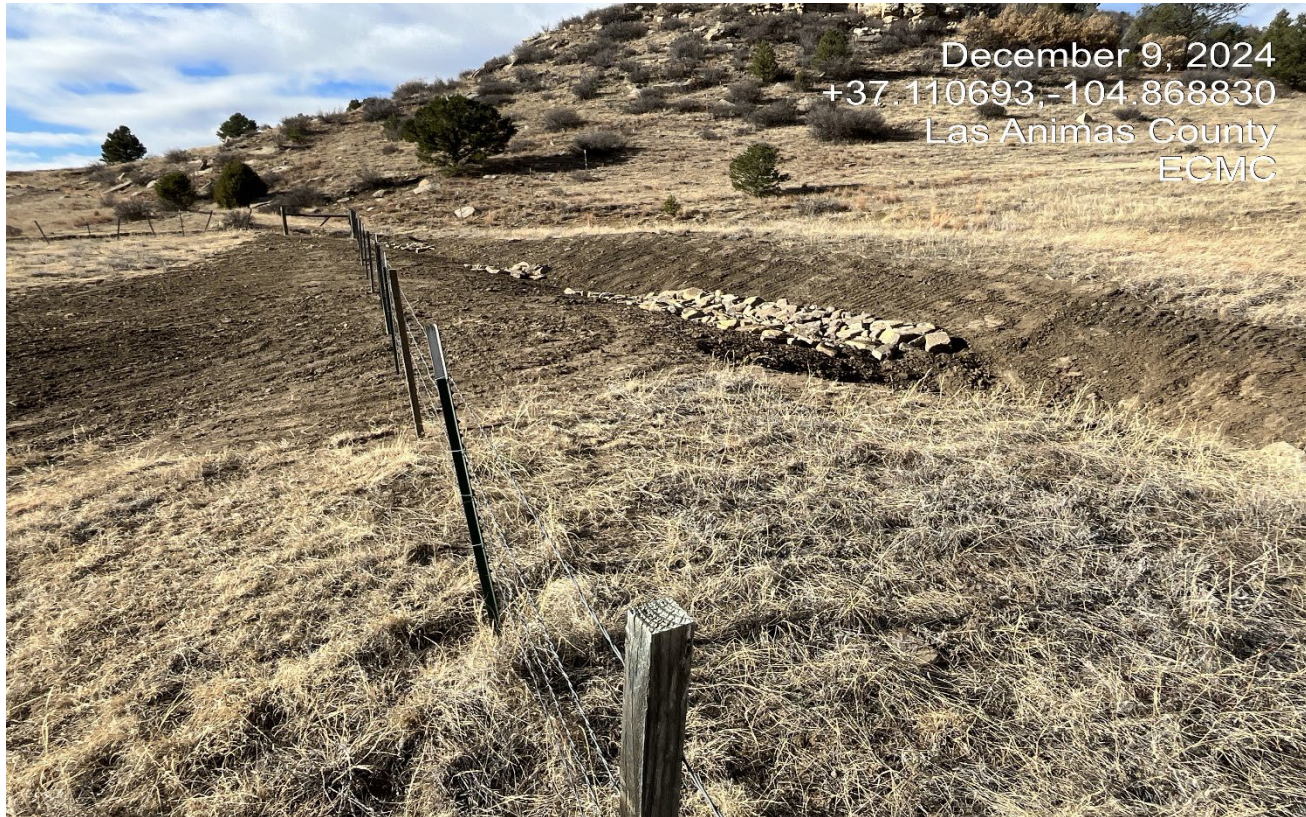
Photo 4. There is a run-of swale above the location that has been graded to promote stormwater away from the cut slope.

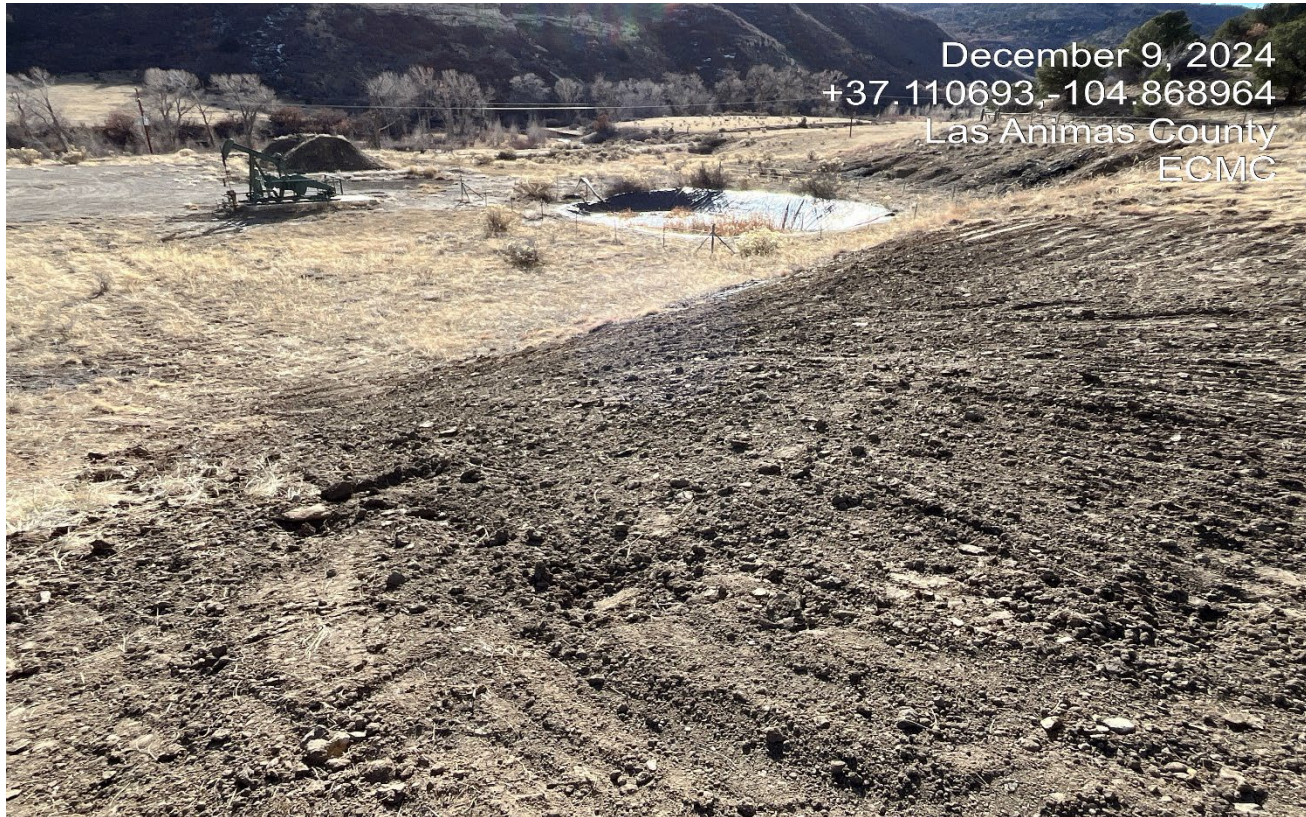
Photo 5. Facing toward the erosion repair. It appears the excavator teeth were dragged downhill along the slope which will promote erosion. Tracking or grading should be performed perpendicular to the slope to prevent erosion.
