# Inspection Photos

**Operator:** TEP ROCKY MOUNTAIN LLC #96850

**Location ID:** 383325

**Inspection Doc:** 718100100

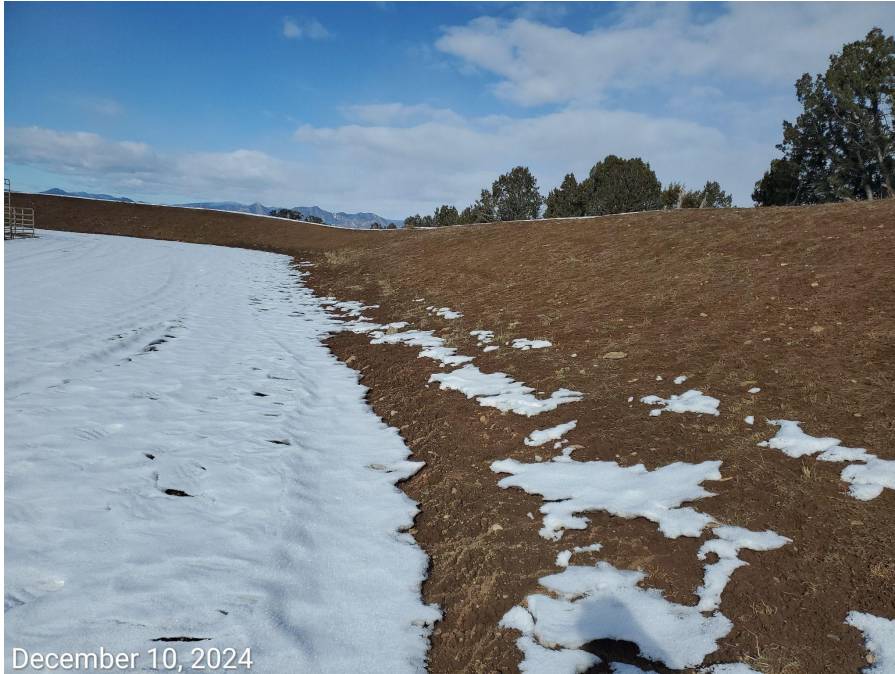
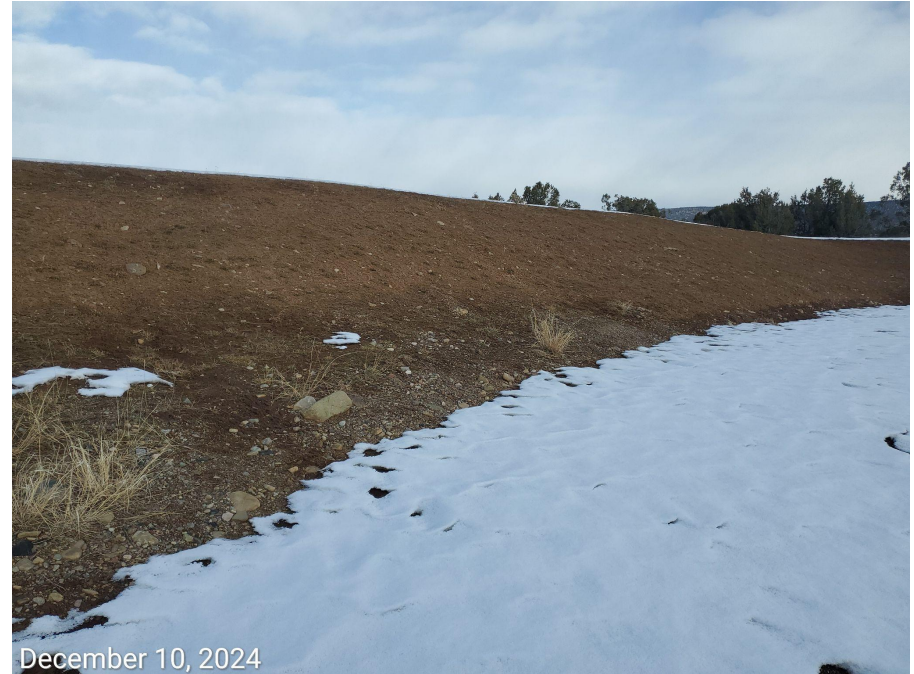
**Photo 1:** Limited inspection due to snow cover. Unable to find evidence that additional reclamation has been performed, and stabilization control measures installed.

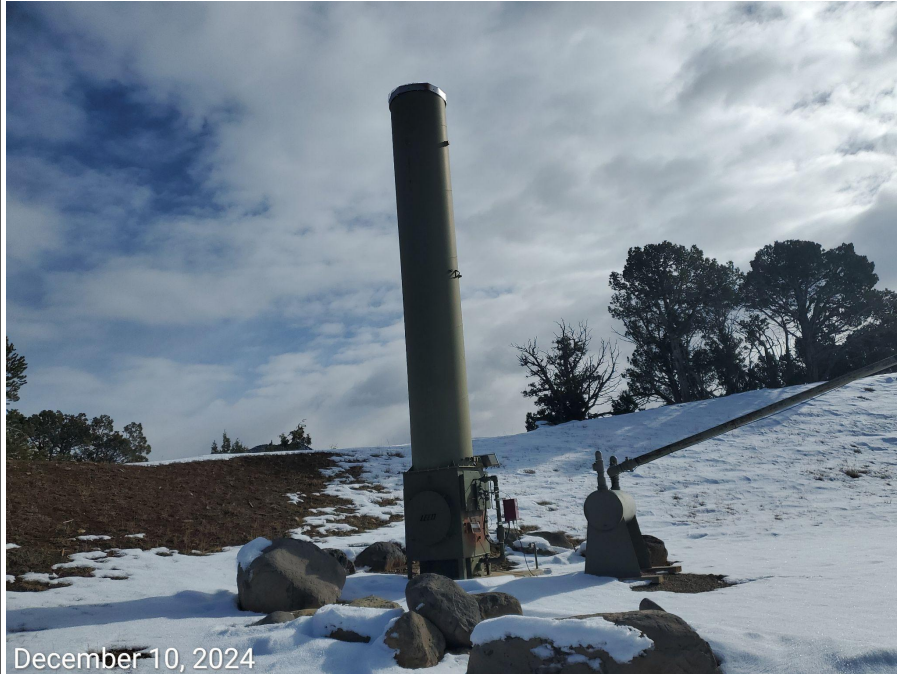
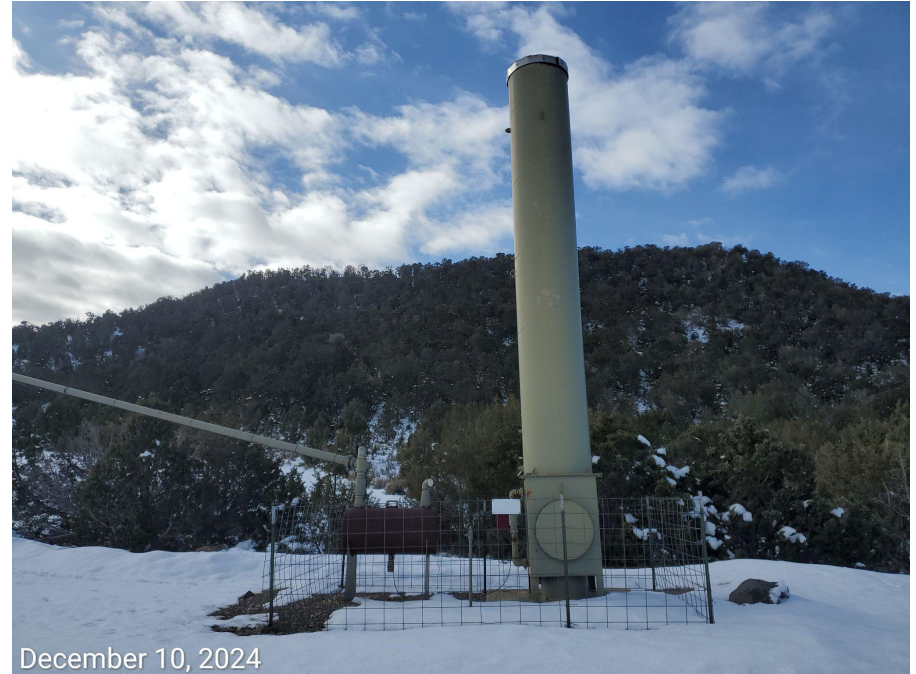
**Photo 2:** Unused equipment.

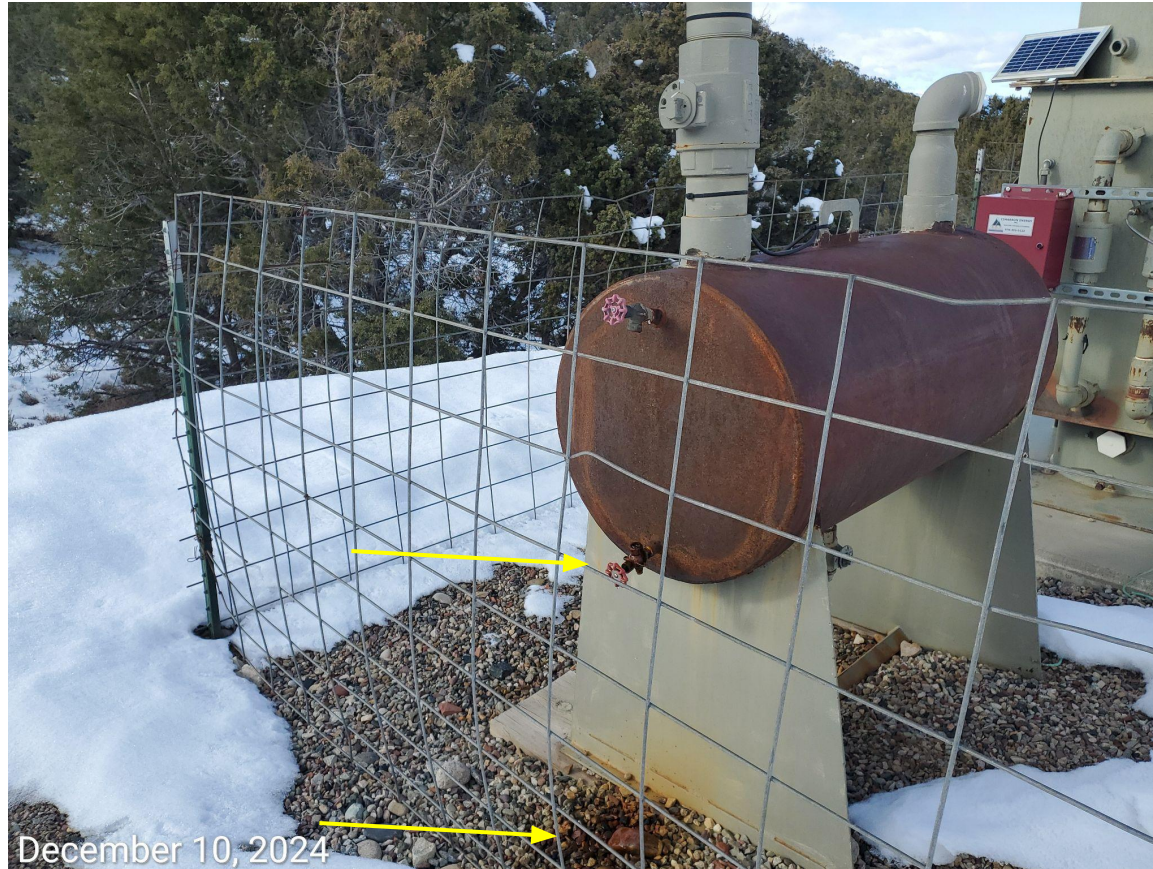
**Photo 3:** Knockout on the NW end of the Location. Leak detected at bottom valve resulting in gas being vented and fluids spilling onto the pad surface.

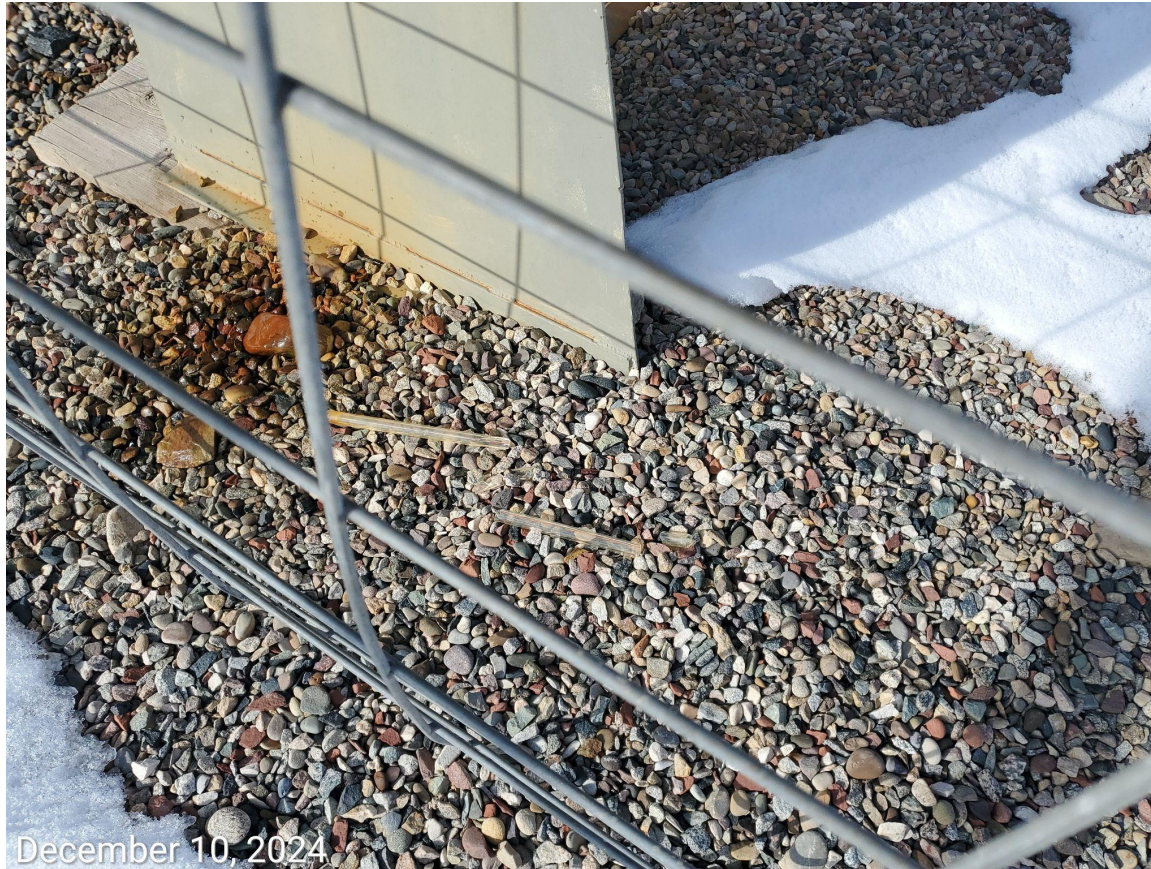
**Photo 4:** Knockout on the NW end of the Location. Photo shows impacted soils due to spill. Photo also shows broken pieces of glass.

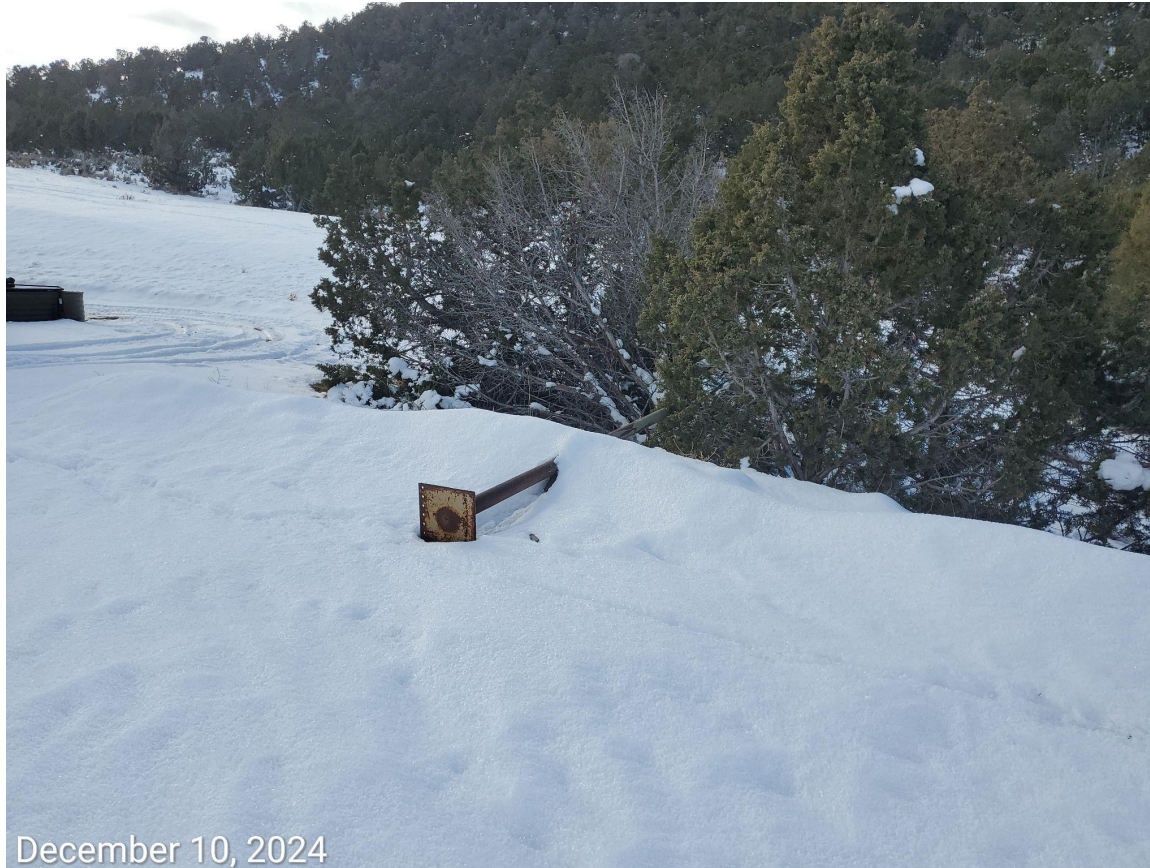
**Photo 5:** Pipe equipment used to support the pipeline between the tank battery and knockout has fallen over.
