Site Specific Final Reclamation Completion Notice – Land Use Change Drone Imagery

Permit Closure Report – Land Use Change

Well Location ID: 418979

Well Location Name: DeJong USX/AB13-06P

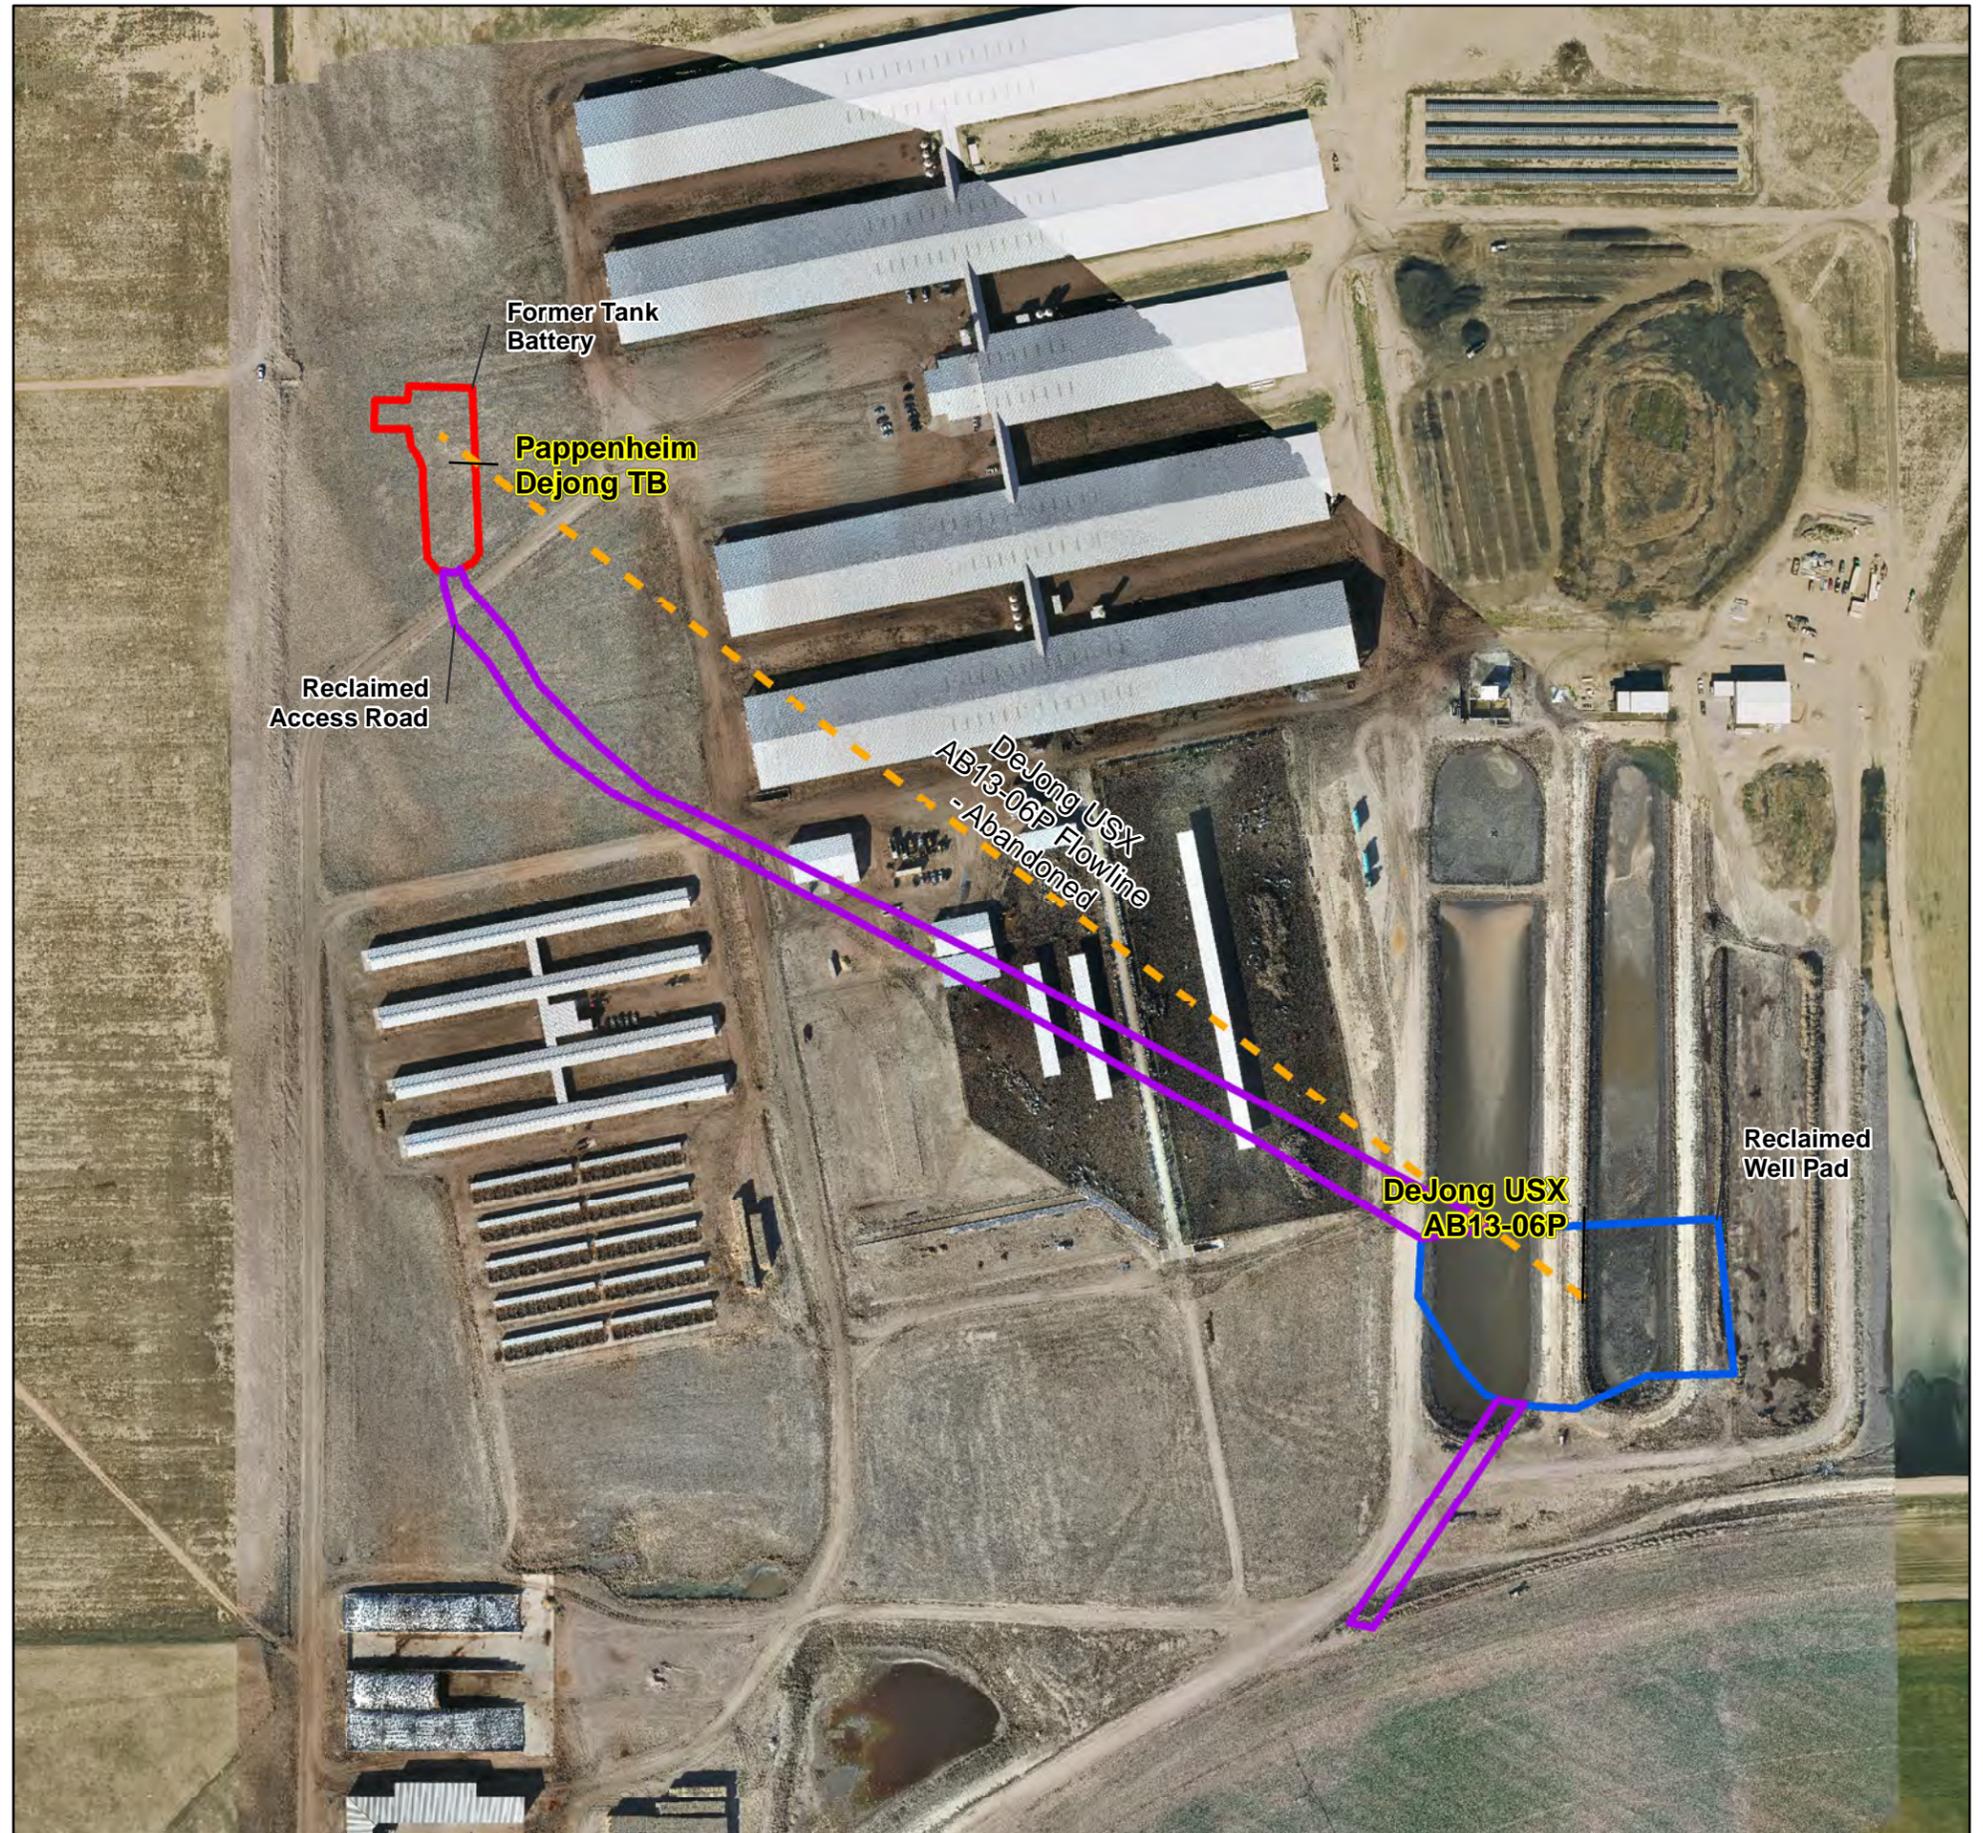
PDC Form 4 Final Reclamation - Post Plugging Overview

Drone imagery confirms that no equipment was left on site at this location after reclamation activities occurred.
