Off-Location Flowline Photos
Flowline Facility ID 478121 & 478122
YE & YF Looplines

INSP Doc #714001501
FIRR #404021703
CA #200845 & 200857

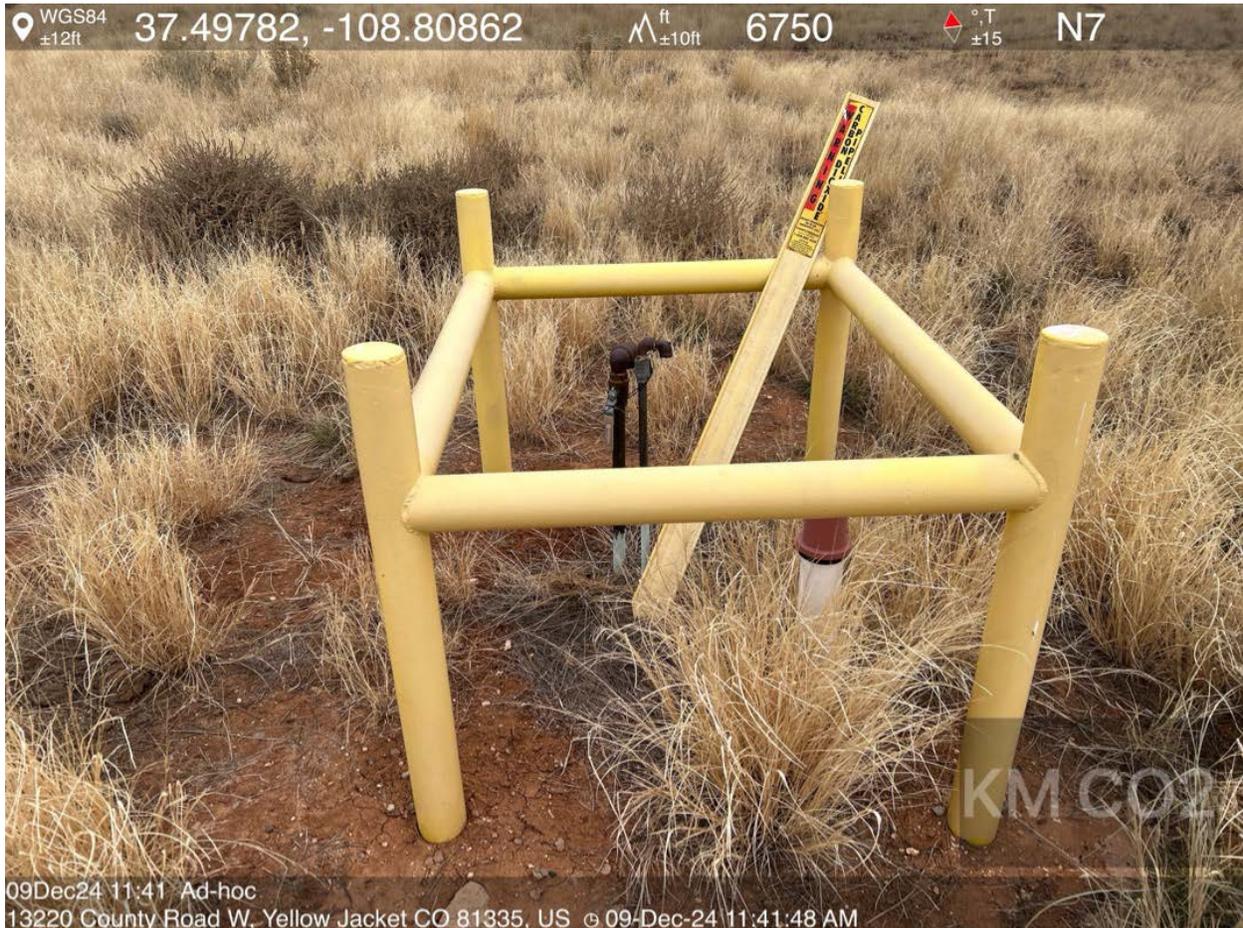
Photo #1. View of above ground bollard cage, pipeline annulus vents, and corrosion protection sleeve located adjacent to the YE-7 P&A well location.

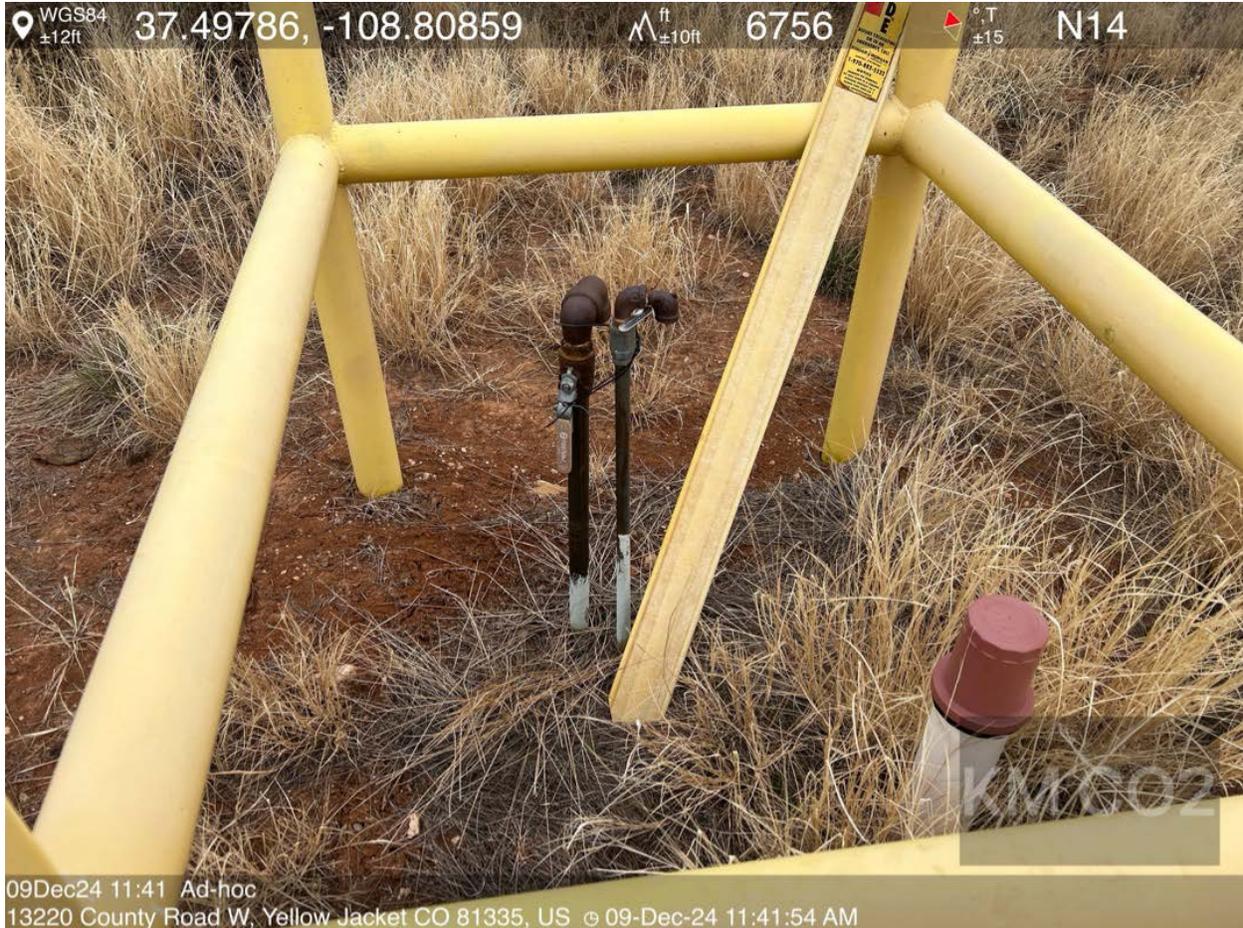
Photo #2. Close up view of the pipeline annulus vents supporting the YE Loopline near the YE-7 P&A well location.

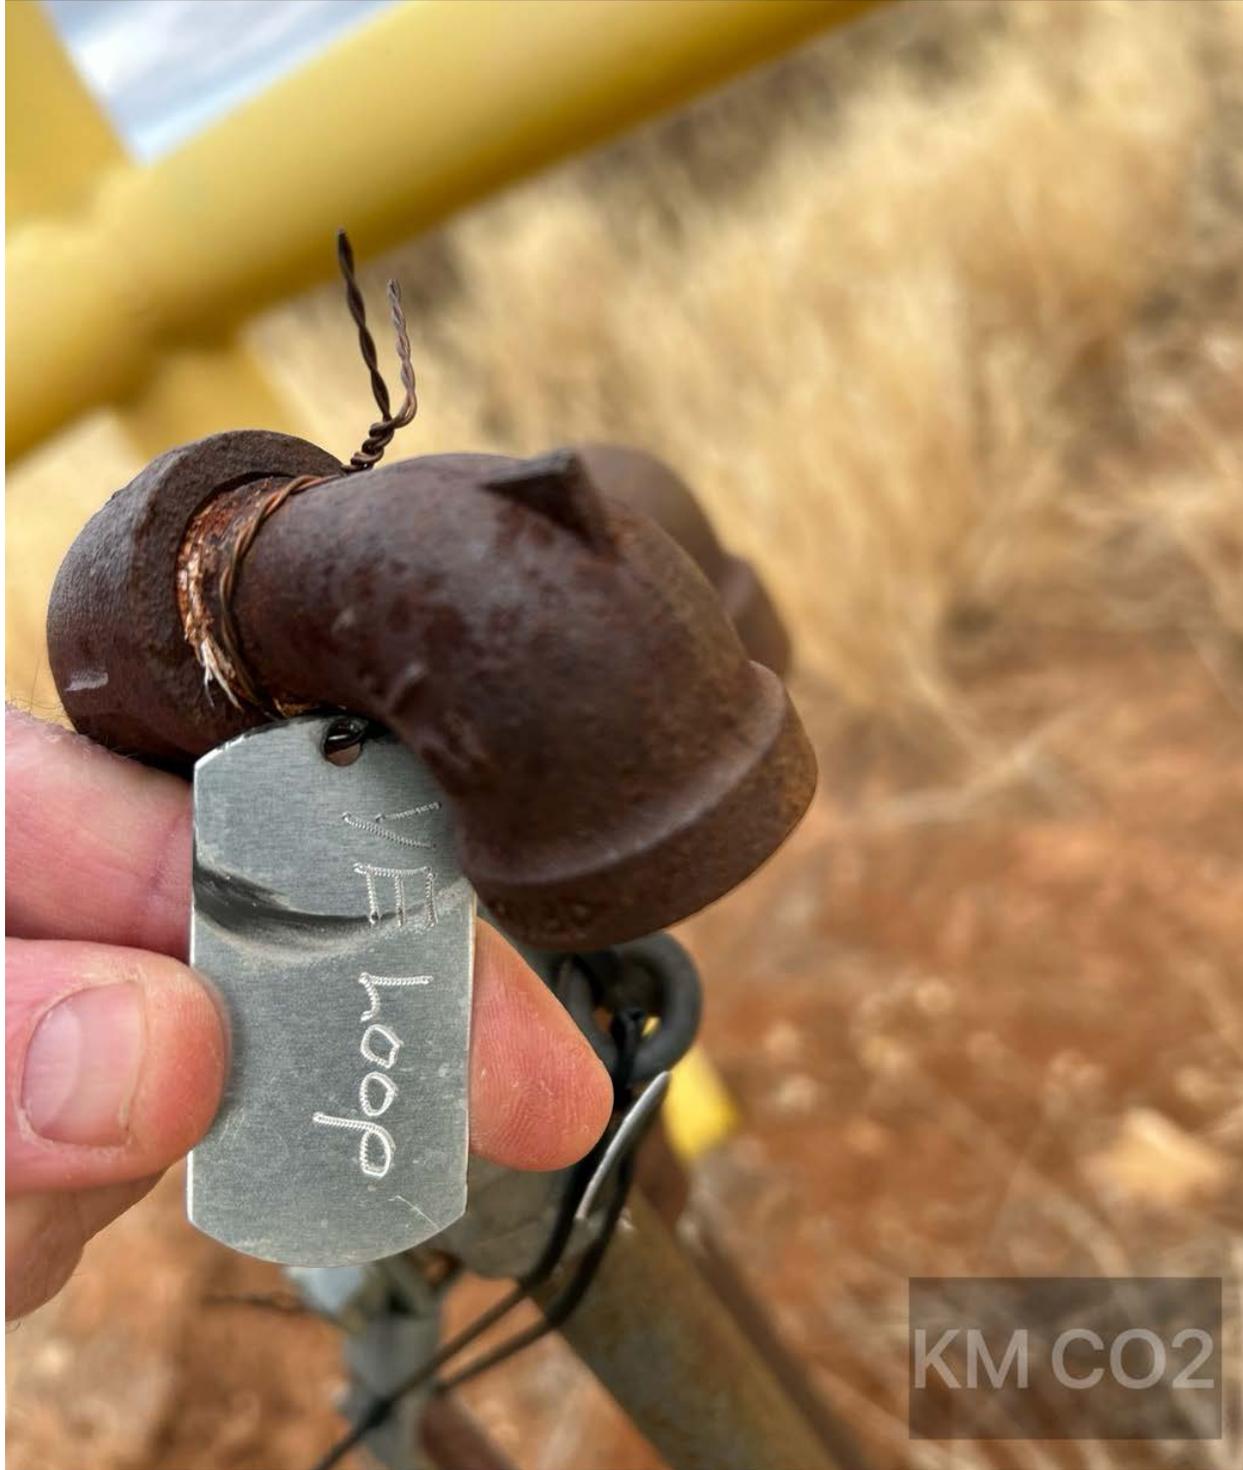
Photo #3. View of a tag on one of the two (2) existing pipeline annulus vents supporting the YE Loopline near the YE-7 P&A well location.

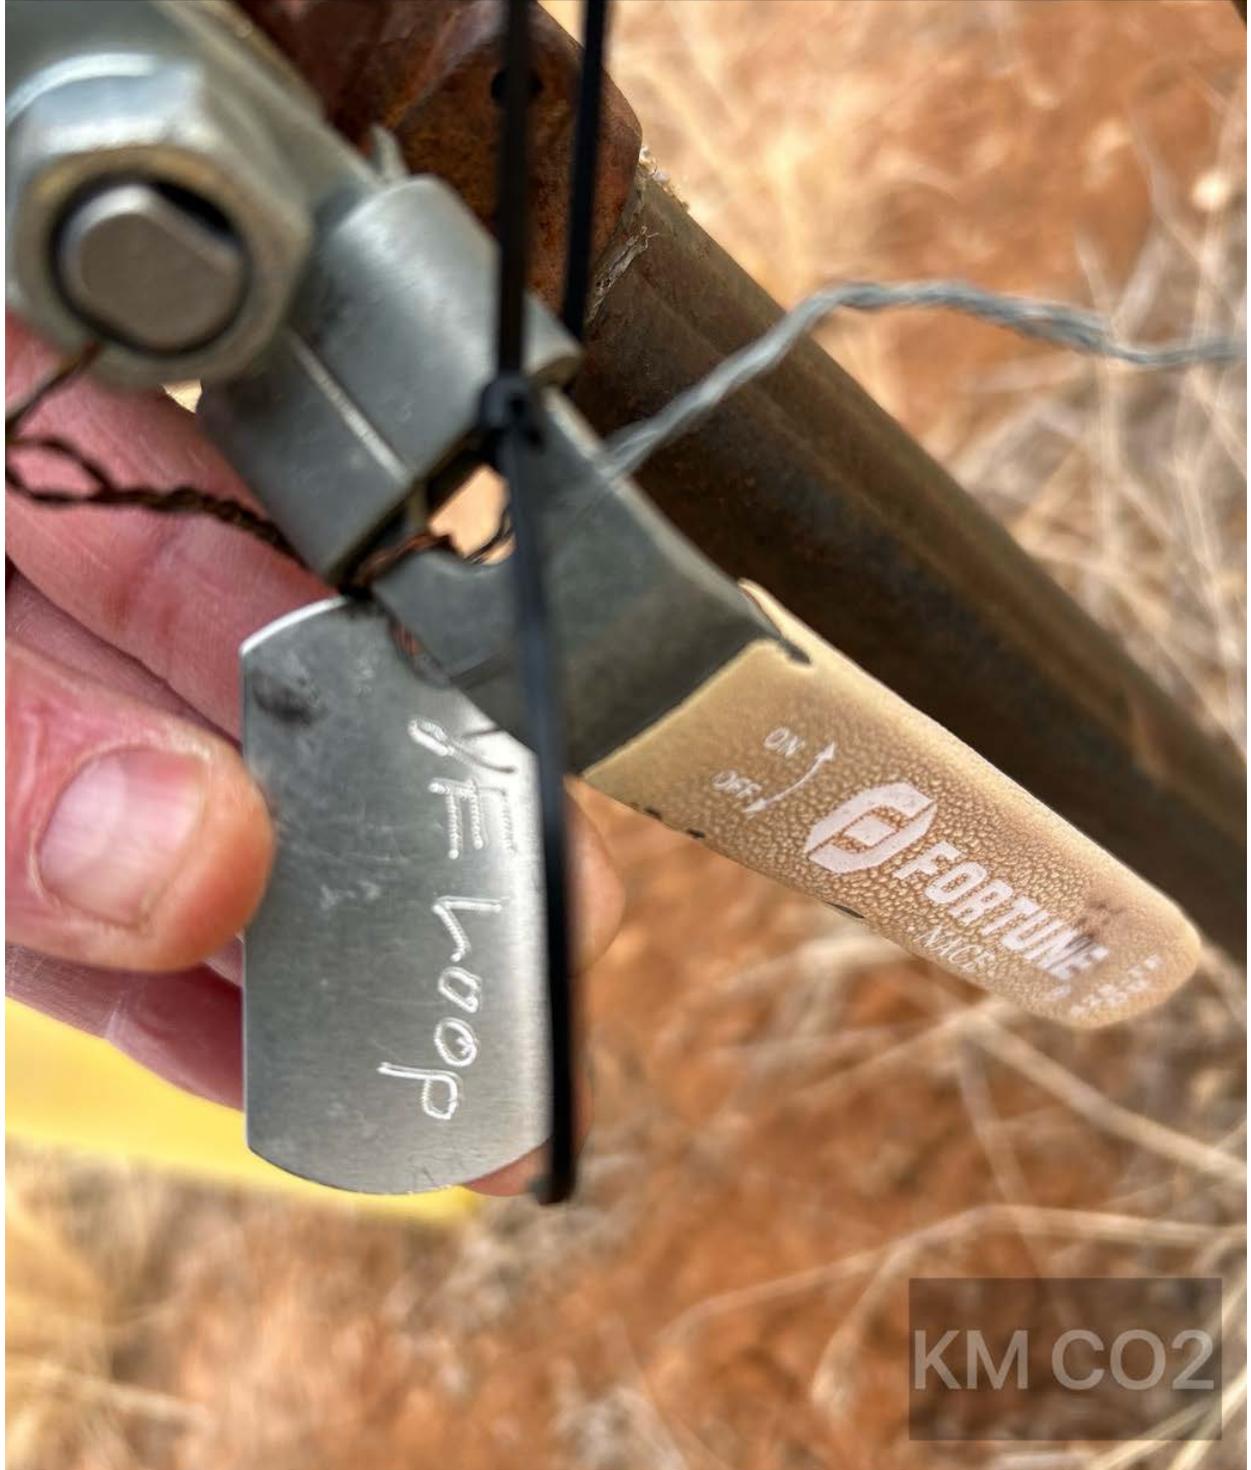
Photo #4. View of the other tag on the two (2) existing pipeline annulus vents supporting the YE Loopline near the YE-7 P&A well location.

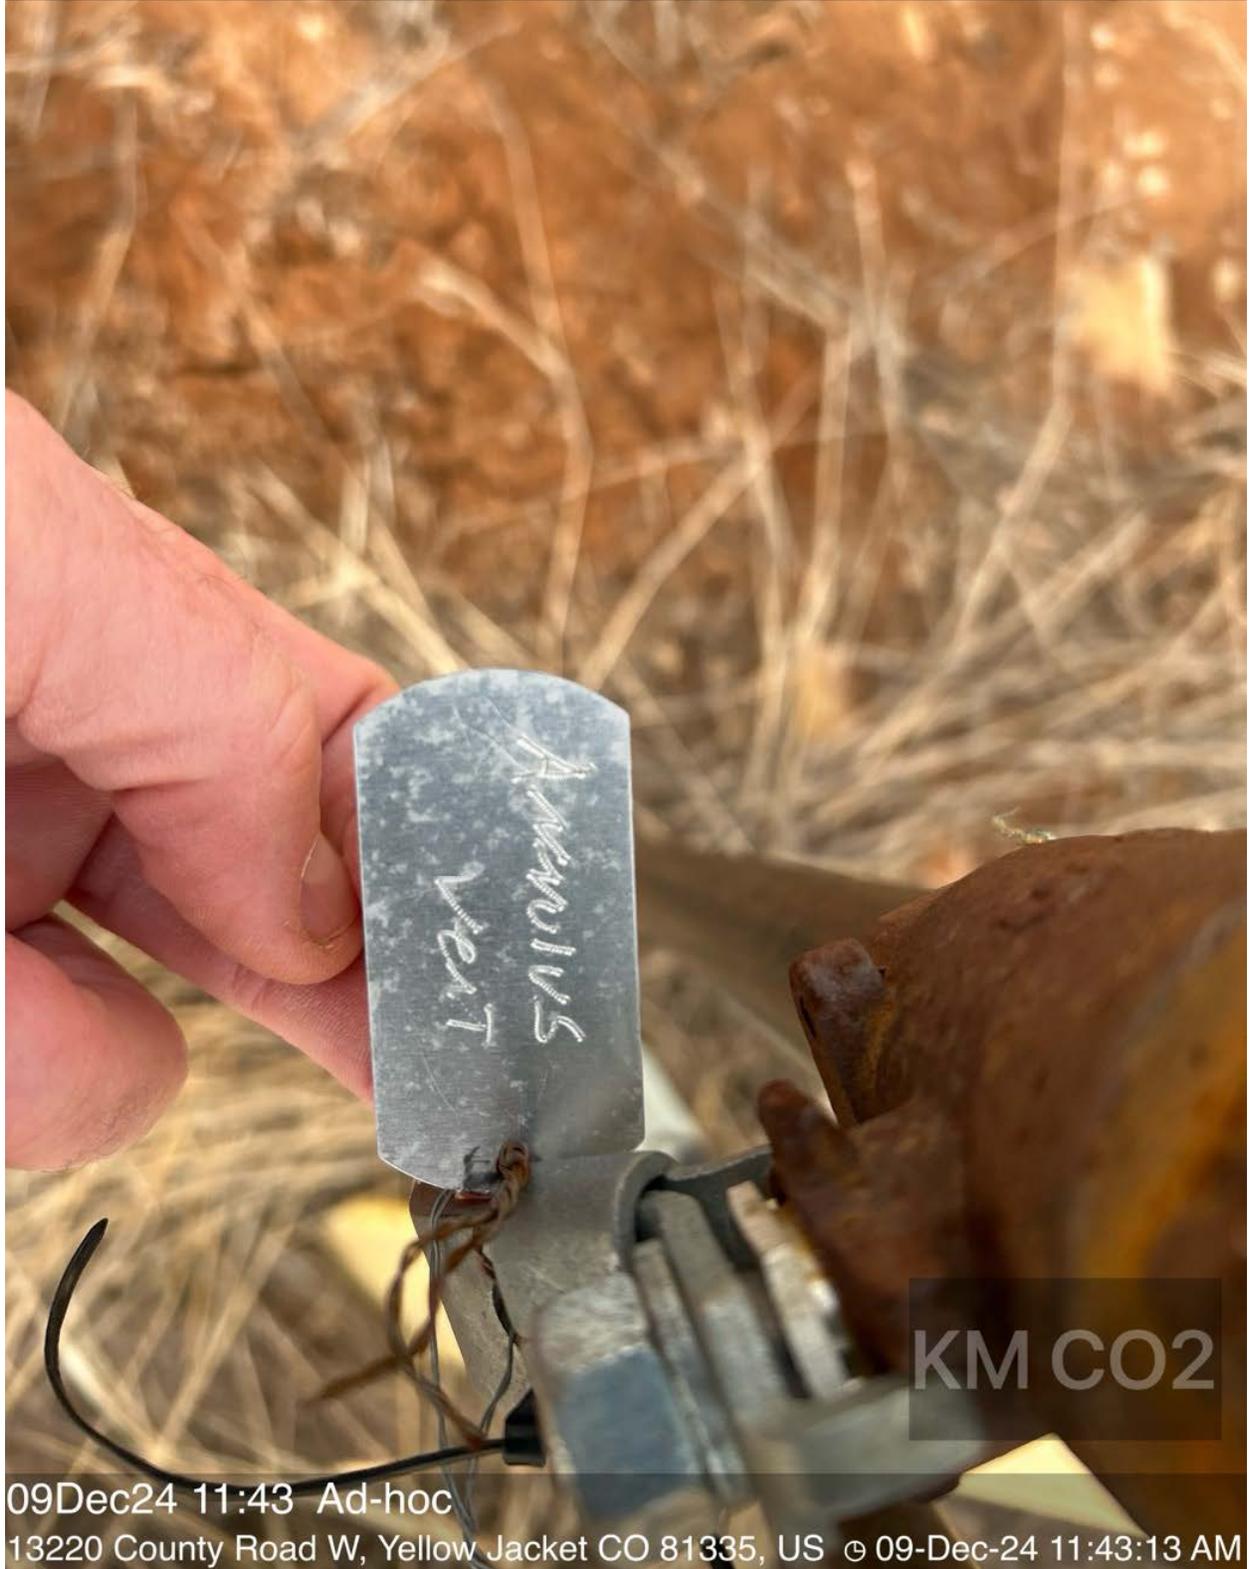
Photo #5. View of the backside of the tags at the existing pipeline annulus vents supporting the YE Loopline near the YE-7 P&A well location.

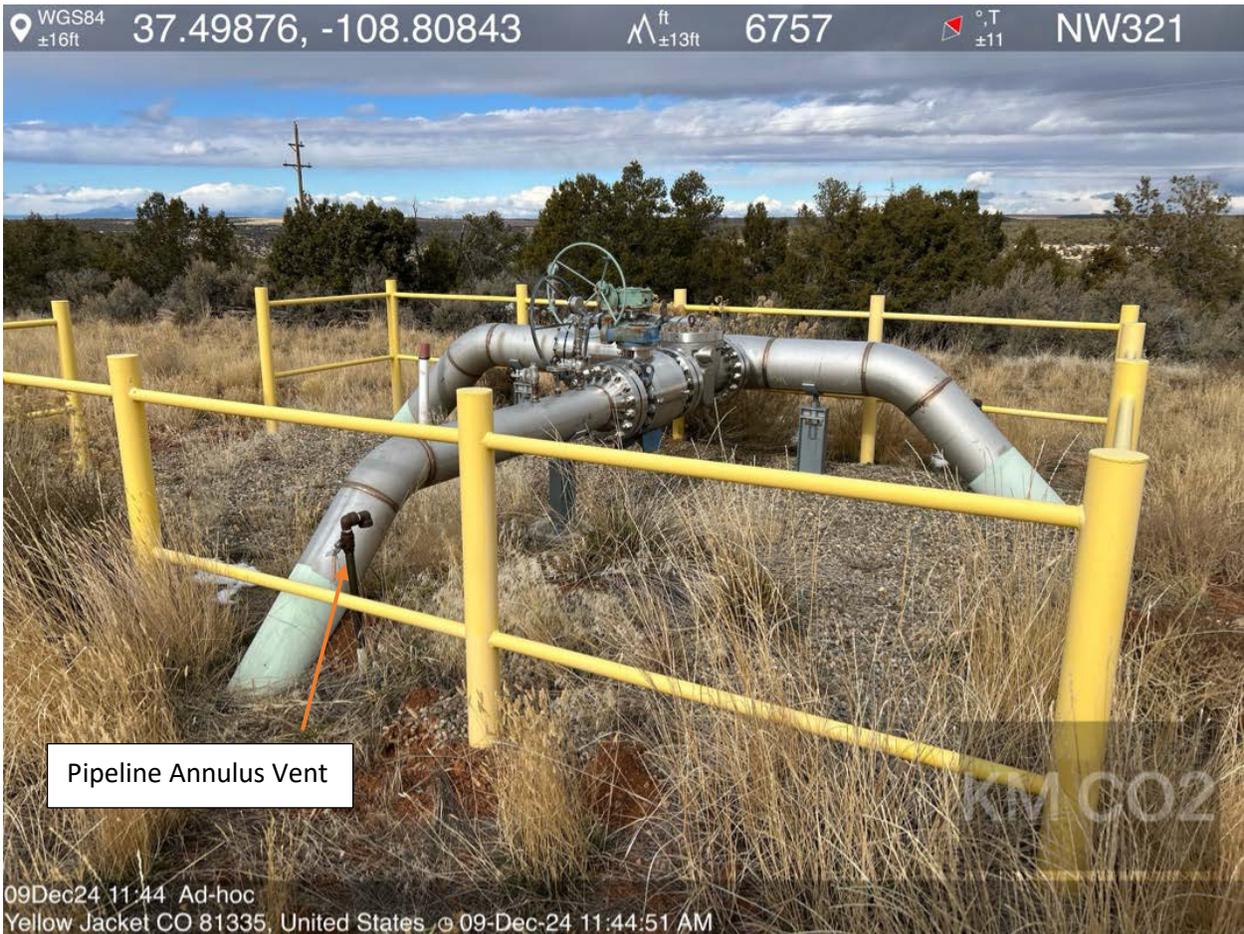
Photo #6. View of above-ground YE-YF Loop Manifold which is located due north of the existing bollard cage (Photos #1 & #2). The pipeline annulus vent visible in the foreground of this photo has a tag that is labeled “YE Loop” and “Annulus Vent”
