Well Integrity Report  
Multifinger Caliper  
Wildcat  
Currier 7-2

Survey Date: 06 September 2024

<b>Customer:</b>	Snow Consulting	<b>API No.:</b>	0507708022
<b>Well:</b>	Currier 7-2	<b>Survey date:</b>	06 Sep 2024
<b>Field:</b>	Wildcat	<b>Job no.:</b>	ANS 1442

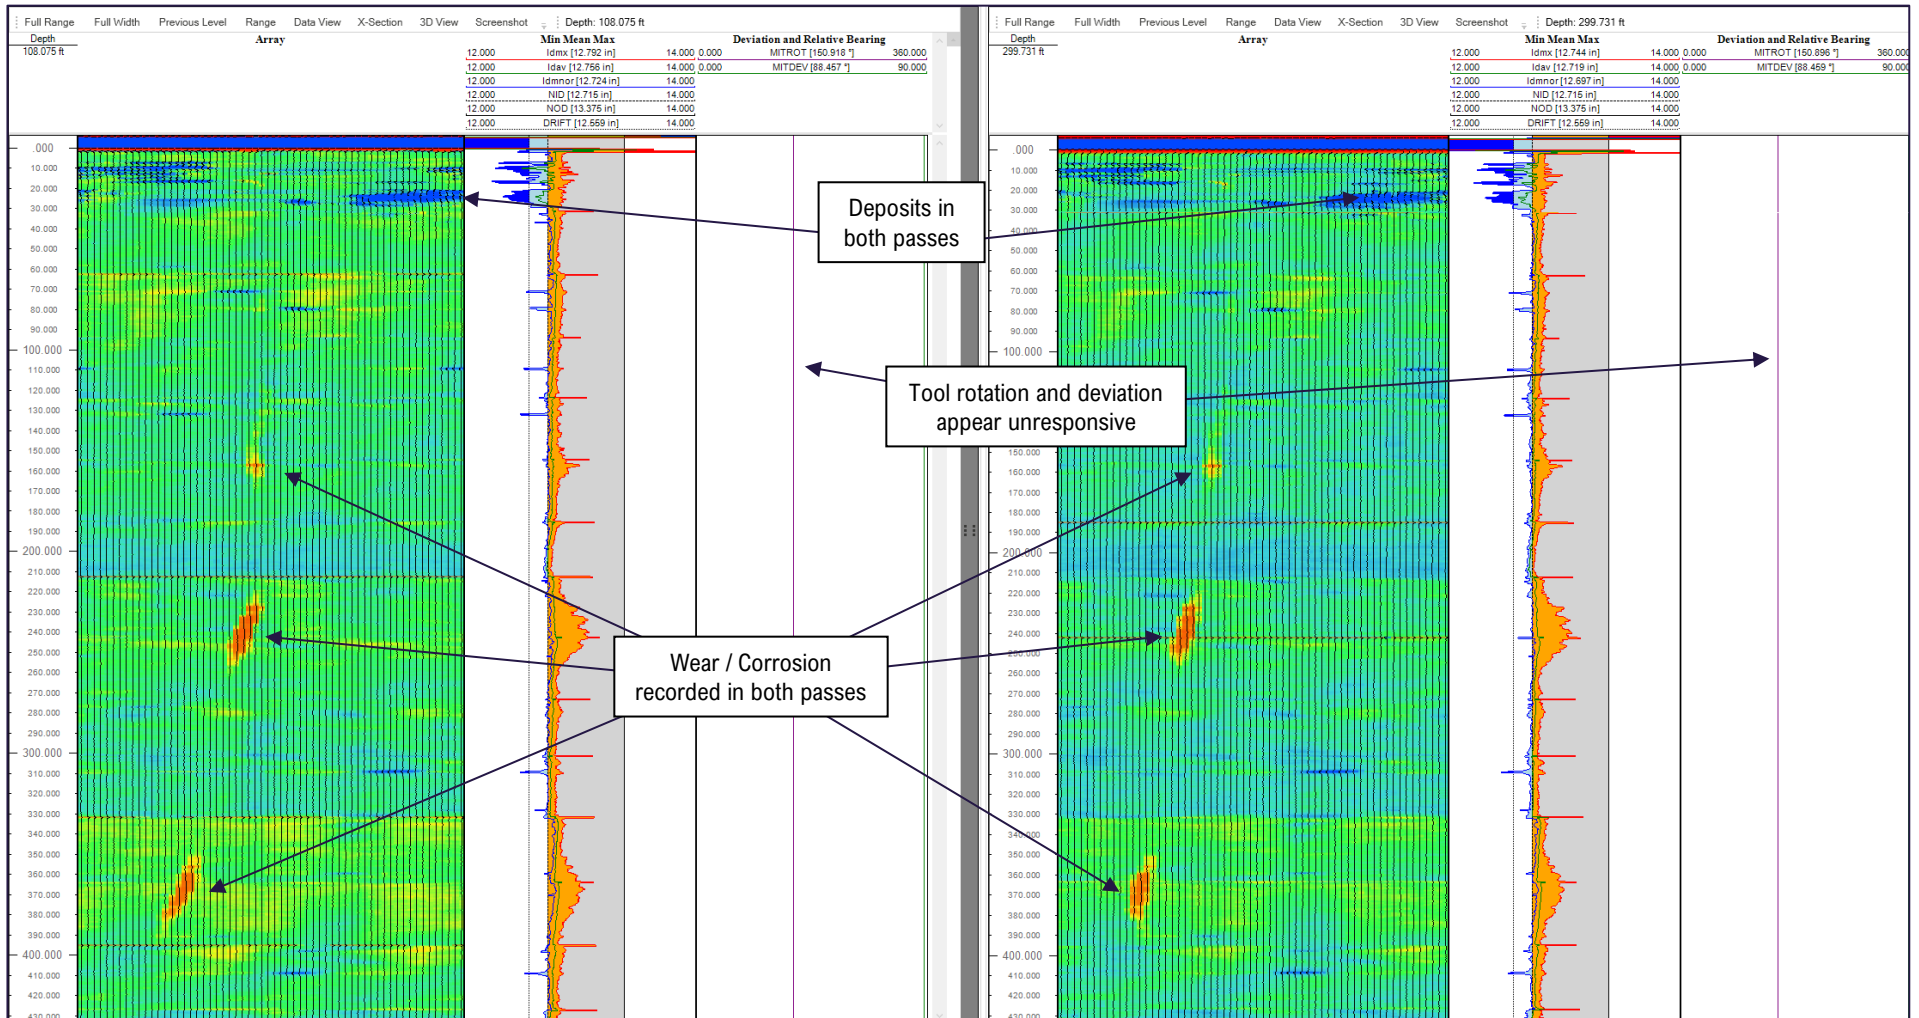
**Figure 1: 13.375" Casing Overview (433.15 ft – surface) Main Pass and Repeat Pass**

- The caliper recordings indicate the short interval of 13.375" casing logged appears to range between moderate and poor condition with respect to internal corrosive and mechanical damage. The average mean ID of the recorded casing is 12.760", slightly higher than the expected nominal ID of 12.715". Figure 1 provides an overview image of both the main and repeat passes across the interval of casing logged. Both passes repeated well, and similar features were logged in both caliper passes. The main pass was used for statistical analysis in this report.

- The caliper recorded four distinct intervals of metal loss in the casing in the form of an intermittent line of corrosion and/or apparent wear to the inside of the casing, see Figure 1. The first interval of line corrosion and wear is recorded between ~6 ft and ~20 ft towards surface. This line of damage is adjacent to deposits in the well which may have masked additional damage to the inside of the pipe wall and prevented the caliper fingers from fully imaging the damage while logging. The maximum recorded wall penetration in this interval of damage is 40.6% of nominal wall thickness recorded at 12.70 ft, see Figures 2 and 3. As previously mentioned, deposits are recorded in this interval of casing reducing the ID to 12.235" at 16.23 ft, see Figures 2 and 4.

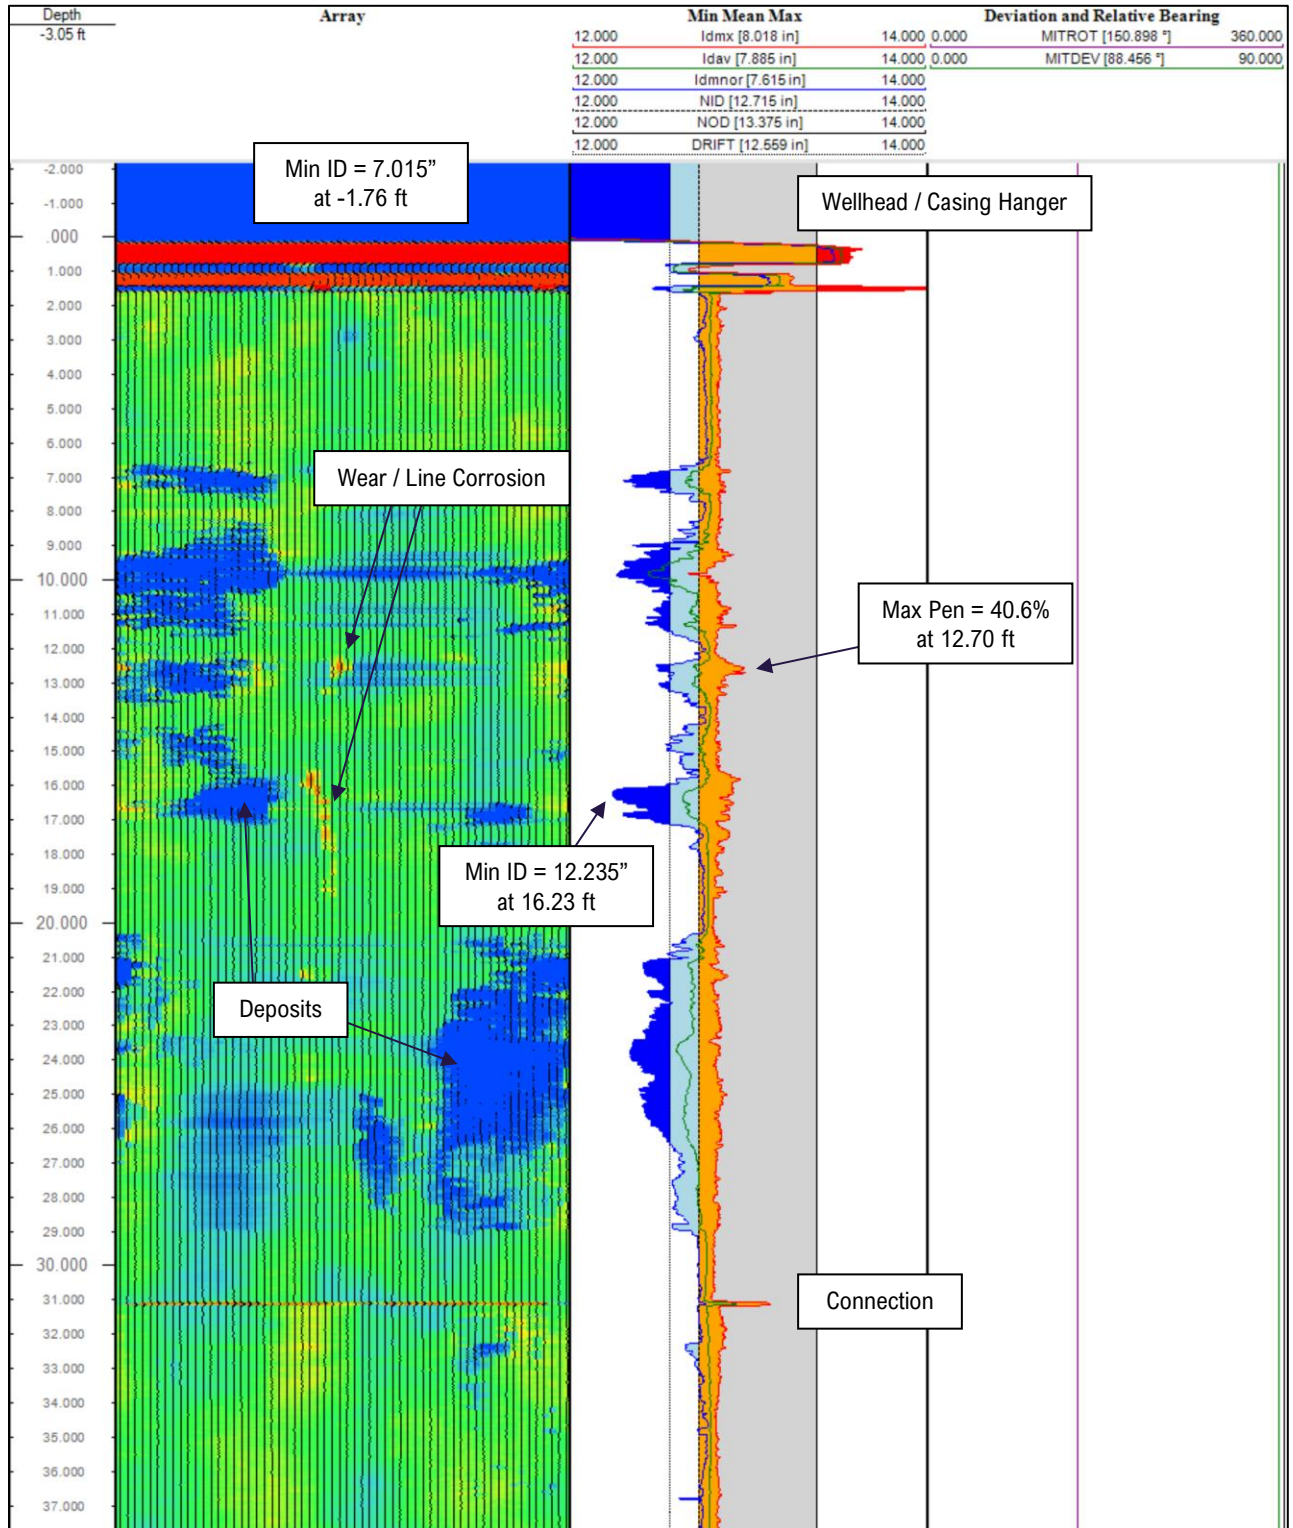
**Figure 2: 13.375" Casing – Wear / Line Corrosion and Deposits Recorded Near Surface**

- The survey minimum diameter is found within the wellhead/casing hanger assembly reducing the ID to 7.015" at -1.76 ft, see Figure 2.

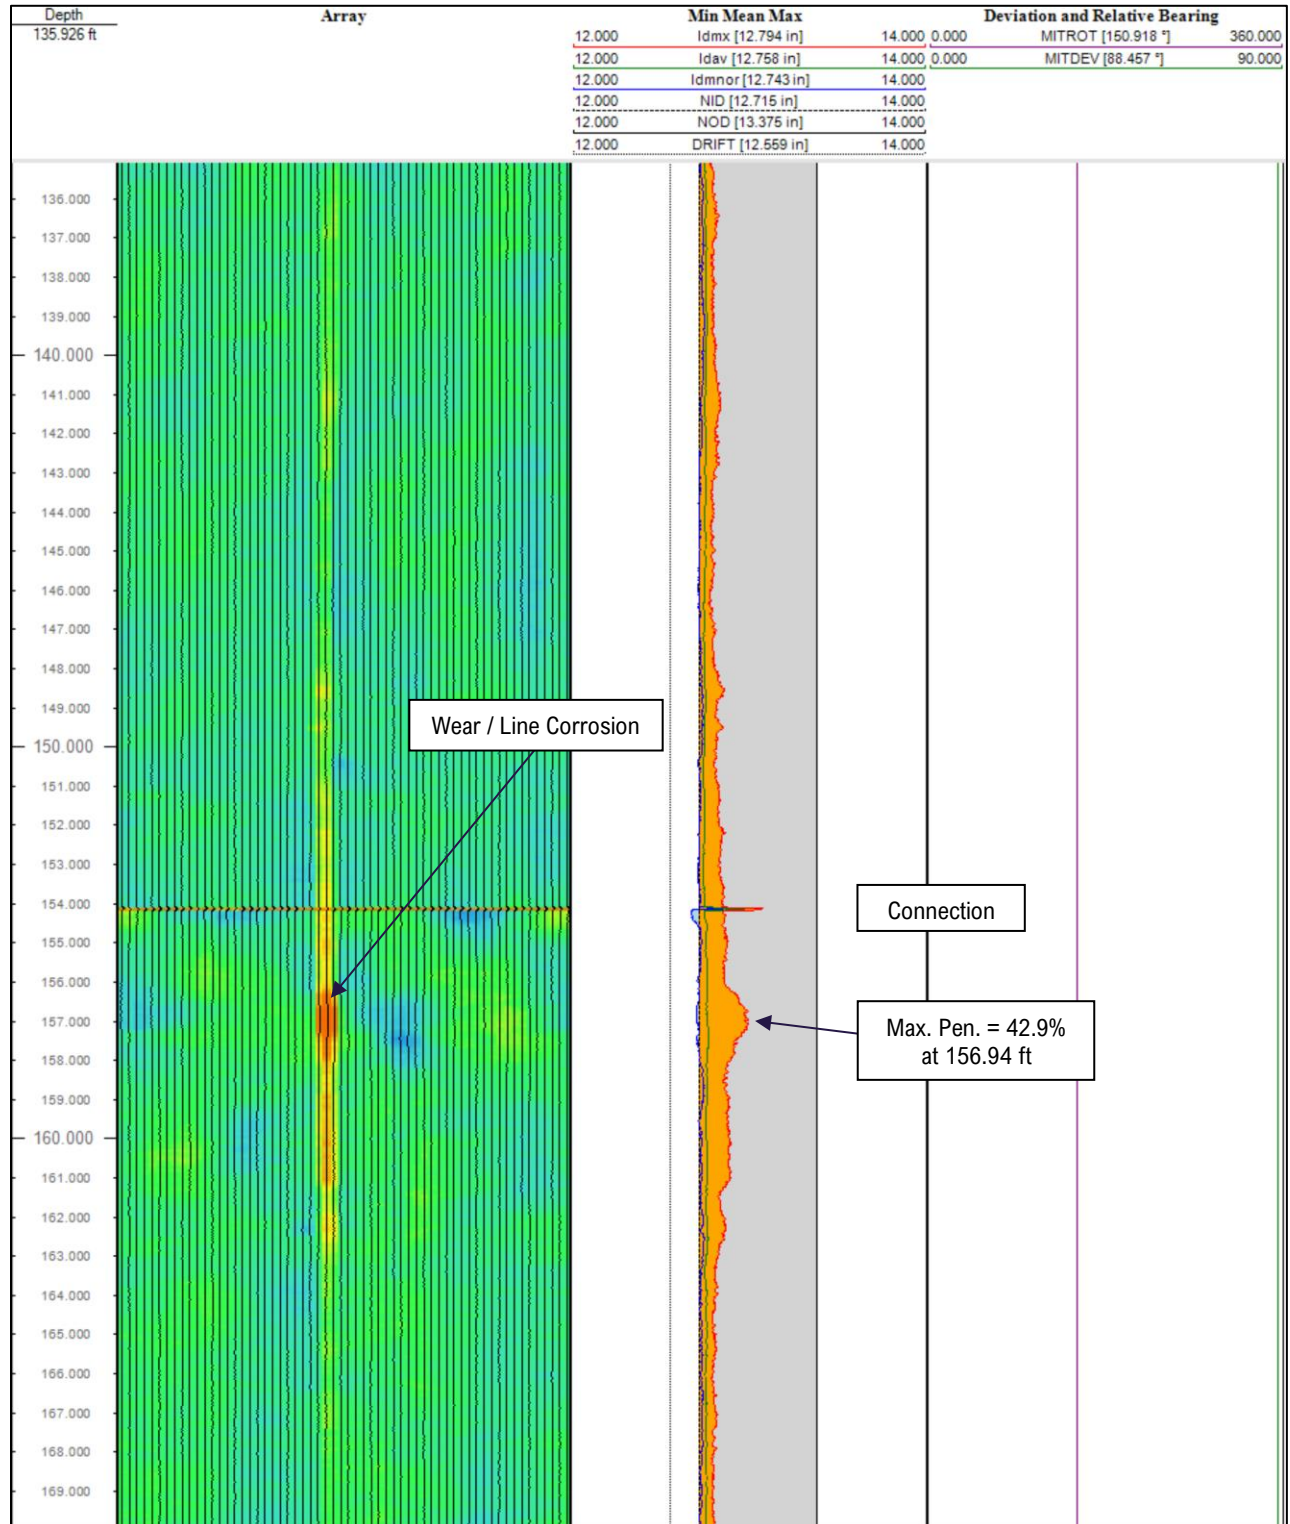
**Figure 5: 13.375" Casing – Wear / Line Corrosion Recorded Between ~140 ft and ~164 ft**

- The second interval of wear is found between ~140 ft and ~164 ft where damage is recorded on up to 3 consecutive caliper fingers. This line of wear appears to be more defined and is most likely caused by assemblies wearing on the inside of the pipe wall creating a groove. The maximum recorded wall penetration across this interval of wear is 42.9% of nominal wall thickness at 156.94 ft, see Figures 5 and 6.

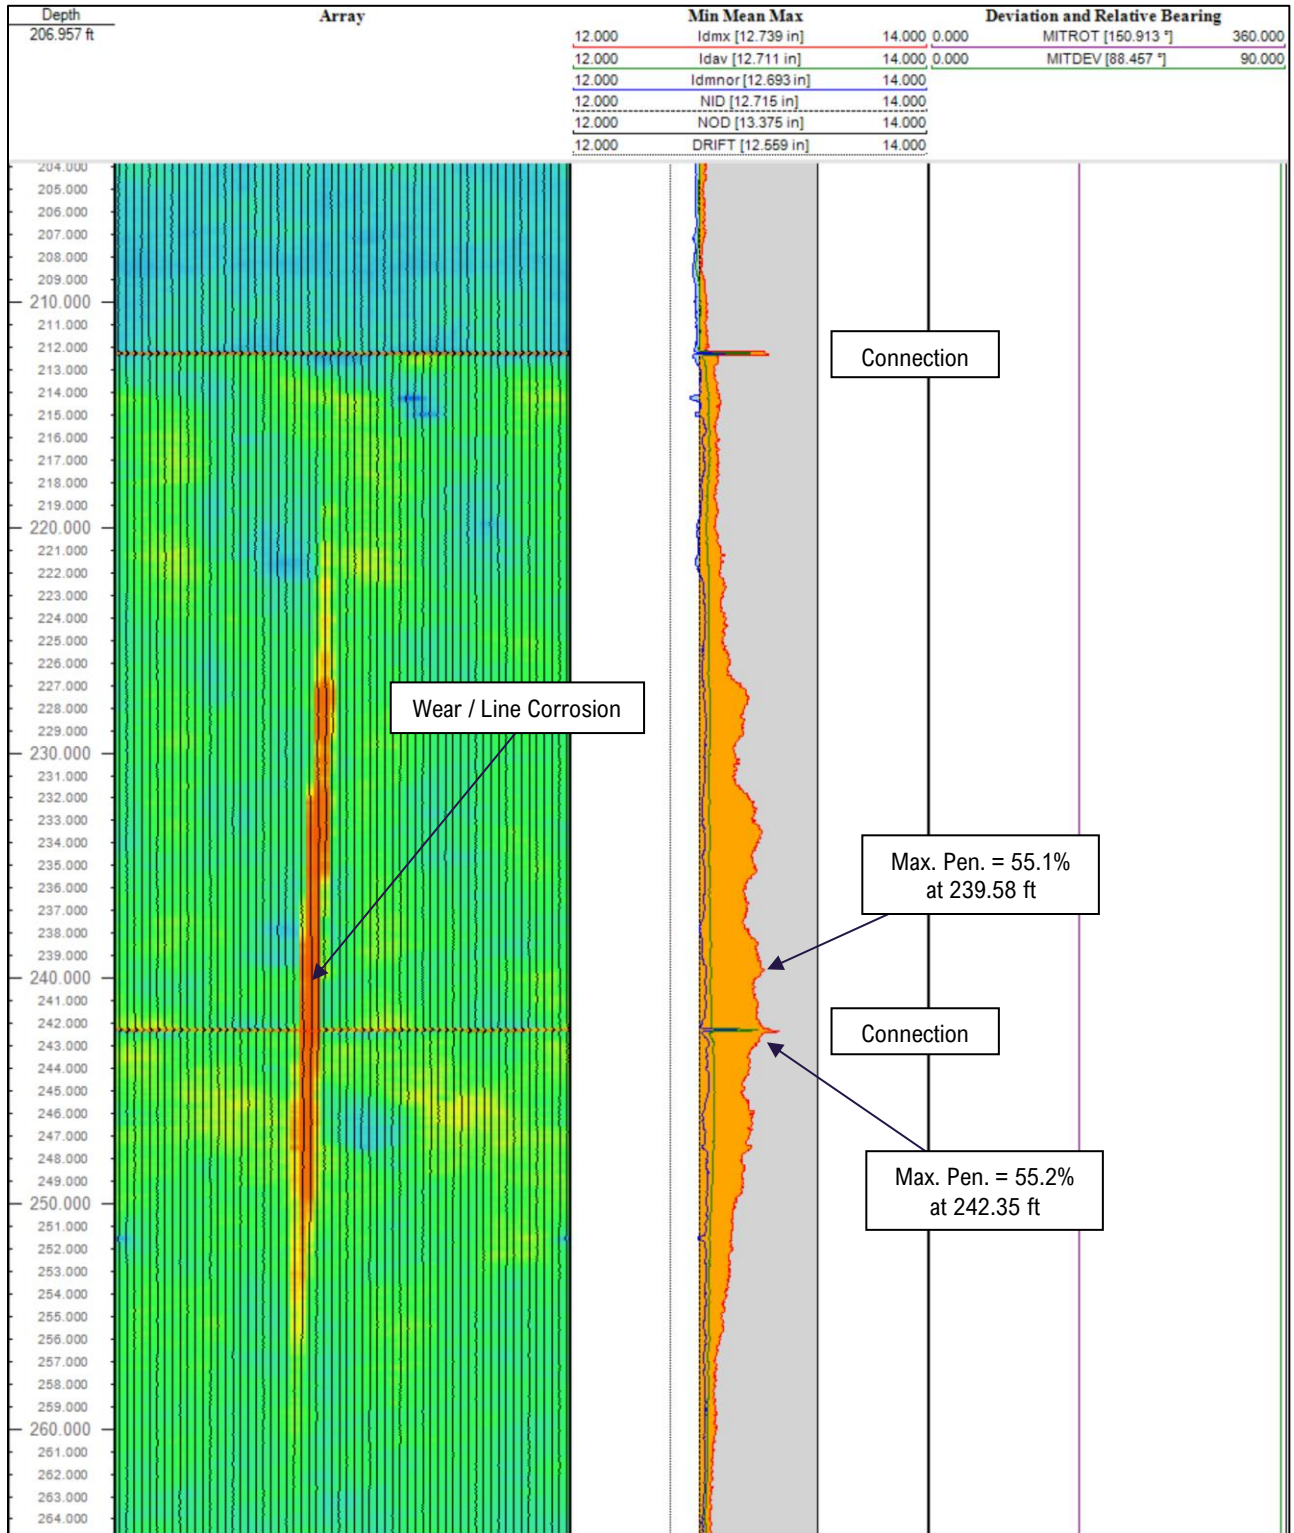
**Figure 7: 13.375" Casing – Wear / Line Corrosion Recorded Between ~220 ft and ~256 ft**

- The third interval of wear is found between ~220 ft and ~256 ft where damage is also recorded on up to 4 consecutive caliper fingers. This line of wear is even more defined than the previous two lines of wear. The maximum recorded wall penetration across this interval of wear is where the survey maximum recorded wall penetration is recorded, measuring 55.2% wall penetration at 242.35 ft, see Figures 7 and 8. The second most significant wall penetration across the surveyed casing is also found within this line of damage, measuring 55.1% wall thickness at 239.58 ft, see Figure 7.

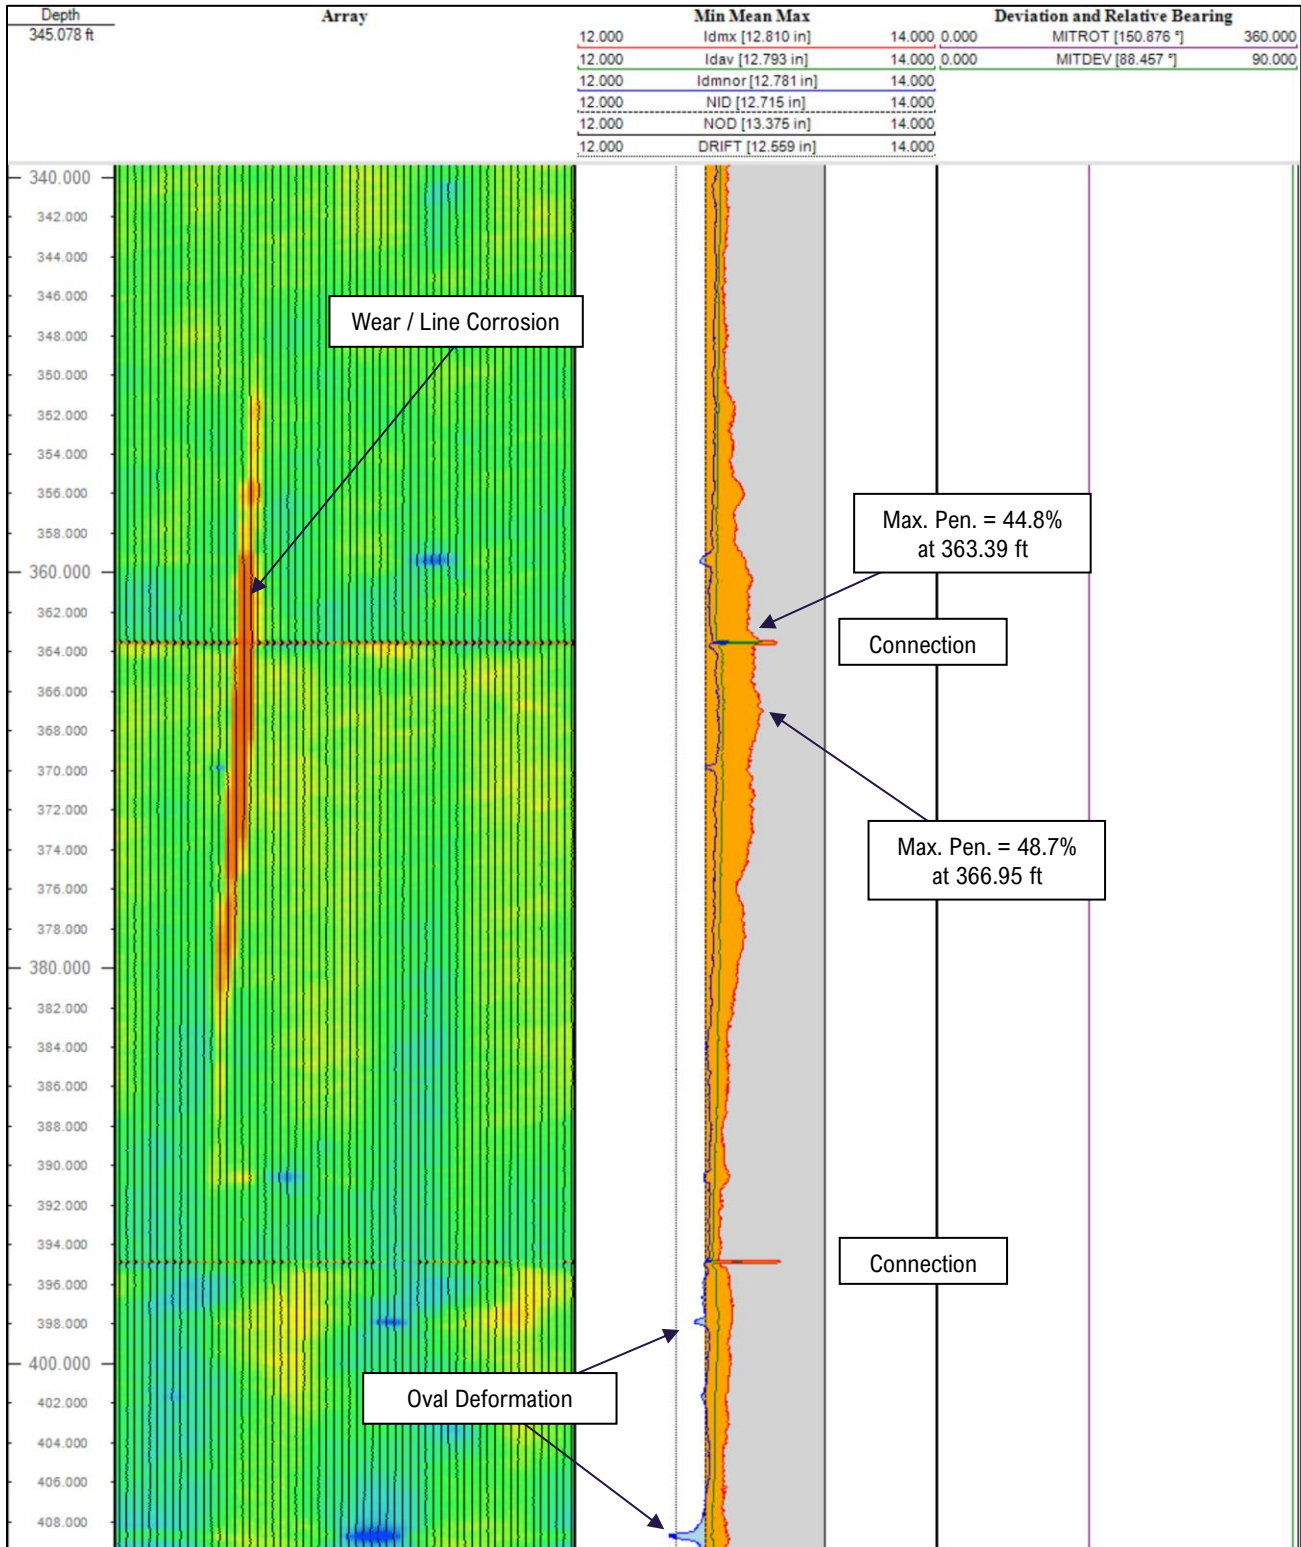
**Figure 9: 13.375" Casing – Wear / Line Corrosion Recorded Between ~352 ft and ~388 ft**

- The fourth interval of wear is found between ~352 ft and ~388 ft where damage is recorded on up to 3 consecutive caliper fingers. This line of wear is pronounced over this interval and the maximum recorded wall penetration across this interval of wear is 48.7% at 366.95 ft, see Figures 9 and 10. Outside of these lines of wear, no other significant wall penetrations are recorded throughout the casing logged.

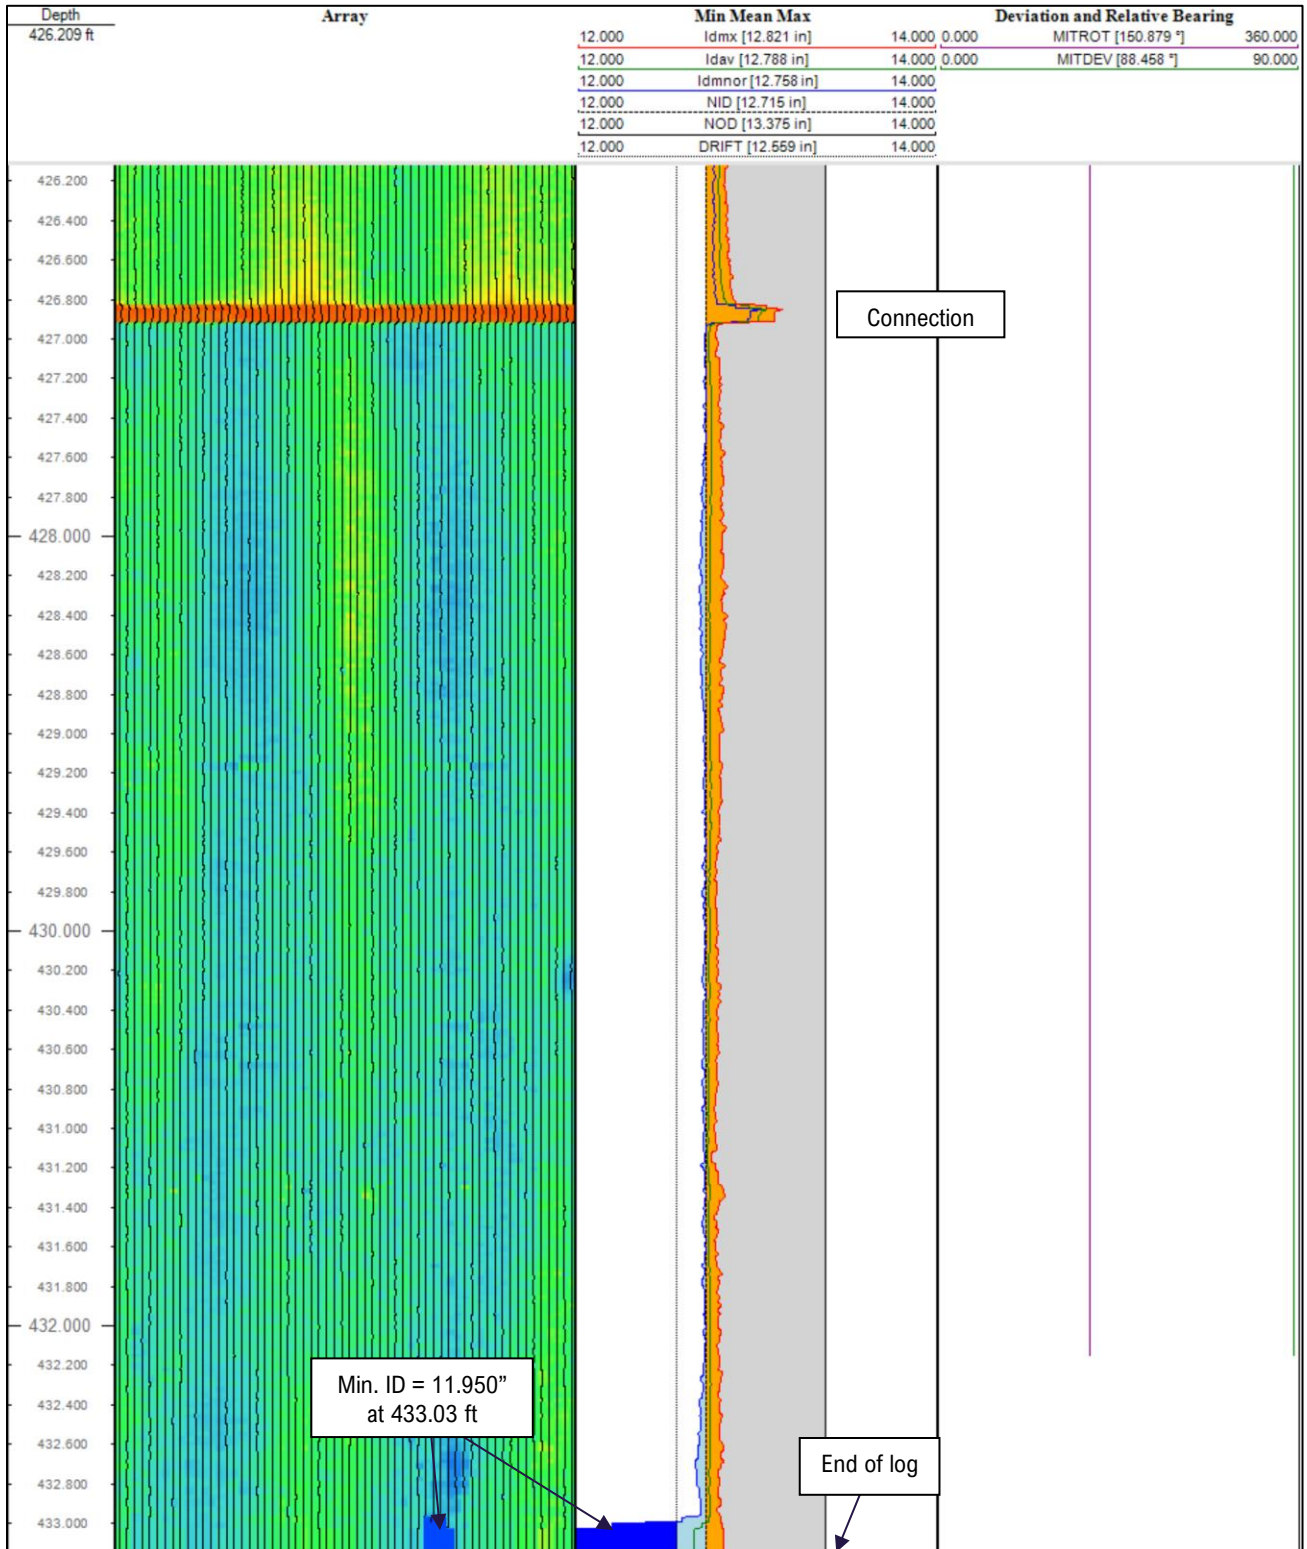
**Figure 11: 13.375" Casing – Deposits Recorded Between 432.96 ft and 433.15 ft (end of log)**

- Other than the large patches of deposit towards surface previously mentioned the caliper recorded a small patch of deposits at the start of the logging interval across 4 consecutive caliper fingers between 432.96 ft and 433.15 ft (end of log). The minimum recorded diameter across this interval is 11.950" at 433.03 ft, see Figures 11 and 12.

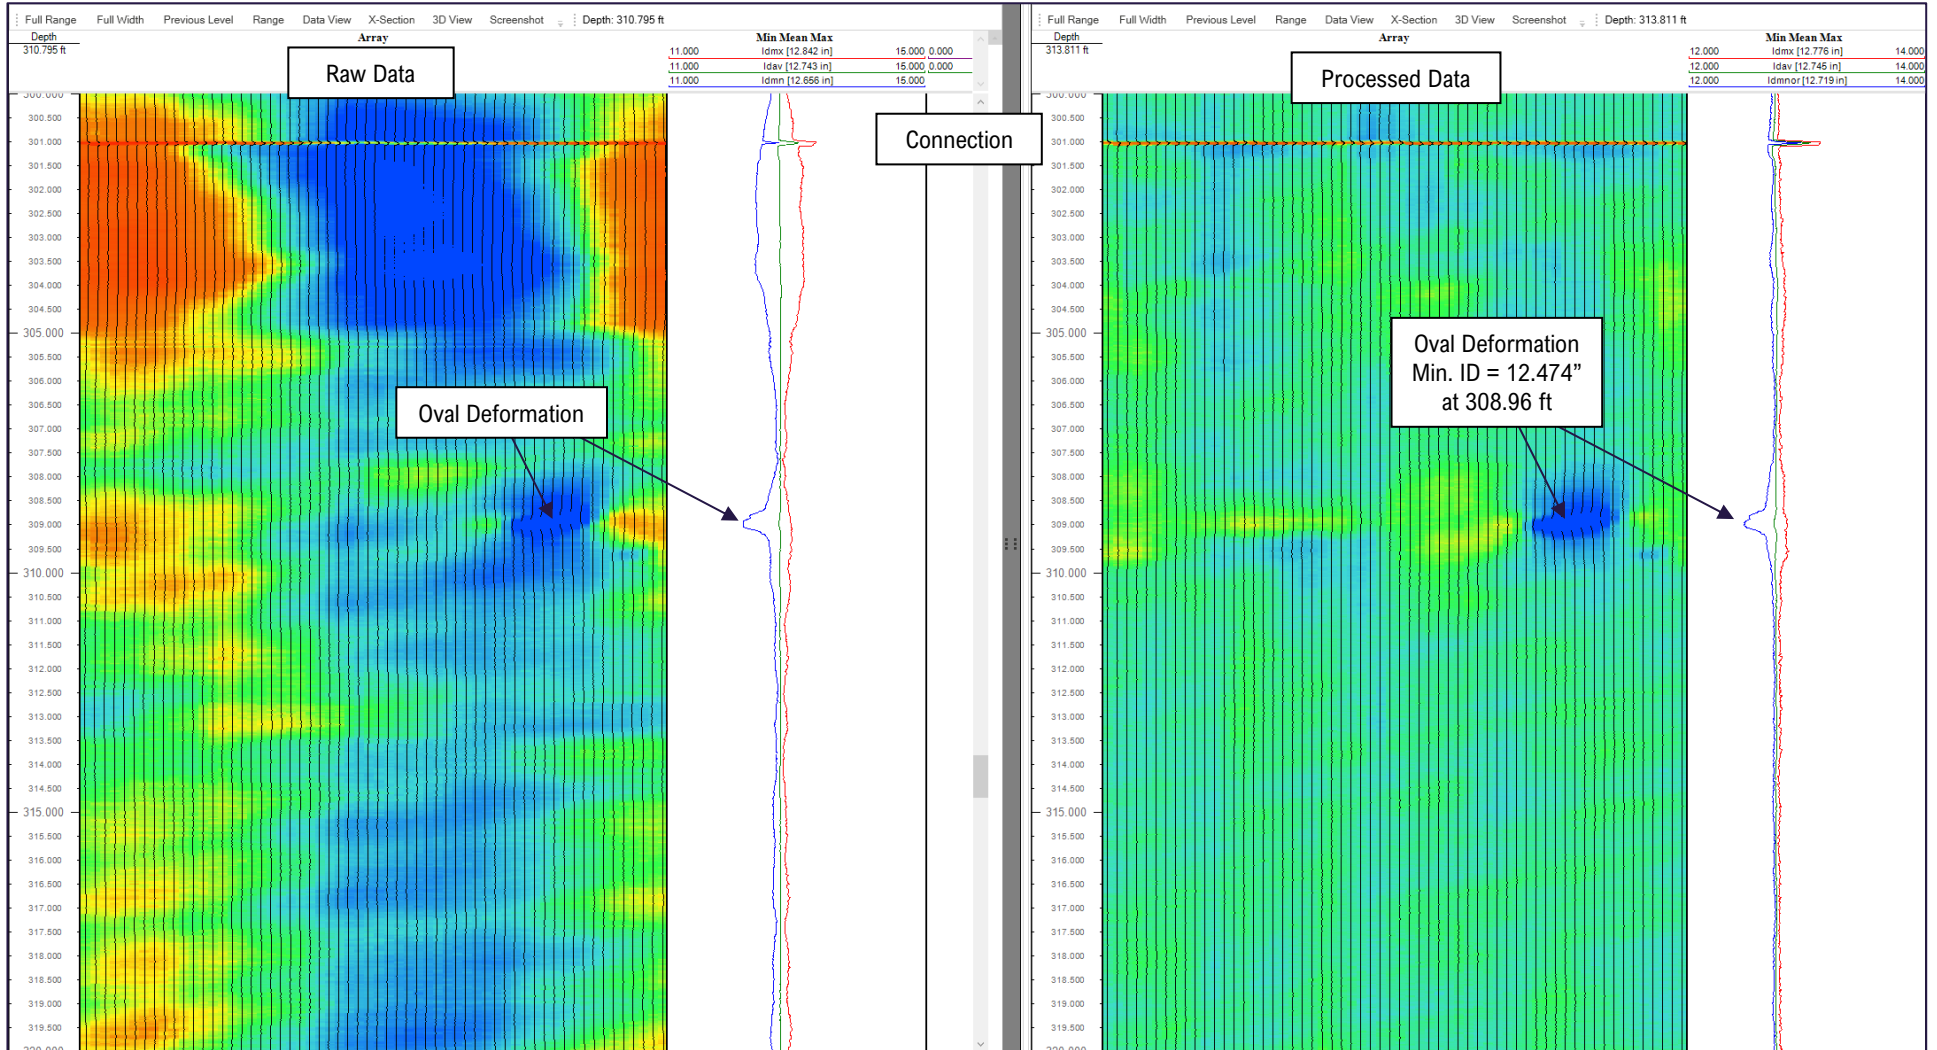
**Figure 13: 13.375" Casing – Oval Deformation Recorded at 308.96 ft**

- The caliper also recorded several short and localized areas of oval deformation throughout the casing logged. The most severe deformation regarding ID restrictions is recorded at 308.96 ft with a minimum ID of 12.474", see Figures 13 and 14. An overview of what the other areas of deformation look like can be seen in Figure 15, highlighting several instances within the casing.
