**Inspection Photos**  
**Location Name: QB Energy GMR 8-6 (K8W) Pad**  
**Location #: 311645**

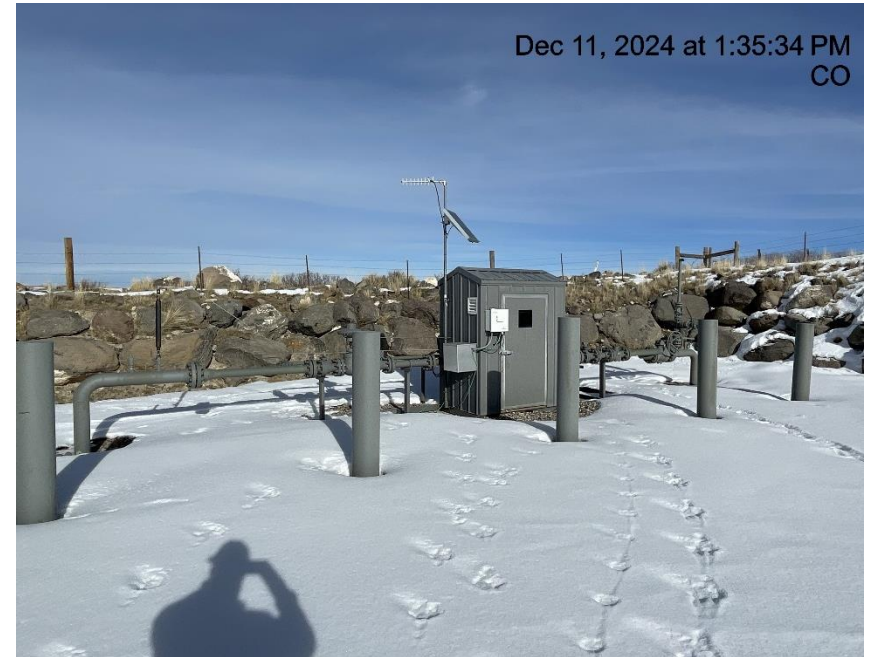
**Photo # 3175 Summit Midstream meter house not listed in  
FORM 2A/not in compliance with CECMC rules**

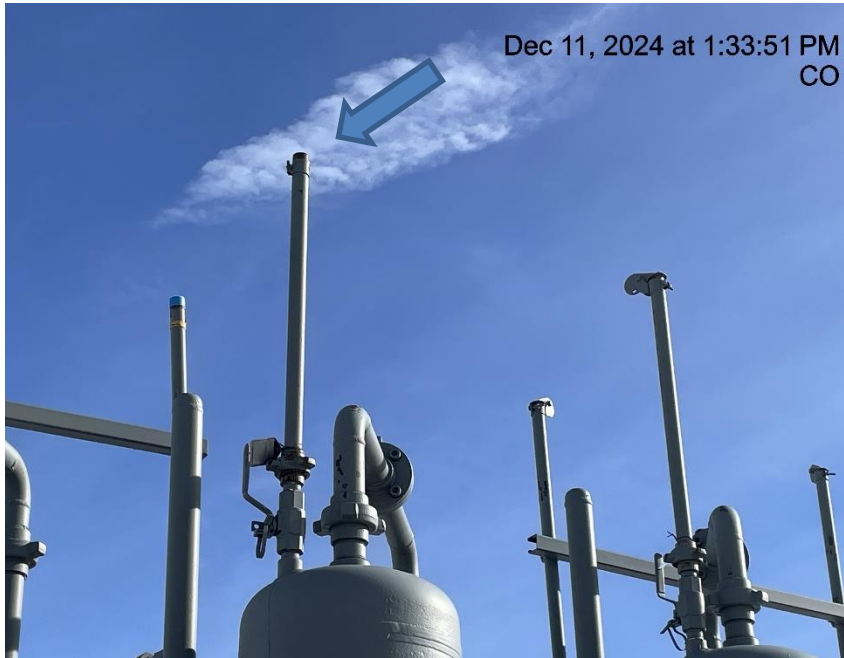
**Photo # 3176 Rupture disc vent line does not comply with CECMC pressure safety device rules**

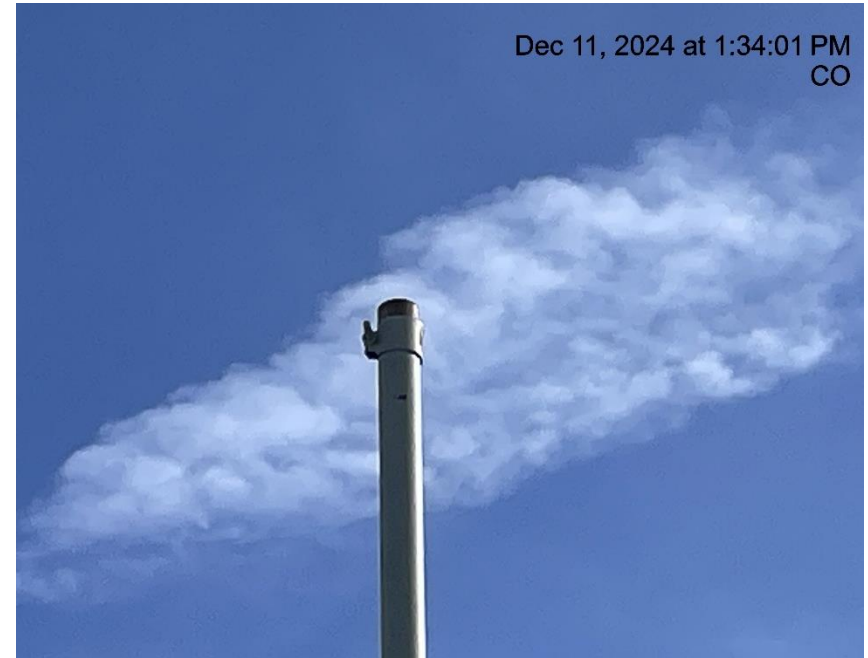
**Photo # 3177 Rupture disc vent line does not comply with CECMC pressure safety device rules**

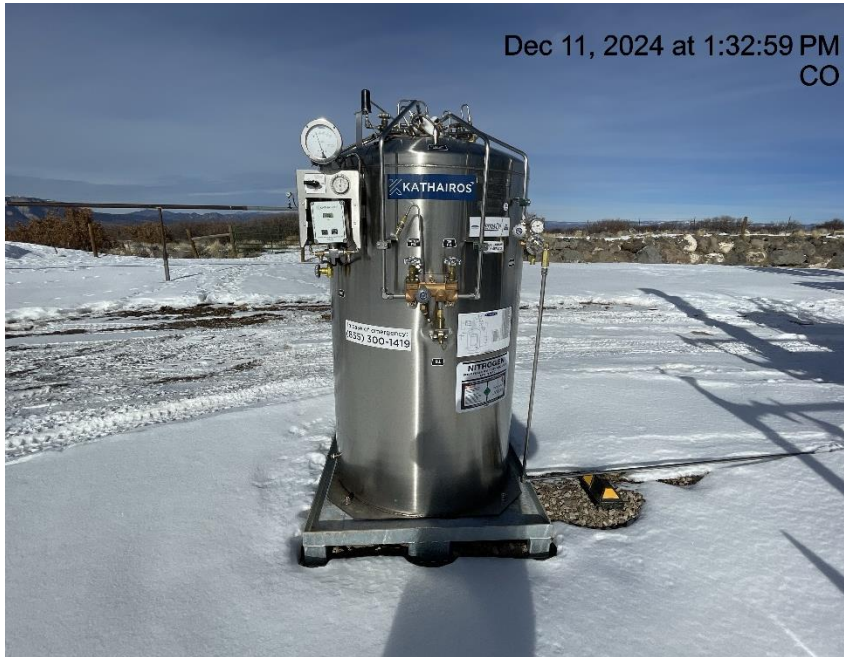
**Photo # 3178 No FORM 4 SUNDRY submitted for liquid nitrogen tank**
