# Inspection Photos

Loc: 484357

Operator: DESERT EAGLE OPERATING LLC

Inspection Date: 12/12/2024

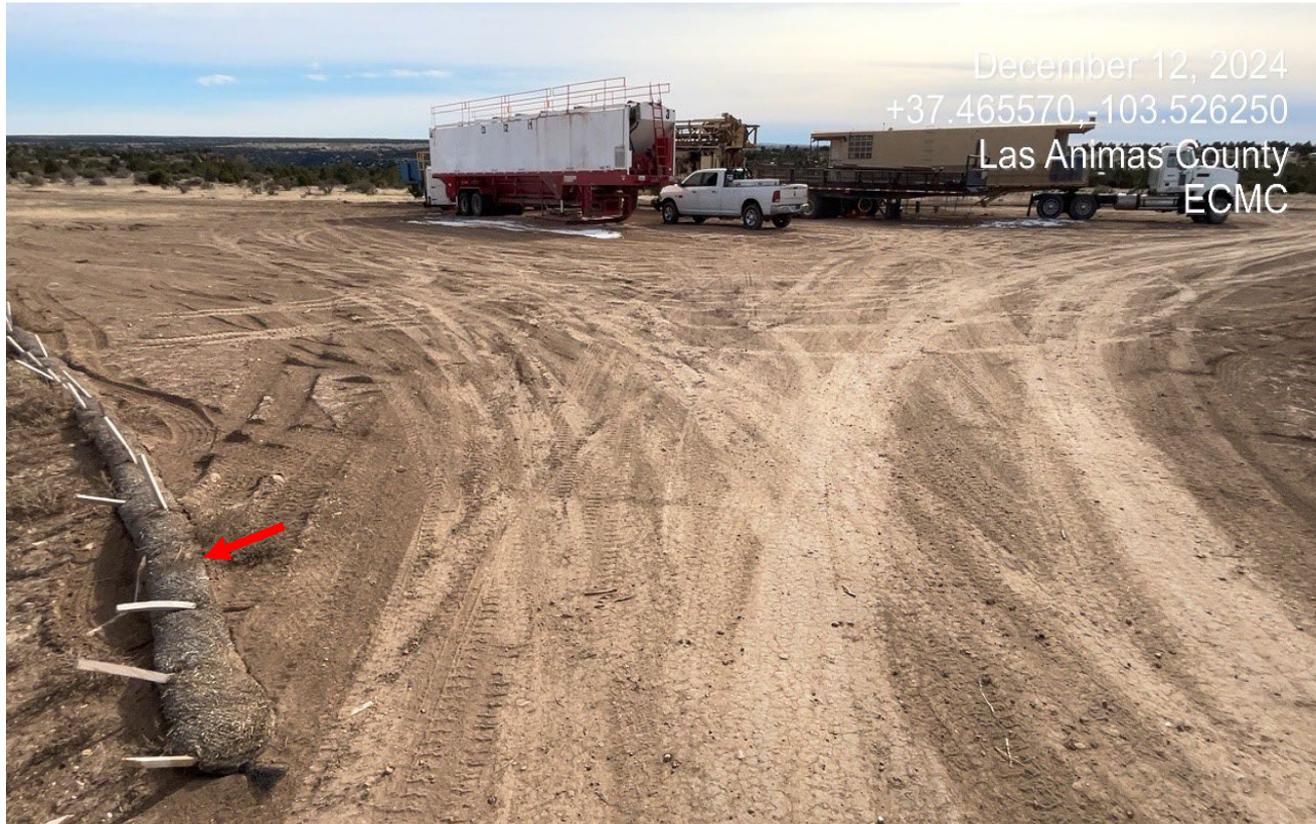
**Photo 1.** Facing south toward the location. There are vehicle driving over and damaging the stormwater wattles which will need to be replaced.

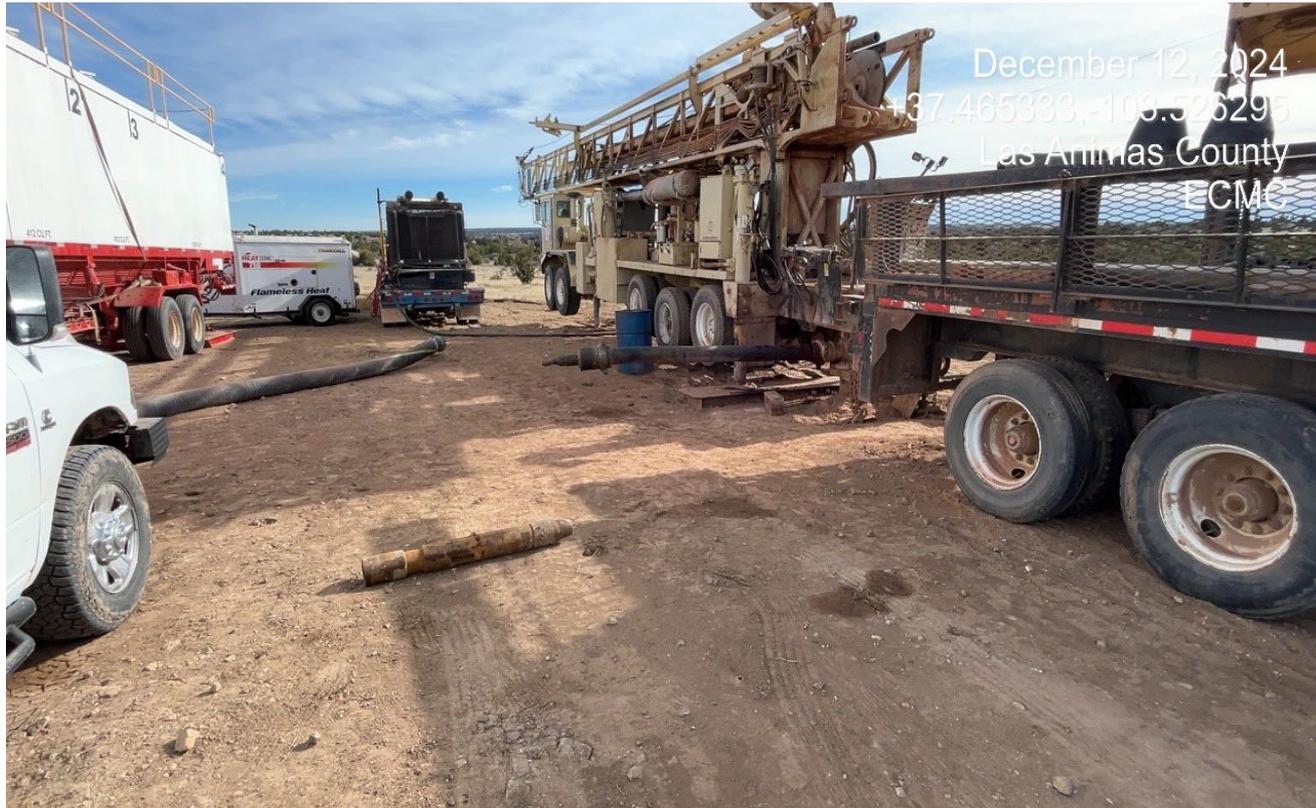
**Photo 2.** Facing toward the well where recent work with the rig was being conducted. There was a audible leak coming from the well and the operator onsite was notified.

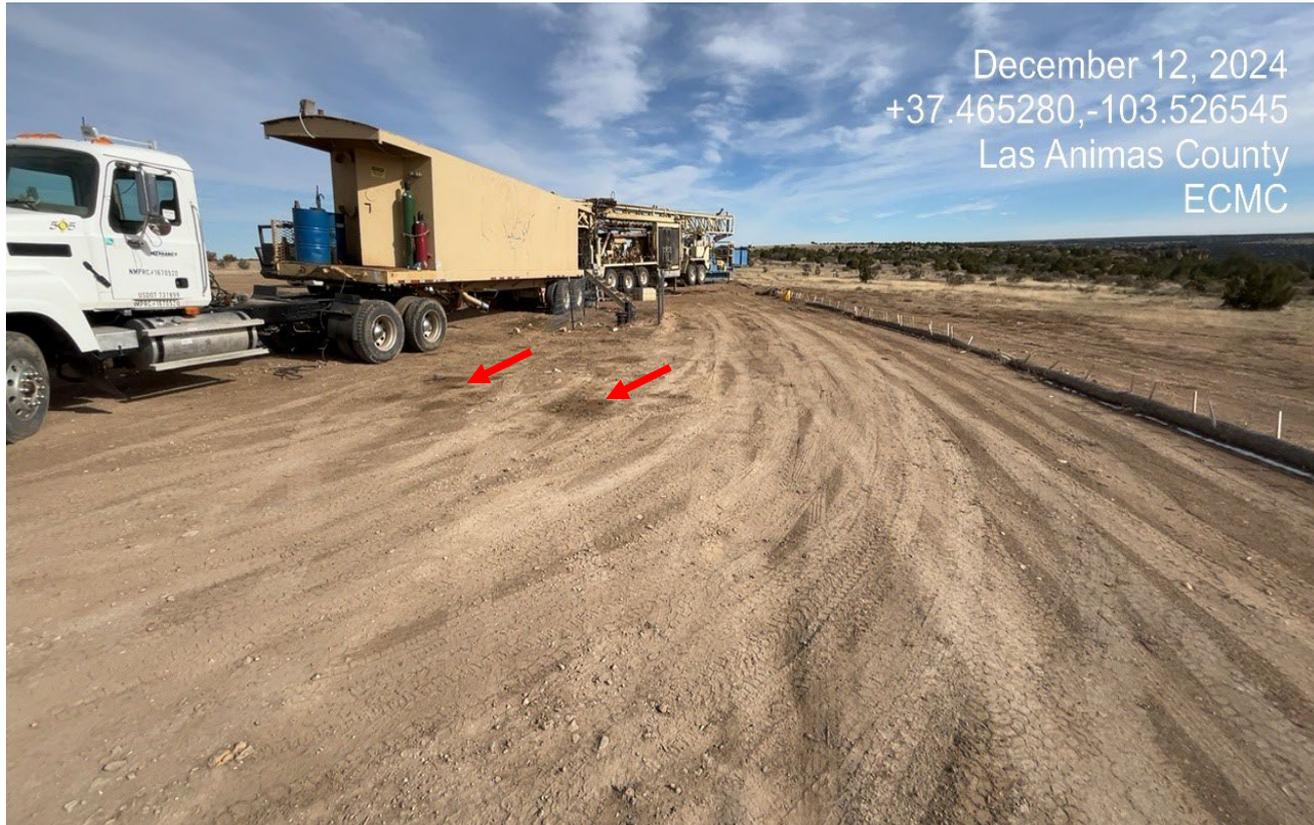
**Photo 3.** Facing east at the location. There are several areas of oil stained soils that must be cleaned up.

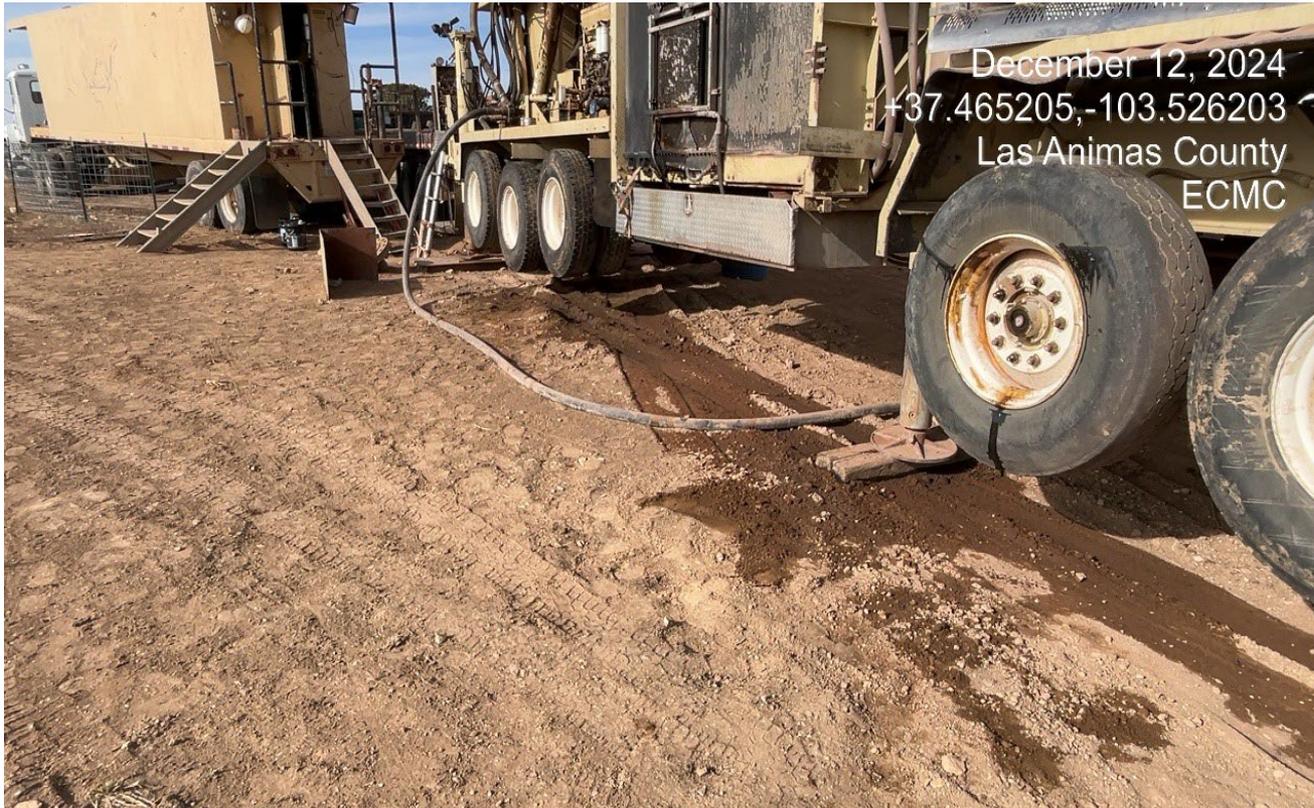
**Photo 4.** There is oil stained soils at the drill rig which has no liner or containment. Stained soils will need to immediate clean up.

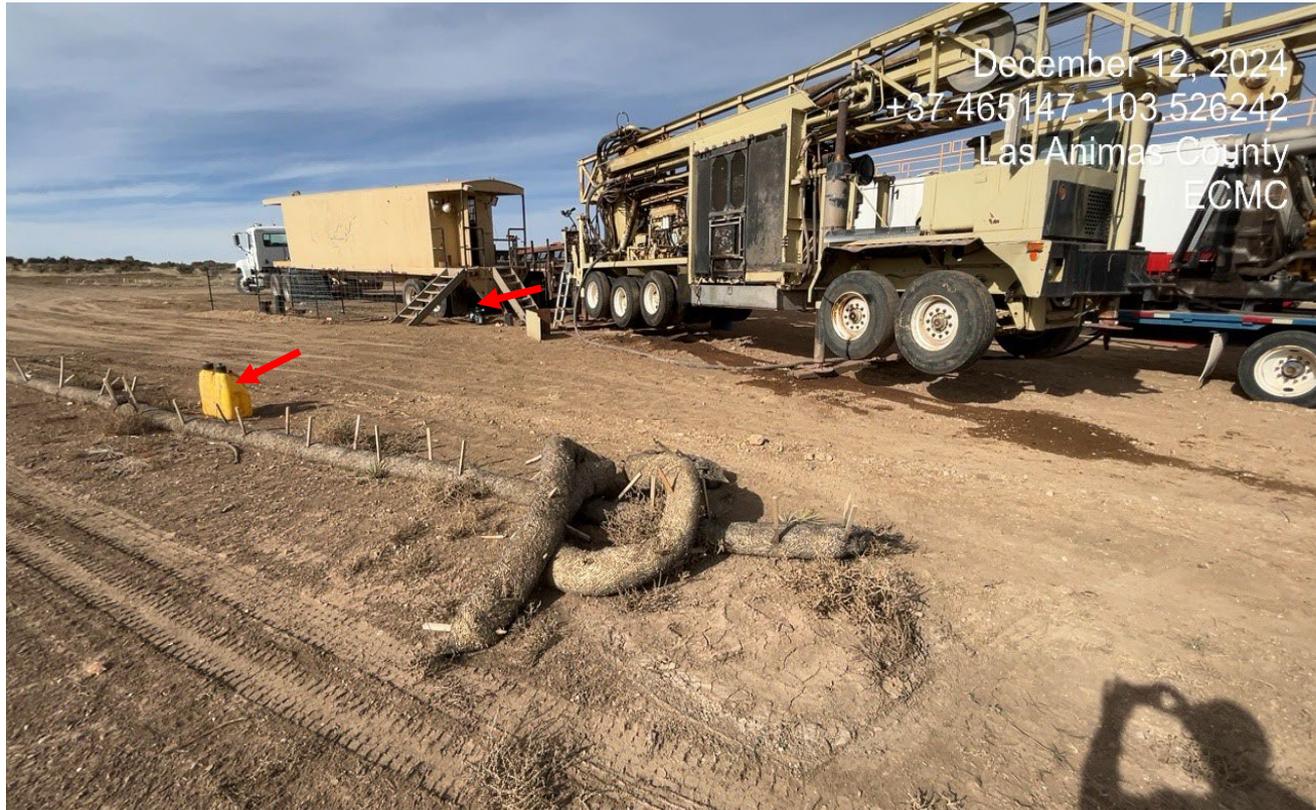
**Photo 5.** There is fuel and lube oil containers not in containment shown at red arrows. The wattles are displaced in this area.

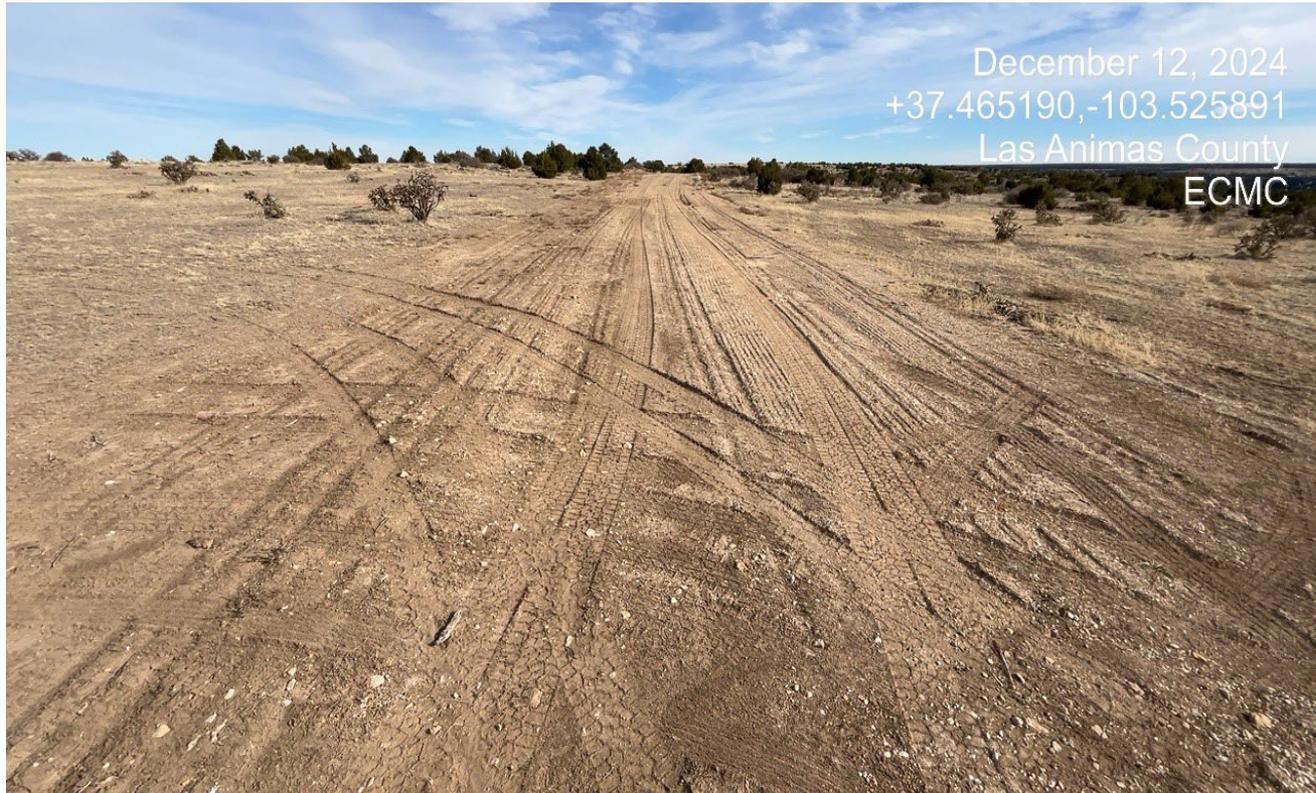
**Photo 6.** Facing east toward the flowline disturbance. The vegetation is not establishing along the flowline and there are vehicle tracks which a causing unnecessary disturbance. The flowline must be reclaimed and stabilized.

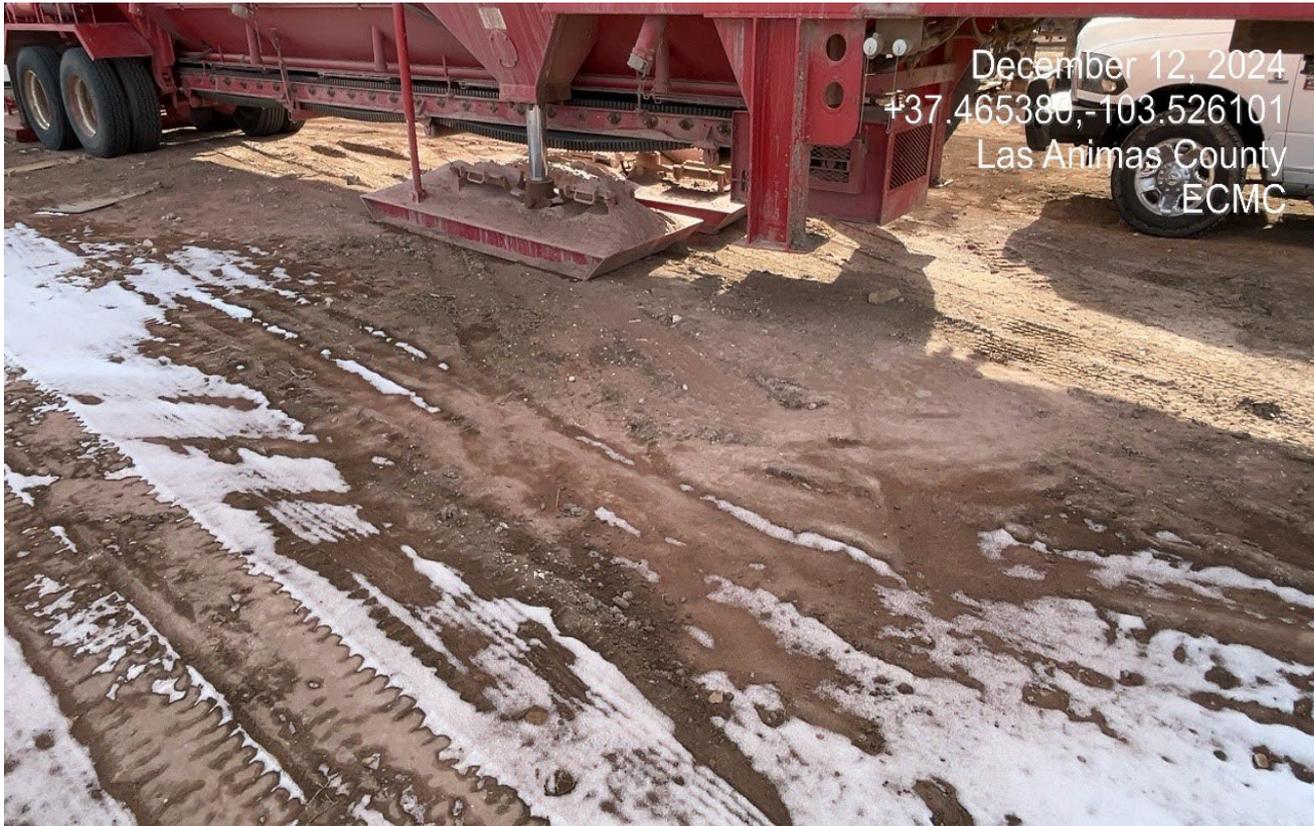
**Photo 8.** There is red drill cutting sand that has spread onto the soil around the equipment. No liner or other containment is present.

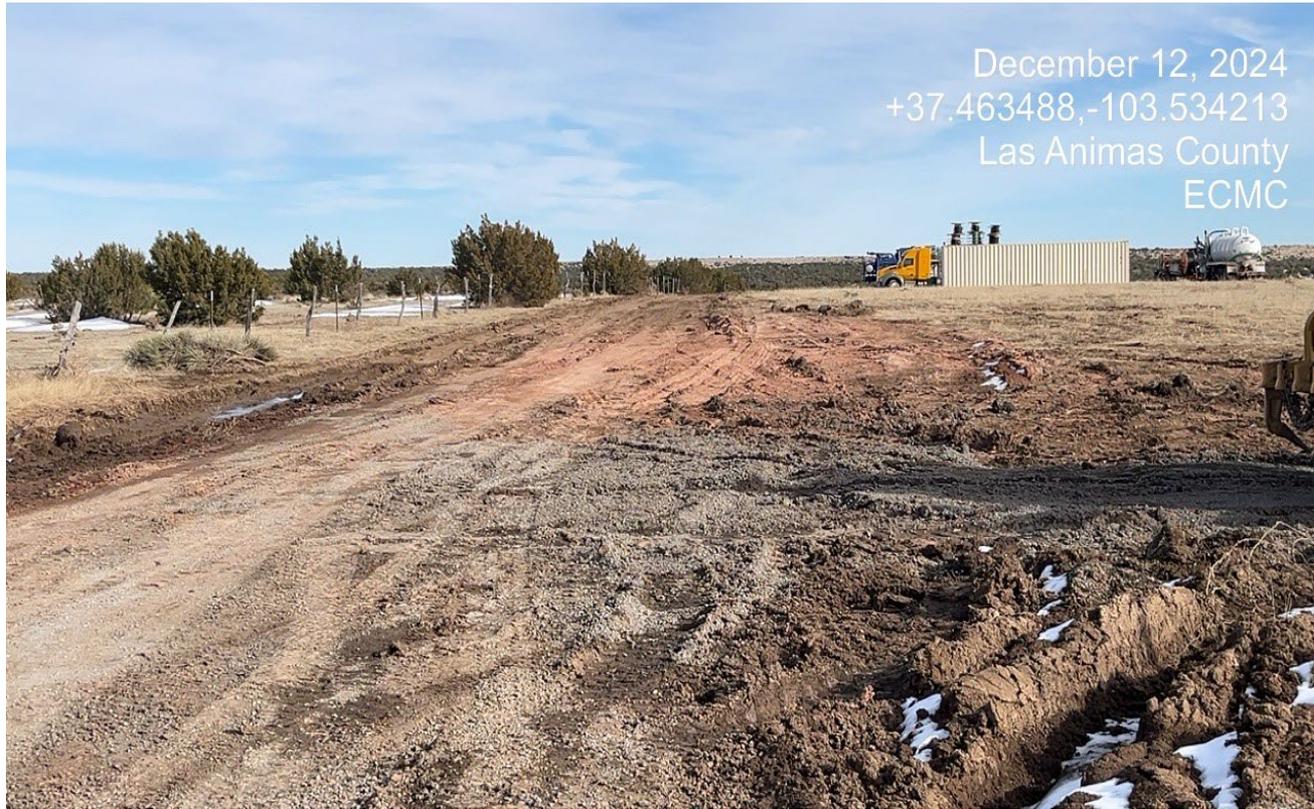
**Photo 9.** Standing on County Road 179 facing east toward DEO property. There is red drill cutting sand that has been spread on the road at Lat/Long:37.40116,-103.51736. E&P waste from the wellsite was not properly disposed.
