# Site Specific Final Reclamation Completion Notice – Cropland Drone Imagery

## Permit Closure Report – Cropland

**Location Name:** Alm #42-33

12/13/2024

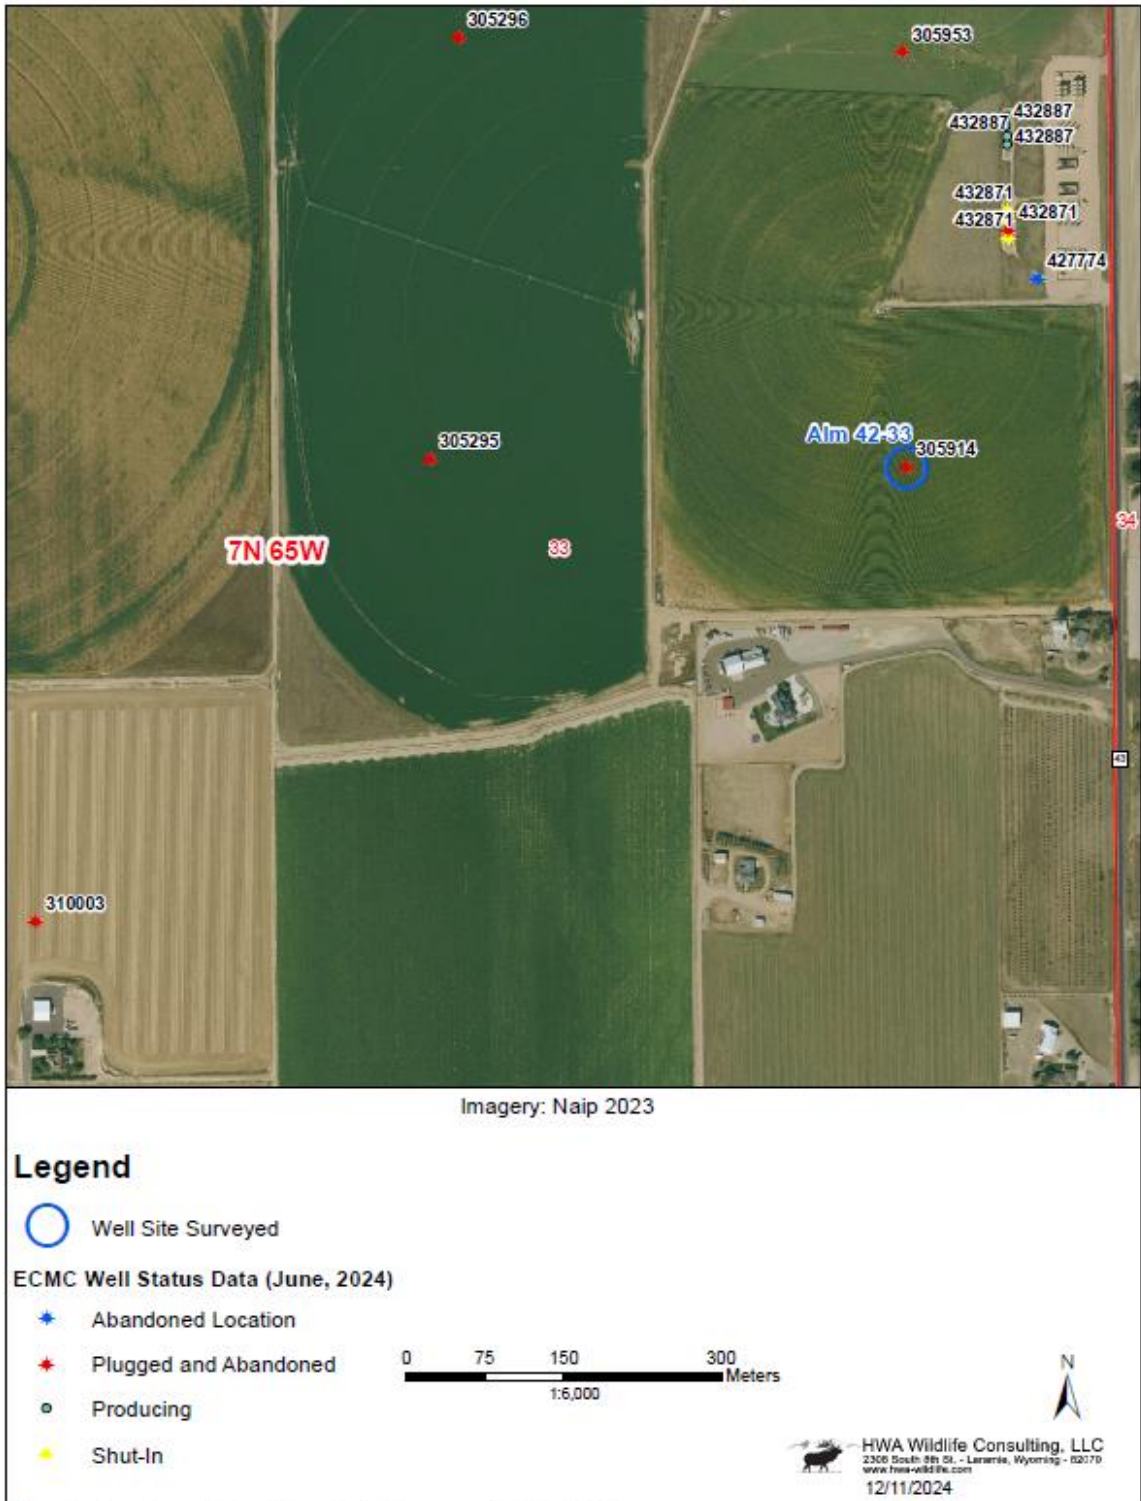
The tank battery will not be passed with this report. The associated tank battery also serviced the Alm #32-33 well. The tank battery will be tied to the Alm #32-33 well (location ID 305295, see Figure 1), allowing the Alm #42-33 well to pass. There were no documented spills or releases, remediation projects, or inspection corrective actions in COGIS related to the Alm #42-33 well.

Figure 1. Overview of the reclaimed well site surveyed during 2024.

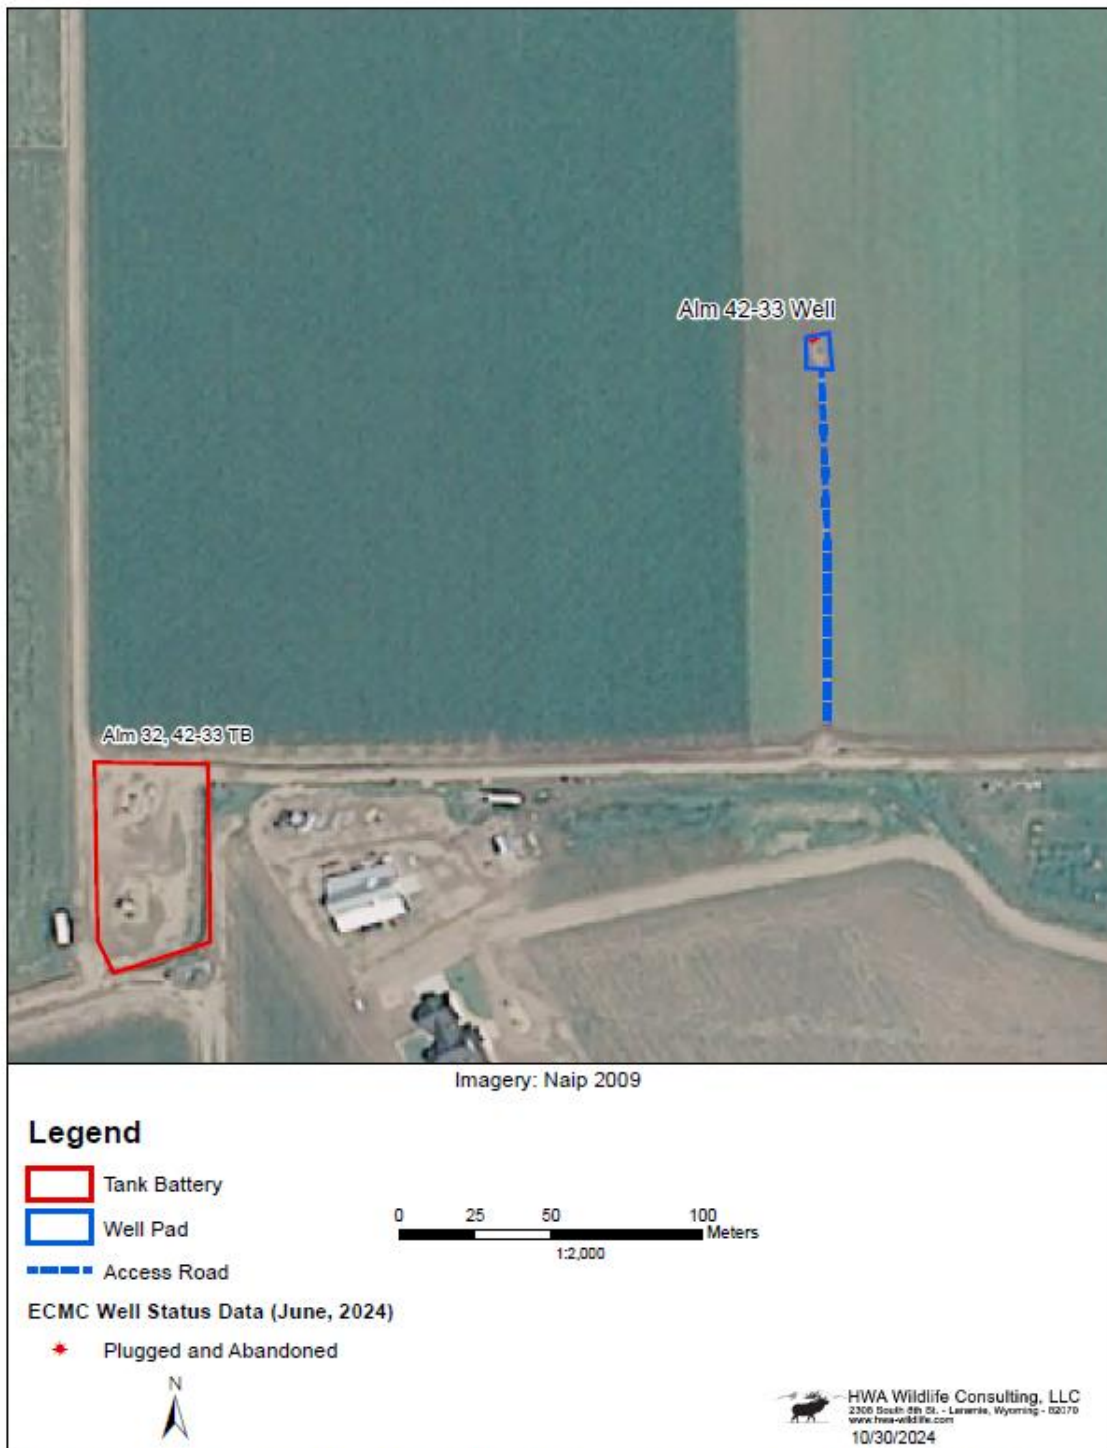
Figure 2. Pre-plugging overview of the reclaimed well site and the associated access road, tank battery, and flowline.

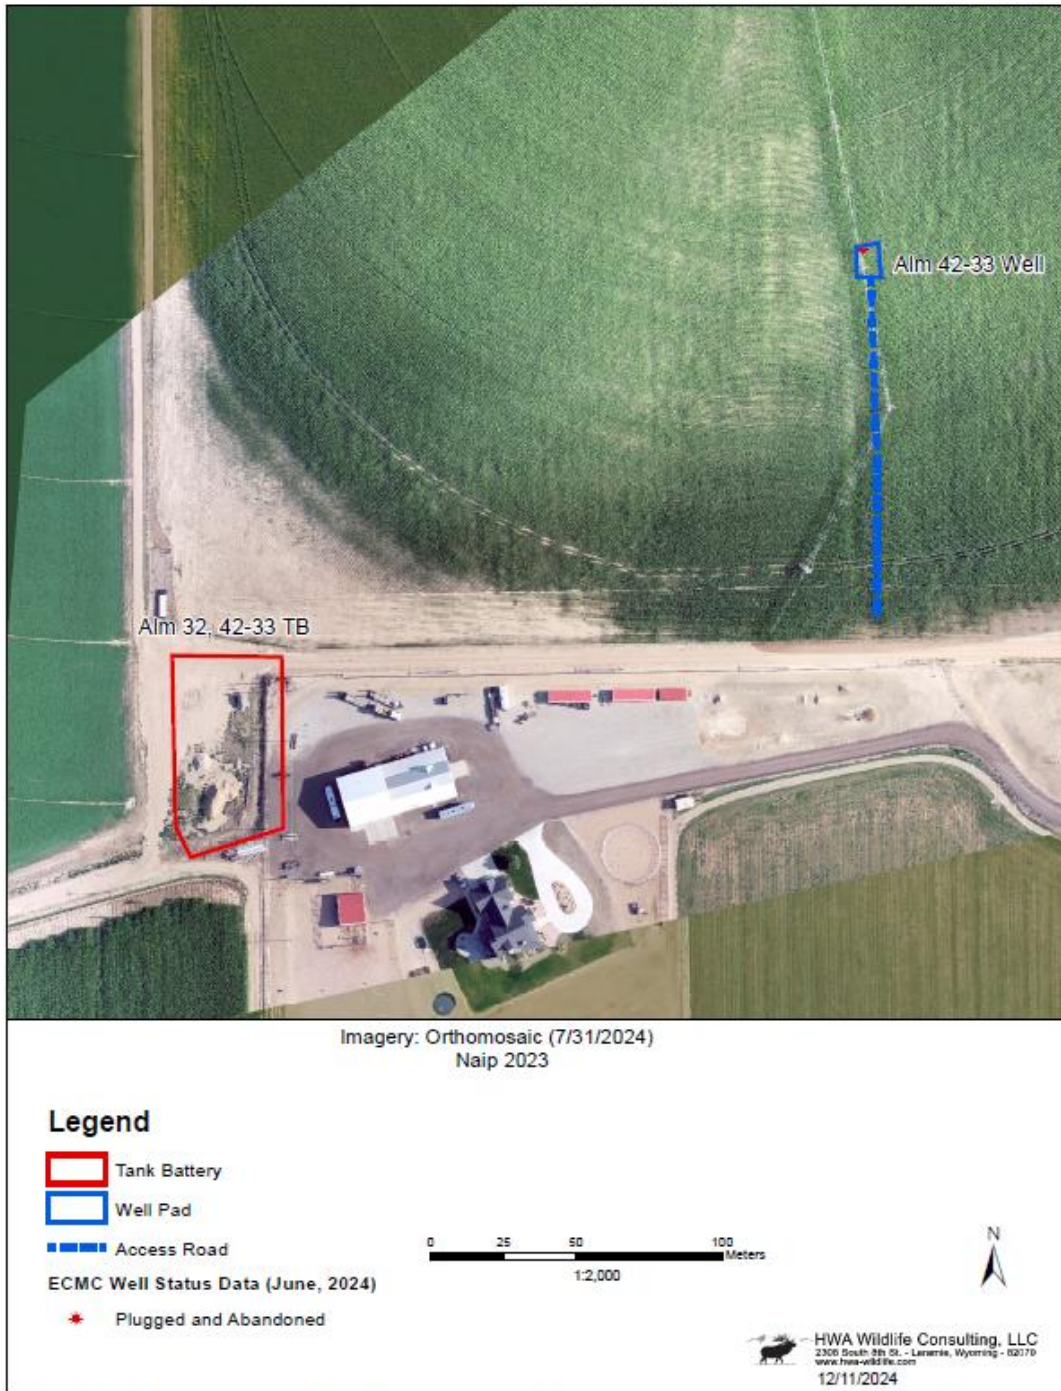
Figure 3. Post-plugging overview of the reclaimed well site and the associated access road, tank battery, and flowline.

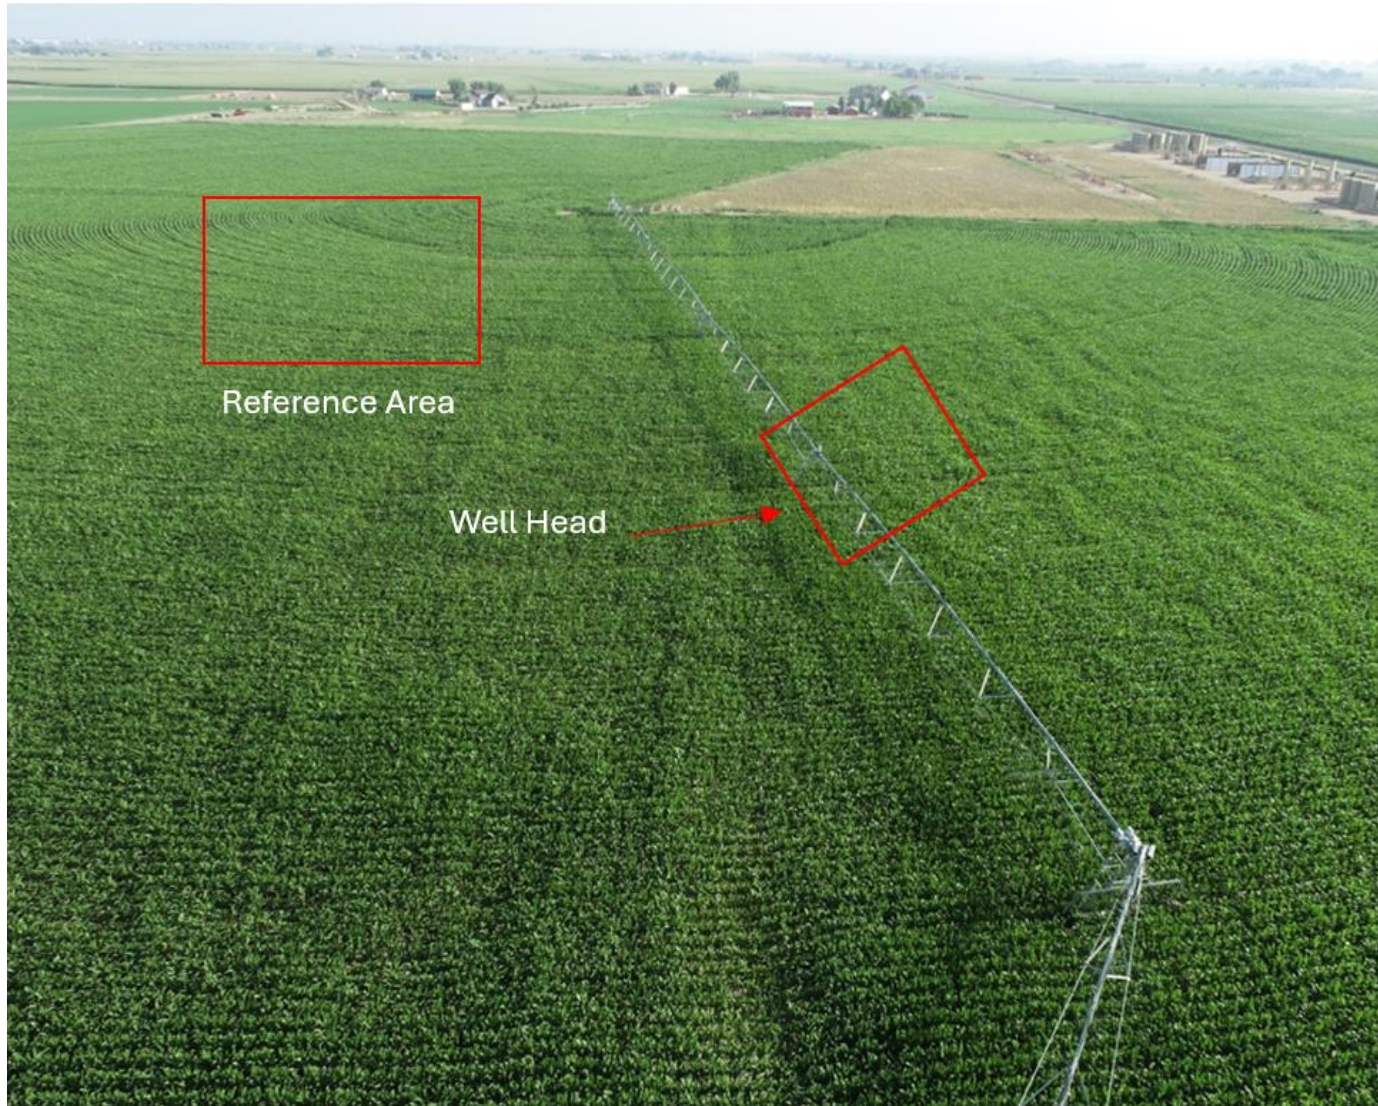
*Figure 4: Looking North towards well and reference area, 200 feet in height, Lat/Long: 40.531736/-104.661206.*

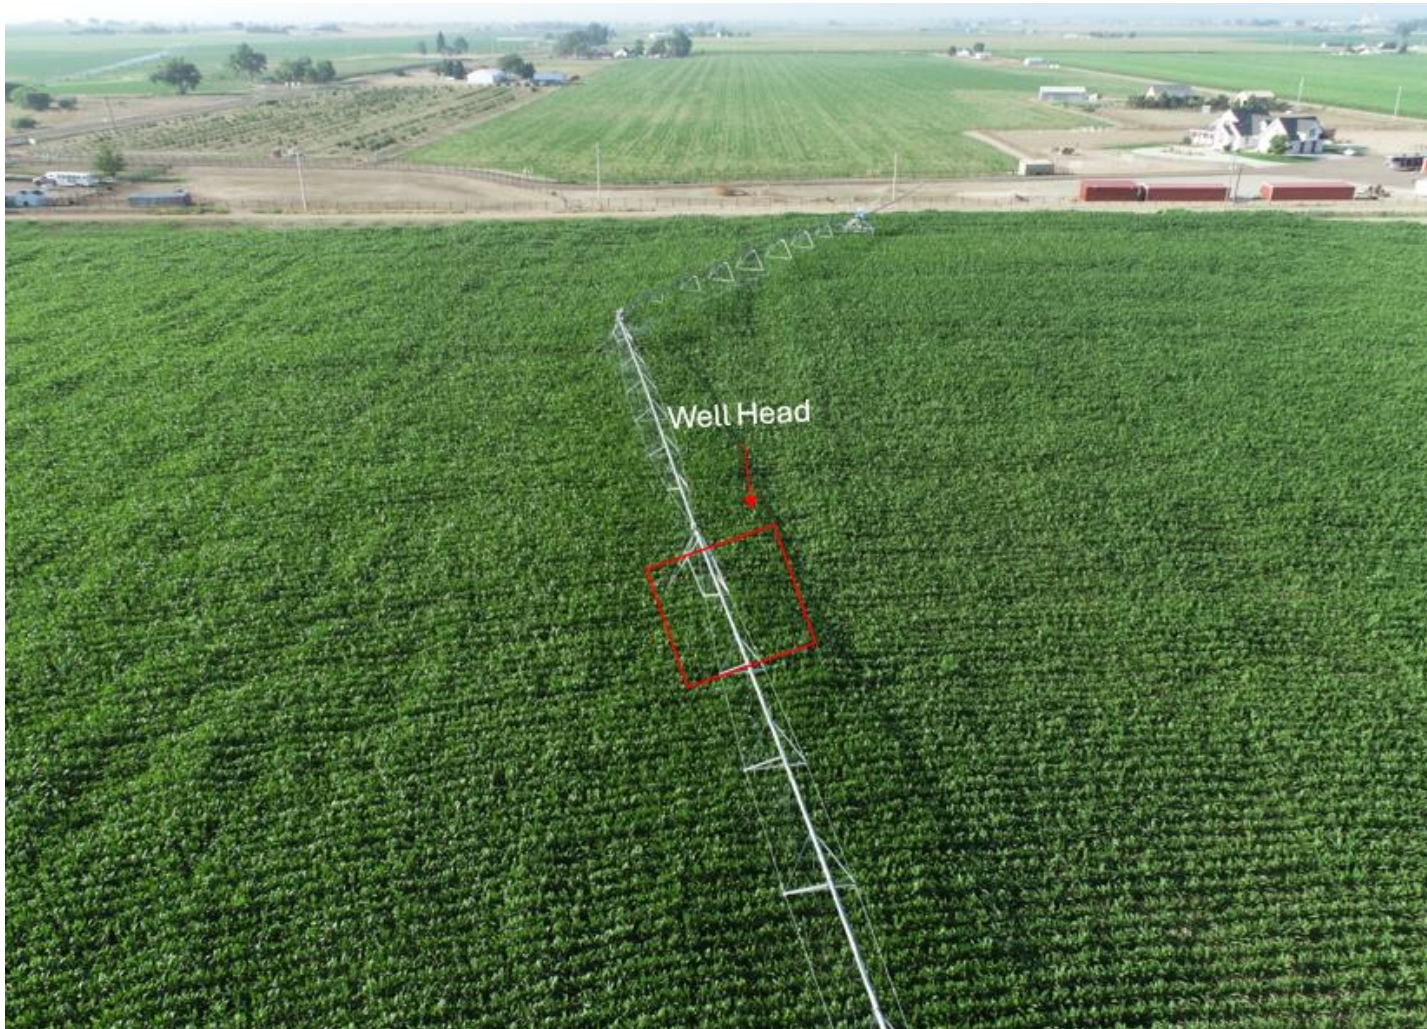
*Figure 5: Looking South towards well, 100 feet in height, Lat/Long: 40.532995/-104.661179.*

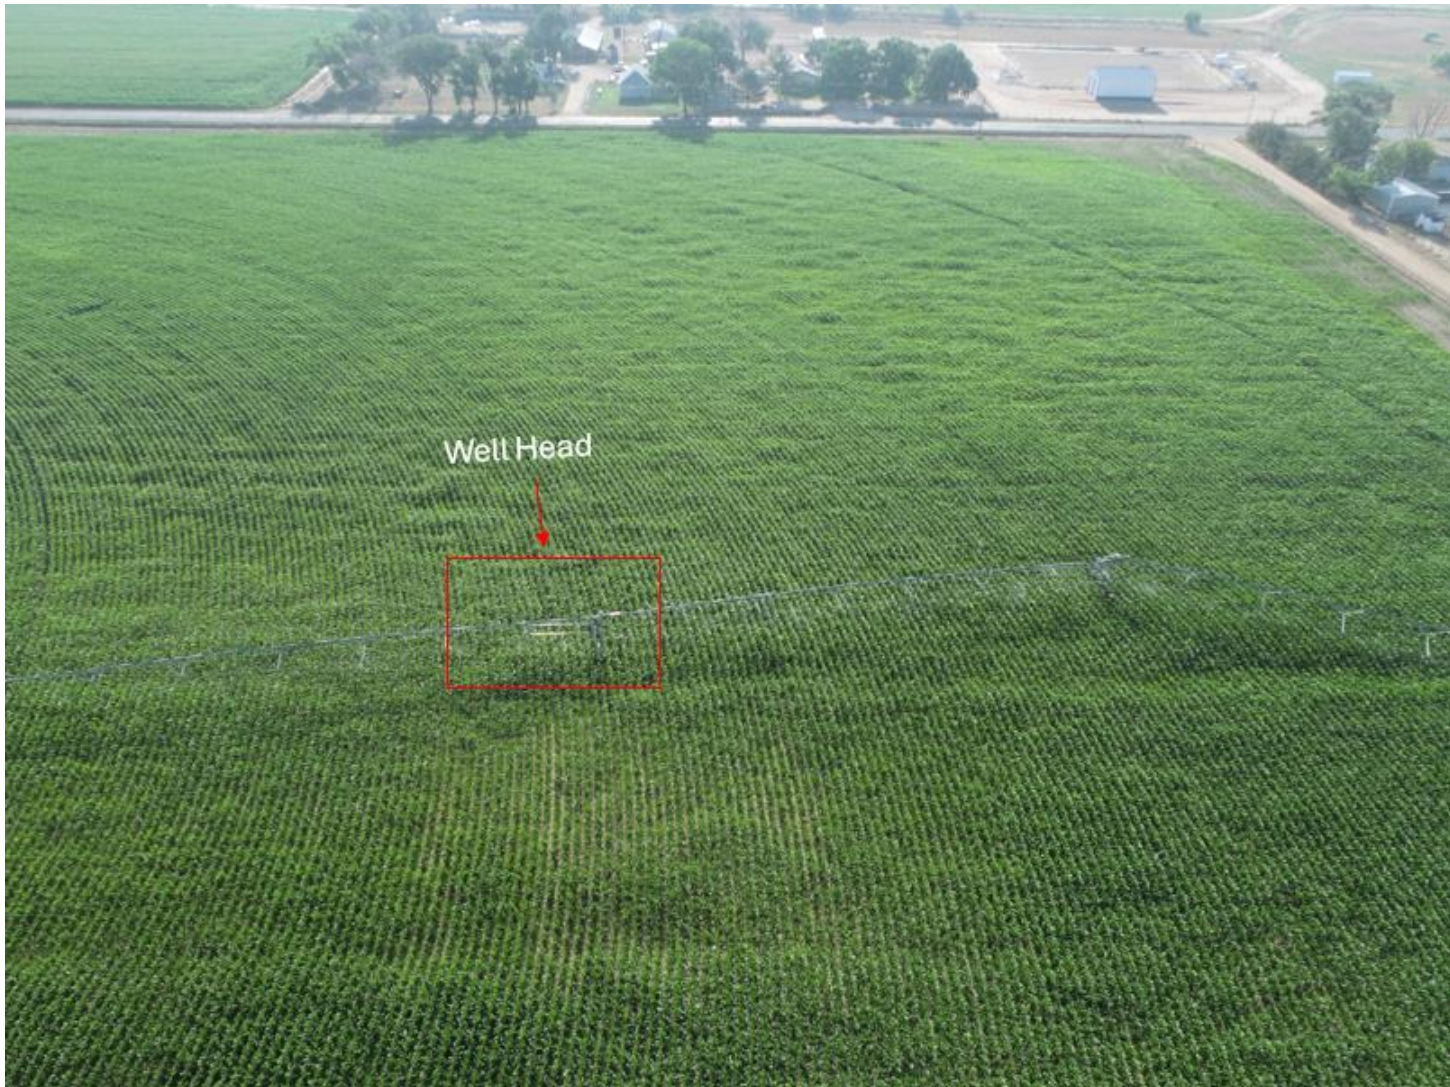
Figure 6: Looking East towards well, 100 feet in height, Lat/Long: 40.532415/-104.662095.

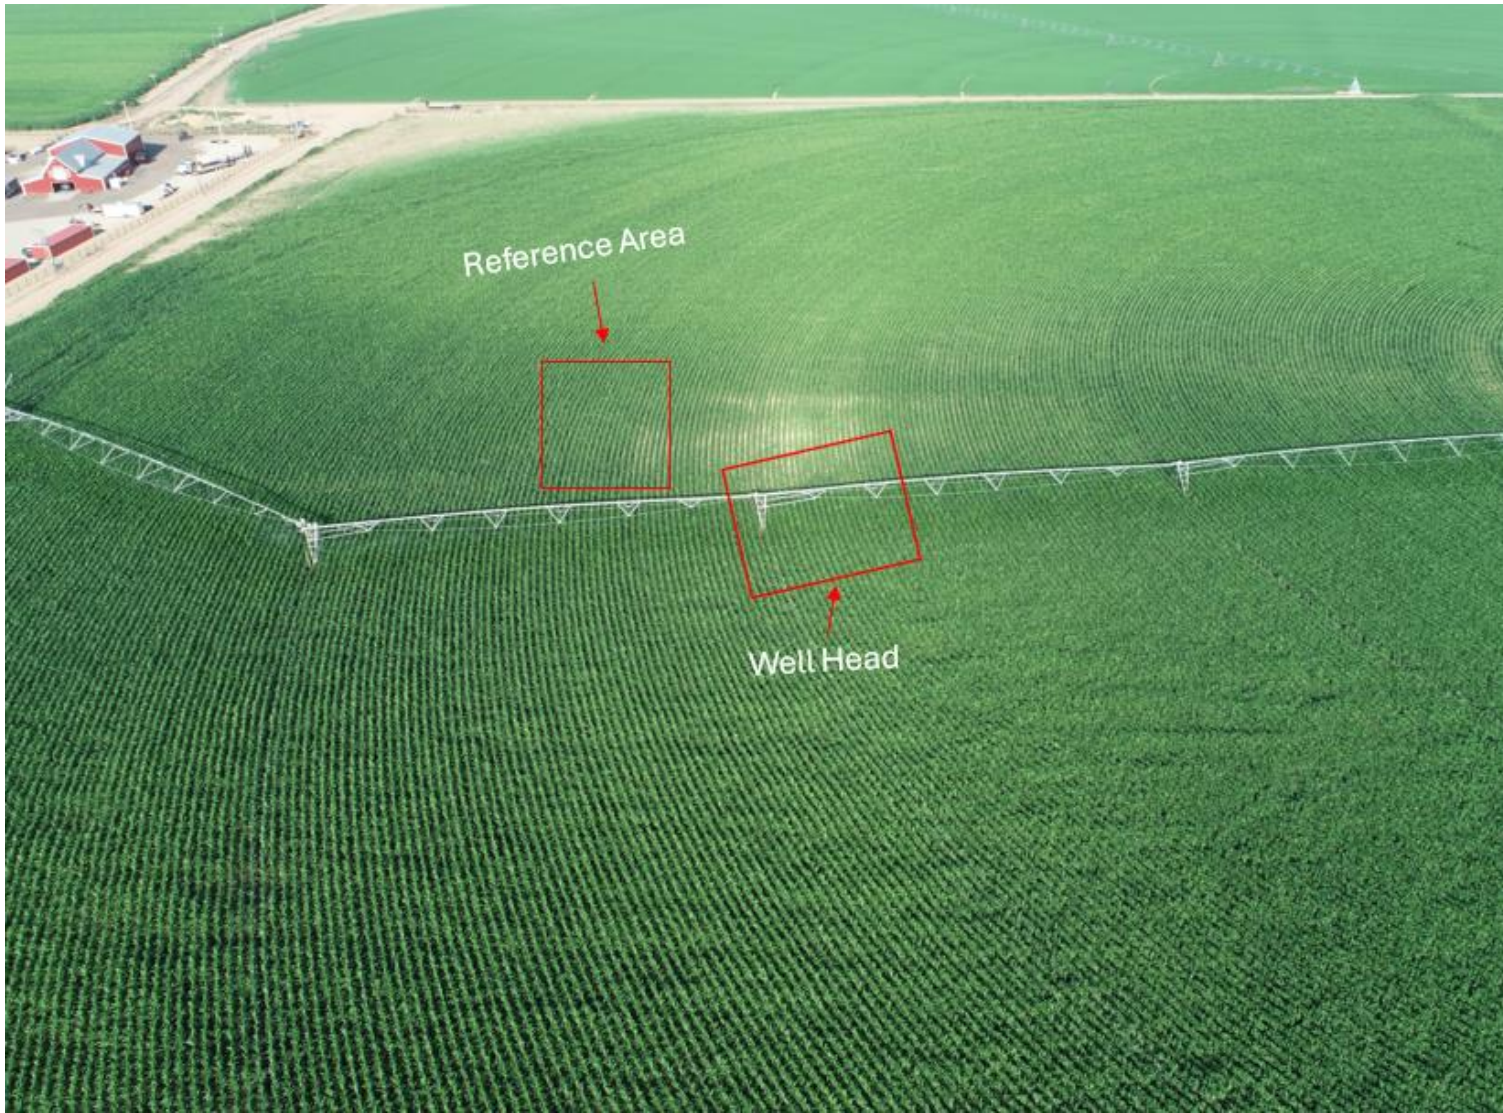
Figure 7: Looking West towards well, 200 feet in height, Lat/Long: 40.532589/-104.659815.

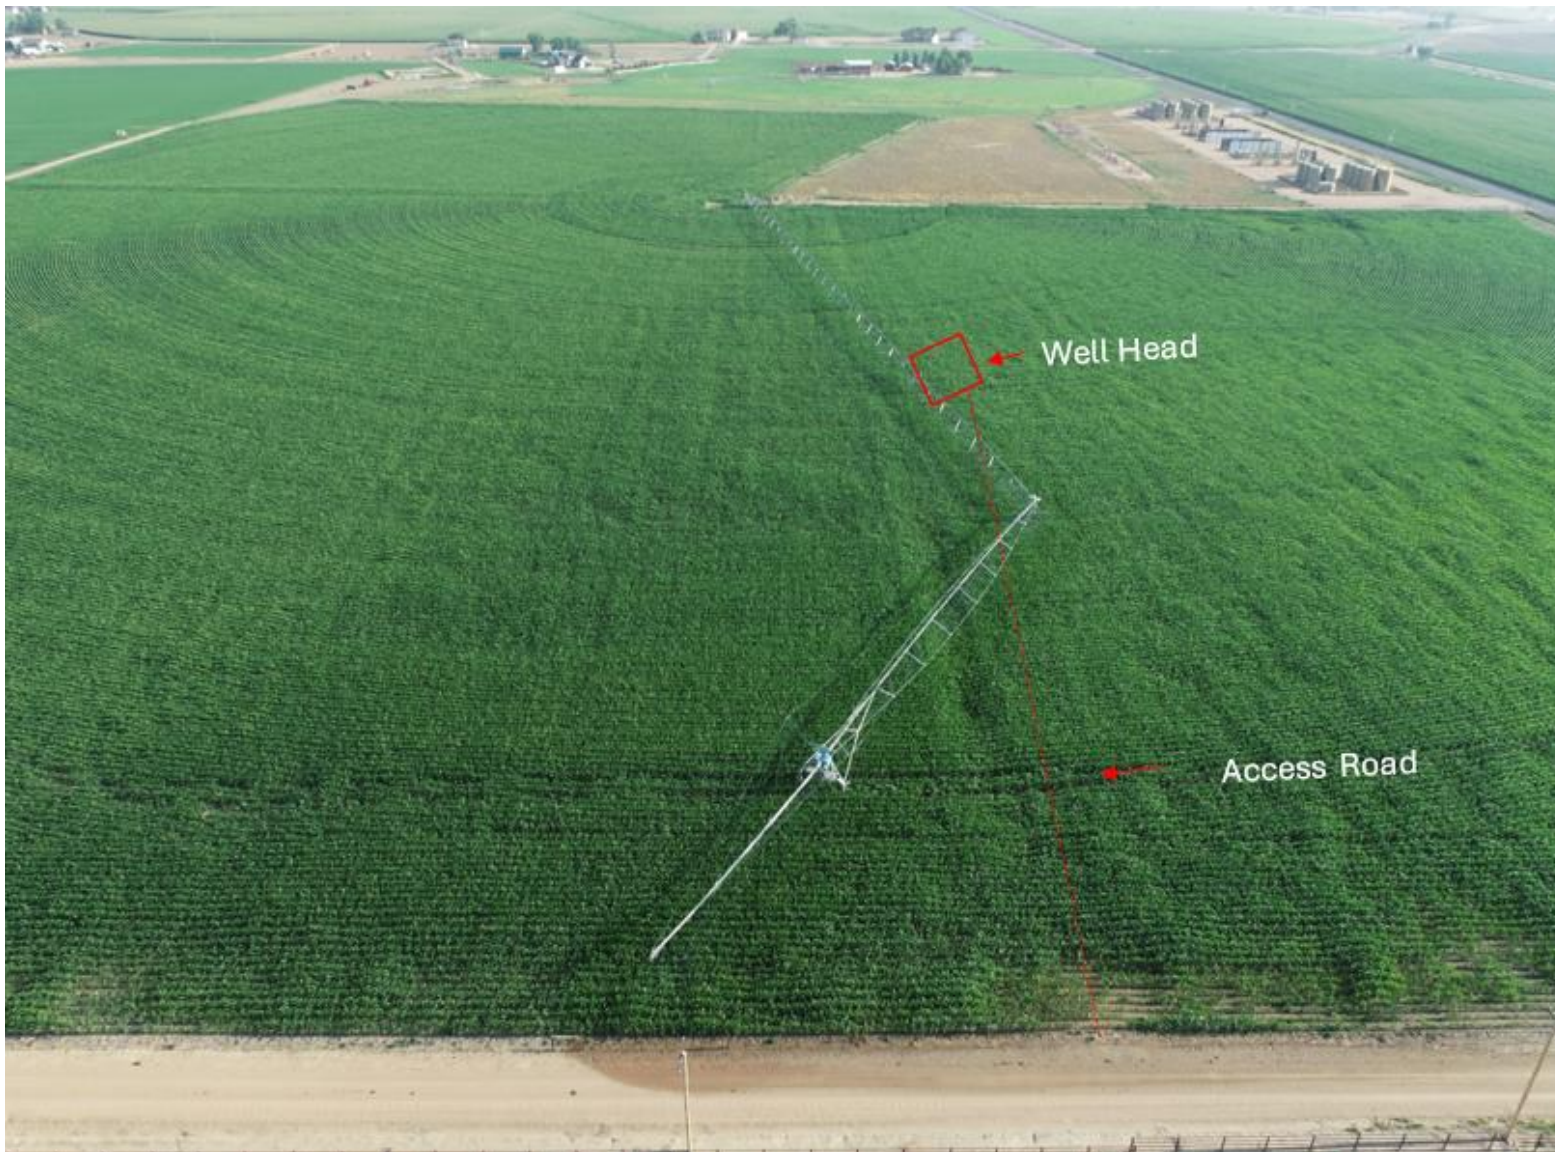
Figure 8: Looking North at access road, 200 feet in height, Lat/Long: 40.530846/-104.661421.

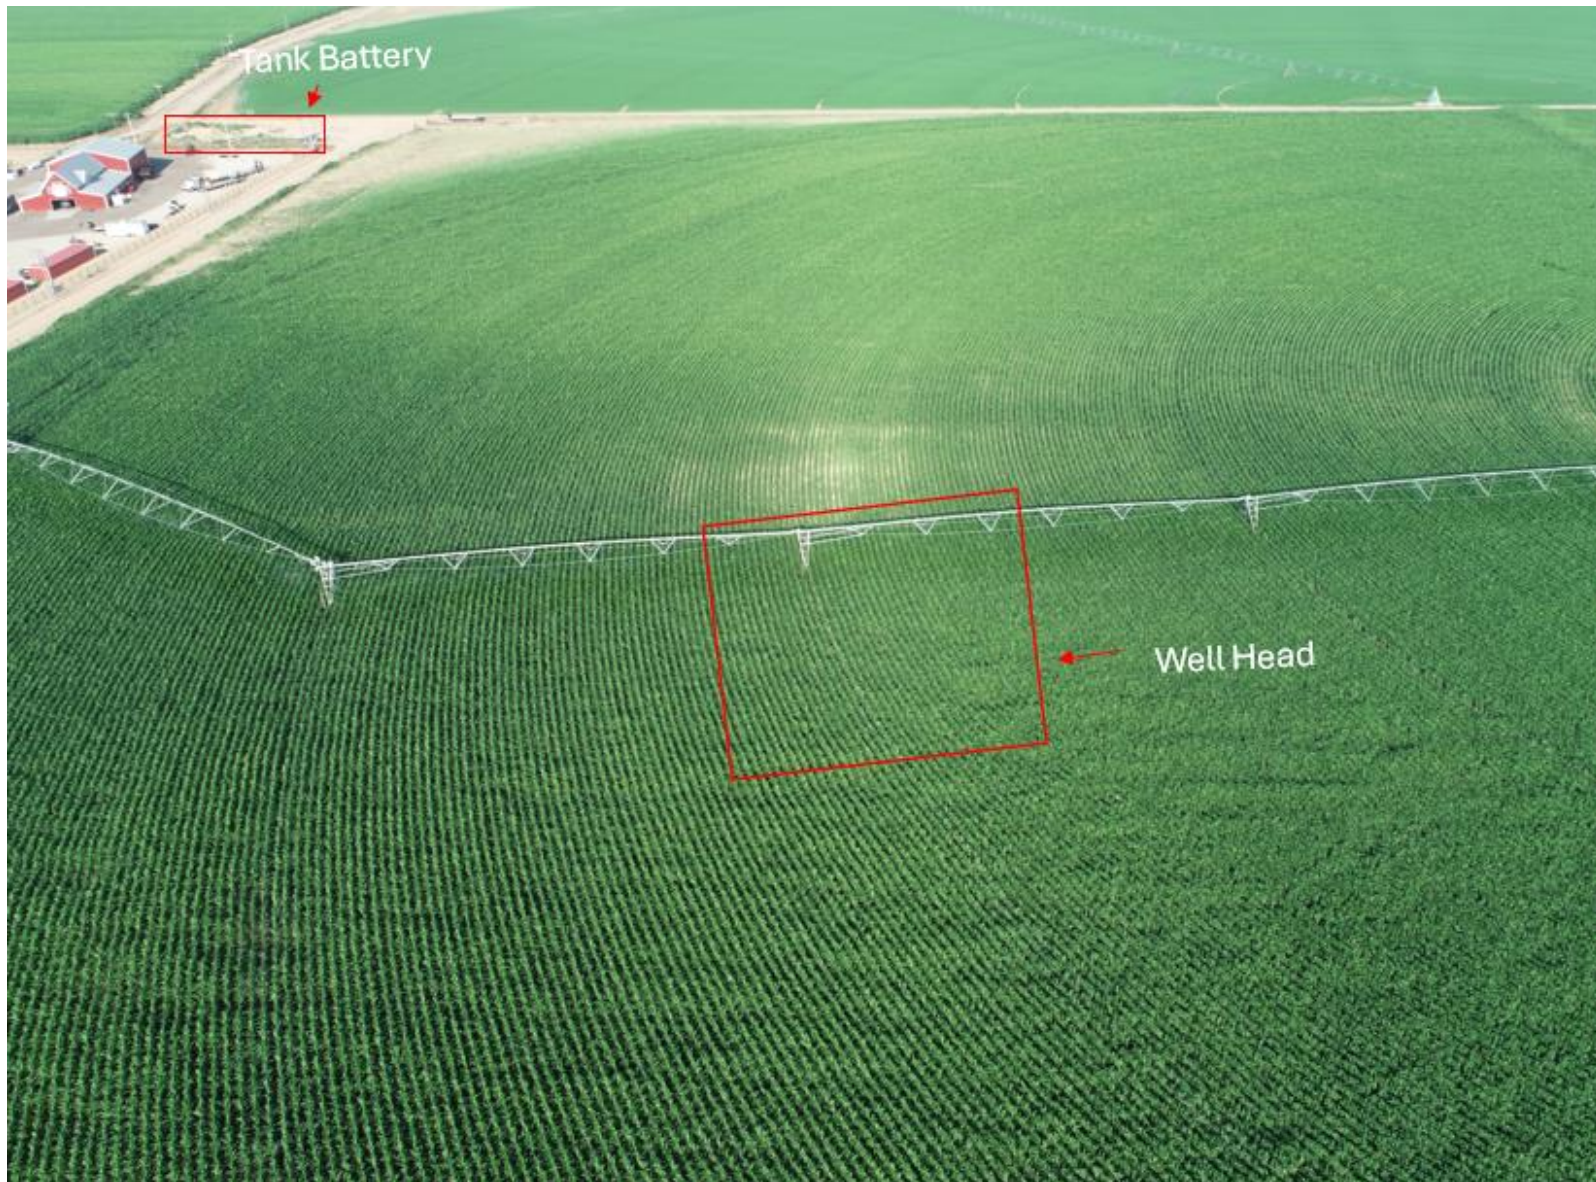
Figure 9: Looking West towards the Flowline, 200 feet in height, Lat/Long: 40.532589/-104.659815.

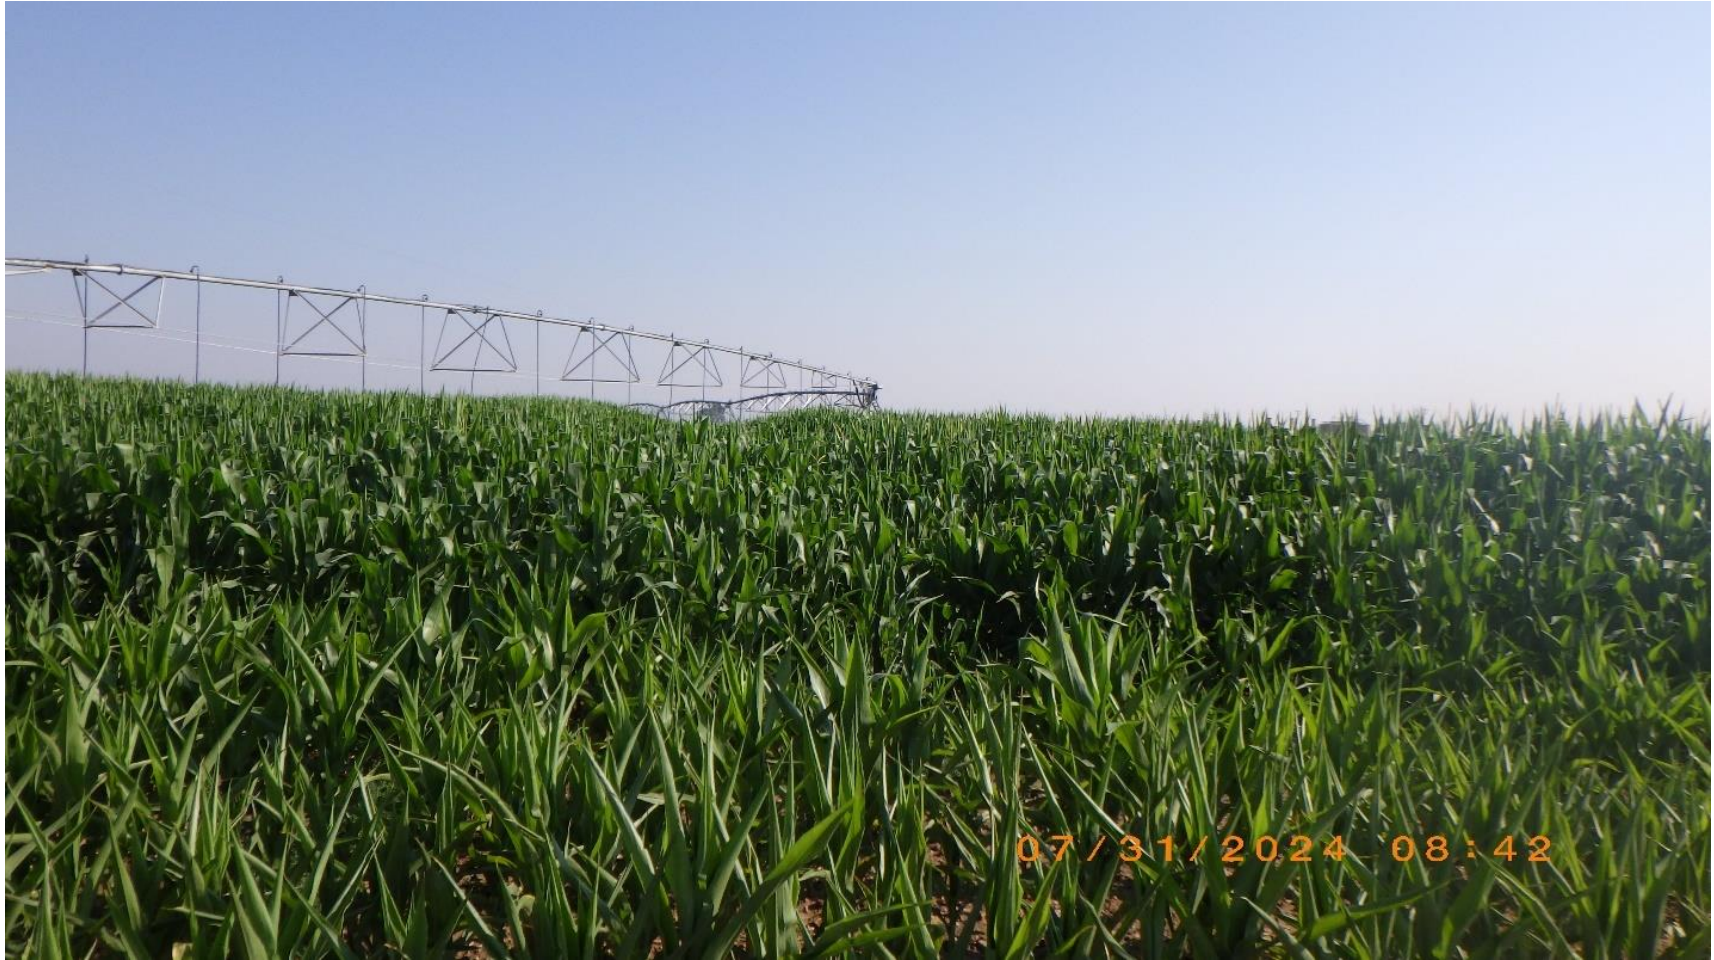
*Figure 10: Looking North at the Access Road take off.*

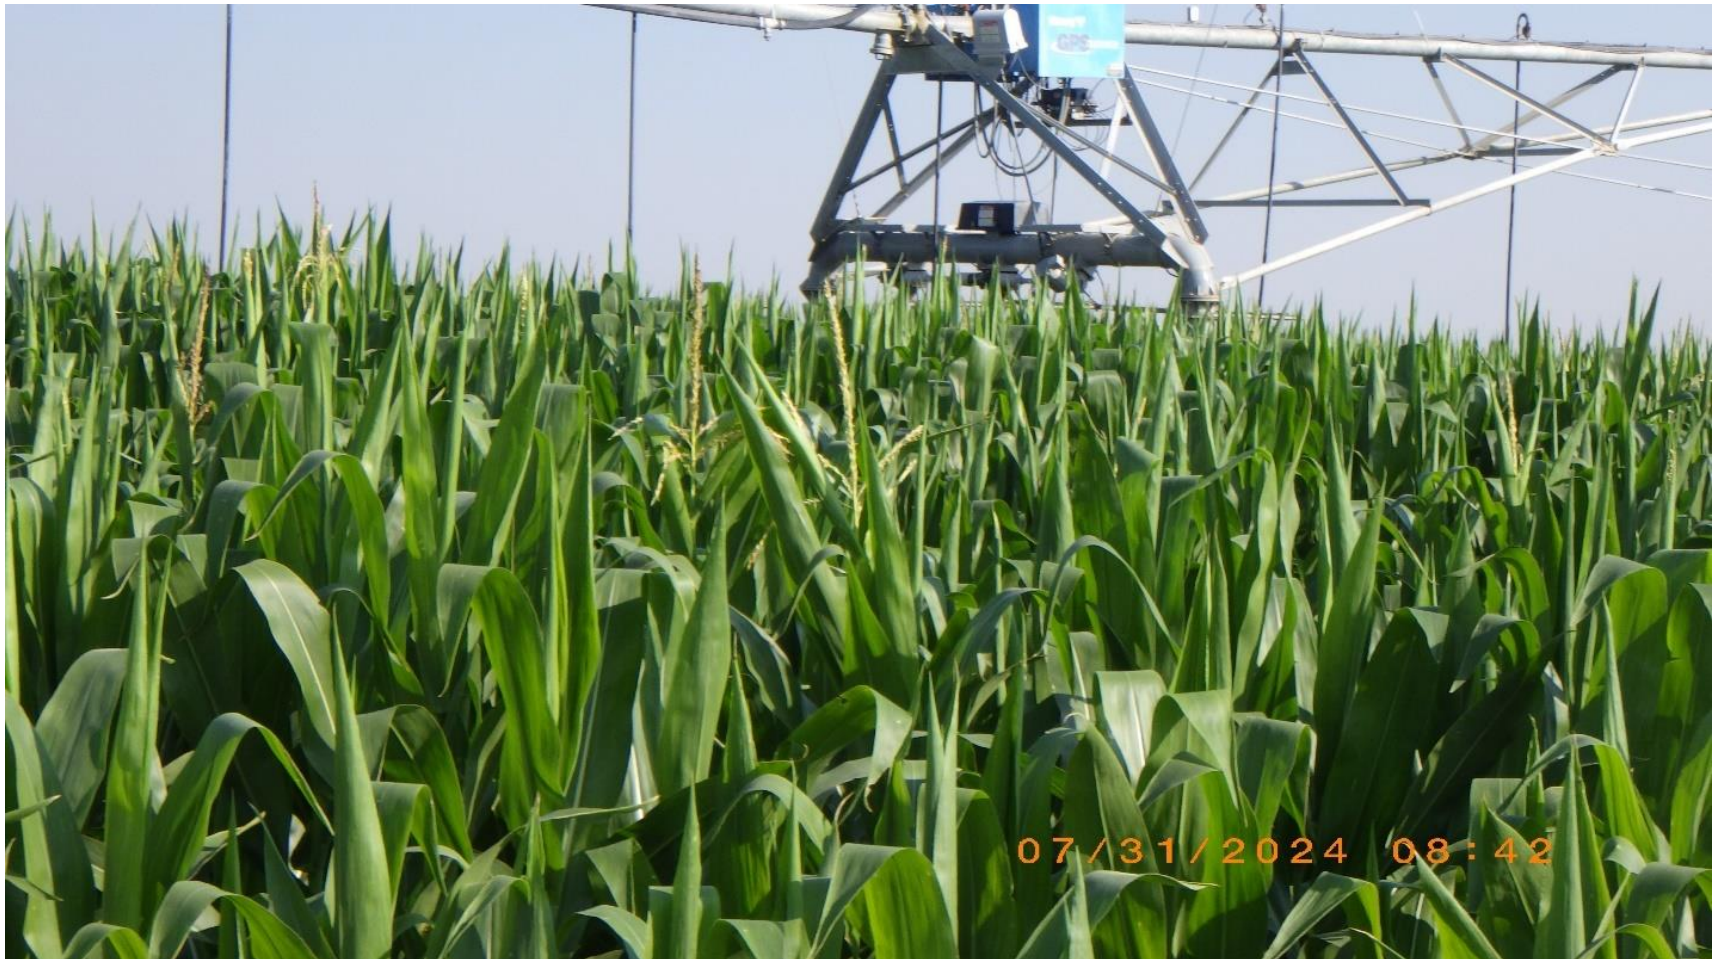
*Figure 11: Cropland Reference Photo showing corn in the appropriate reproductive growth stage.*
