Inspection Photos

Loc #: 481115

Operator: DESERT EAGLE OPERATING

Inspection Date: 12/12/2024

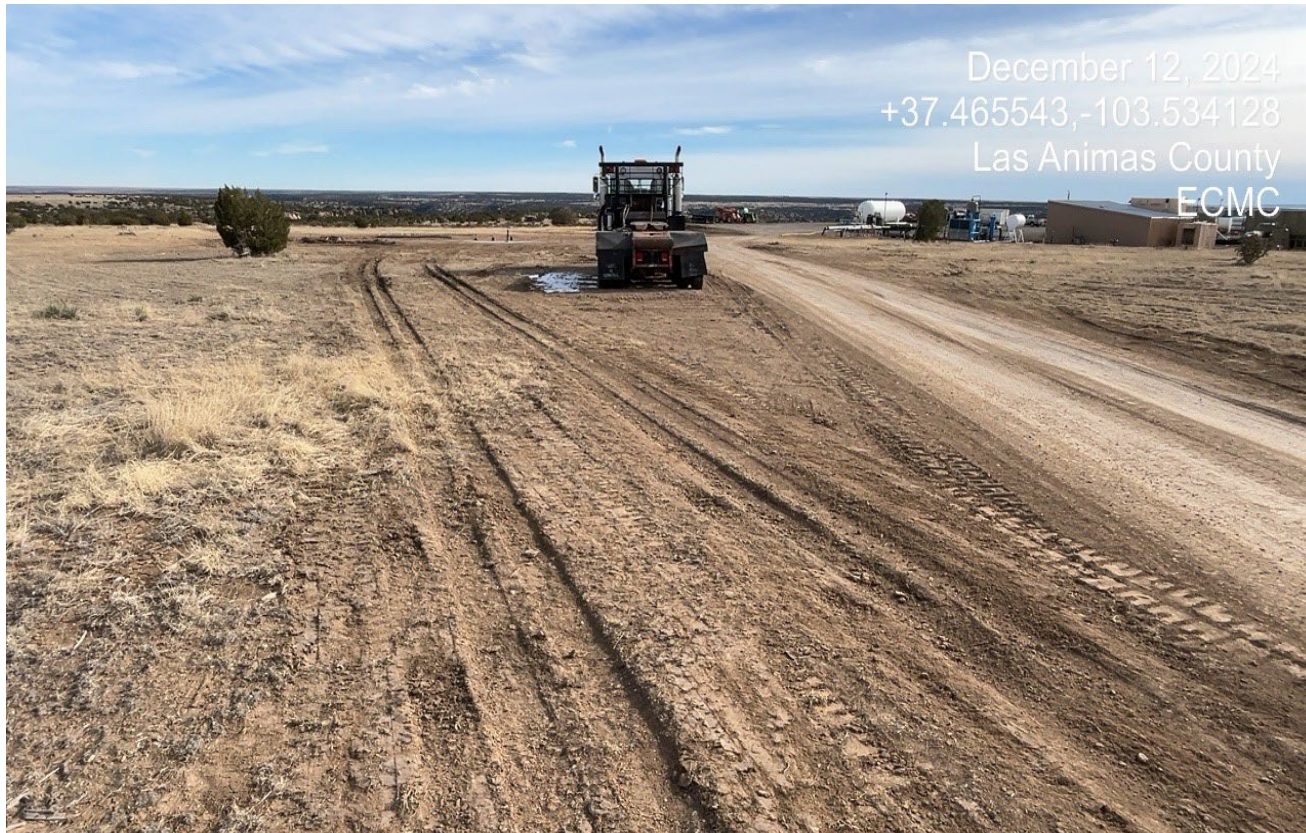
Photo 1. Facing southeast toward the location. There are vehicle tracks causing disturbance outside of the location. Vehicles must stay on access road boundary and wellsite only.

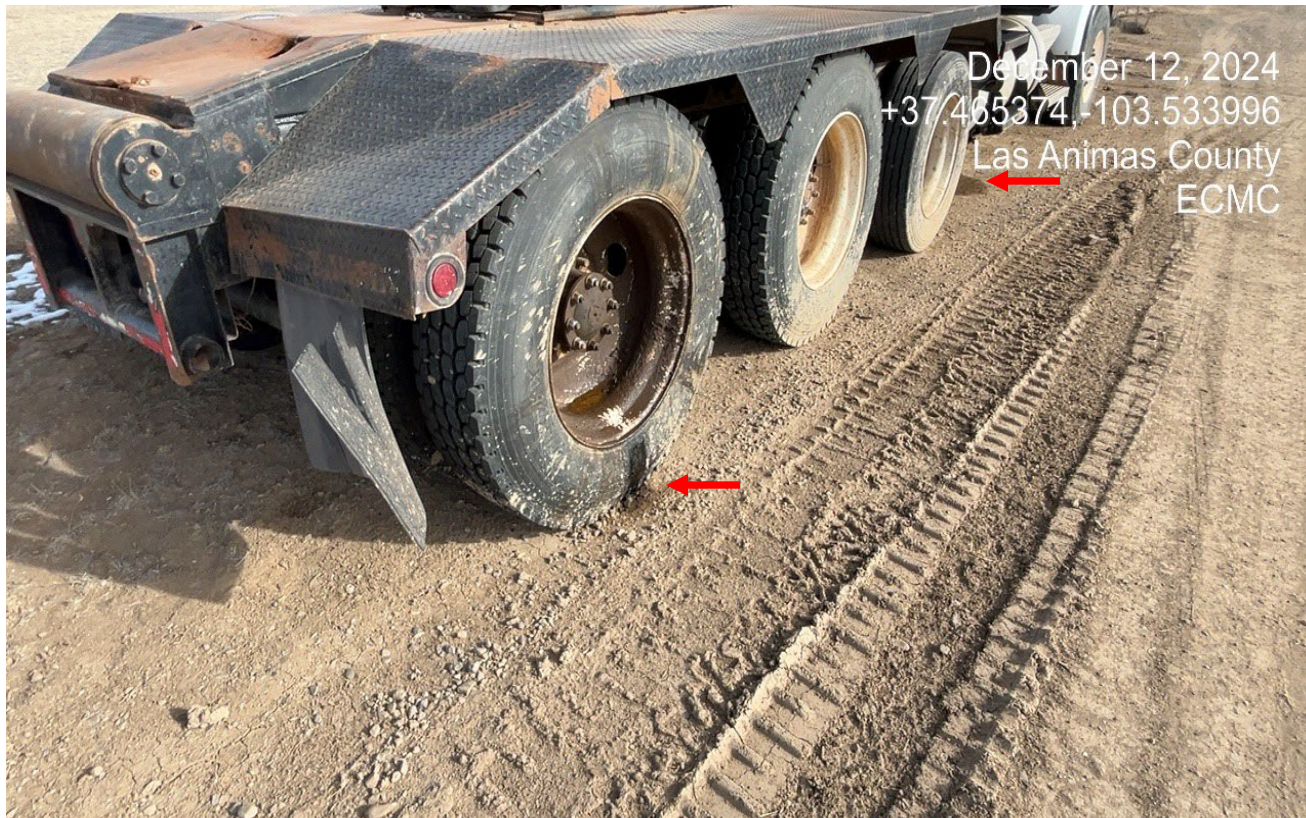
Photo 2. There is oil leaking from the wheel hub and stained soils that need to be cleaned up.

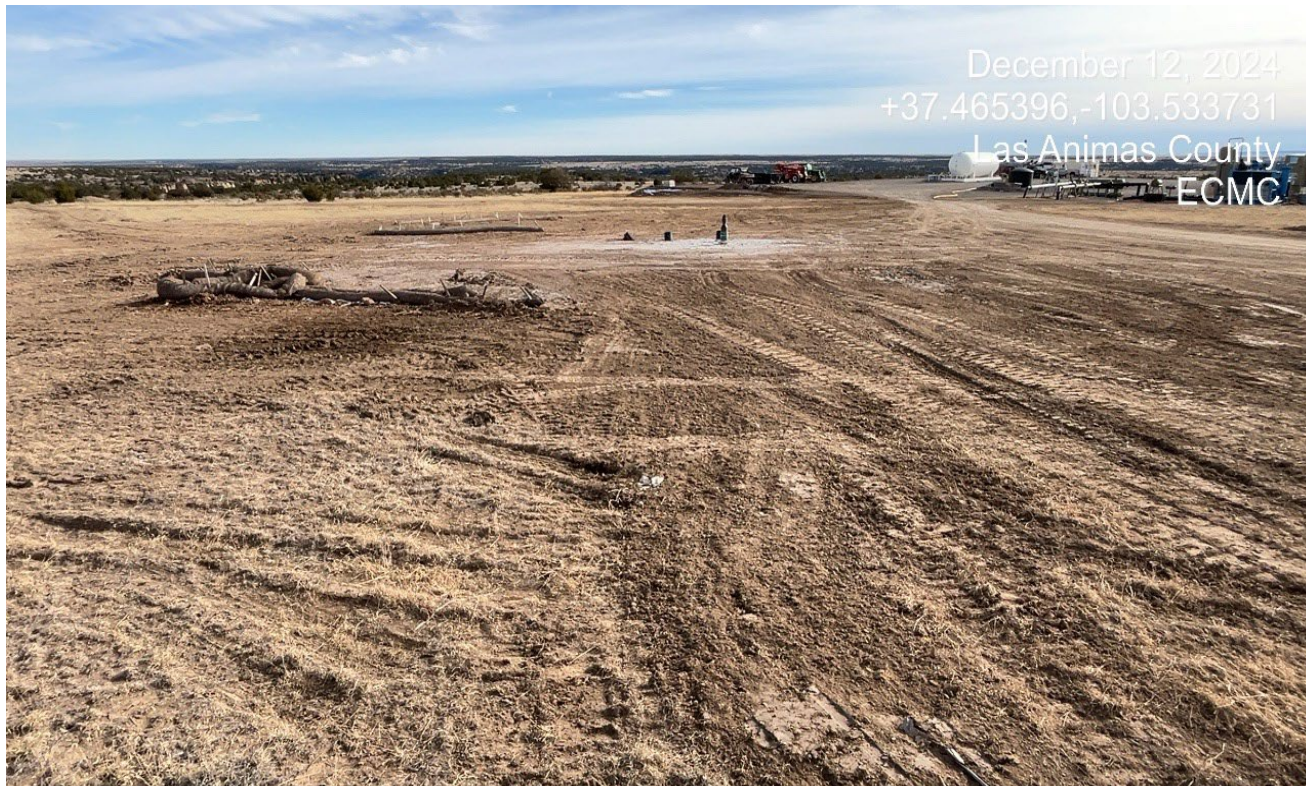
Photo 3. Facing southeast toward the wellsite. It appears recent work has been performed and the soils have been disturbed. The wattles are displaced and not maintained.

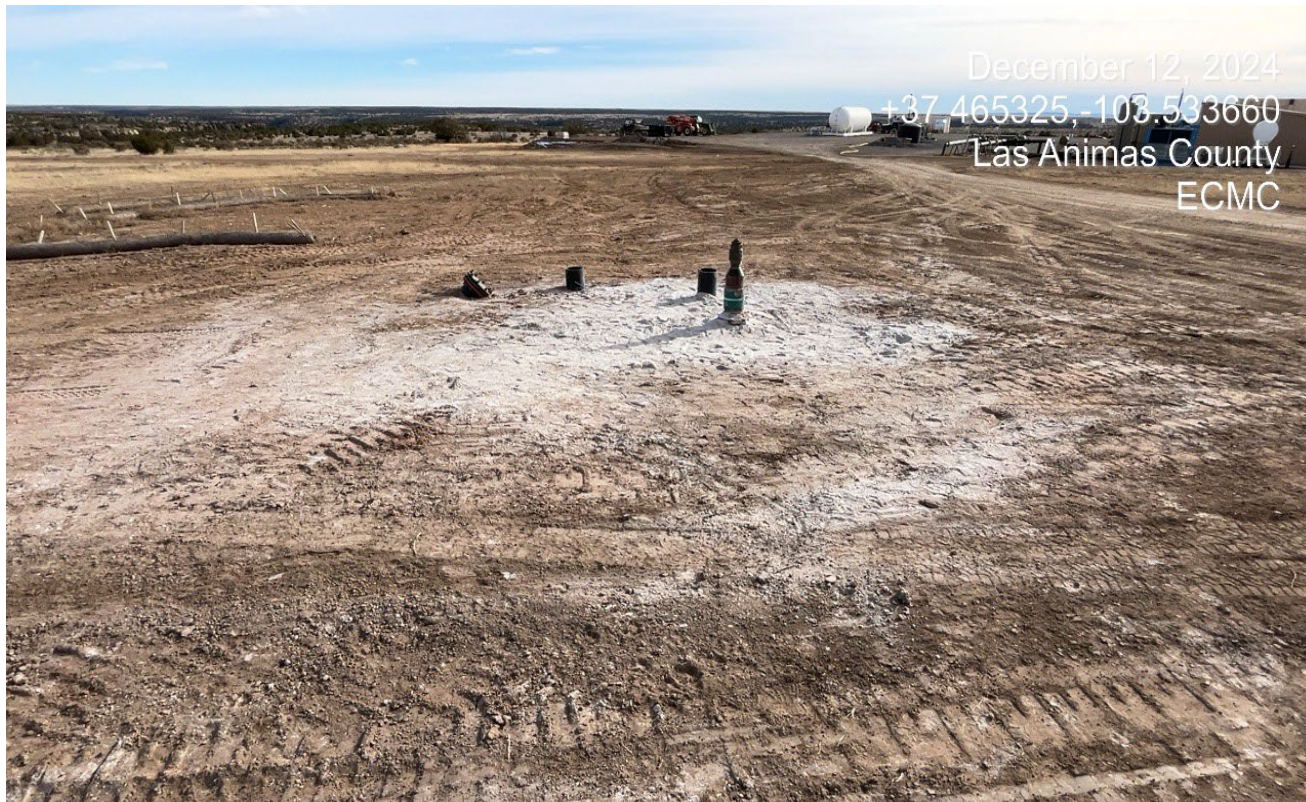
Photo 4. Facing toward the wellsite. There is white material waste around the well that must be cleaned up and properly disposed..

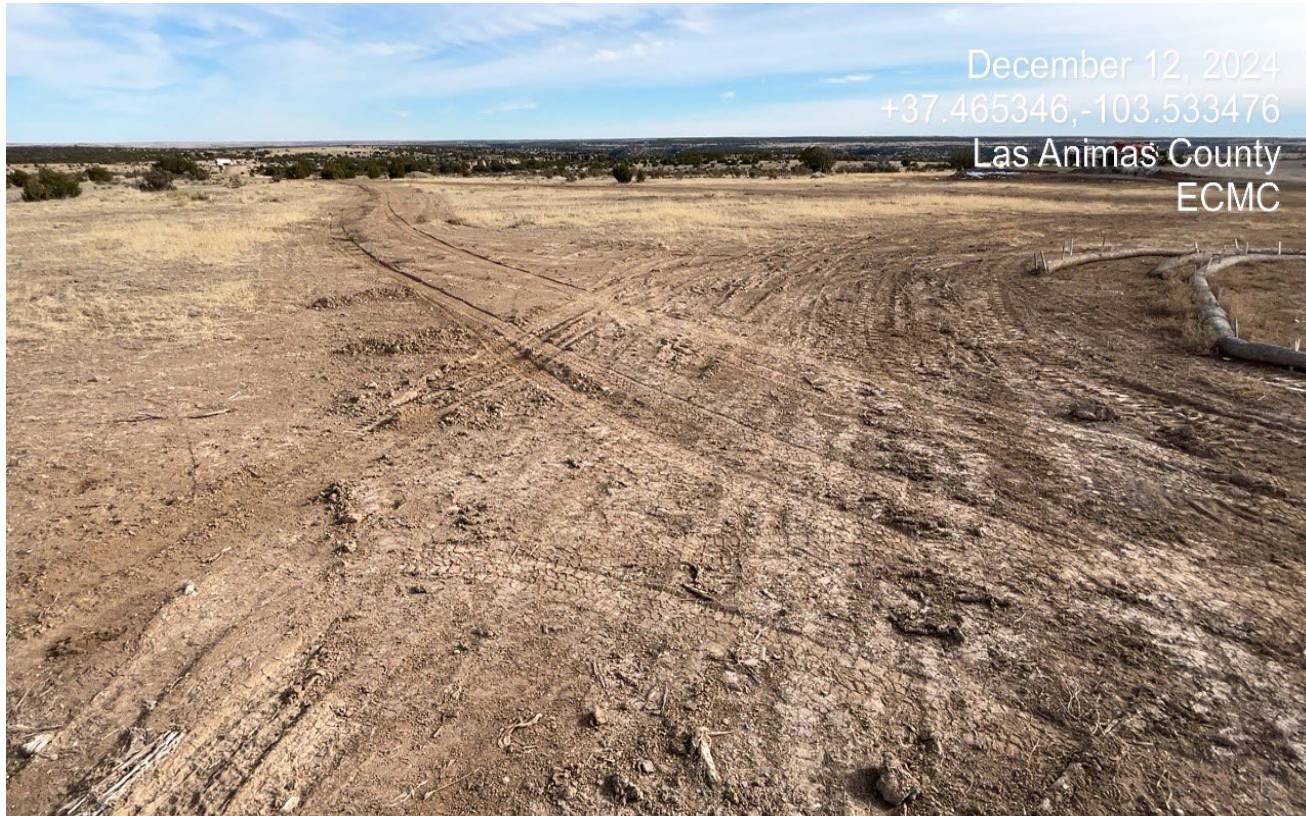
Photo 5. Facing south at the location. There are vehicle tracks along the flowline disturbance and vegetation is not establishing.

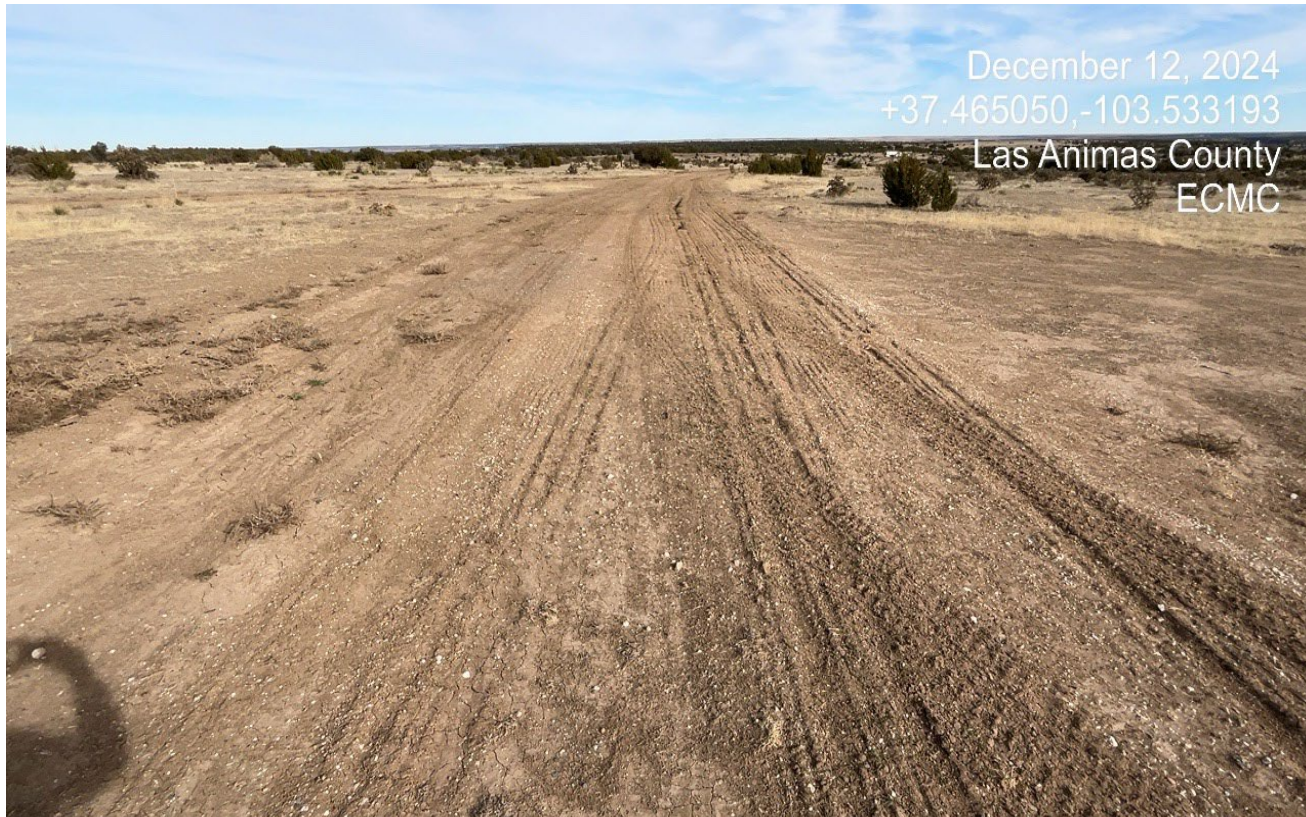
Photo 6. Facing east toward the flowline disturbance which has not established vegetation. Soils are not stabilized and are susceptible to erosion.

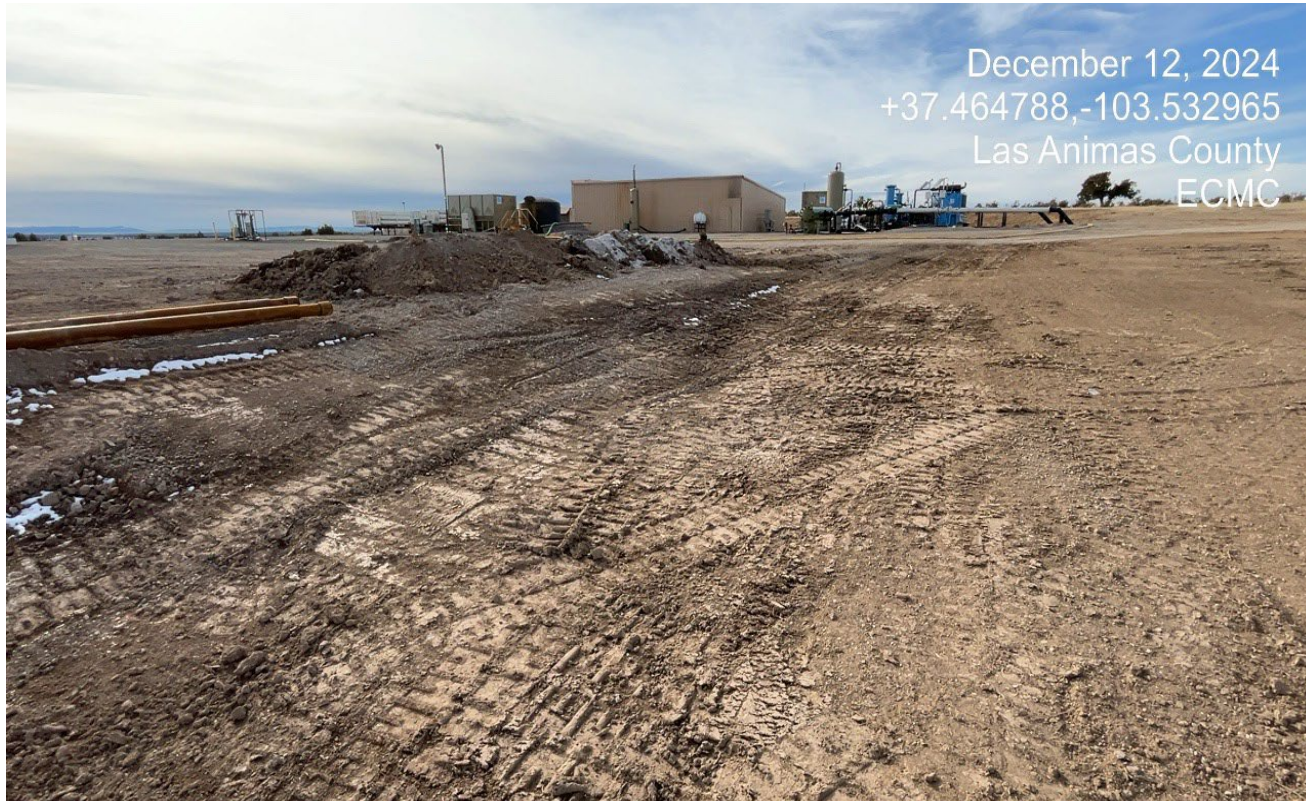
Photo 7. Facing southwest at toward the adjacent gas plant. Soils are caompacked in this area have not been reclaimed.

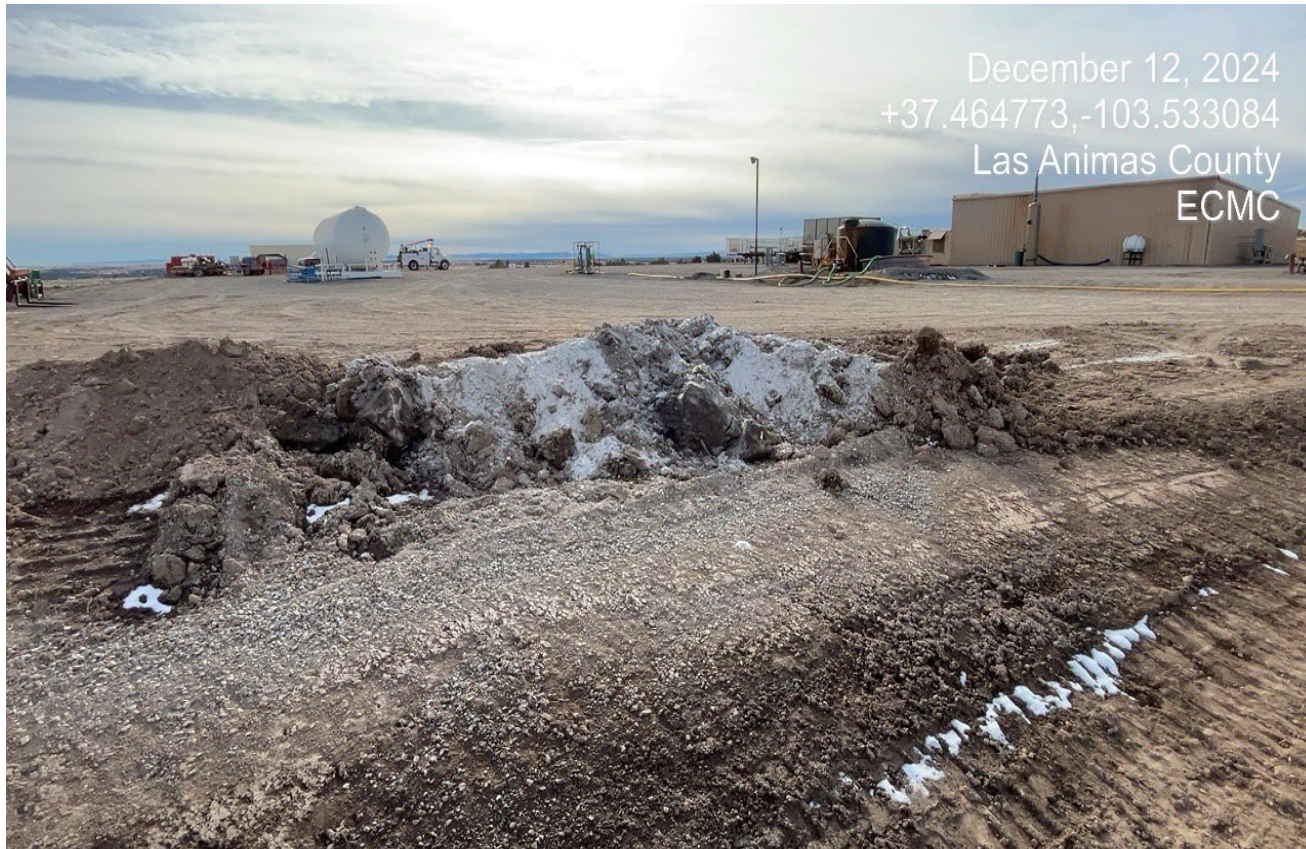
Photo 8. Facing toward the gas plant. There is a whit material that pushed and mixed in with soil which is adjacent to the wellsite. All waste material needs to be cleaned up and properly disposed.

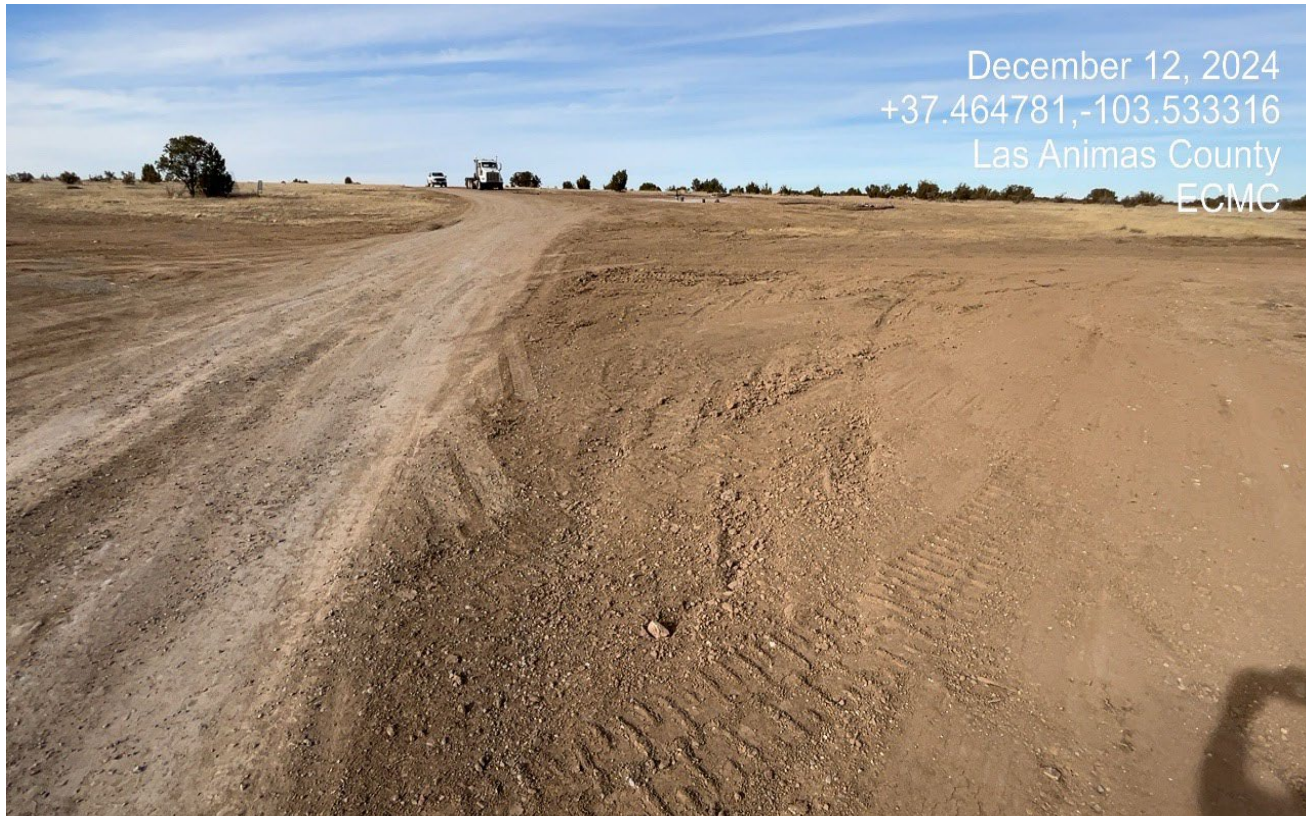
Photo 9. South side of the location facing north. The disturbed soils are not establishing vegetation. Vehicle use has compacted the top soils.
