Inspection Photos

Operator: TEP ROCKY MOUNTAIN LLC #96850

Location ID: 335052

Inspection Doc: 718100105

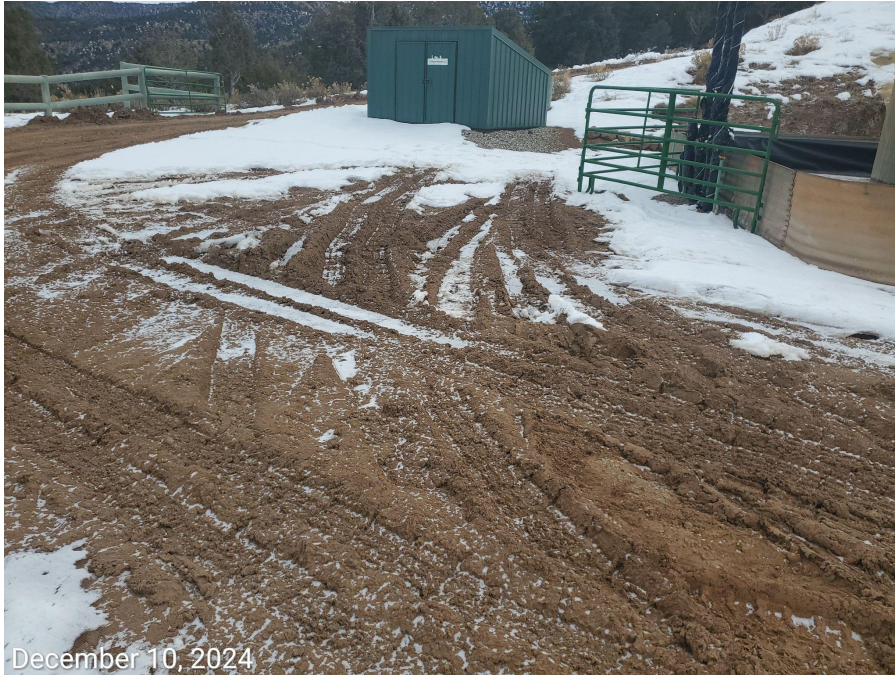
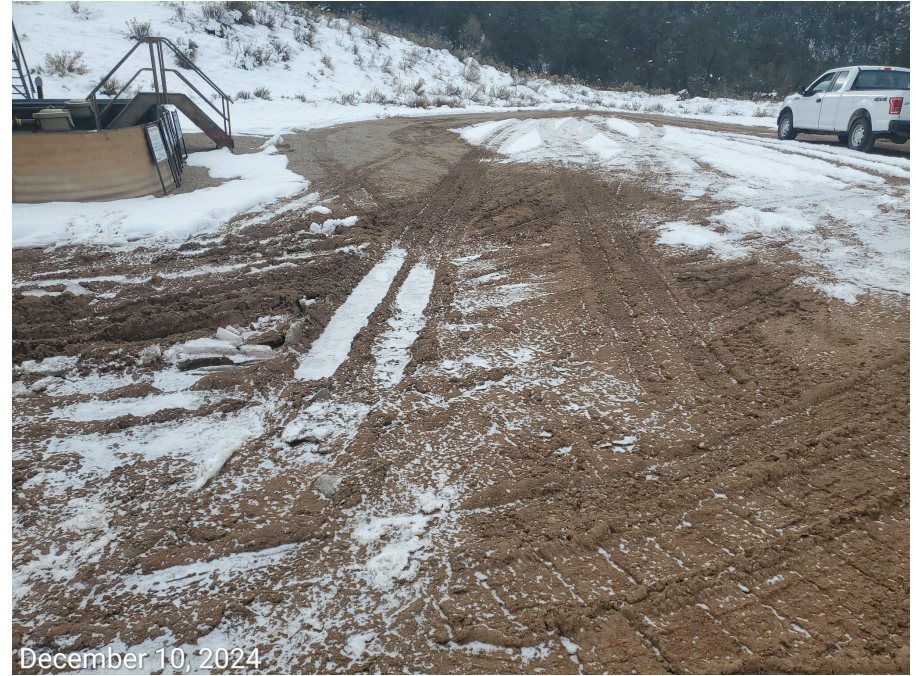
Photo 1: Photos taken from the working pad surface on the east end of the Location. Photo shows tracking/degradation; BMPs to stabilize, as well as to minimize erosion, degradation and sediment transport are no longer in proper functioning condition.

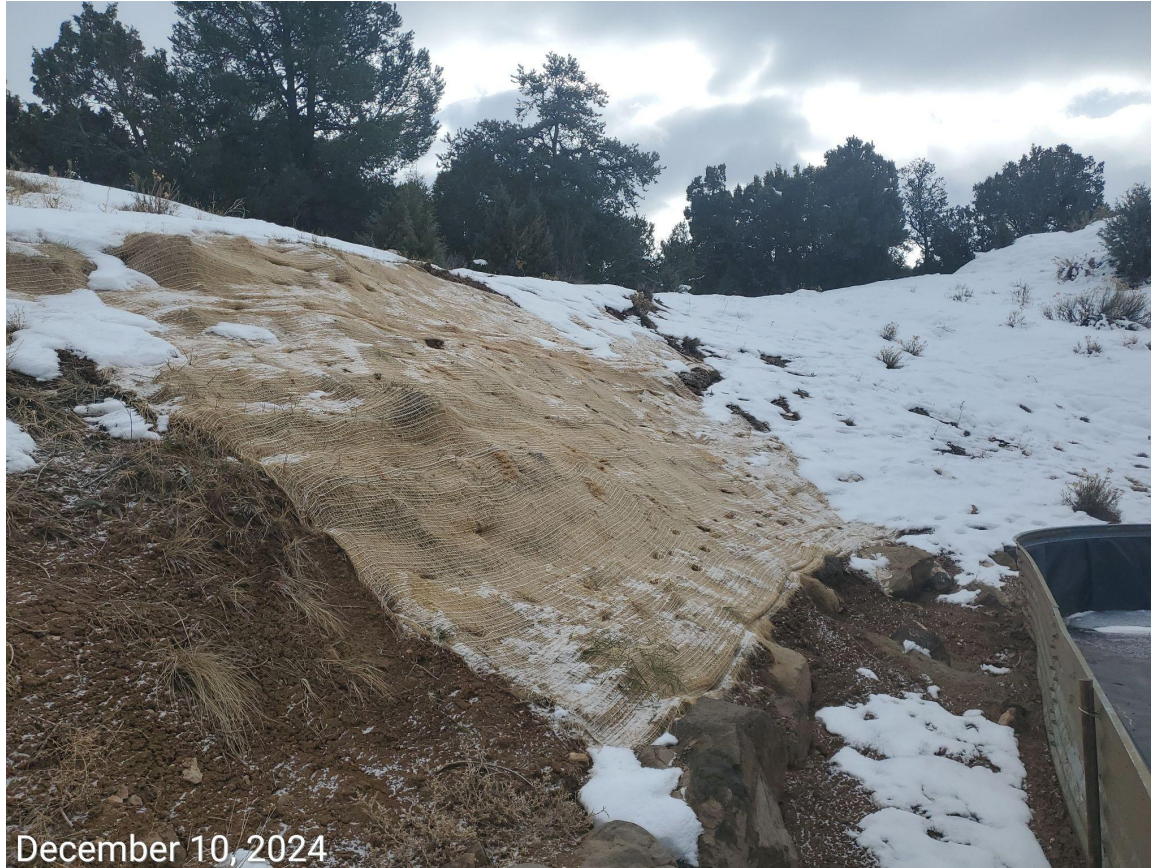
Photo 2: Photo taken from east end of the Location. Operator has placed an erosion blanket on a portion of the slopes. BMPs were not evident, or apparent, within remaining areas of concern identified within the previous inspection.

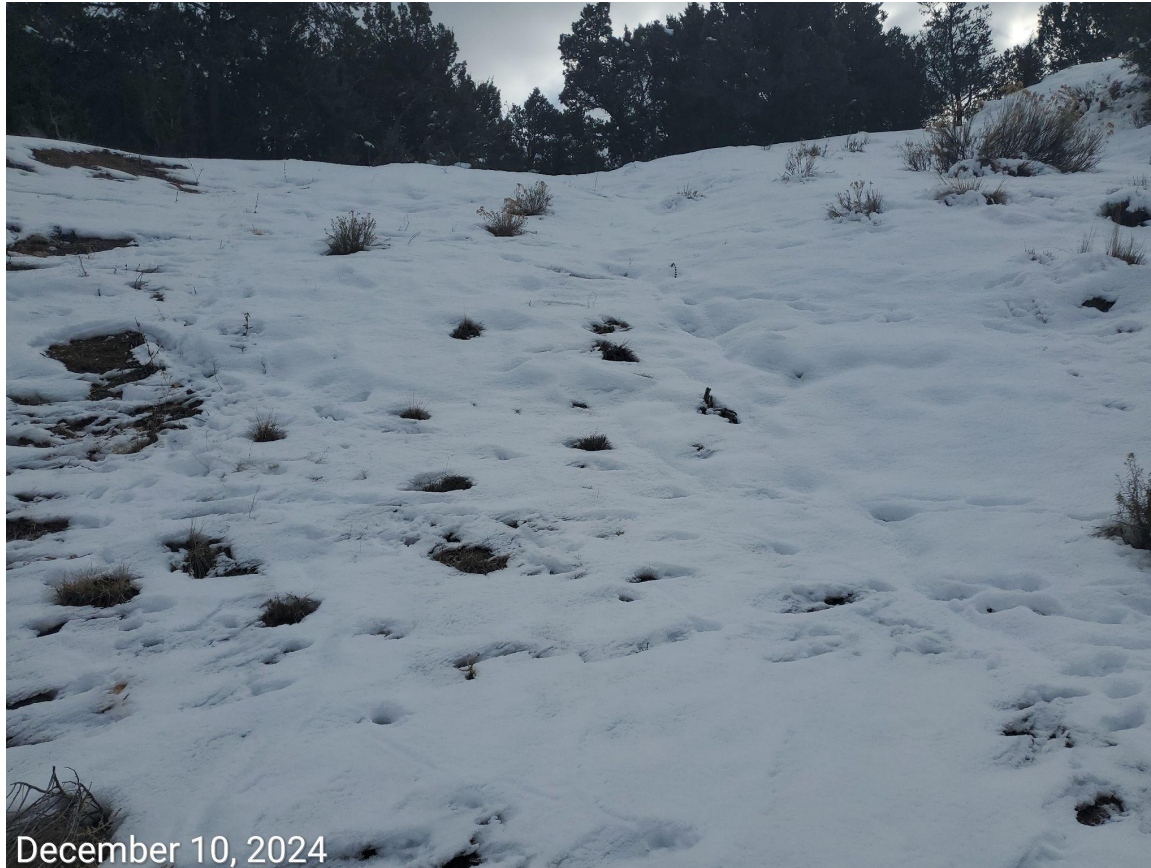
Photo 3: See comments under photo 2. Photo shows interim areas/slopes on the east end of the Location where stormwater and reclamation issued were identified.

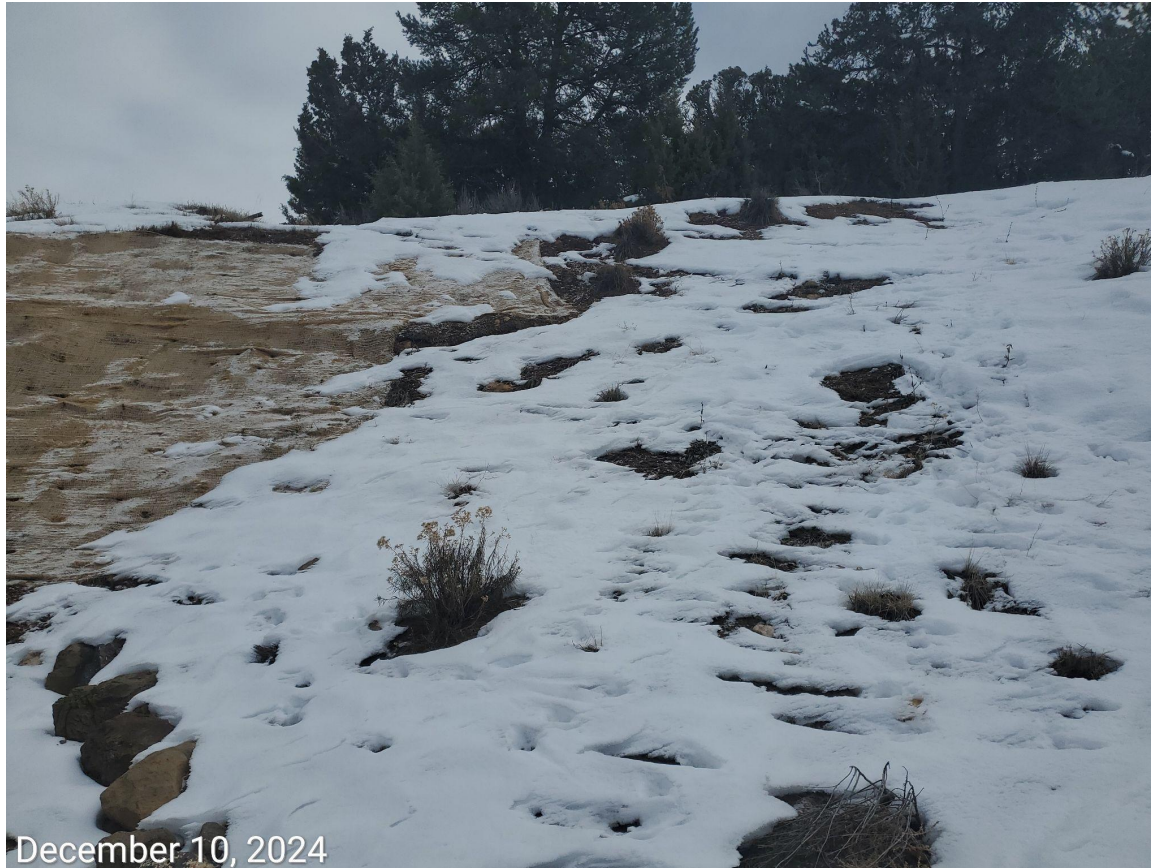
Photo 4: See comments under photo 2 and 3.

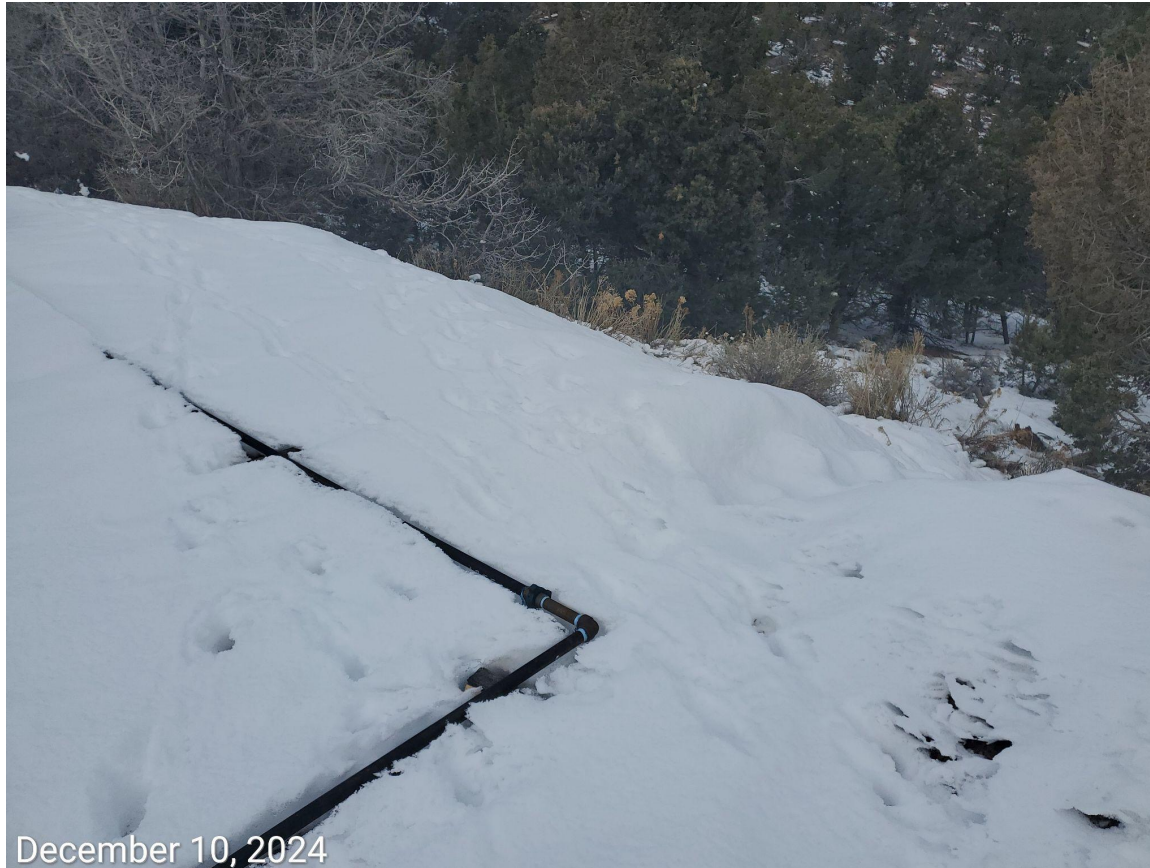
Photo 5: Photo shows areas of gully erosion on the northeast end of the Location.

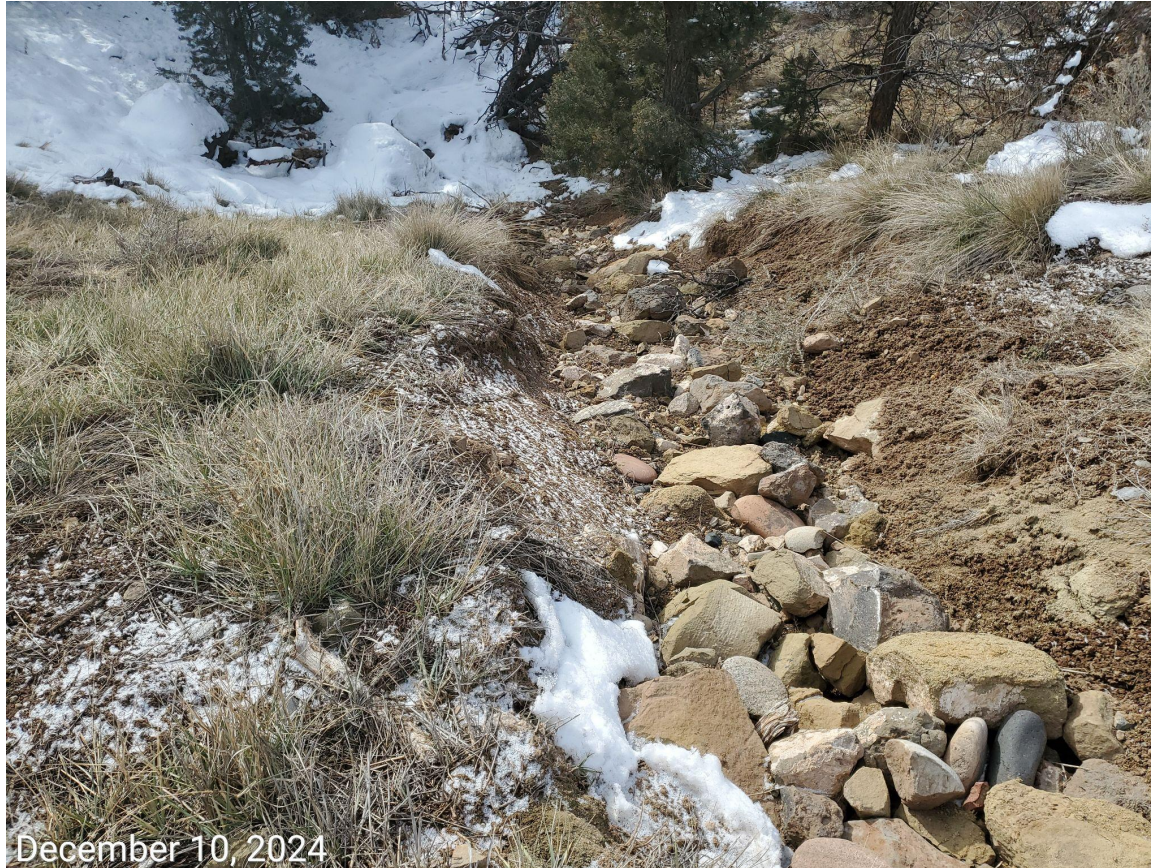
Photo 6: Photo taken from below the sediment trap on the southwest end of the Location. Sediment trap has not been installed with a properly engineered outlet; geotextile lining in conjunction with the rip-rap material not observed; slopes within outlet lacks stabilization and erosion degradation / sediment transport is evident
