Inspection Photos

Location Name: TEP ROCKY MOUNTAIN LLC Federal RU 34-6 Pad

Location ID: 335044

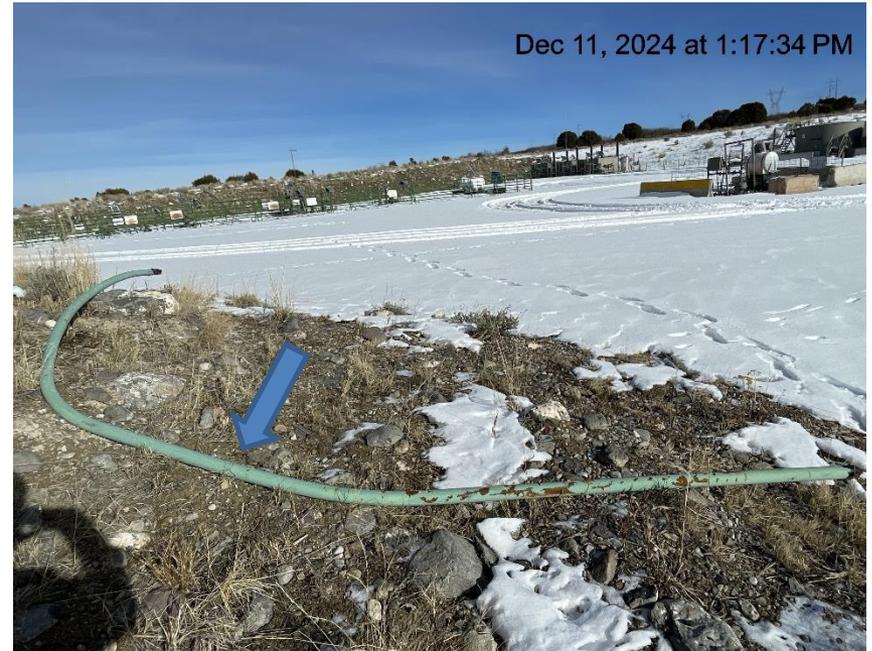
Photo # 3074 Debris

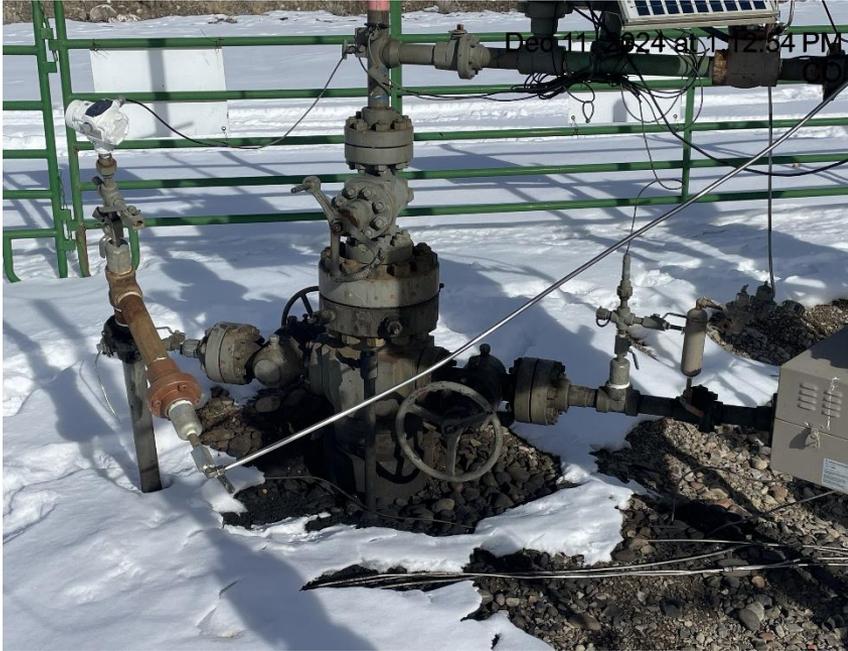
Photo # 3075 Staining around RU 43-6 wellhead

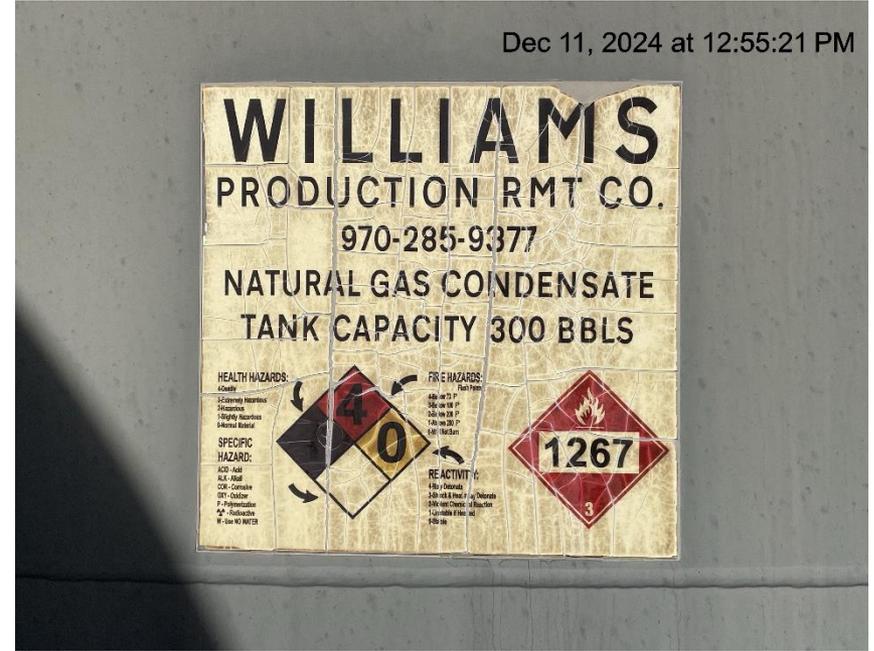
Photo # 3076 Tank label contains inaccurate information

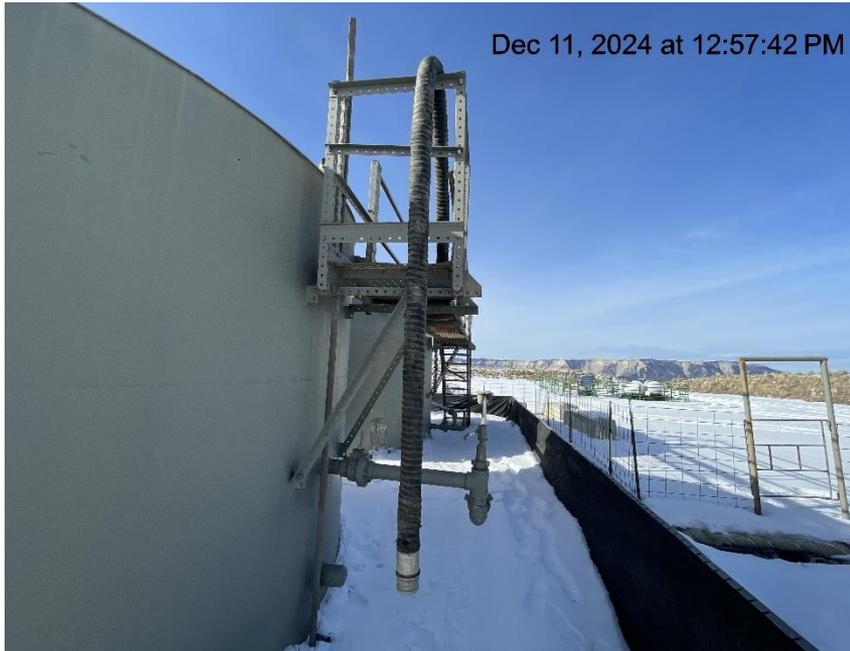
Photo # 3077 Unused hose on tank battery stairs

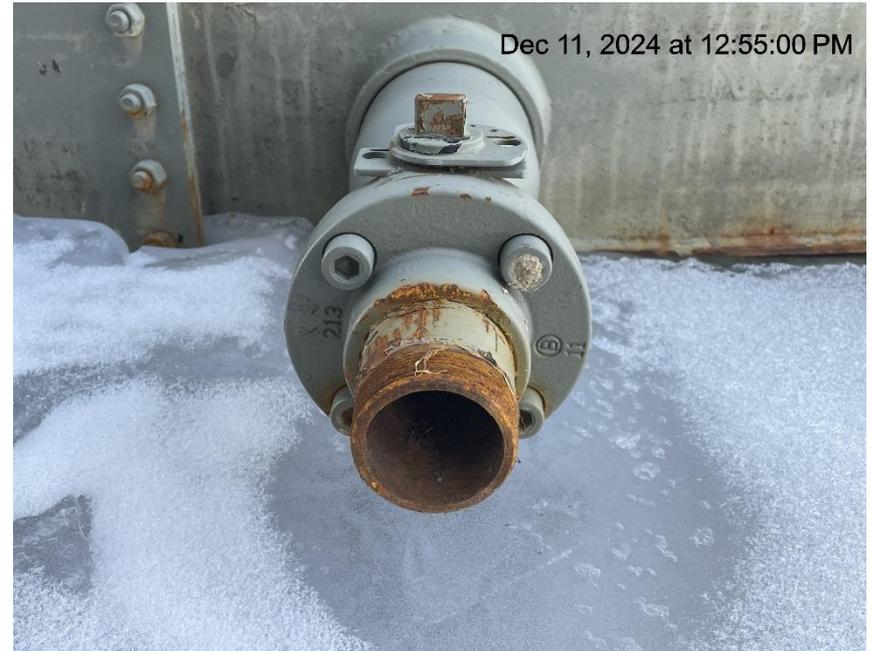
Photo # 3078 Open ended load line

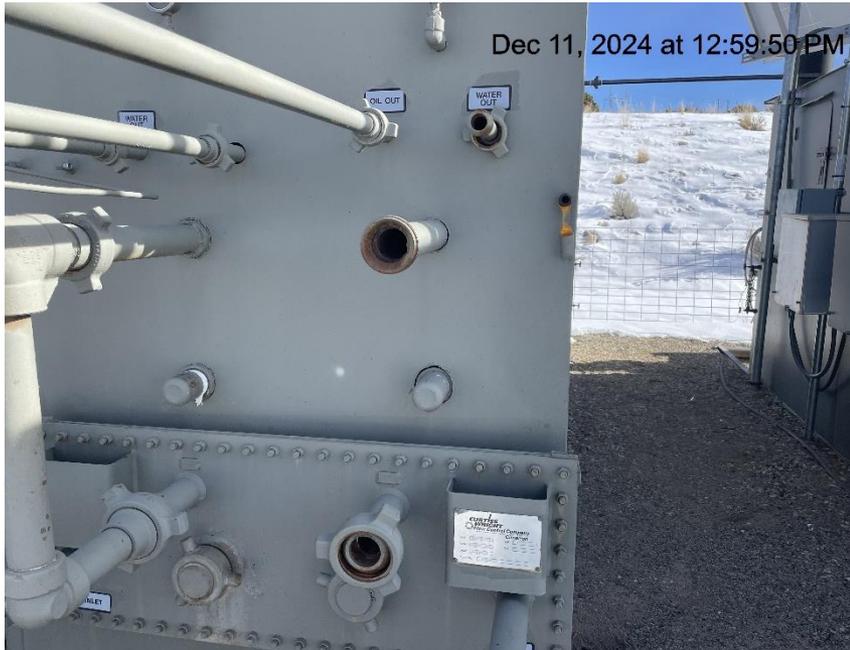
Photo # 3079 Multiple open ended piping on separator unit/wildlife hazards/available for entry by wildlife
