# Inspection Photos

Loc: 483008

Operator: BNL (ENTERPRISE) INC

Inspection Date: 12/12/2024

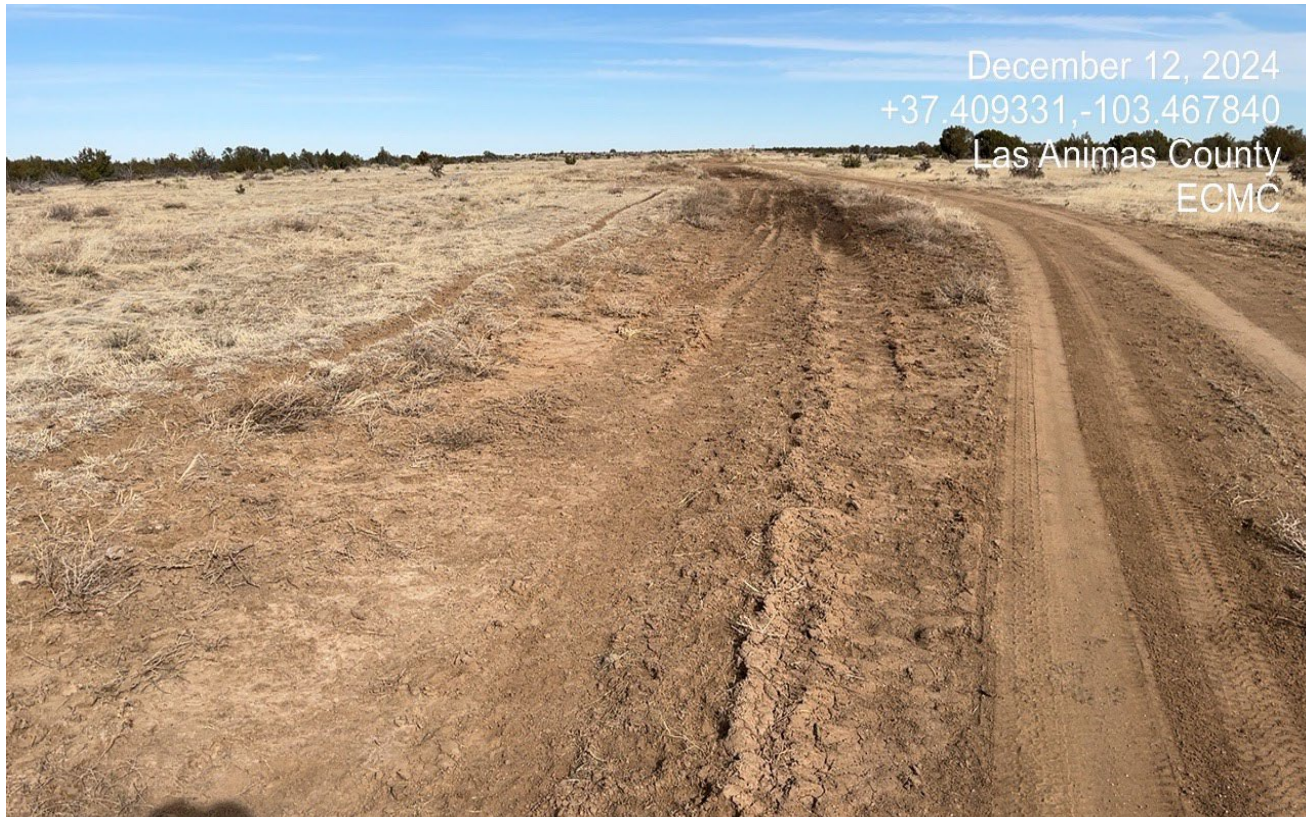
**Photo 1.** Facing northeast along the access road. There are areas of the road that will need to be repaired and stabilized.

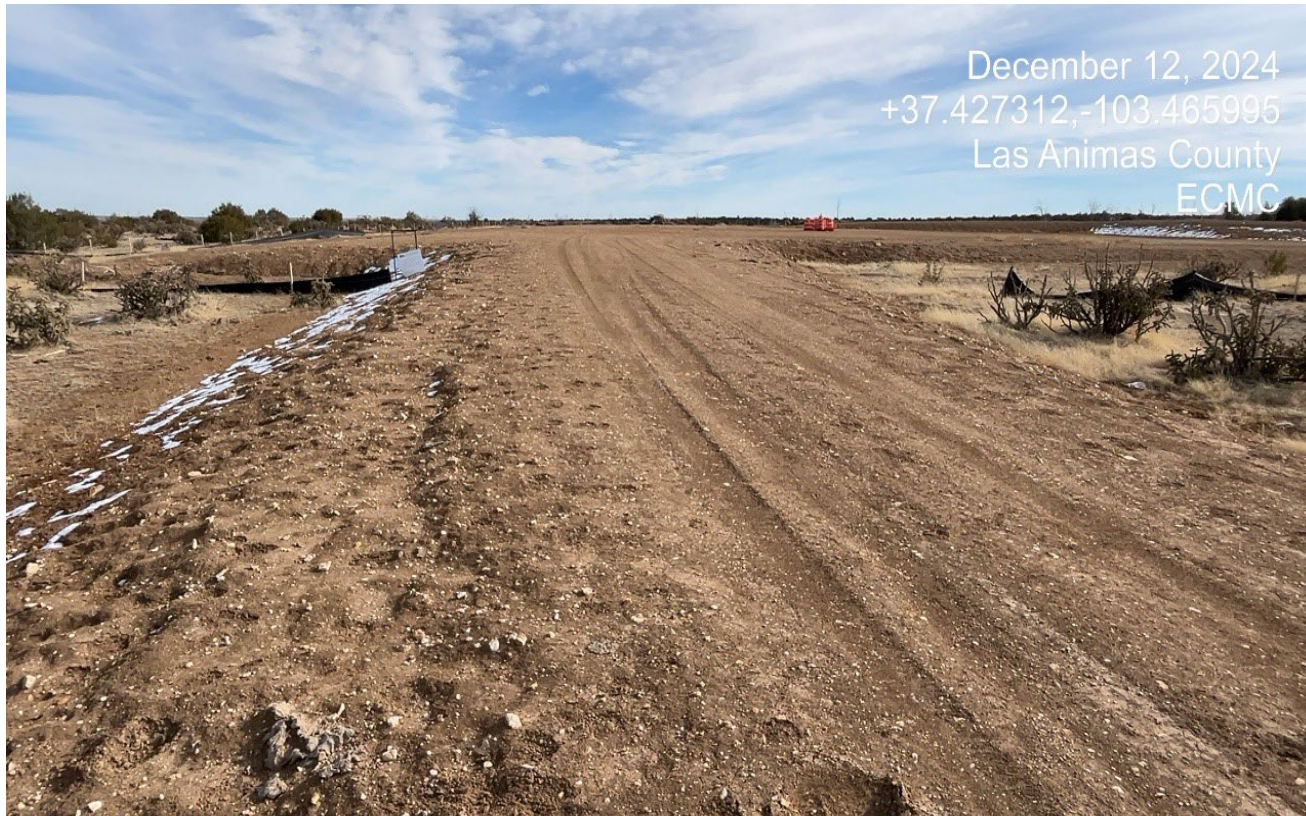
**Photo 2.** Facing toward the northwest side of the location. The silt fence is not maintained at the location. The loose soils along the access road at red arrow are not stabilized.

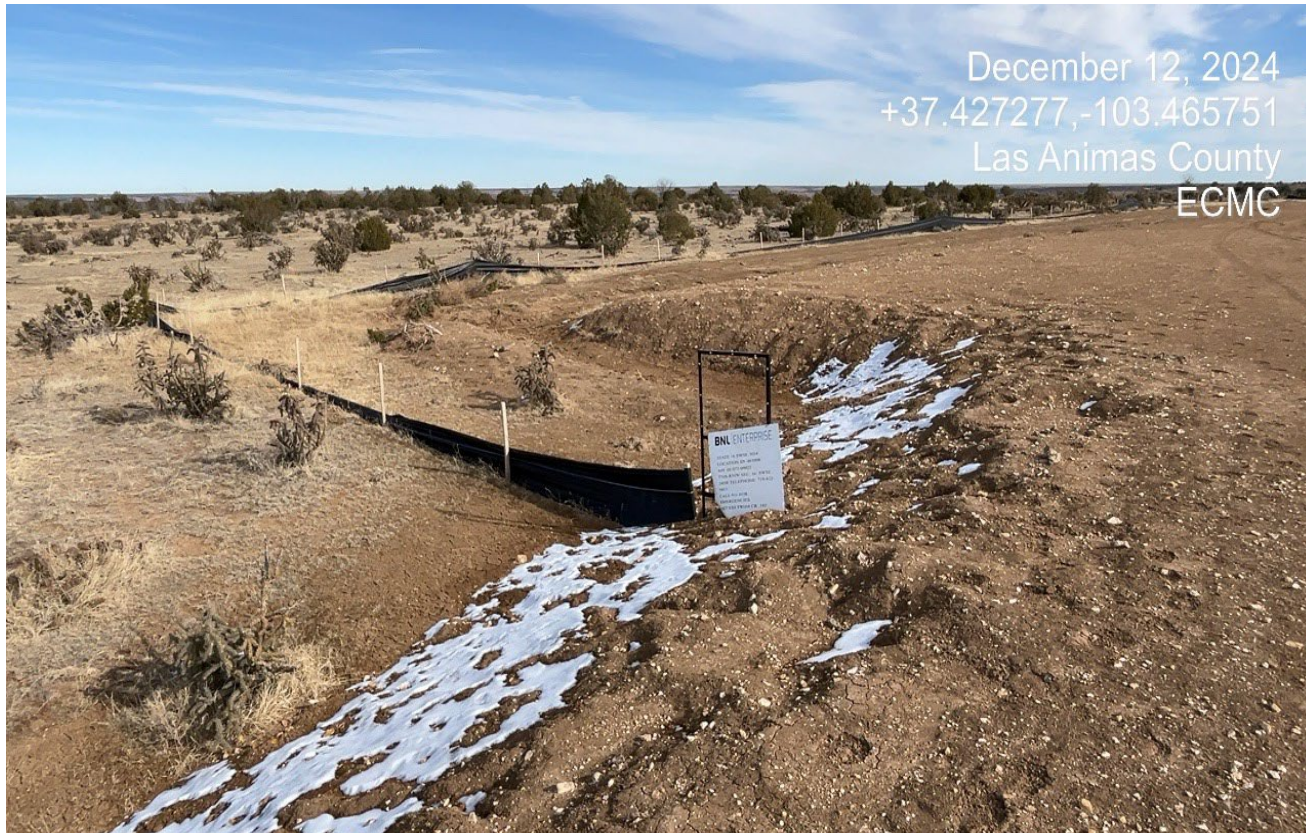
**Photo 2.** Facing toward the northwest side of the location. The silt fence is not maintained at the location.

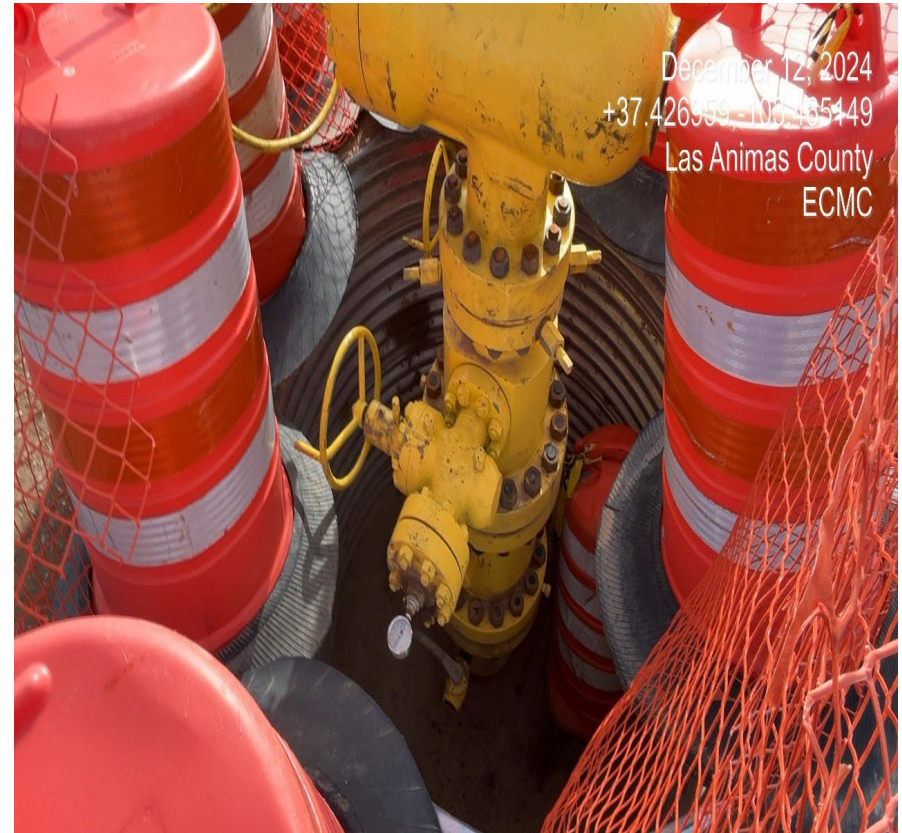
**Photo 6.** The open cellar at the wellhead does not have adequate wildlife protections..

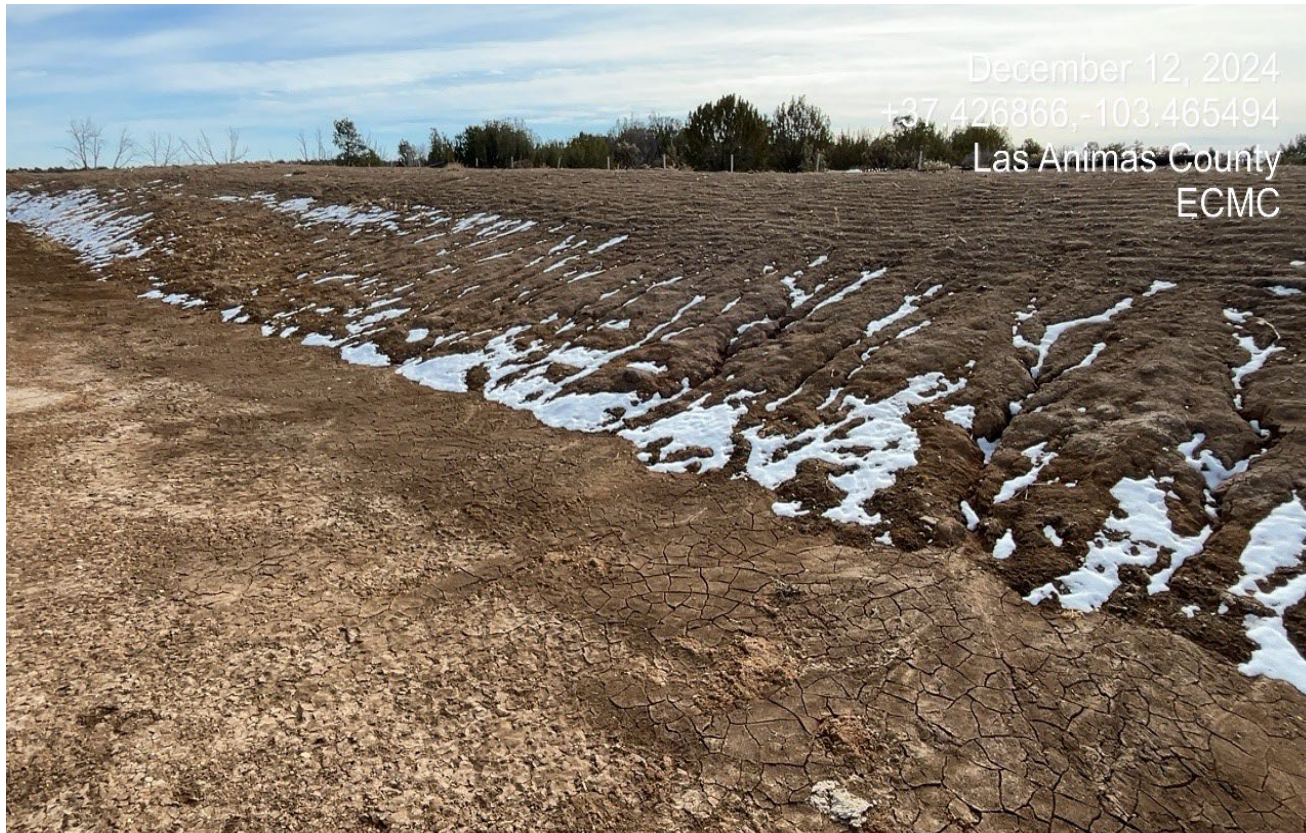
**Photo 7.** Facing toward the topsoil pile at the south side of the location. There is erosion occurring along the topsoil which is not stabilized or protected..

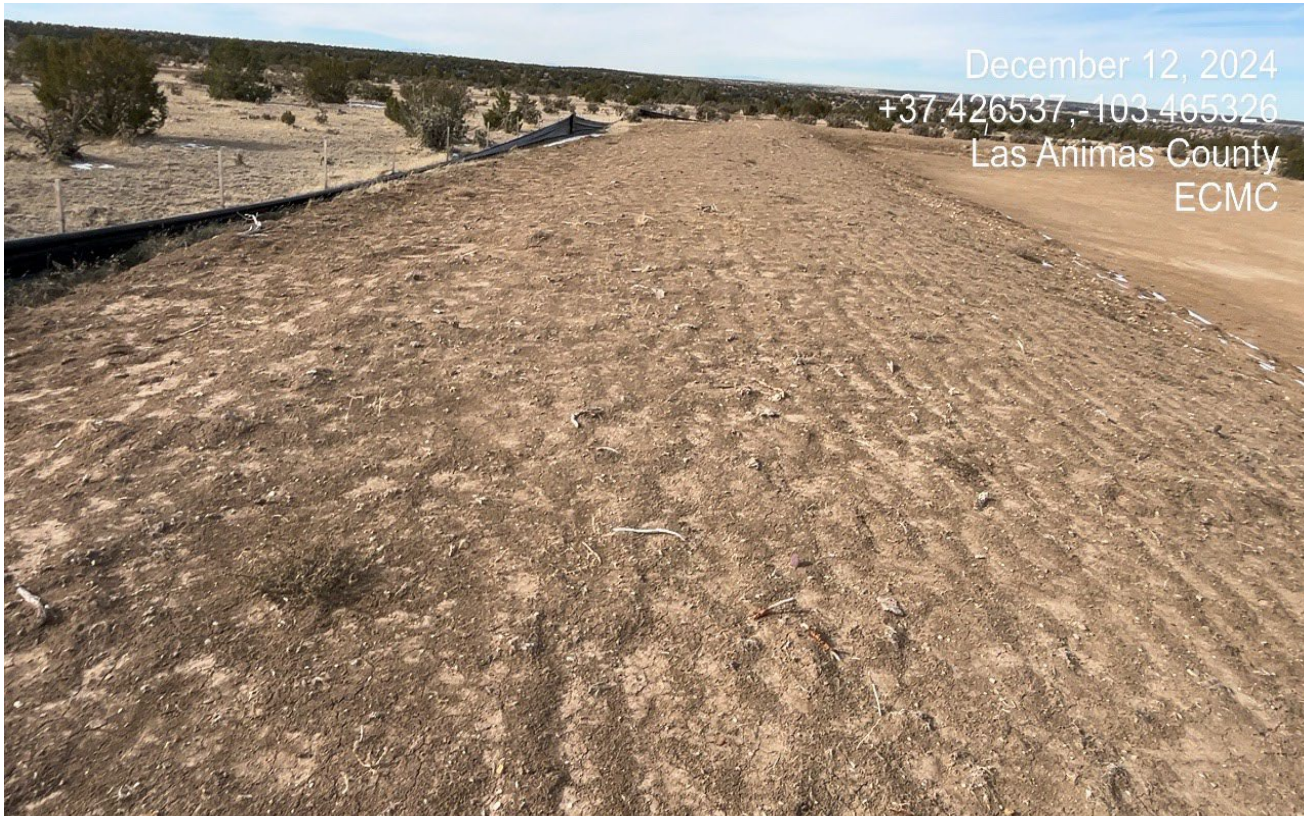
**Photo 8.** South side of the location facing westtoward the topsoil pile. The topsoil has not been seeded and is not stabilized. The perimeter silyt fence is not maintained.

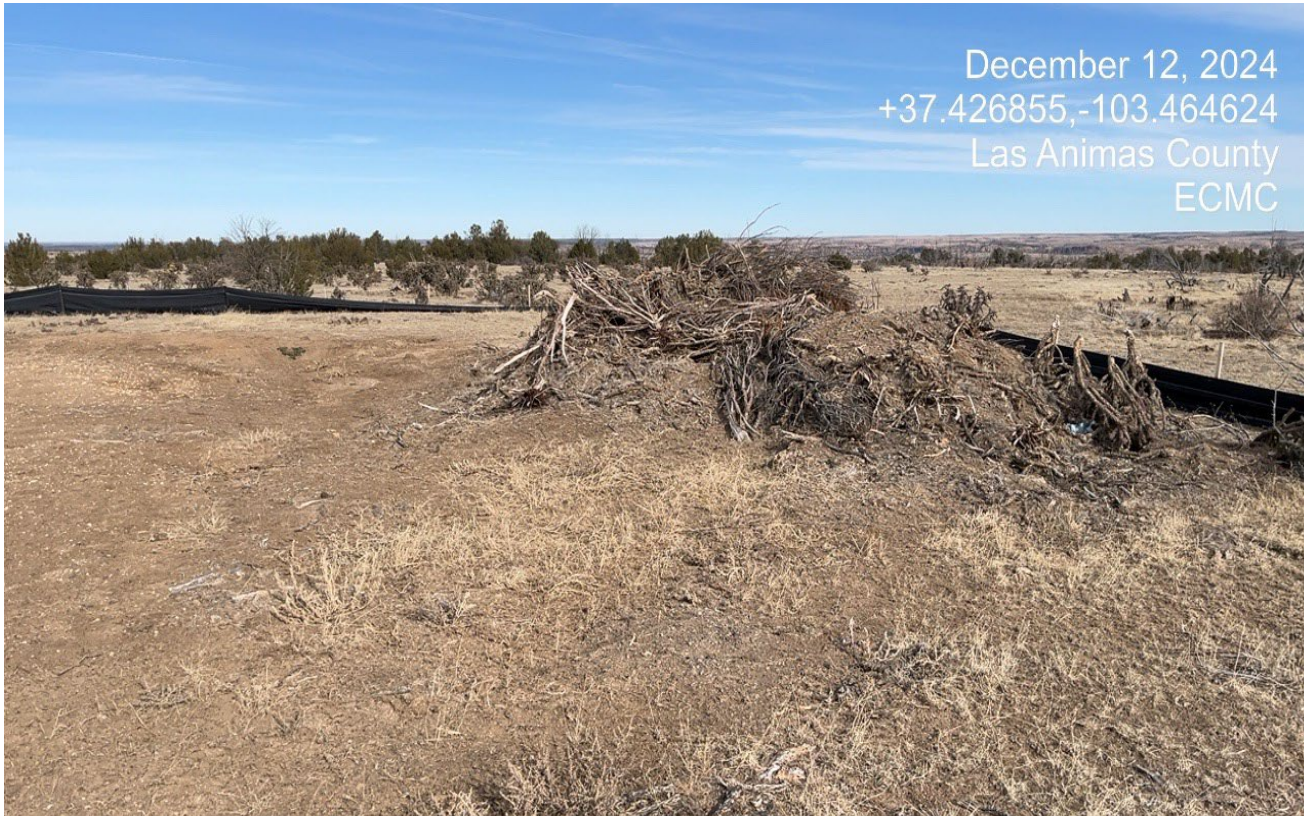
**Photo 9.** Facing toward the northeast side. This brush pile debris needs to be removed.
