Site Specific Final Reclamation Completion Notice – Cropland Drone Imagery

Permit Closure Report – Cropland

Location ID: 327274

Location Name: Succo Gas #4-20

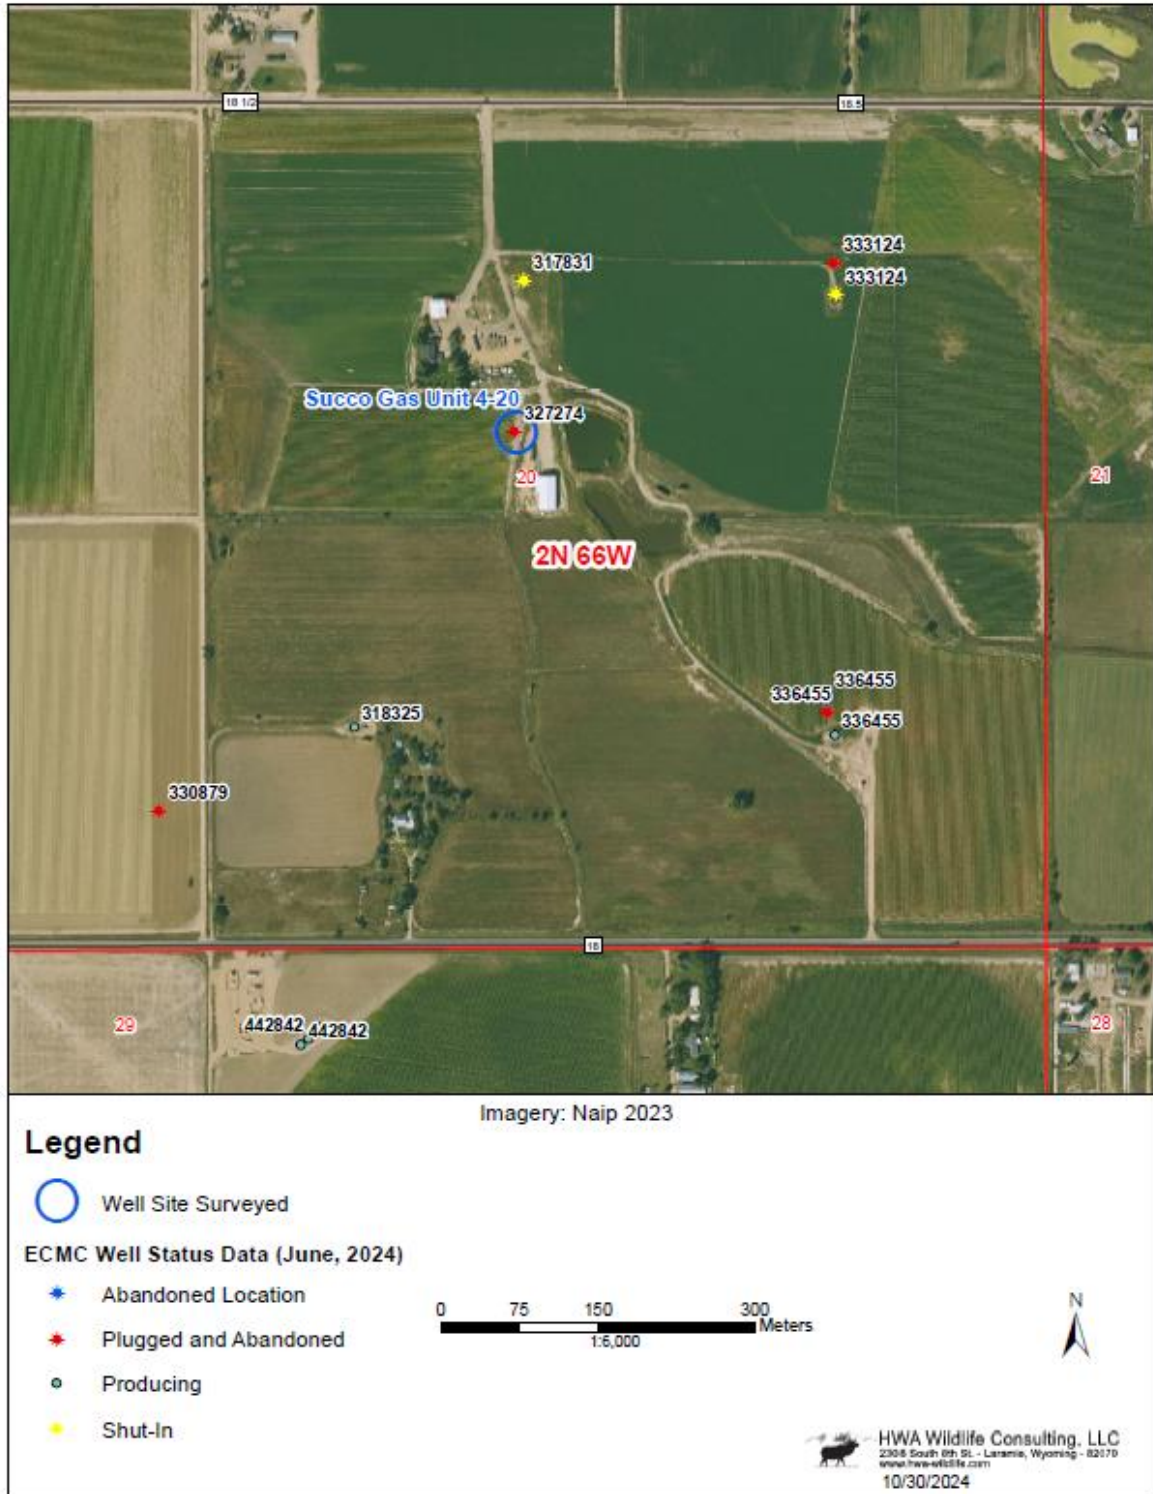
Drone imagery confirms that no equipment remains following reclamation activities. There is no sign of disturbance or stunted crop within the well, access road, flowlines, or TB (not associated within the approved variance).

Figure 1. Overview of the reclaimed well site surveyed during 2024.

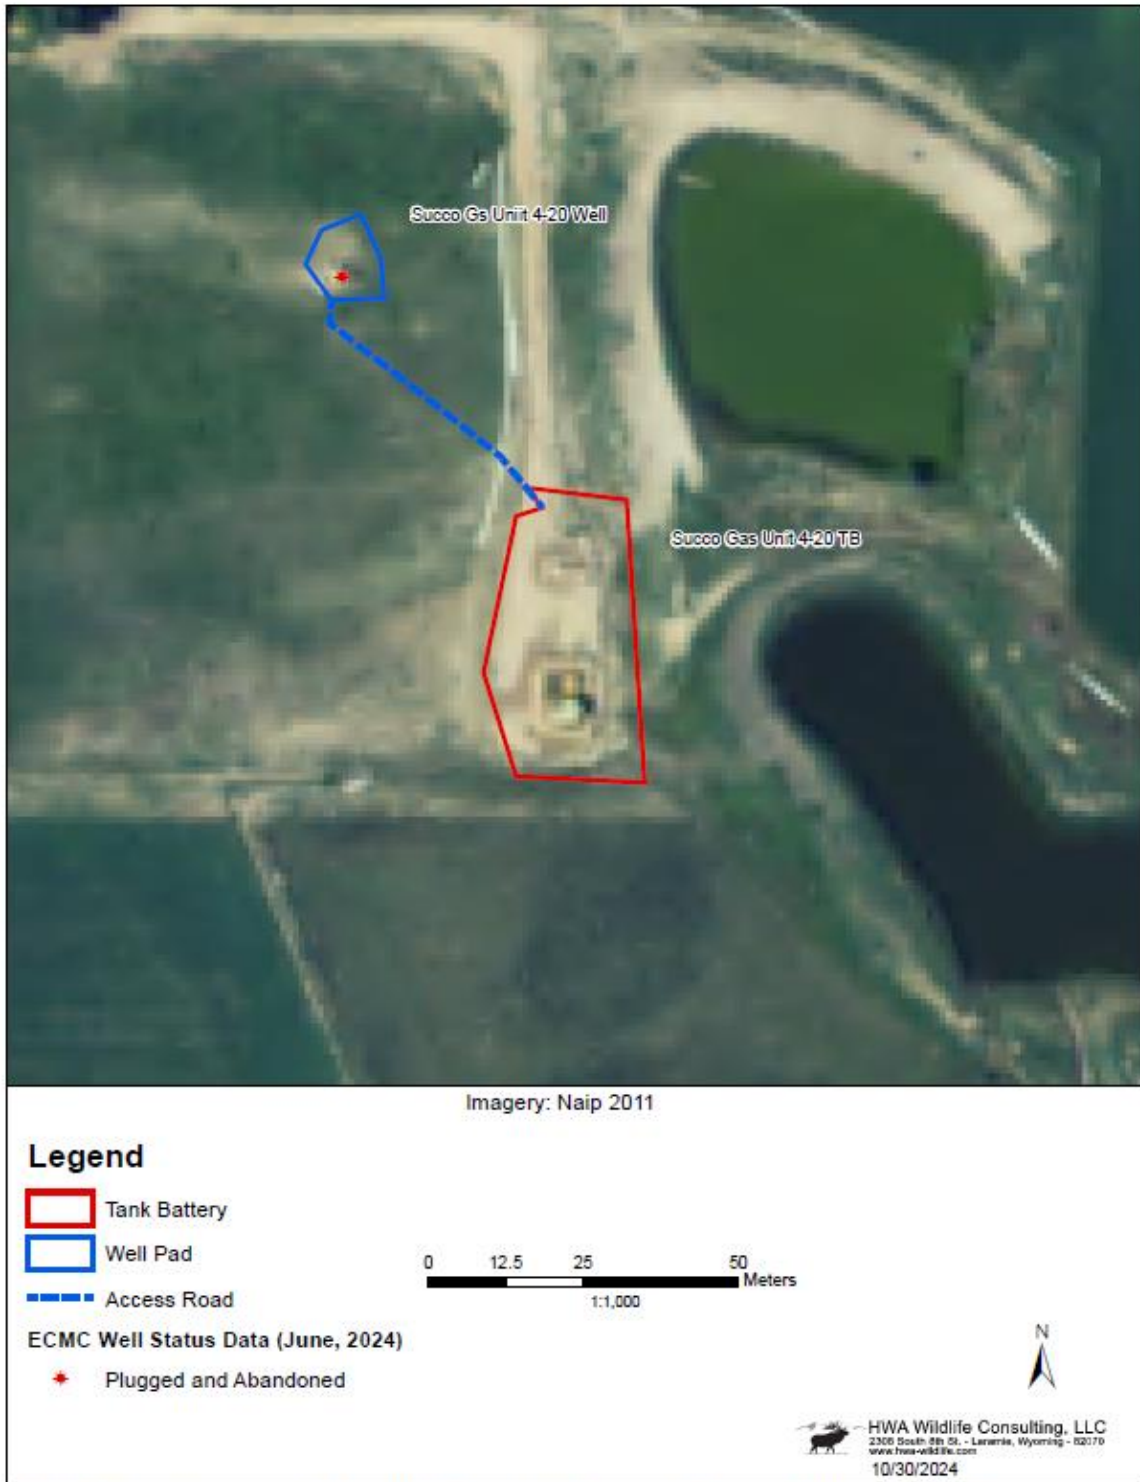
Figure 2. Pre-plugging overview of the reclaimed well site and the associated access road, tank battery, and flowline.

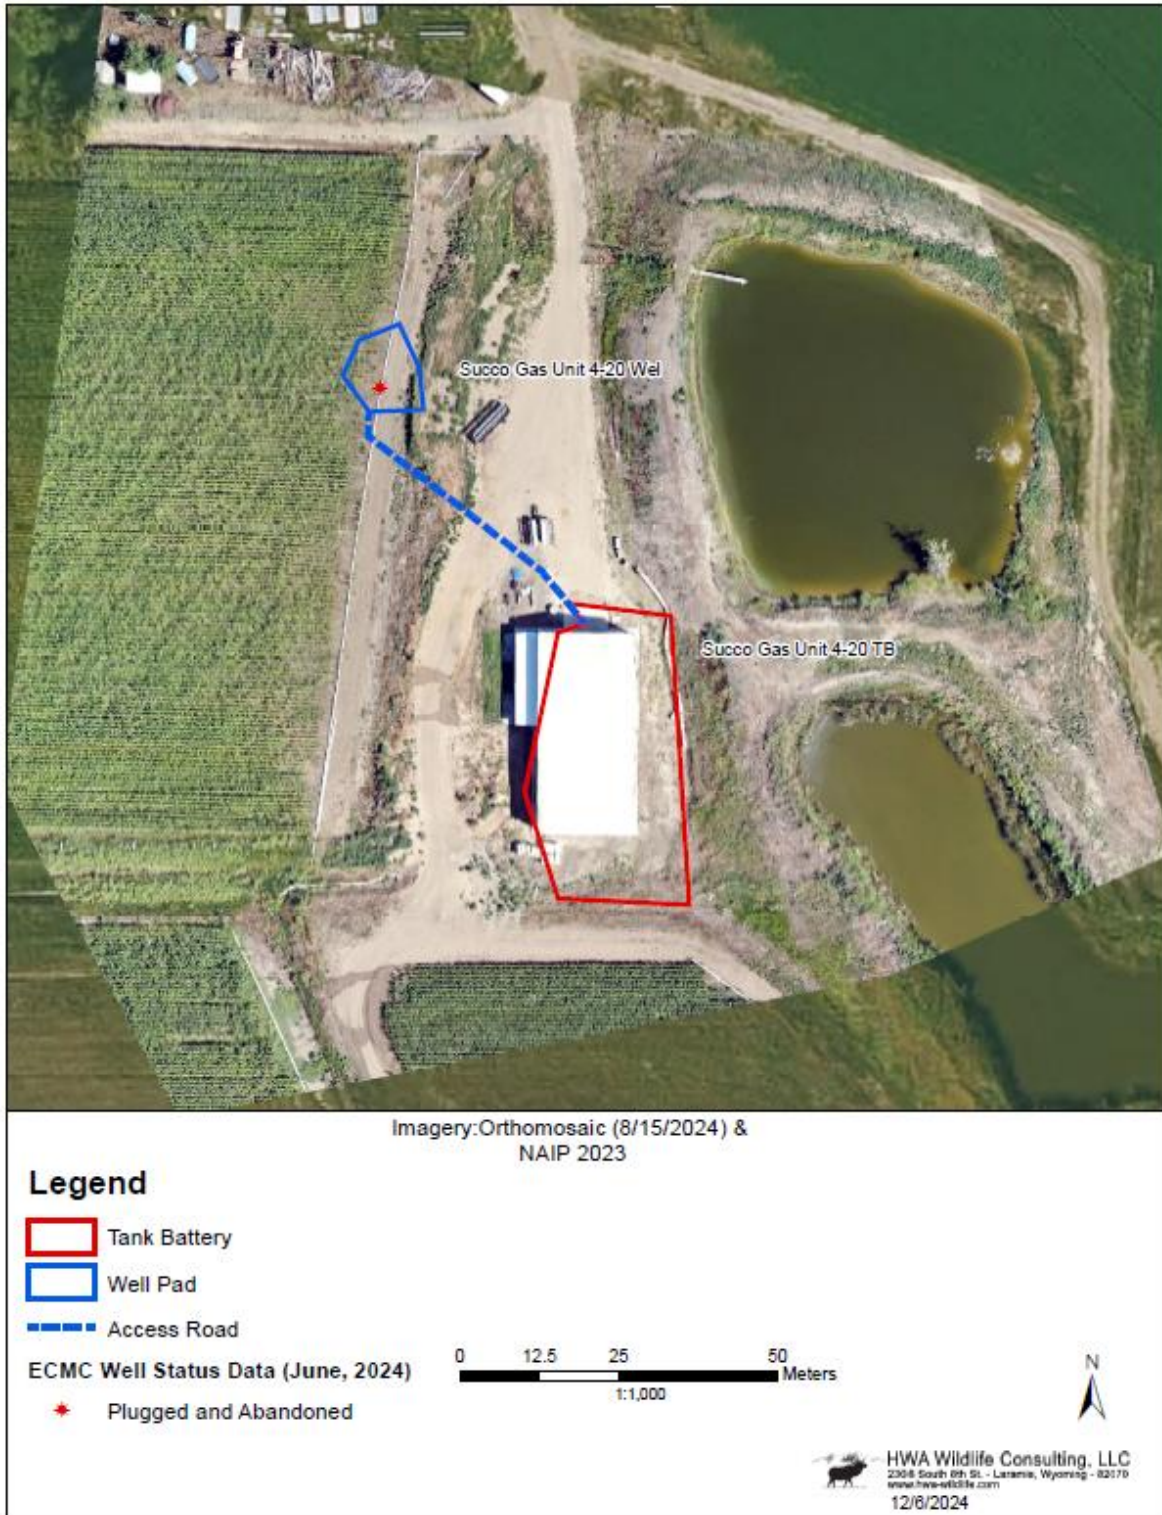
Figure 3. Post-plugging overview of the reclaimed well site and the associated access road, tank battery, and flowline.

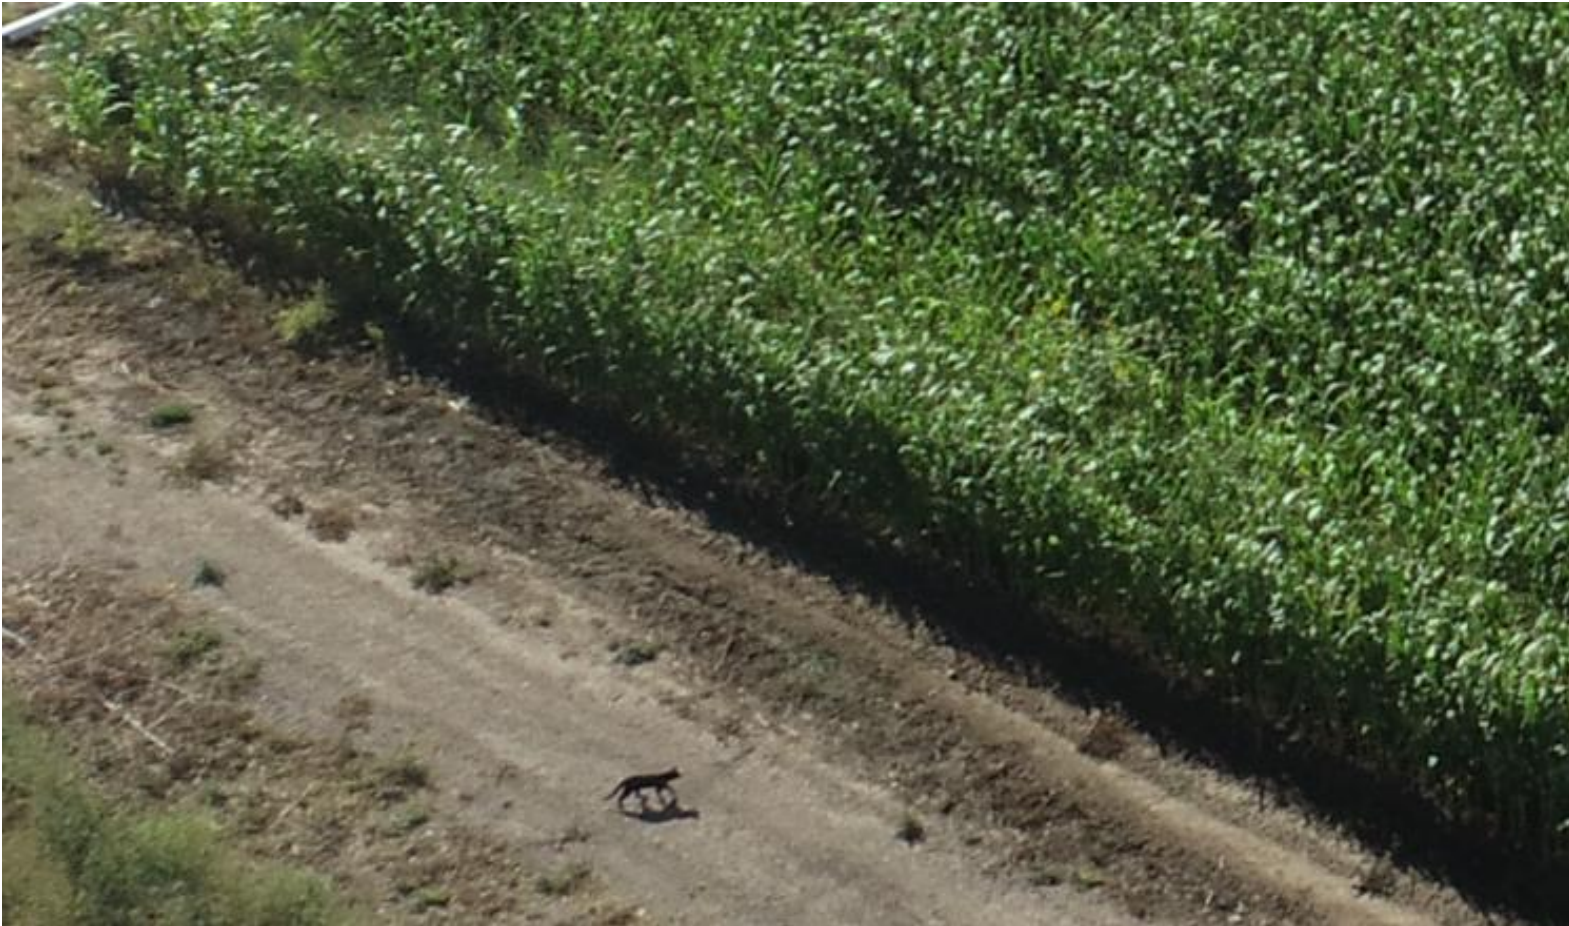
Figure 12: Cropland Reference Photo showing corn in the appropriate reproductive growth stage.
