# Inspection Photos

Loc #: 484359

Operator: DESERT EAGLE OPERATING

Inspection Date: 12/12/2024

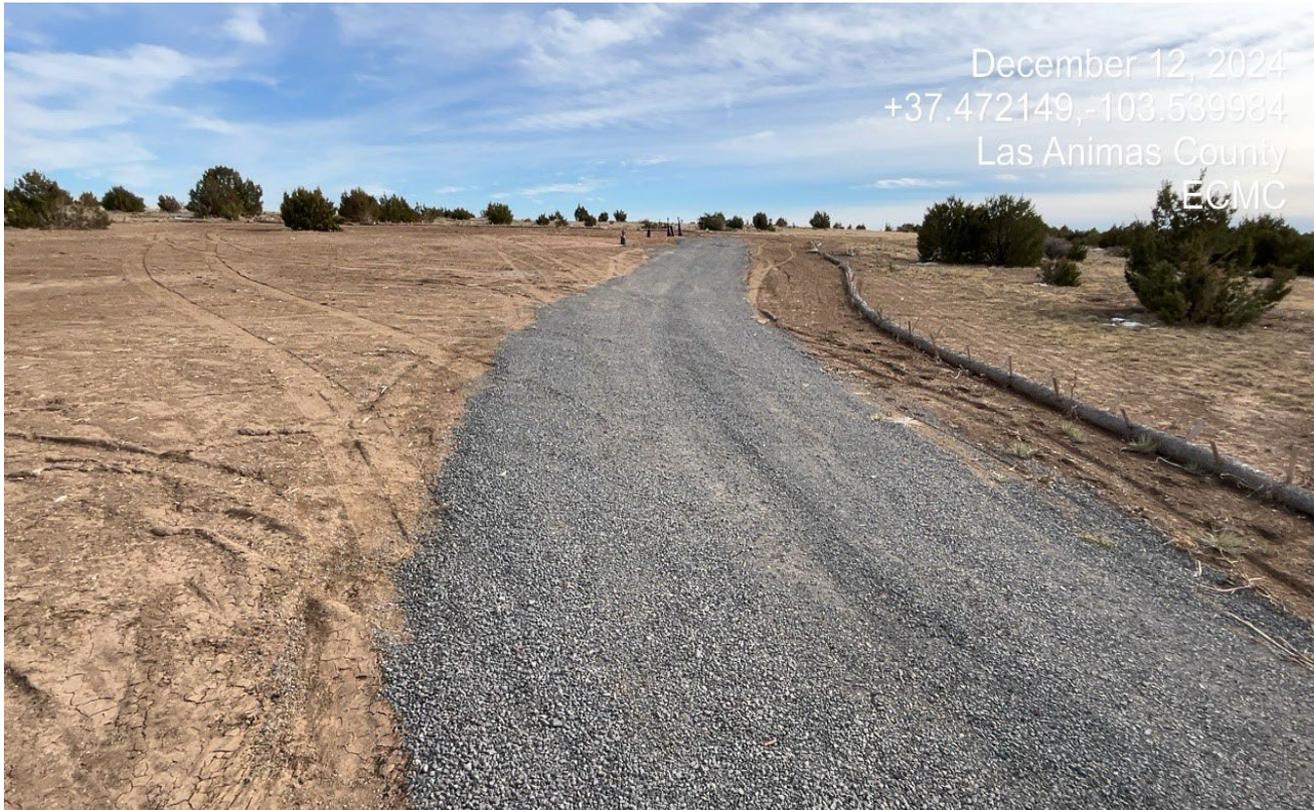
**Photo 1.** Facing southeast toward the wellsite.

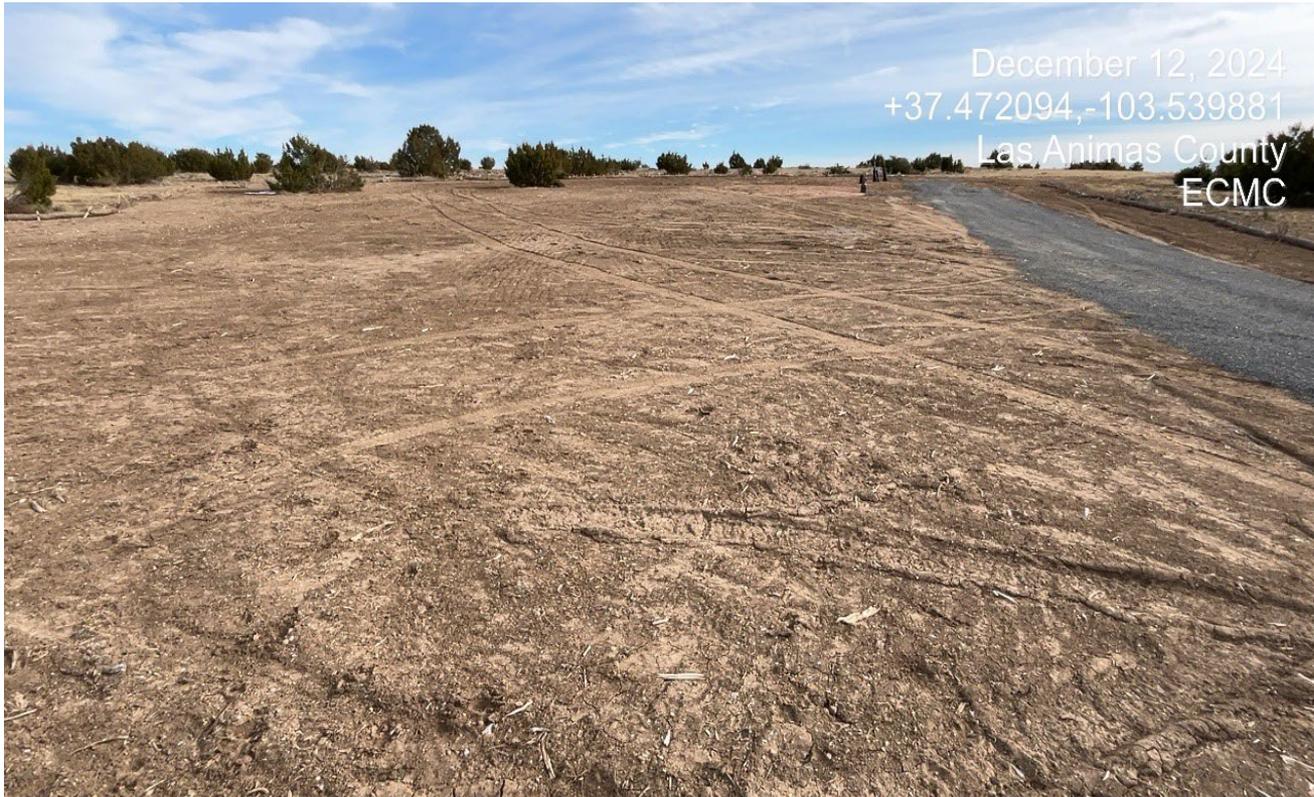
**Photo 2.** Facing southeast. The vegetation is not establishing at the location and soils are not stabilized.

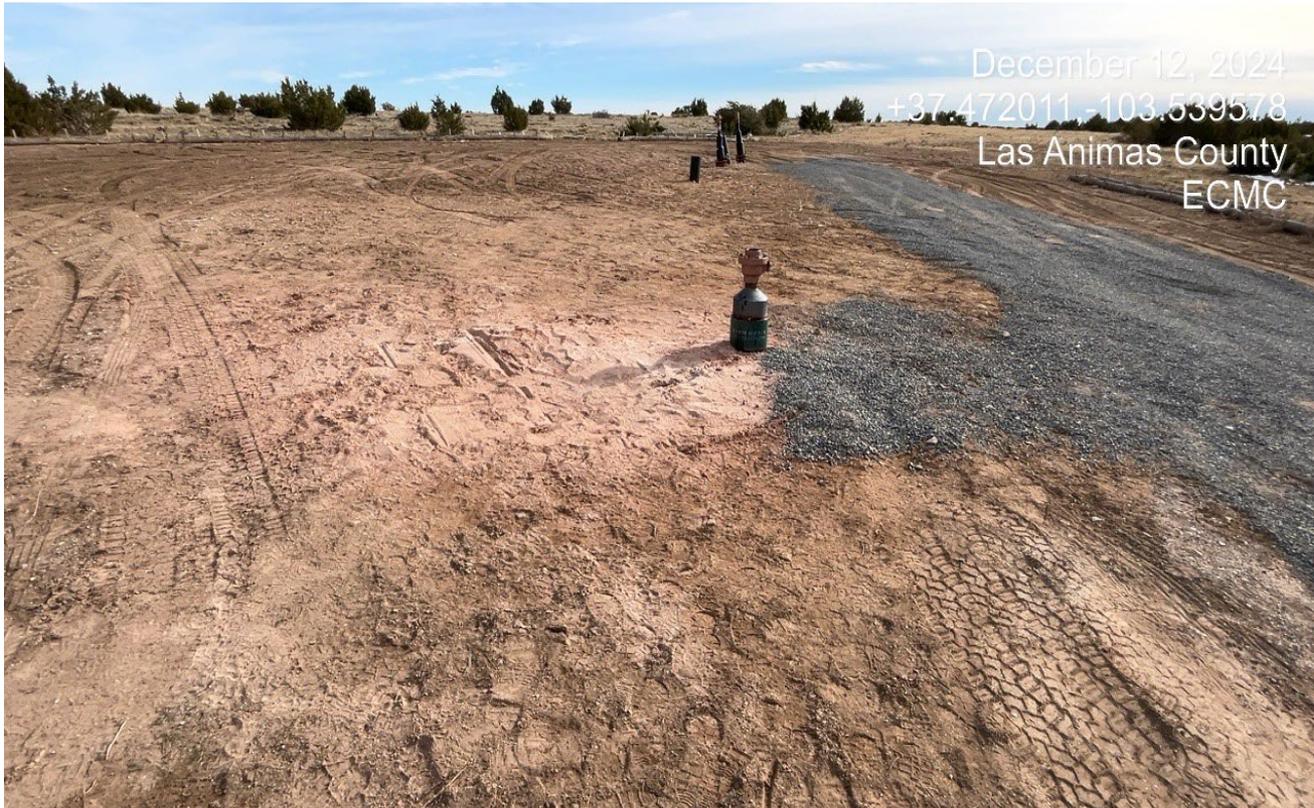
**Photo 3.** Facing toward the wellsite. It appears recent drilling work was performed at the location and red cuttings were left behind around the wellhead. E&P waste was not properly managed. The fencing and sign were removed from the well.

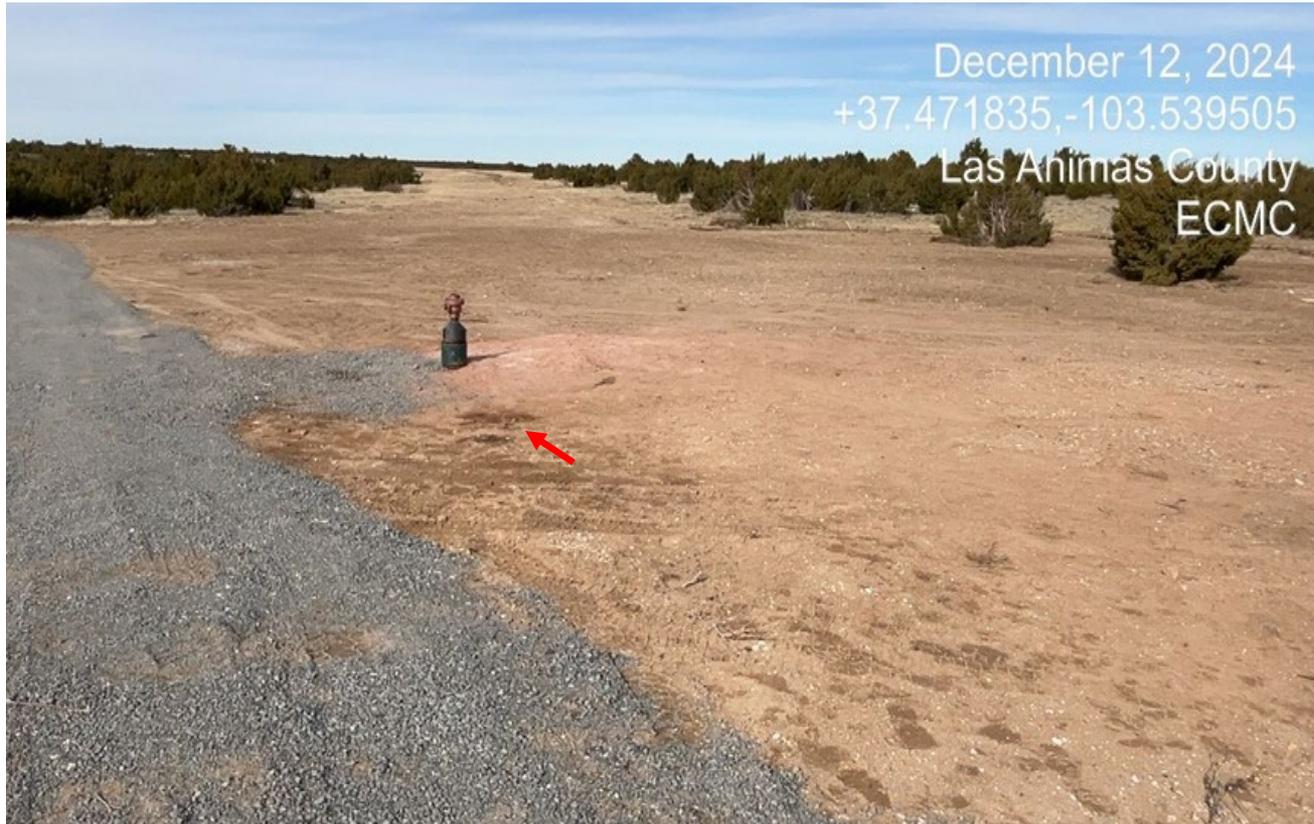
**Photo 4.** Facing north toward the wellsite. It appears recent drilling work was performed at the location and red cuttings were left behind around the wellhead. E&P waste was not properly managed. There is also oil stained soil at red arrow.

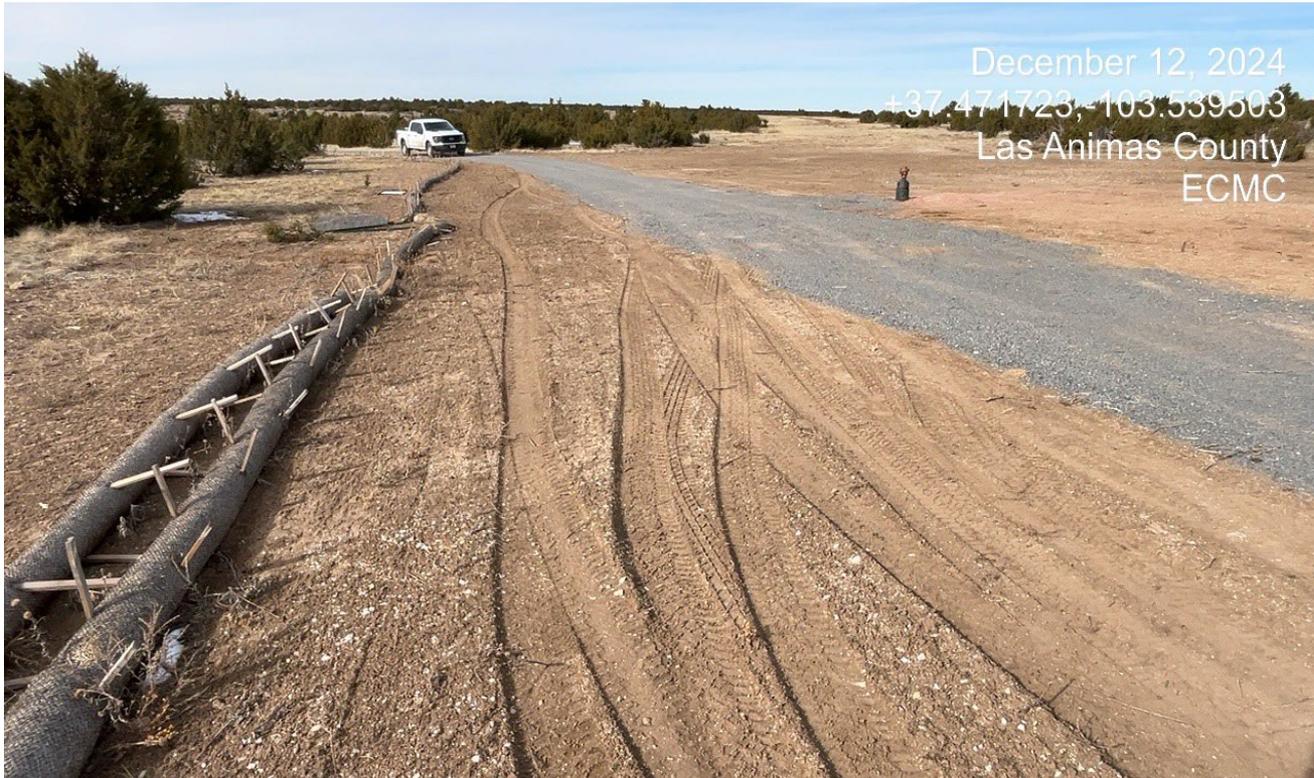
**Photo 5.** Facing north at the location. The wattles at left side of the photo are not installed.
