Catamount Energy Partners
Cox 2
Inspection 708700072 Remedial Report

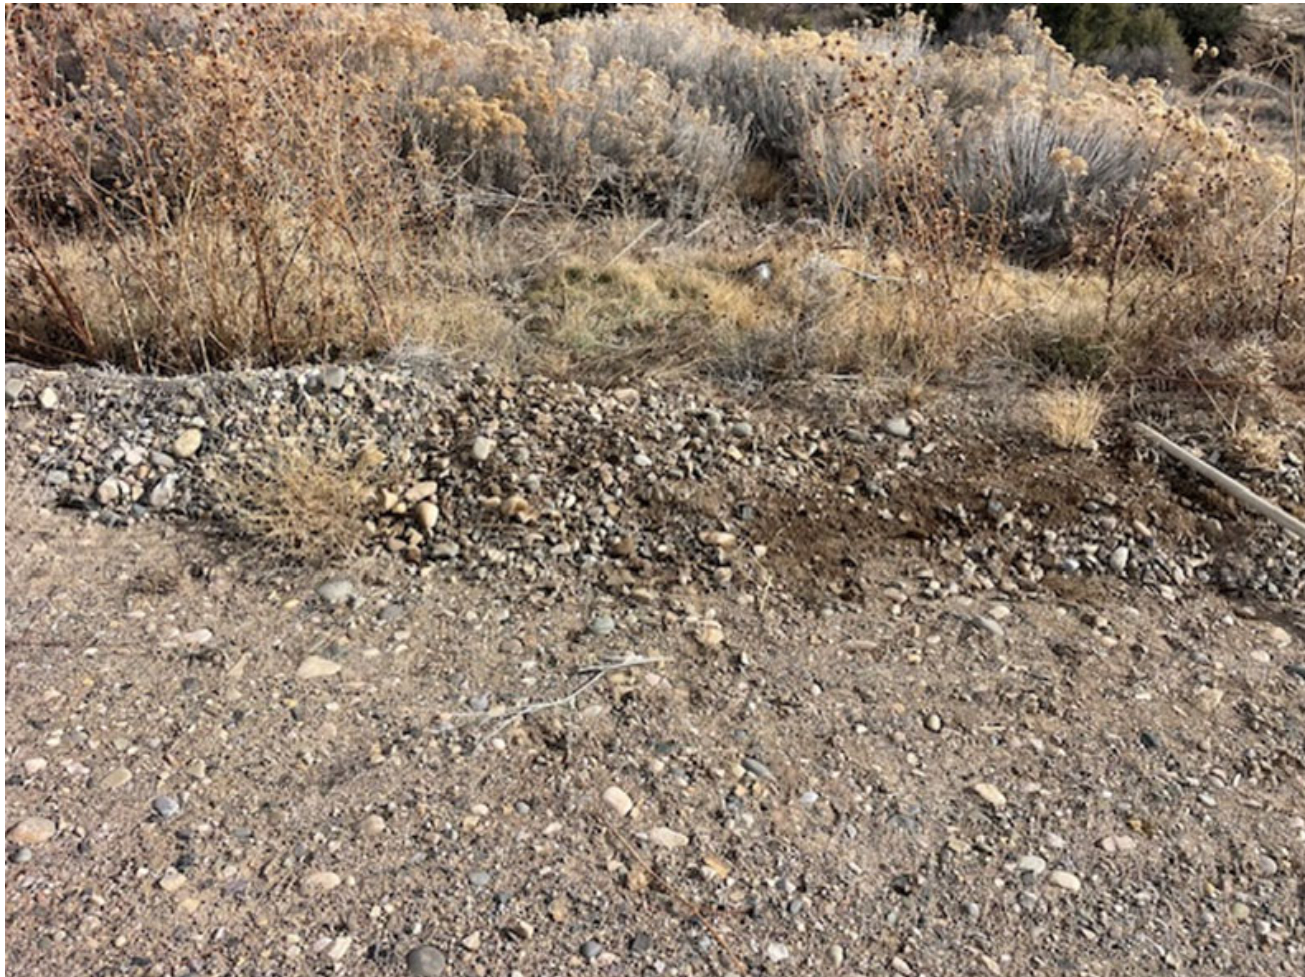
Comment: [Hole in stormwater berm on east side of well pad. See attached photos.](#)

Corrective Action: [Repair hole in stormwater berm](#)

Action Taken: Repaired hole in stormwater berm
