**Antler Energy LLC  
Amoco-Federal 21-1  
Location ID: 312970**

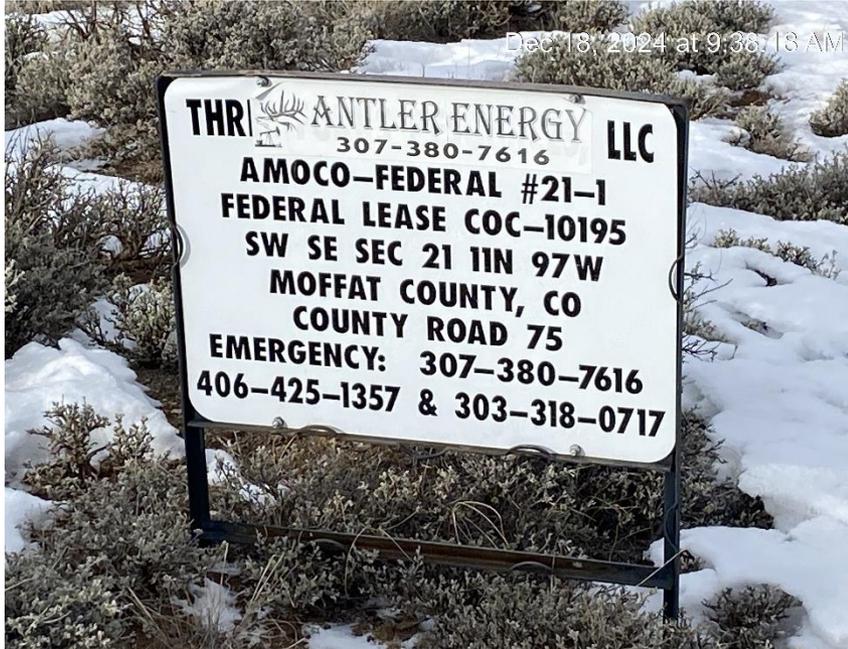
**When replaced additional information is required**

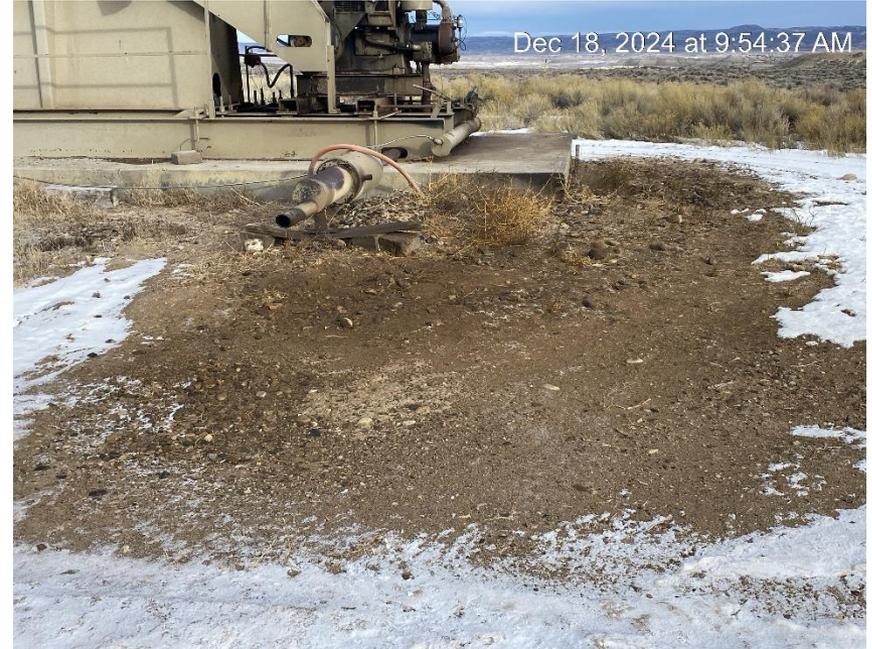
**Soil staining**

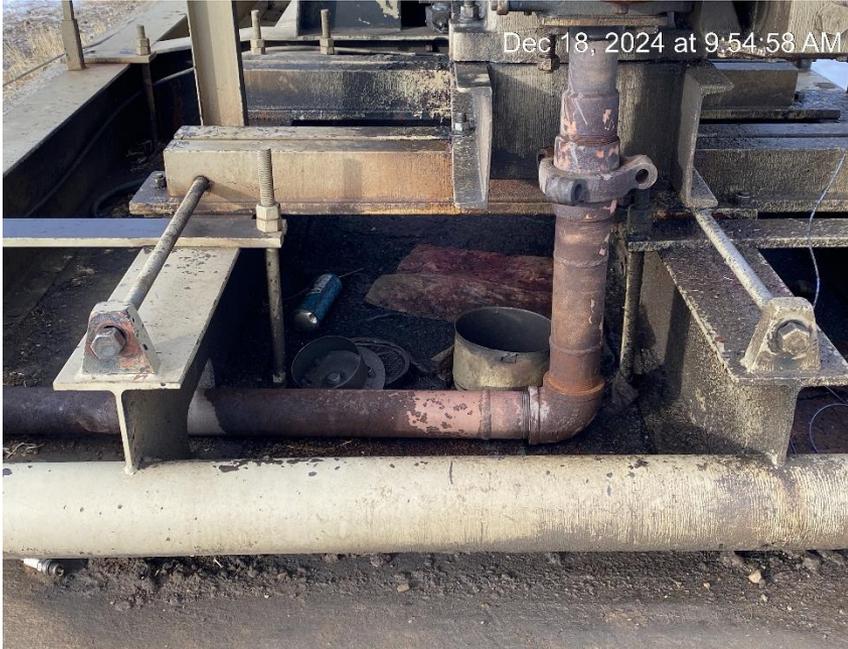
**Oily waste and debris**

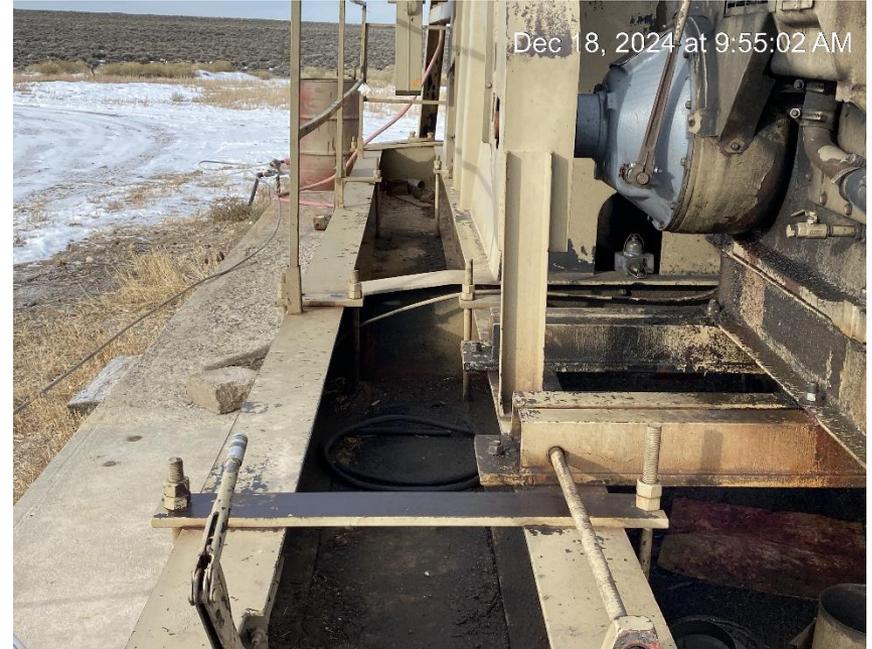
**Oily waste and debris**

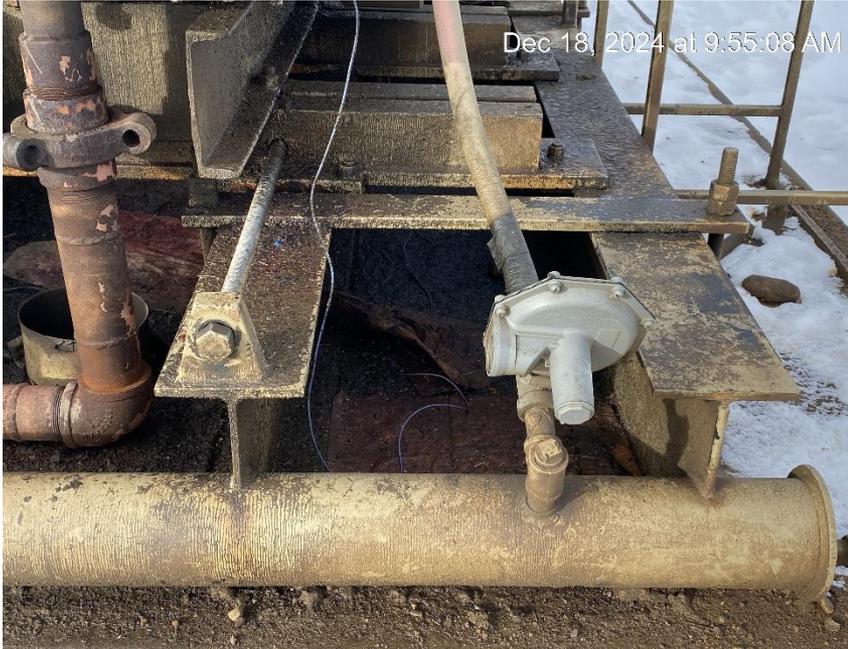
**Oily waste and debris**

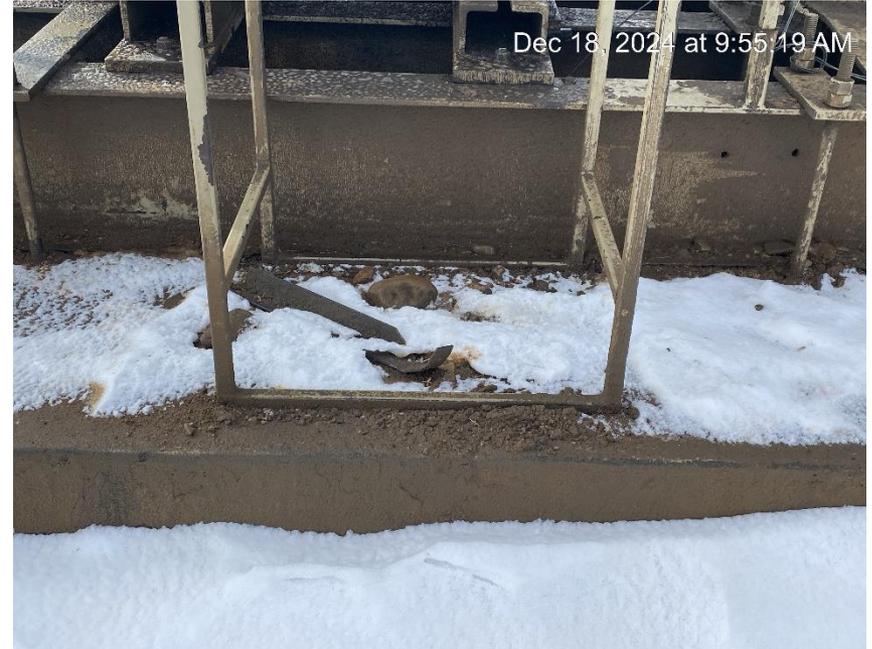
**Debris**

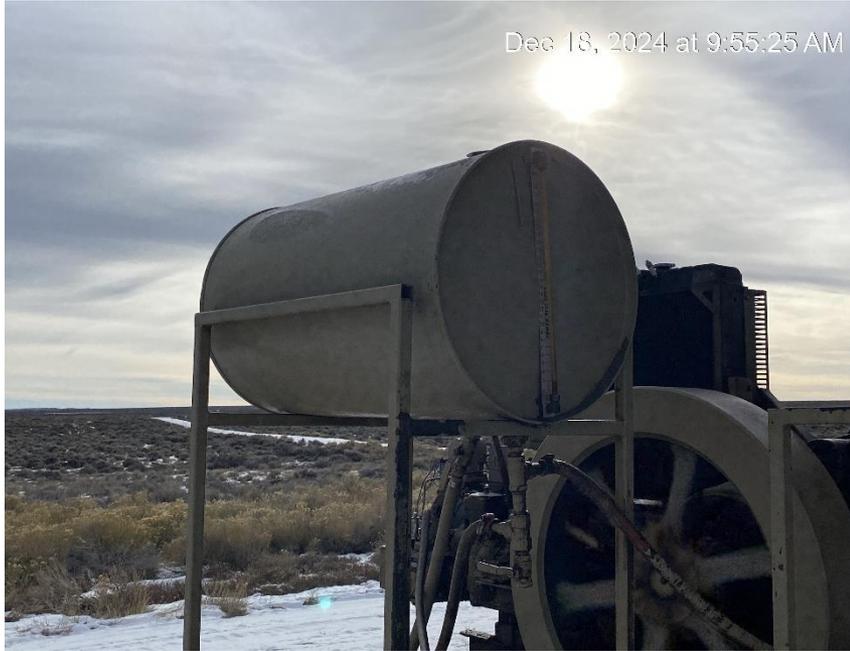
**Unlabeled tank**

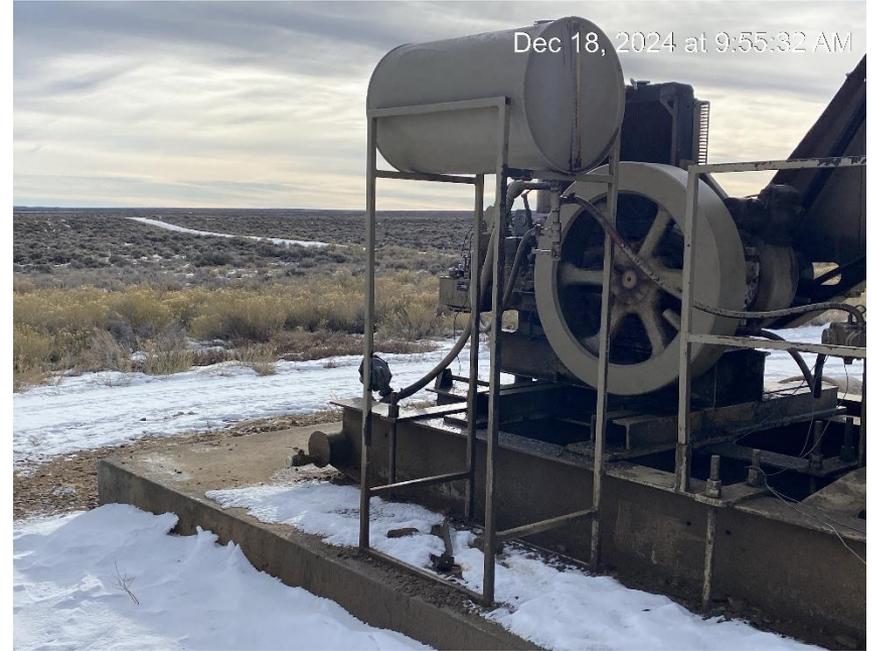
**No spill containment**

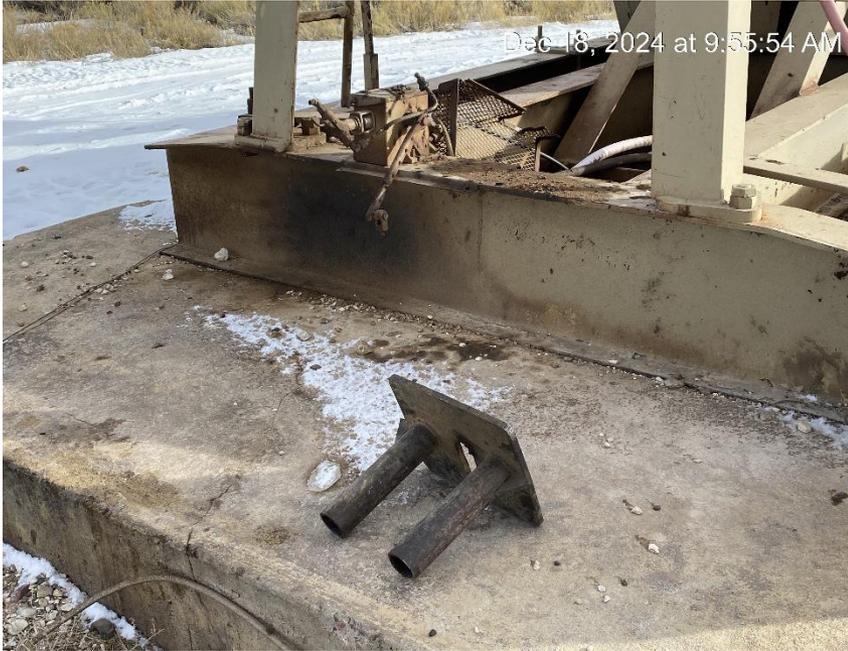
**Debris**

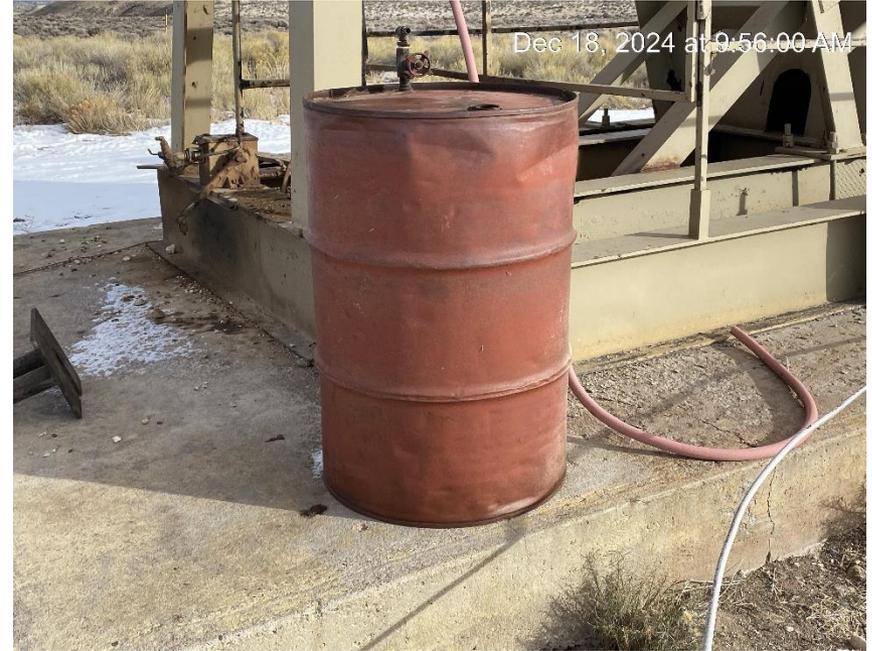
**Unlabeled debris**

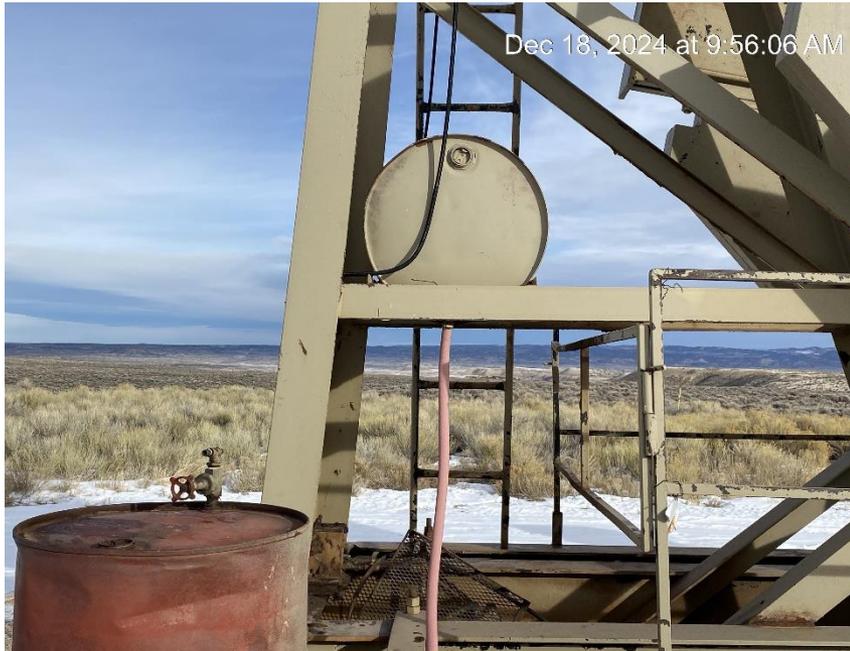
Unlabeled debris

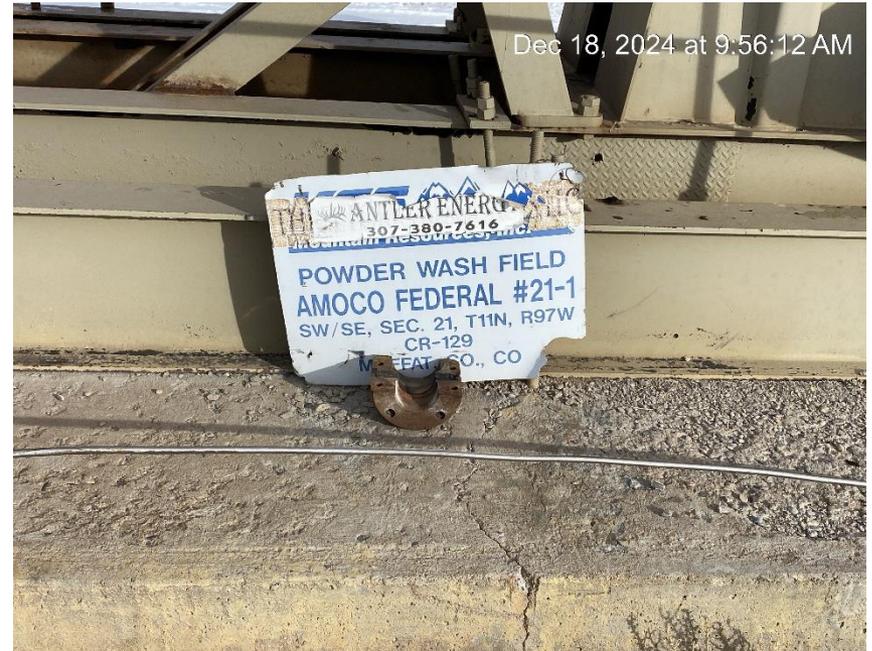
Missing required information

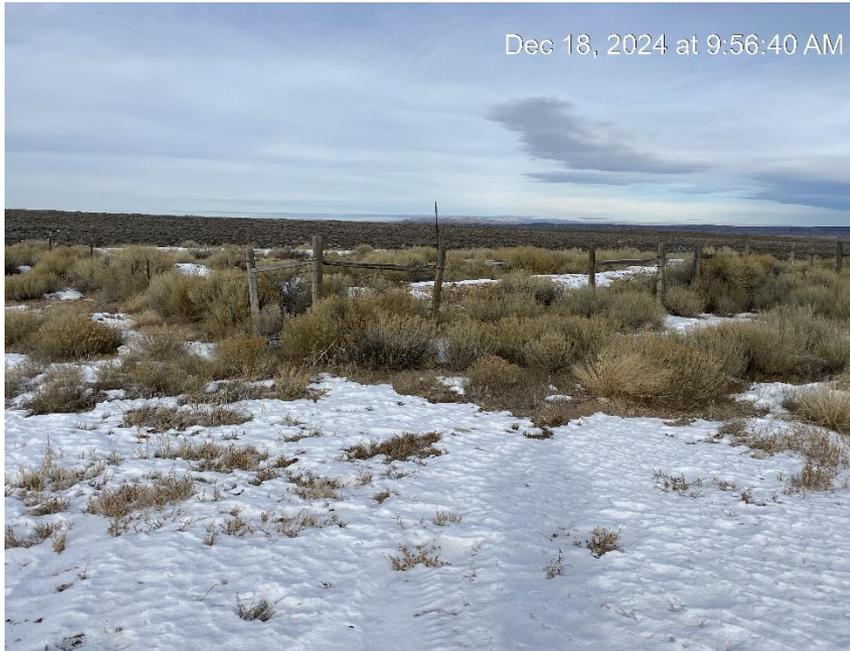
**Unregistered pit**

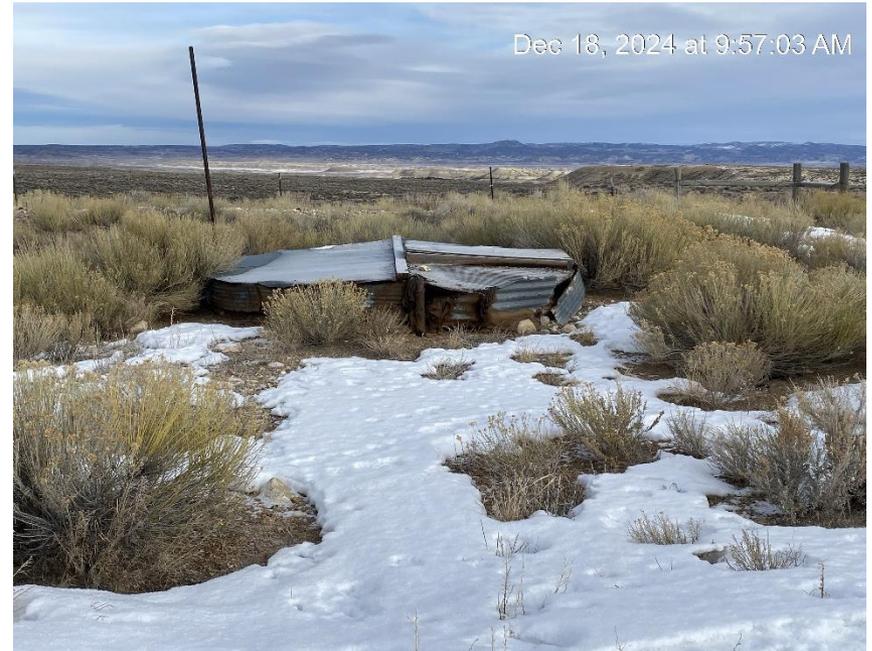
**Unregistered pit**

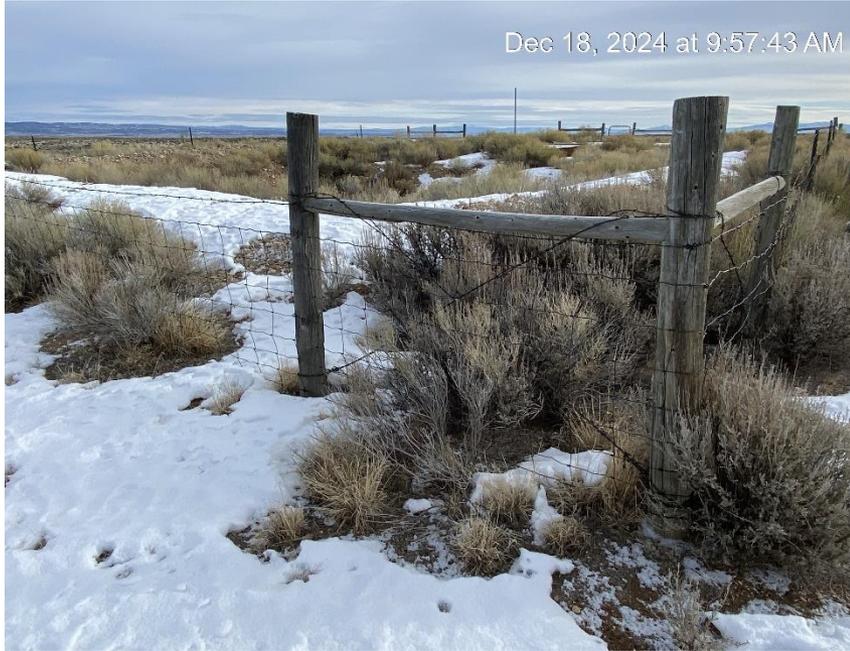
**Unregistered pit**

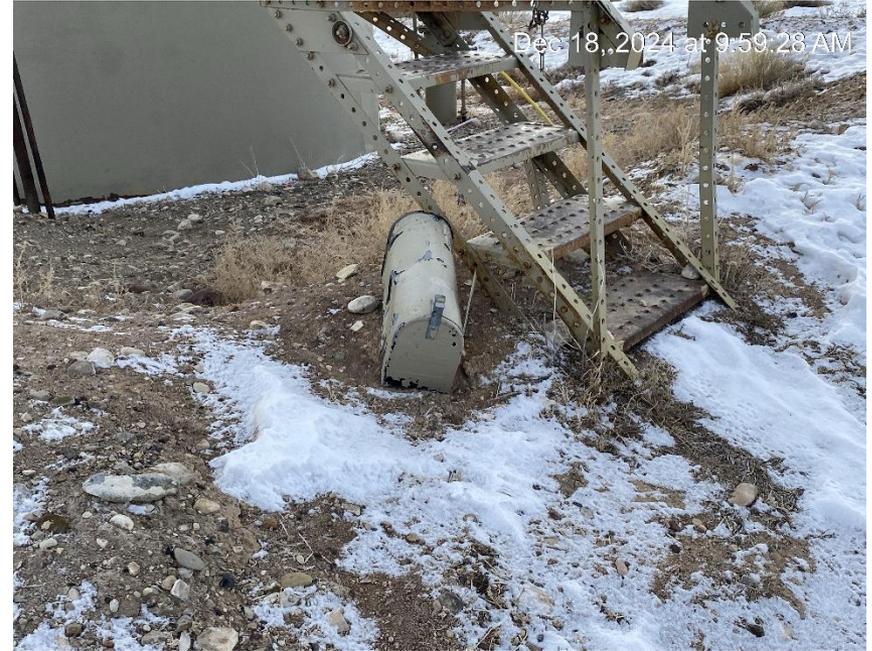
**Debris**

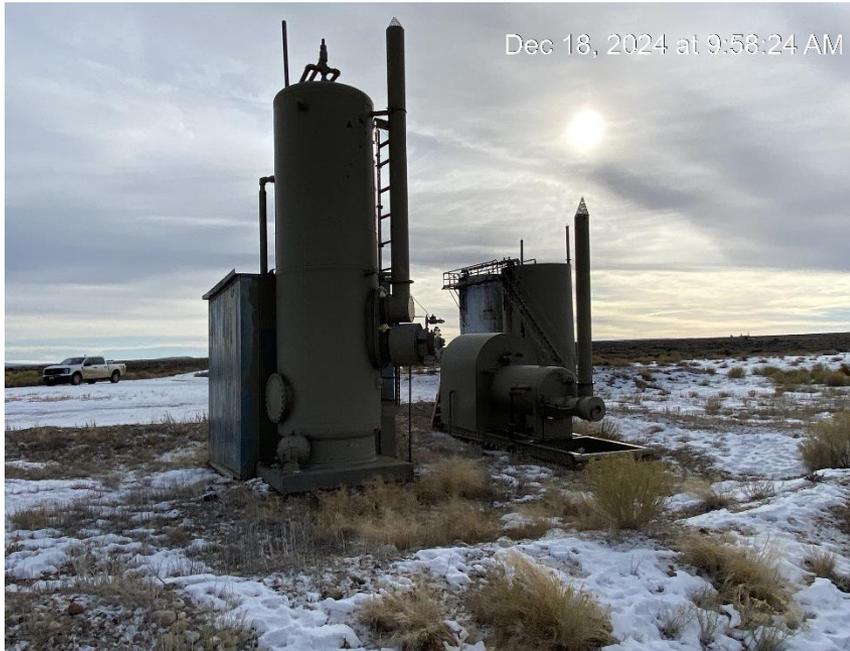
**Equipment out of service**

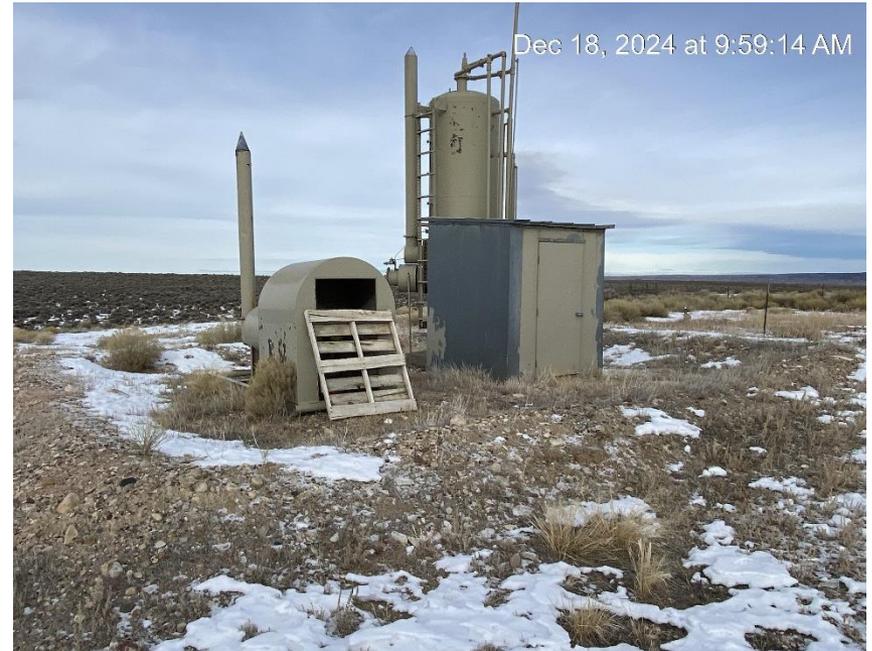
**Equipment out of service**

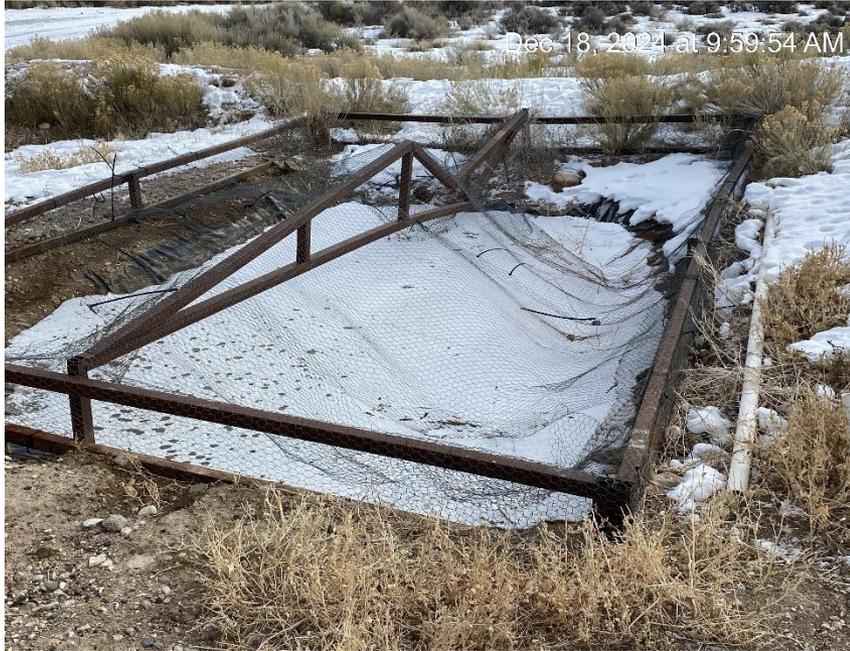
**Pit open to wildlife**

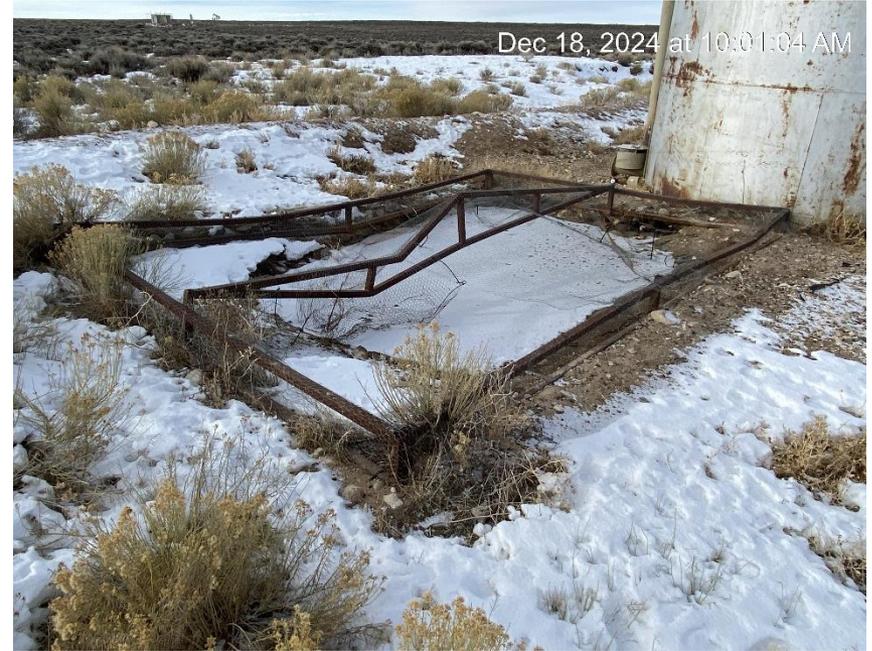
**Pit open to wildlife**

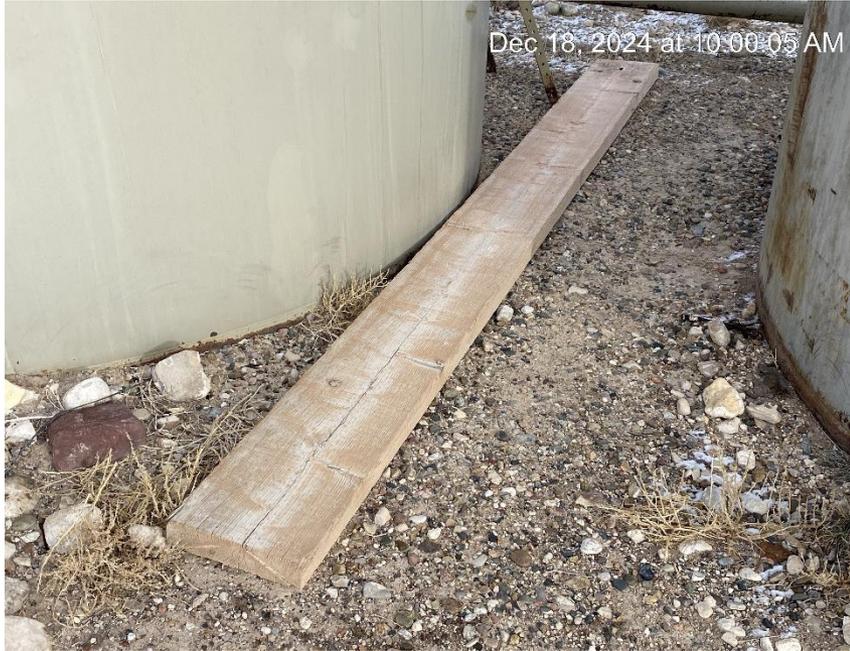
**Debris**

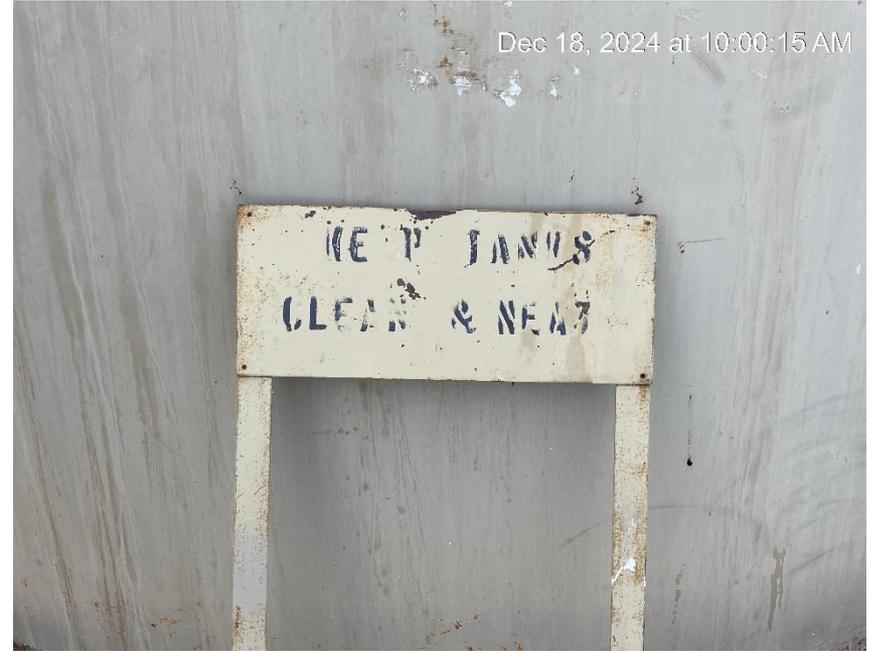
**Debris**

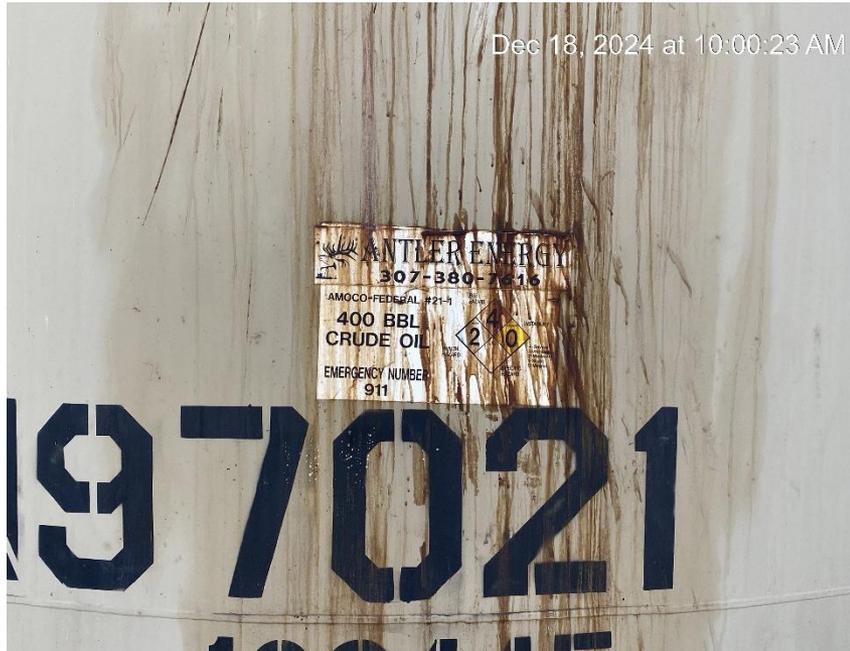
**Illegible label**

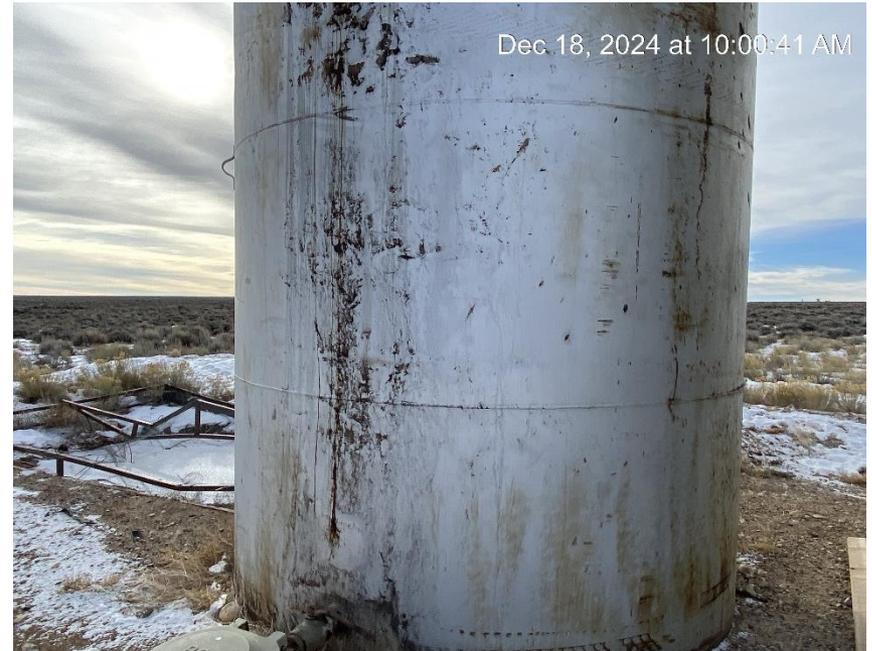
**Unlabeled production tank**

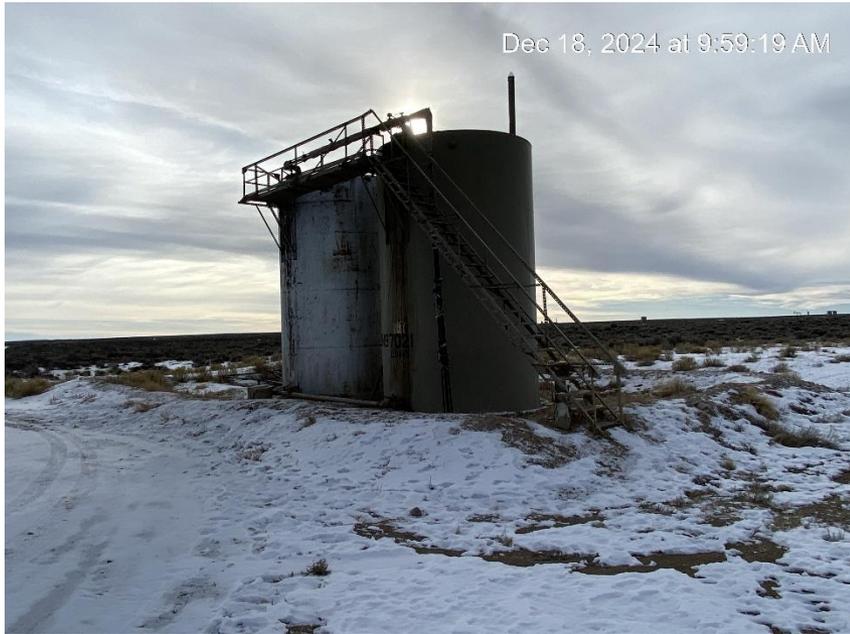
**No tank battery sign**
