Antler Energy LLC
Ross-Government-USA 43-7
Location ID: 312938

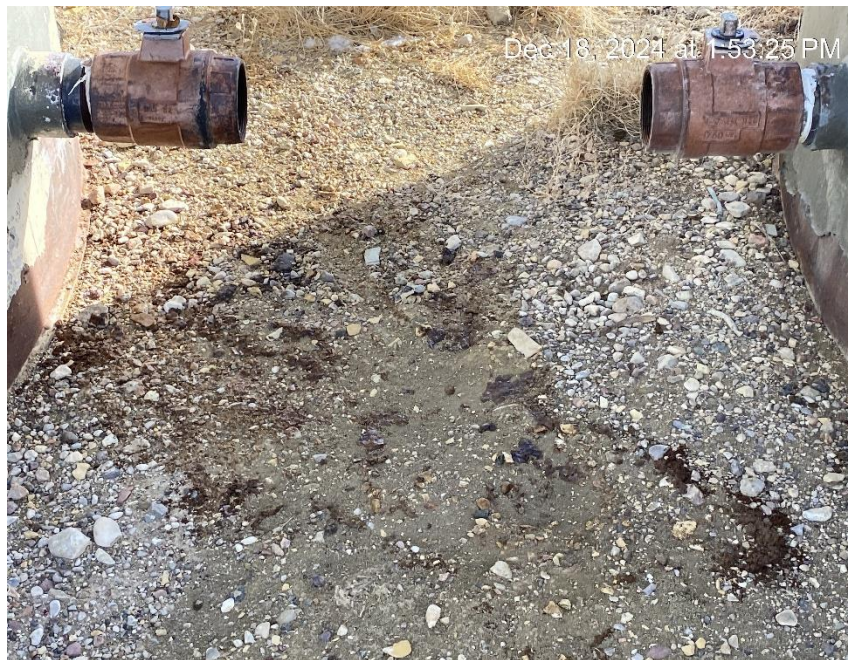
Open end tank valves. Oily waste and staining

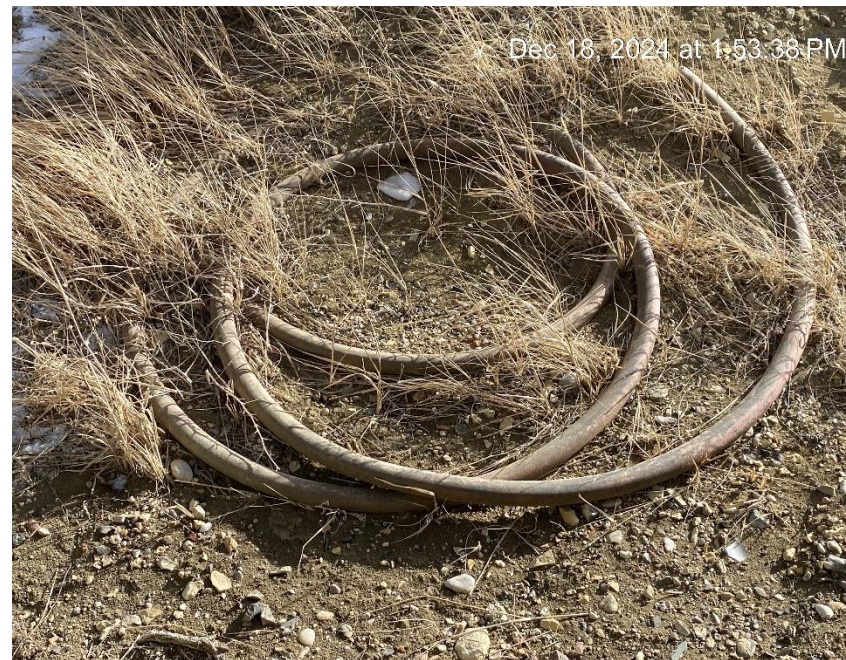
Debris.

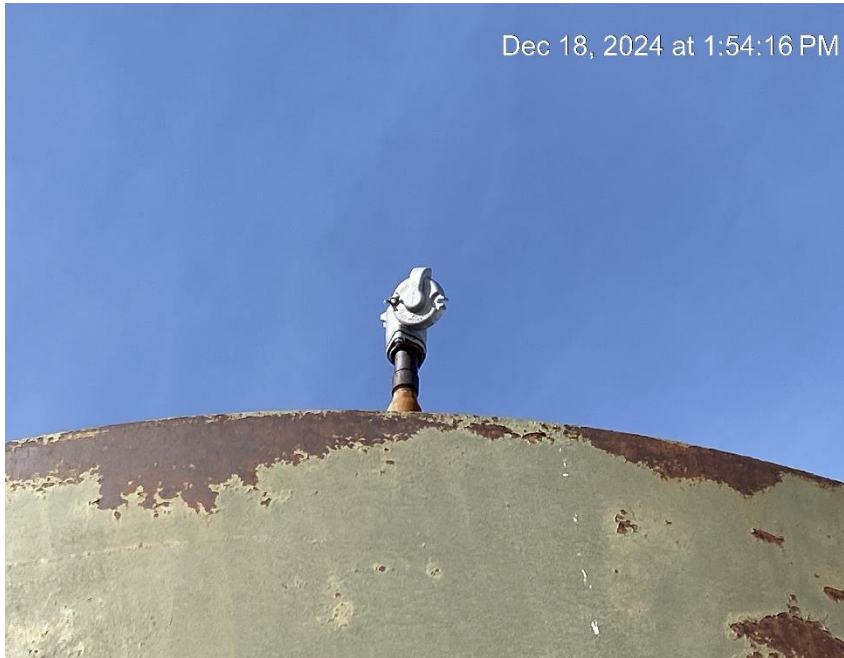
Valve needs repaired

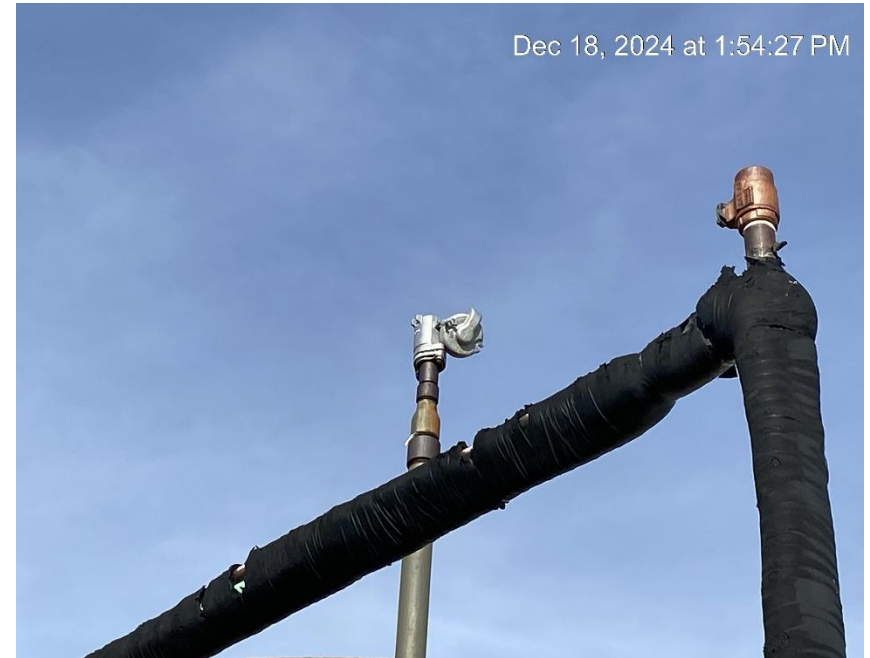
Valve needs repaired

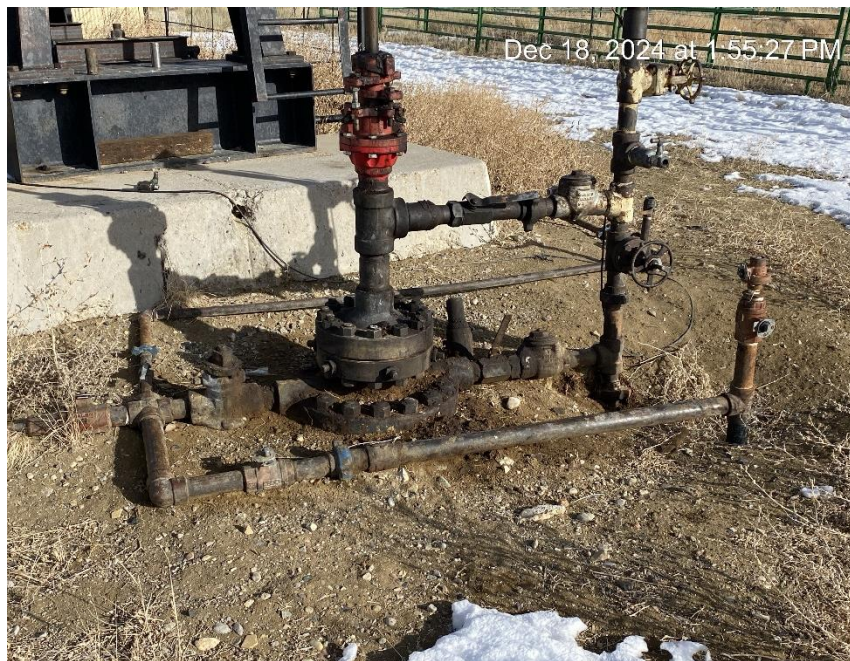
Oily waste and staining

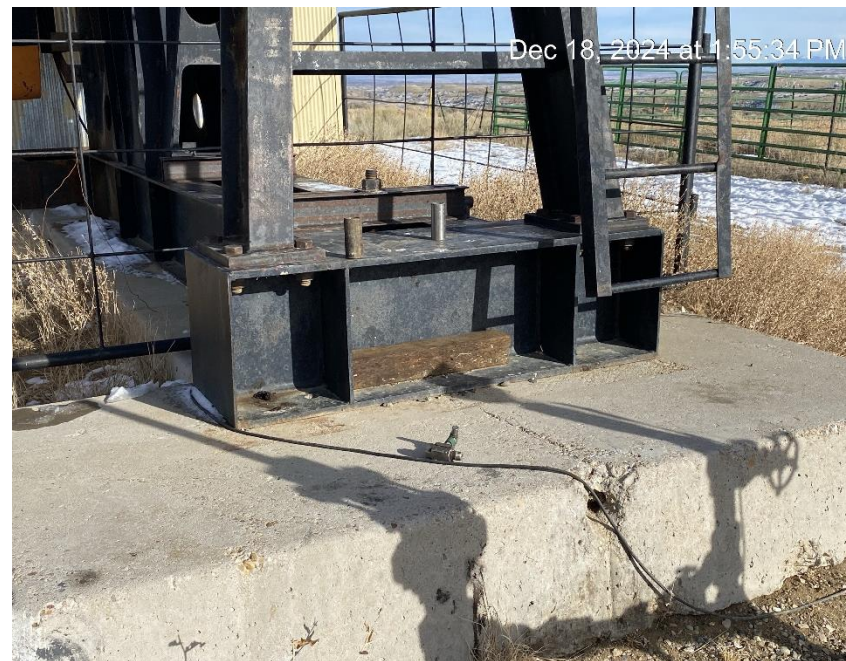
Debris

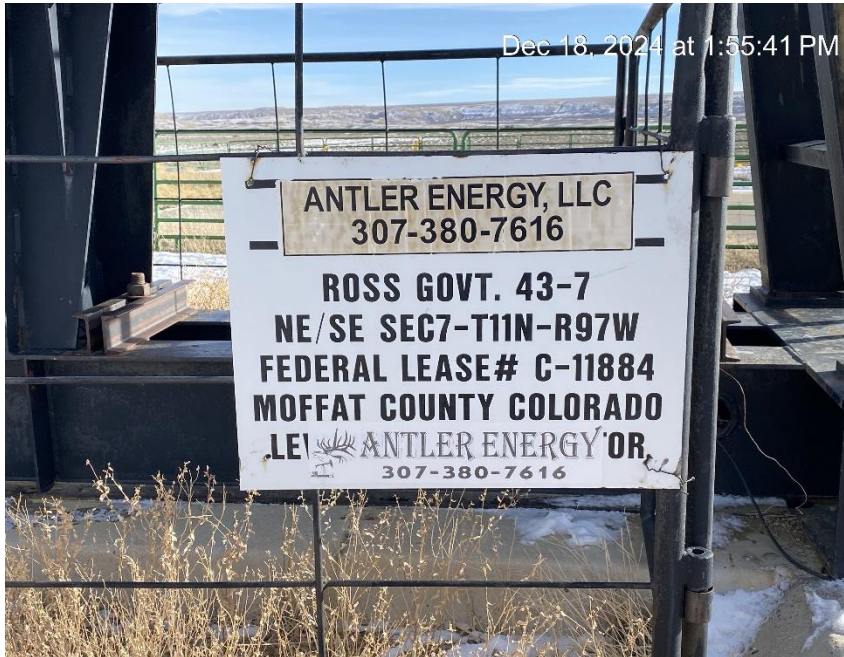
Missing required information

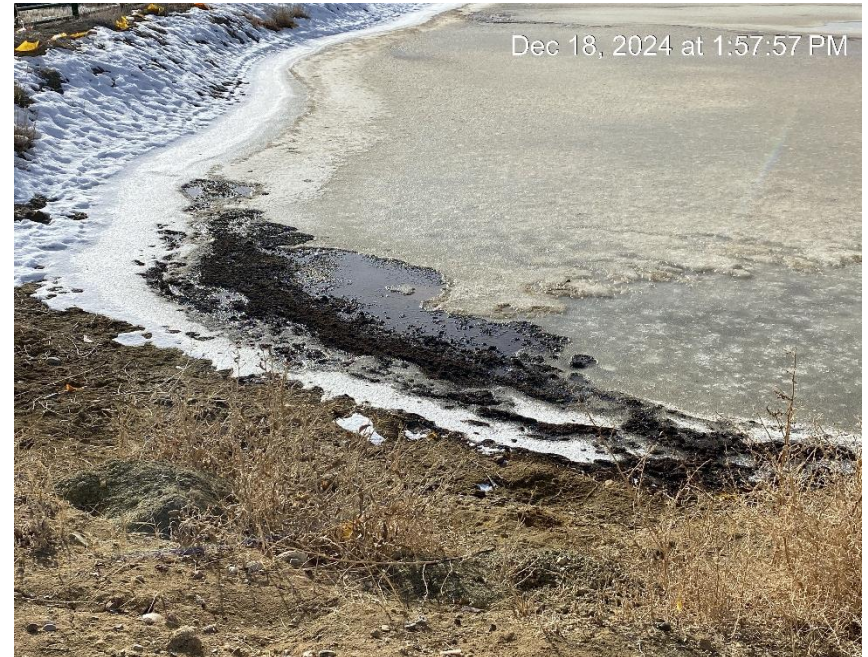
Hydrocarbon evidence on pit surface

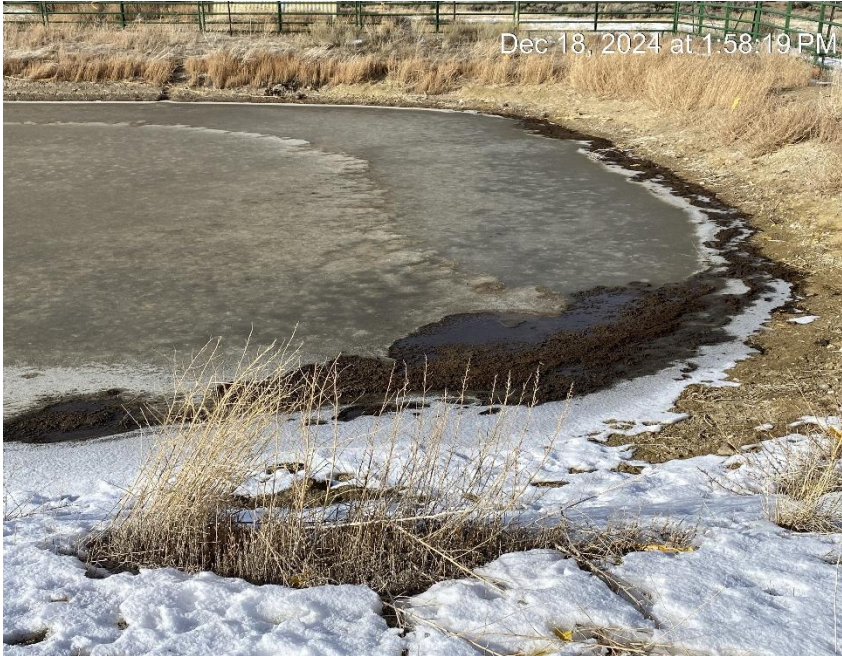
Hydrocarbon evidence on pit surface

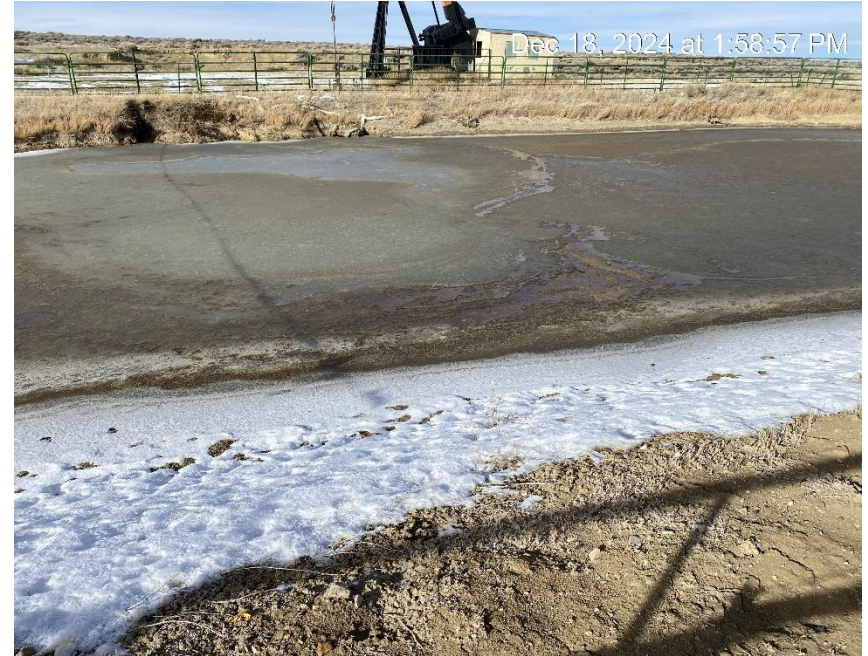
Hydrocarbon evidence on pit surface

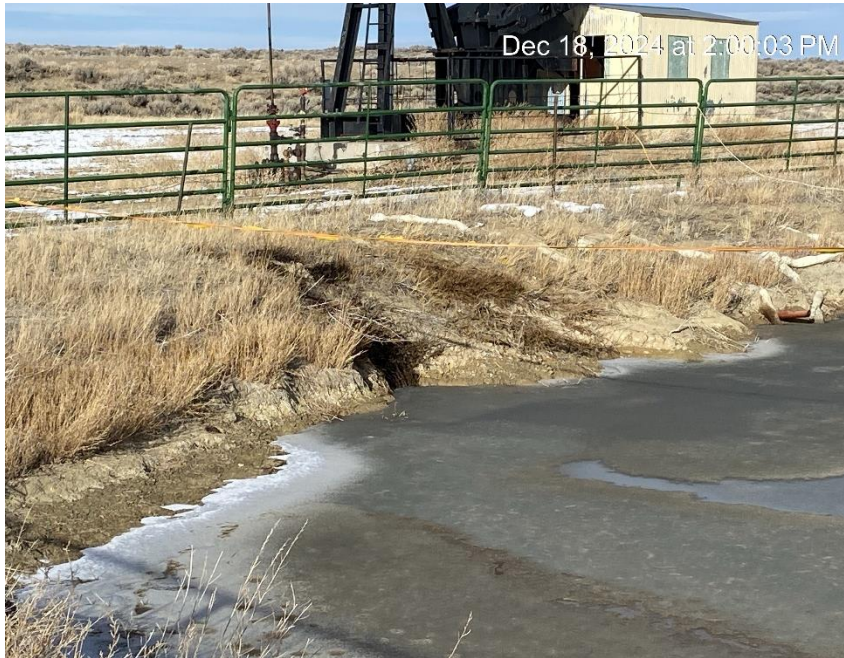
Staining

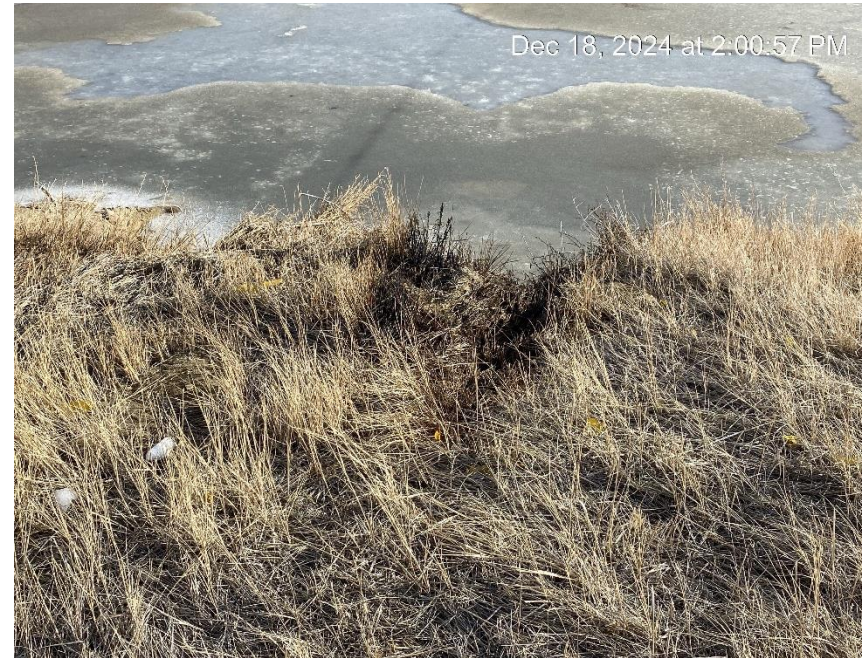
Staining

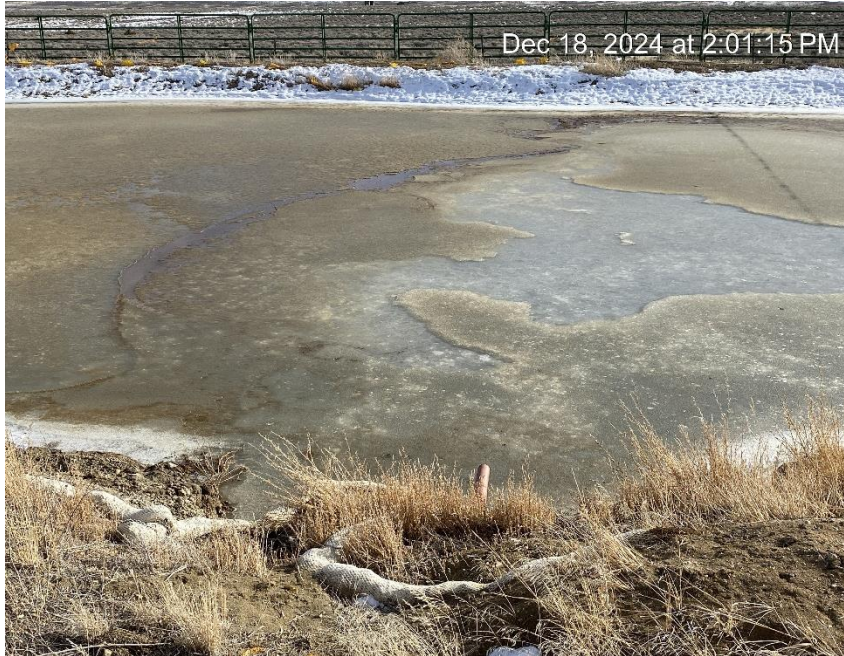
Hydrocarbon evidence on pit surface

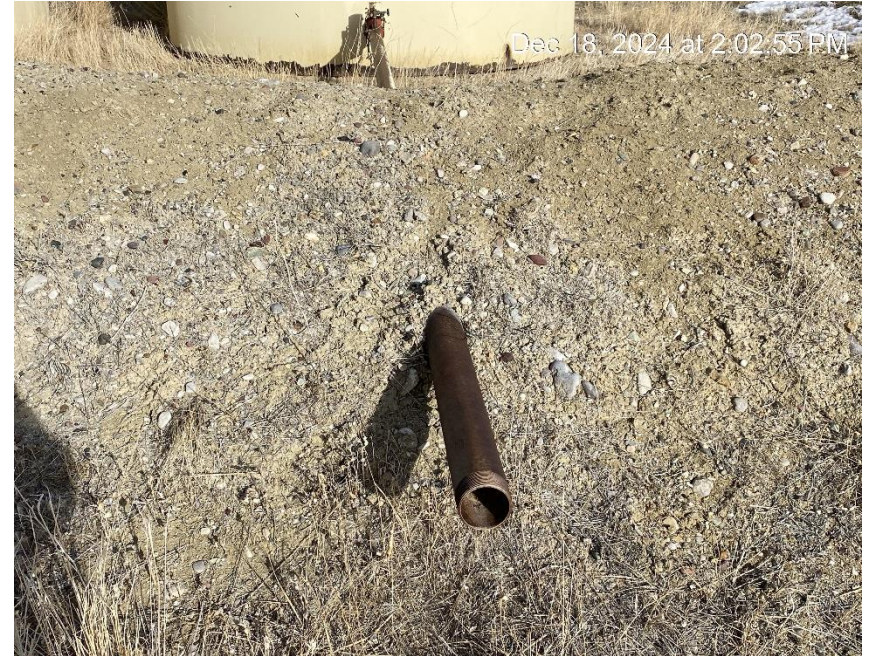
Open end load line

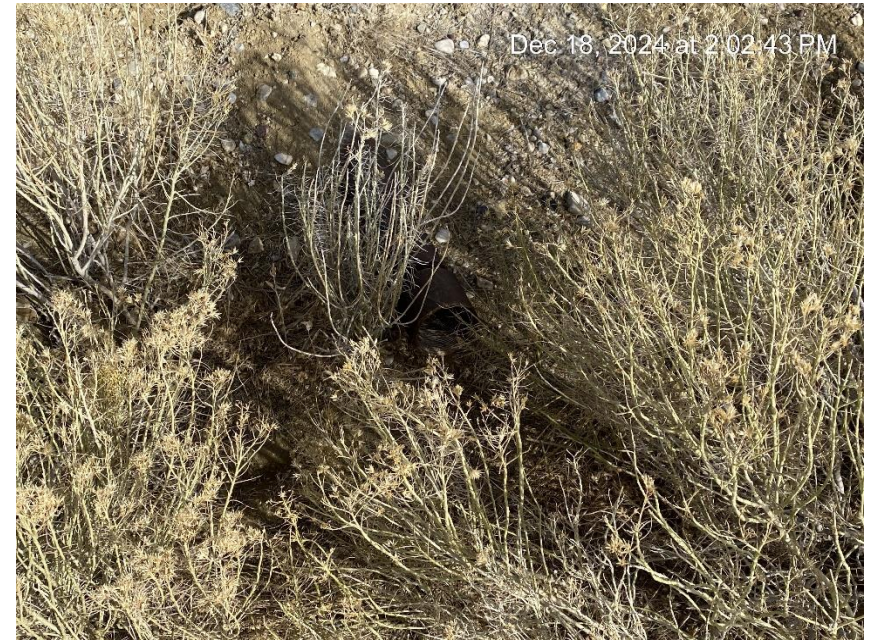
Open end load line

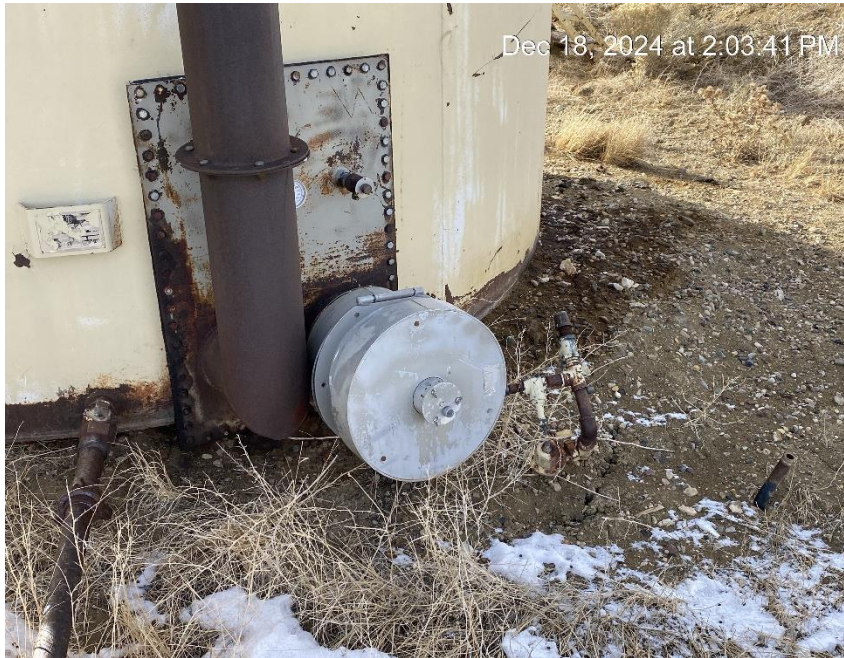
Stained soil

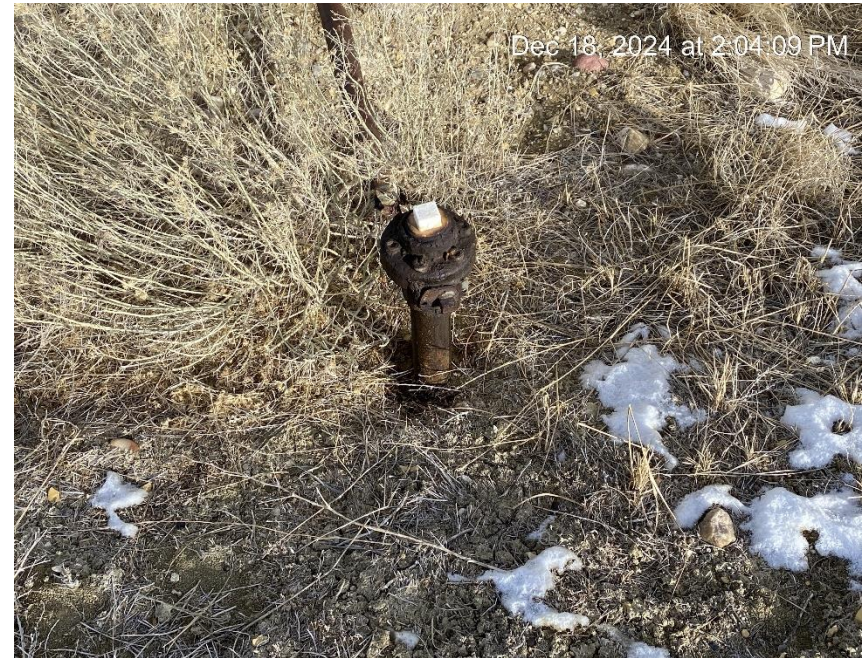
Staining

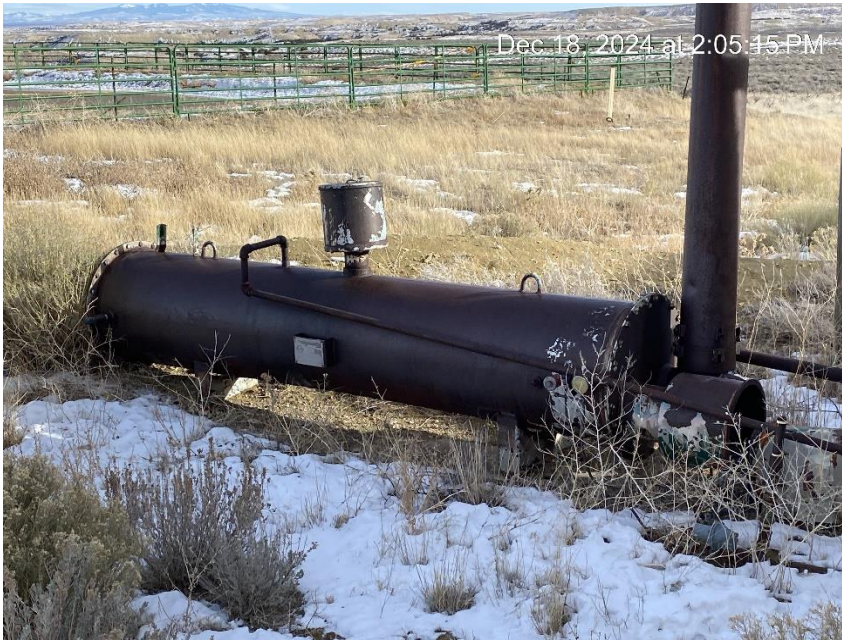
Debris. Unused equipment.

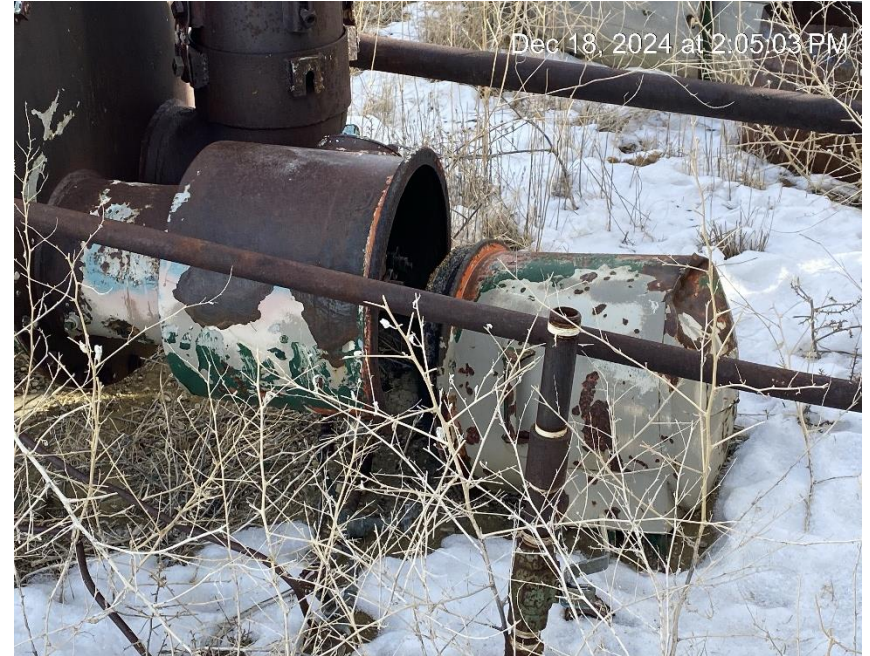
Open to wildlife

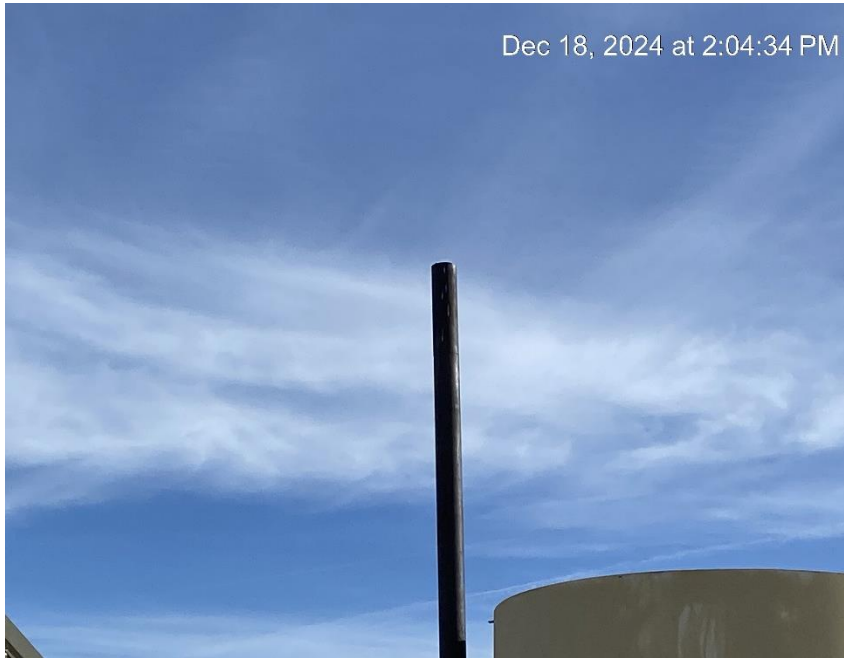
Missing bird protection
