Inspection Photos

Location Name: TEP ROCKY MOUNTAIN LLC SPECIALTY 34A-20-692 Pad

Location #: 335470

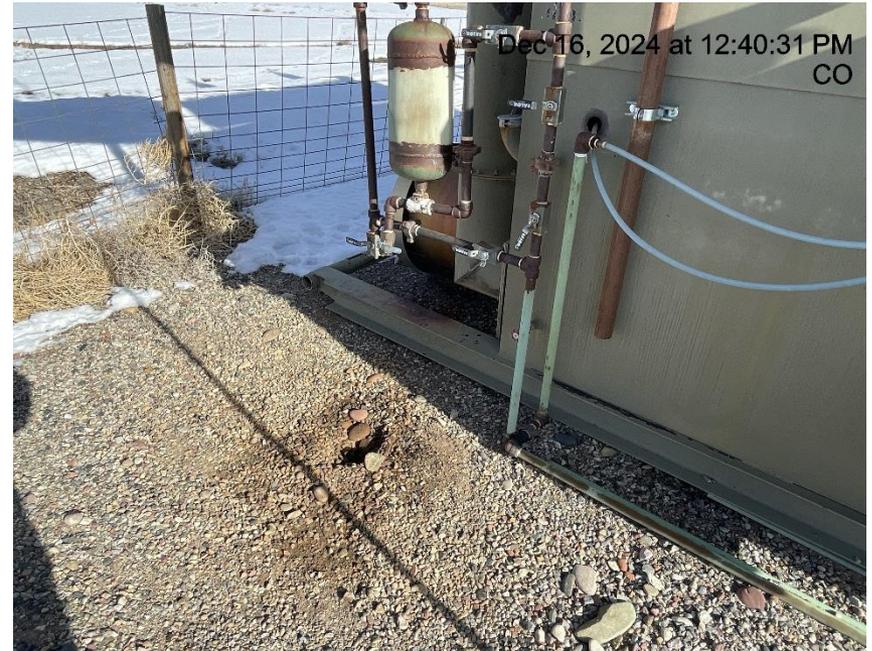
Photo # 3748 Staining near separator

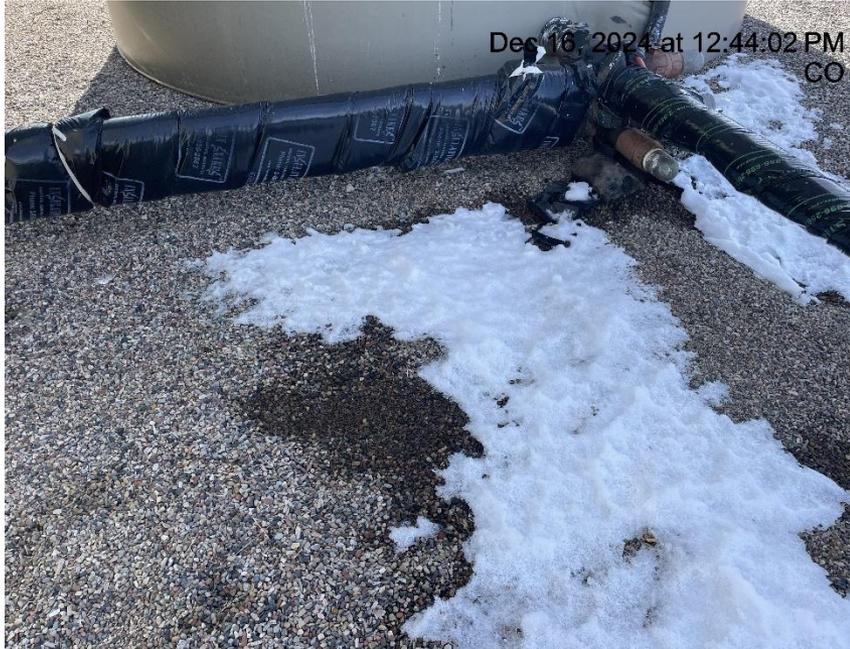
Photo # 3749 Staining in secondary containment

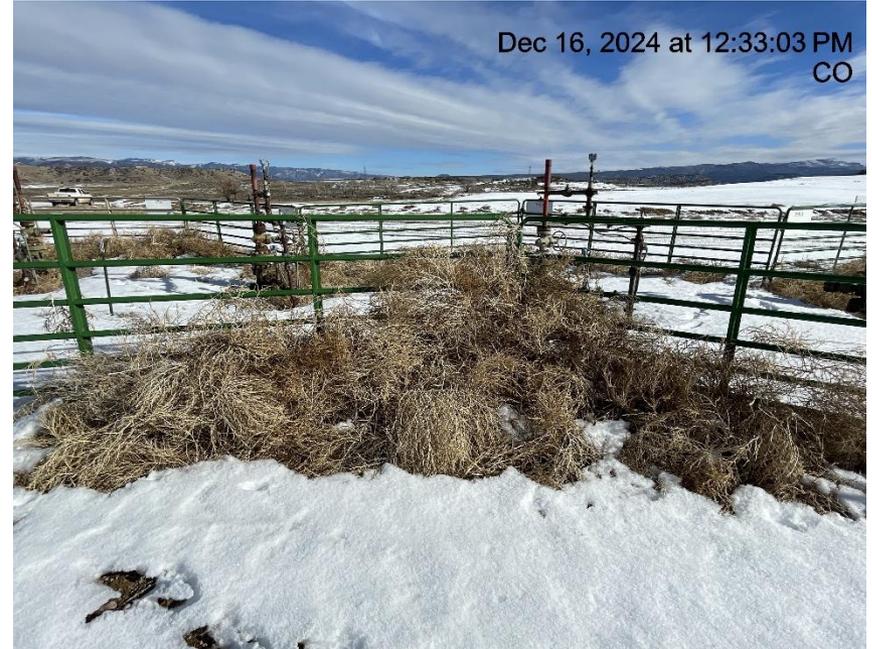
Photo # 3750 Dead weeds/debris

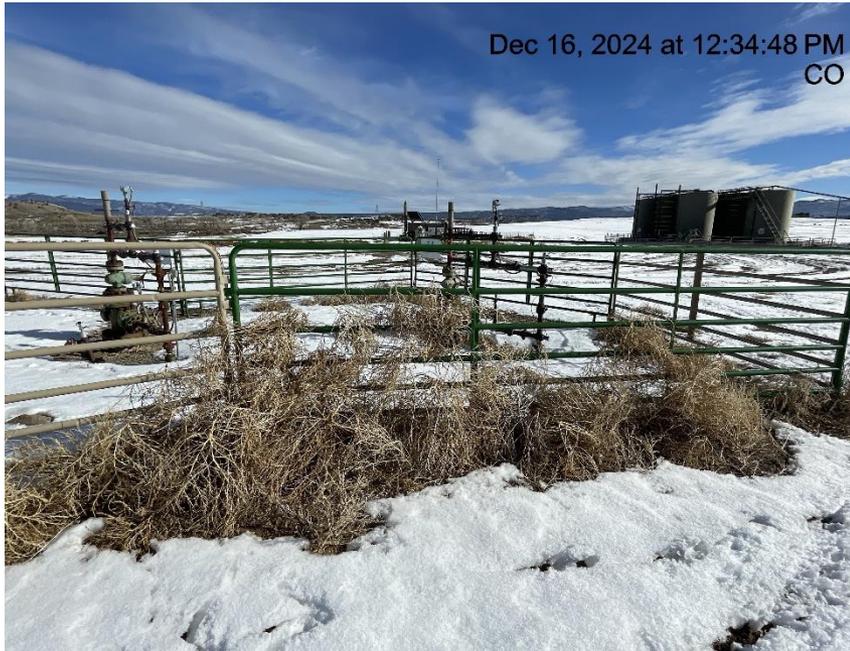
Dec 16, 2024 at 12:34:48 PM
CO

Photo # 3751 Dead weeds/debris

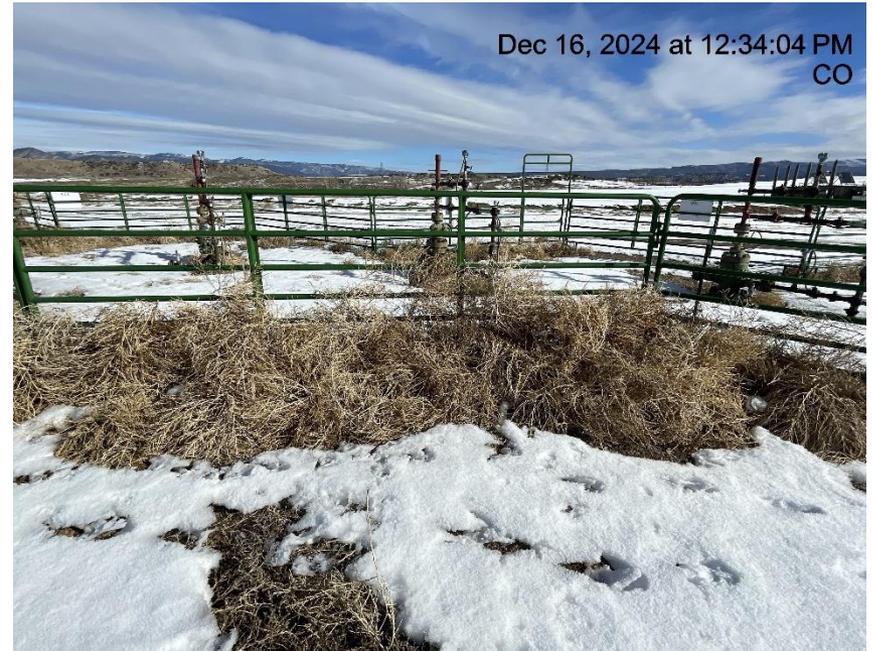
Dec 16, 2024 at 12:34:04 PM
CO

Photo # 3752 Dead weeds/debris

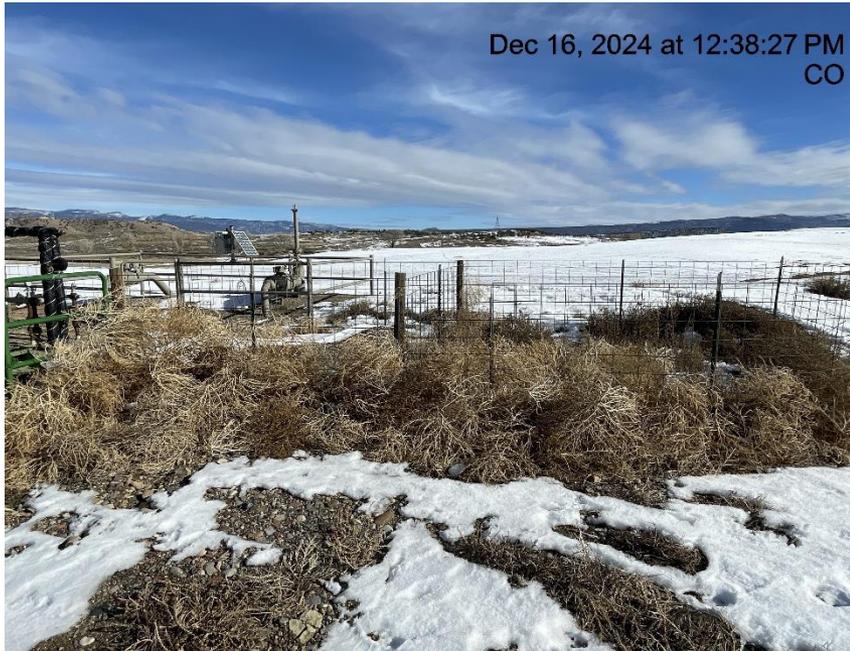
Photo # 3753 Dead weeds/debris

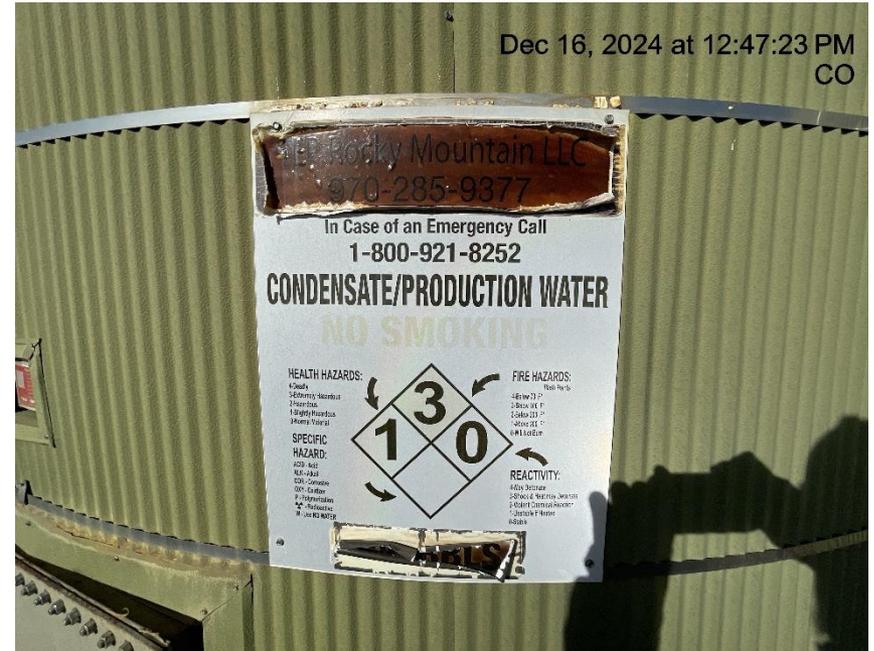
Photo # 3754 Tank label weathered & some required info is illegible

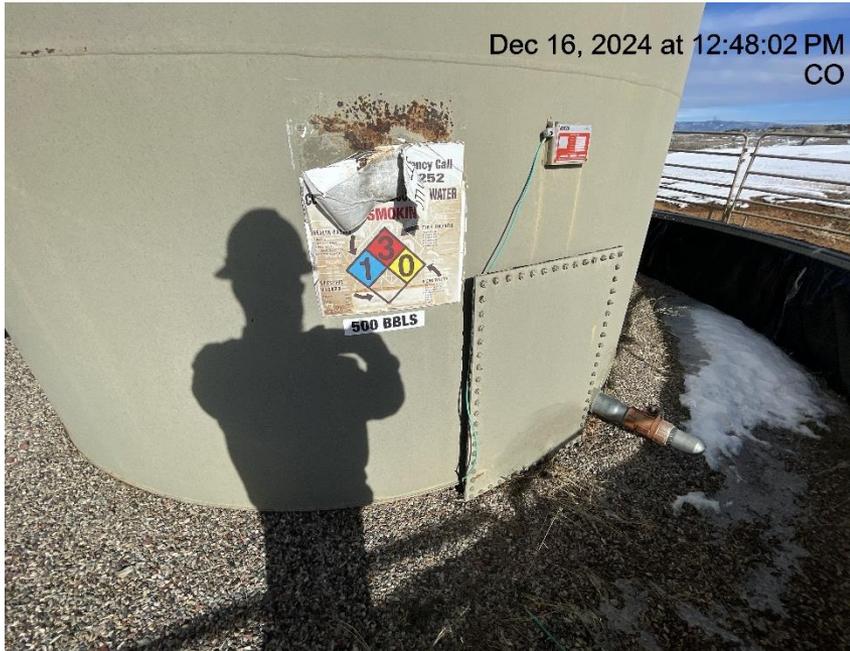
Photo # 3755 Tank label damaged & some required info is illegible

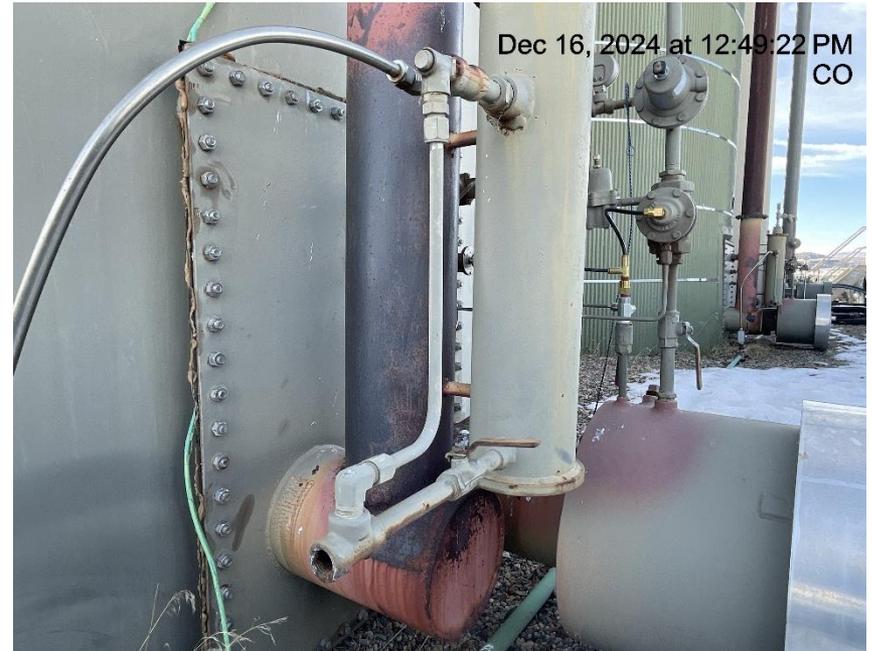
Photo # 3756 PRV vent line on tank burner does not comply with CECCM pressure safety device rules

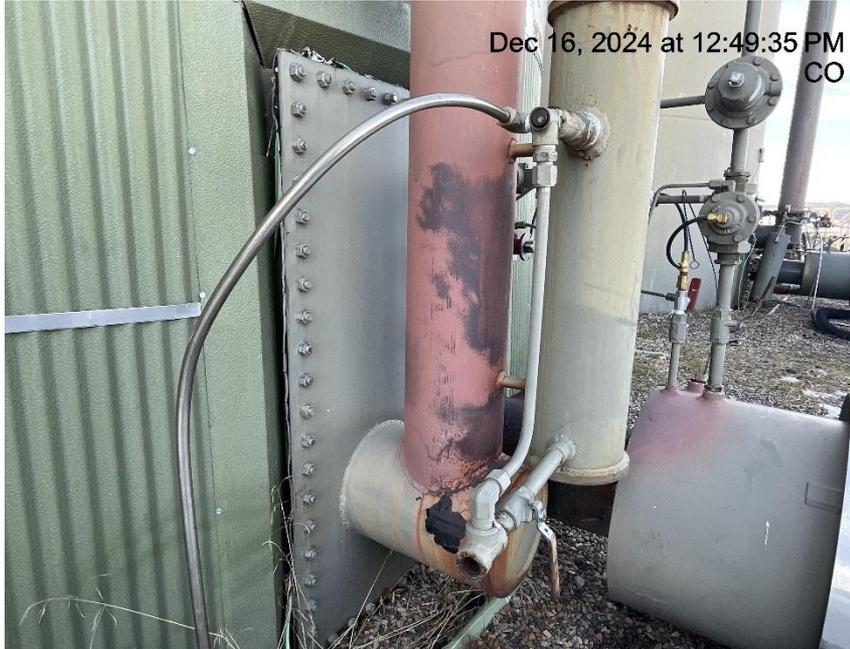
Photo # 3757 PRV vent line on tank burner does not comply with CECMC pressure safety device rules

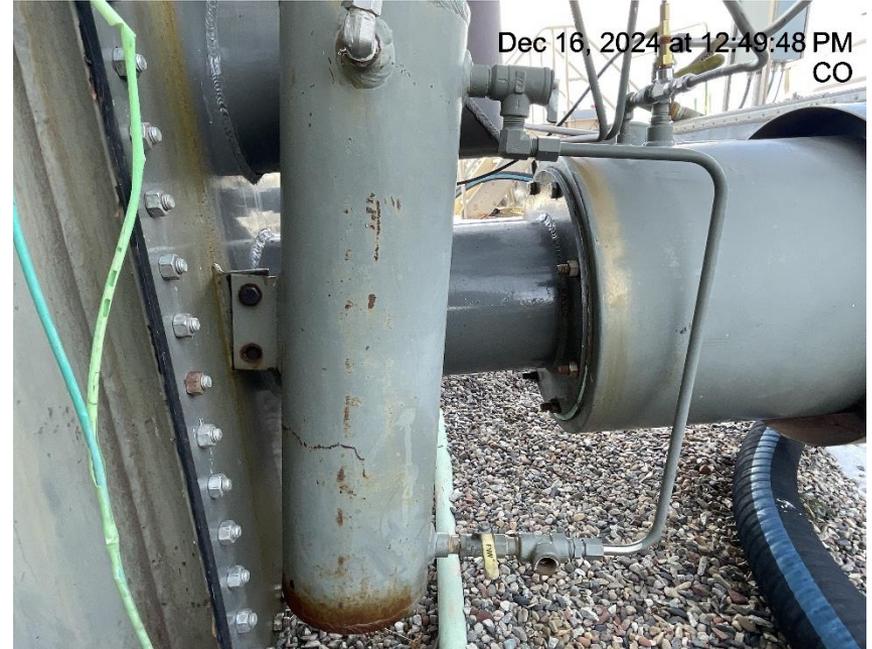
Photo # 3758 PRV vent line on tank burner does not comply with CECMC pressure safety device rules

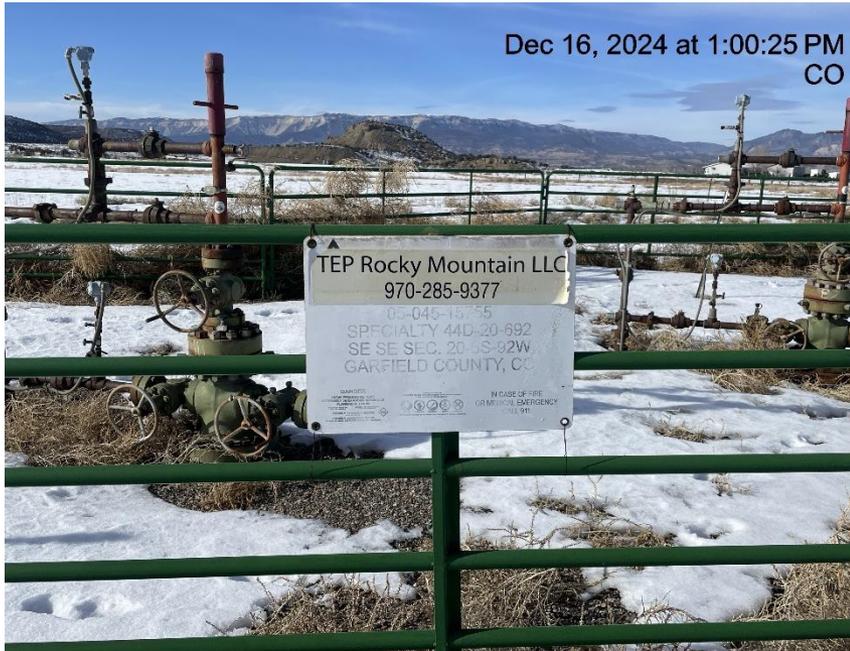
Photo # 3759 SPECIALTY 44D wellhead sign weathered & becoming illegible

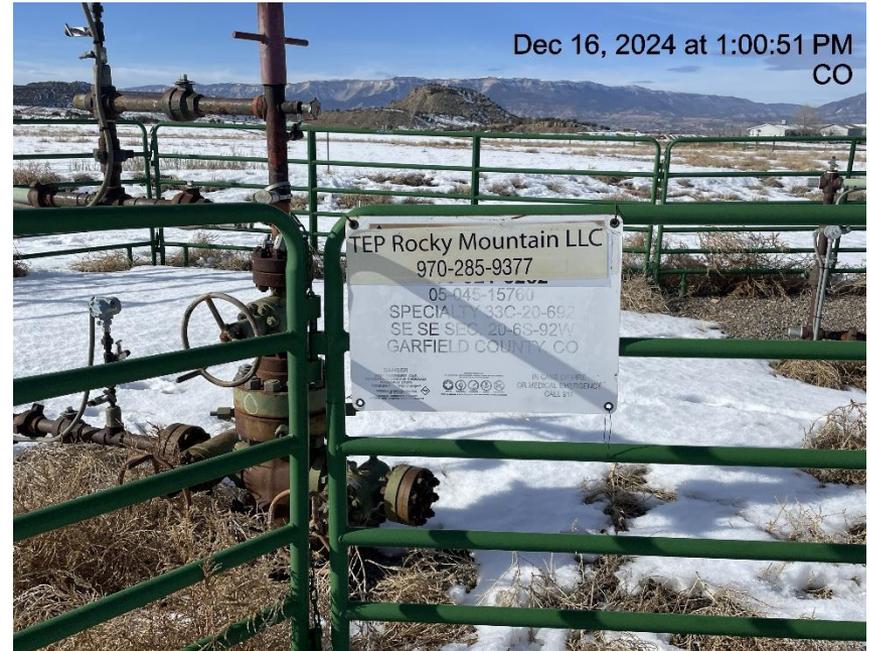
Photo # 3760 SPECIALTY 33C wellhead sign weathered & becoming illegible

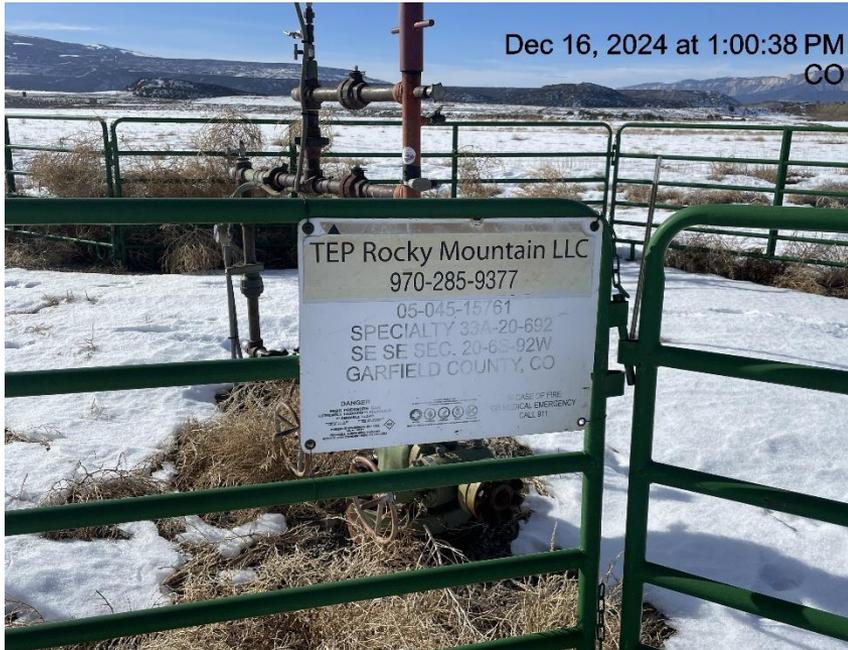
Photo # 3761 SPECIALTY 33A wellhead sign weathered & becoming illegible
