WELL NAME: SALIDA 44-26, API #: 071-07675, INSP. # 716300321

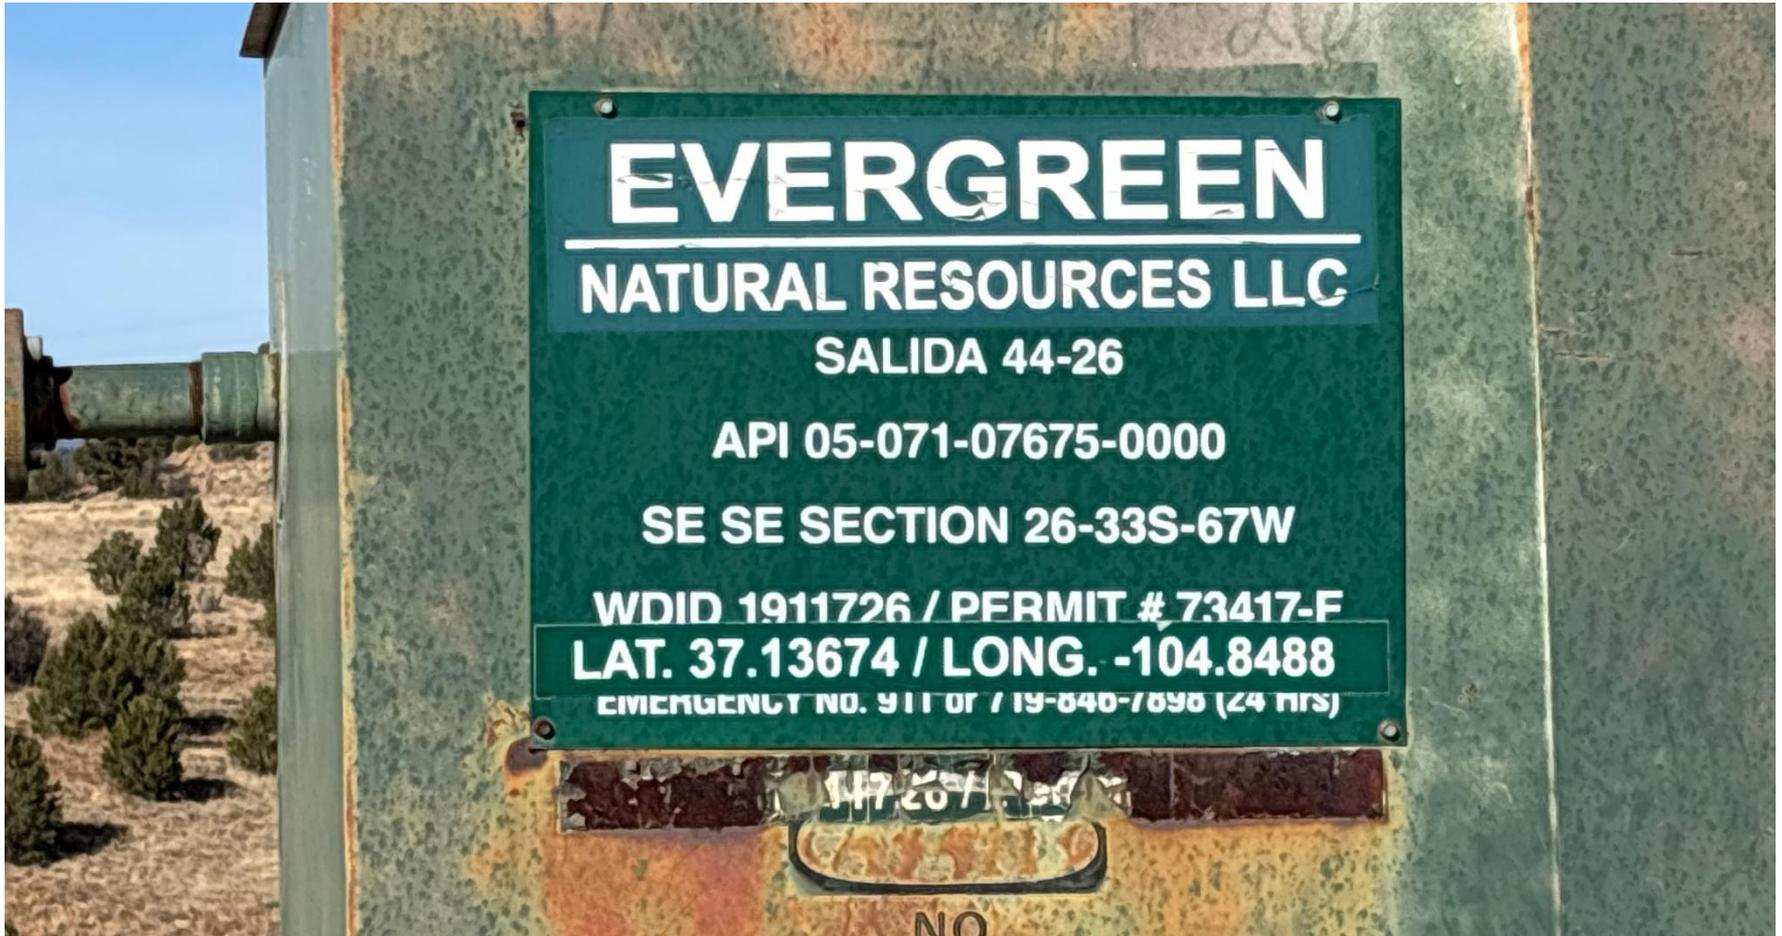
PHOTO 1: WELL SIGN

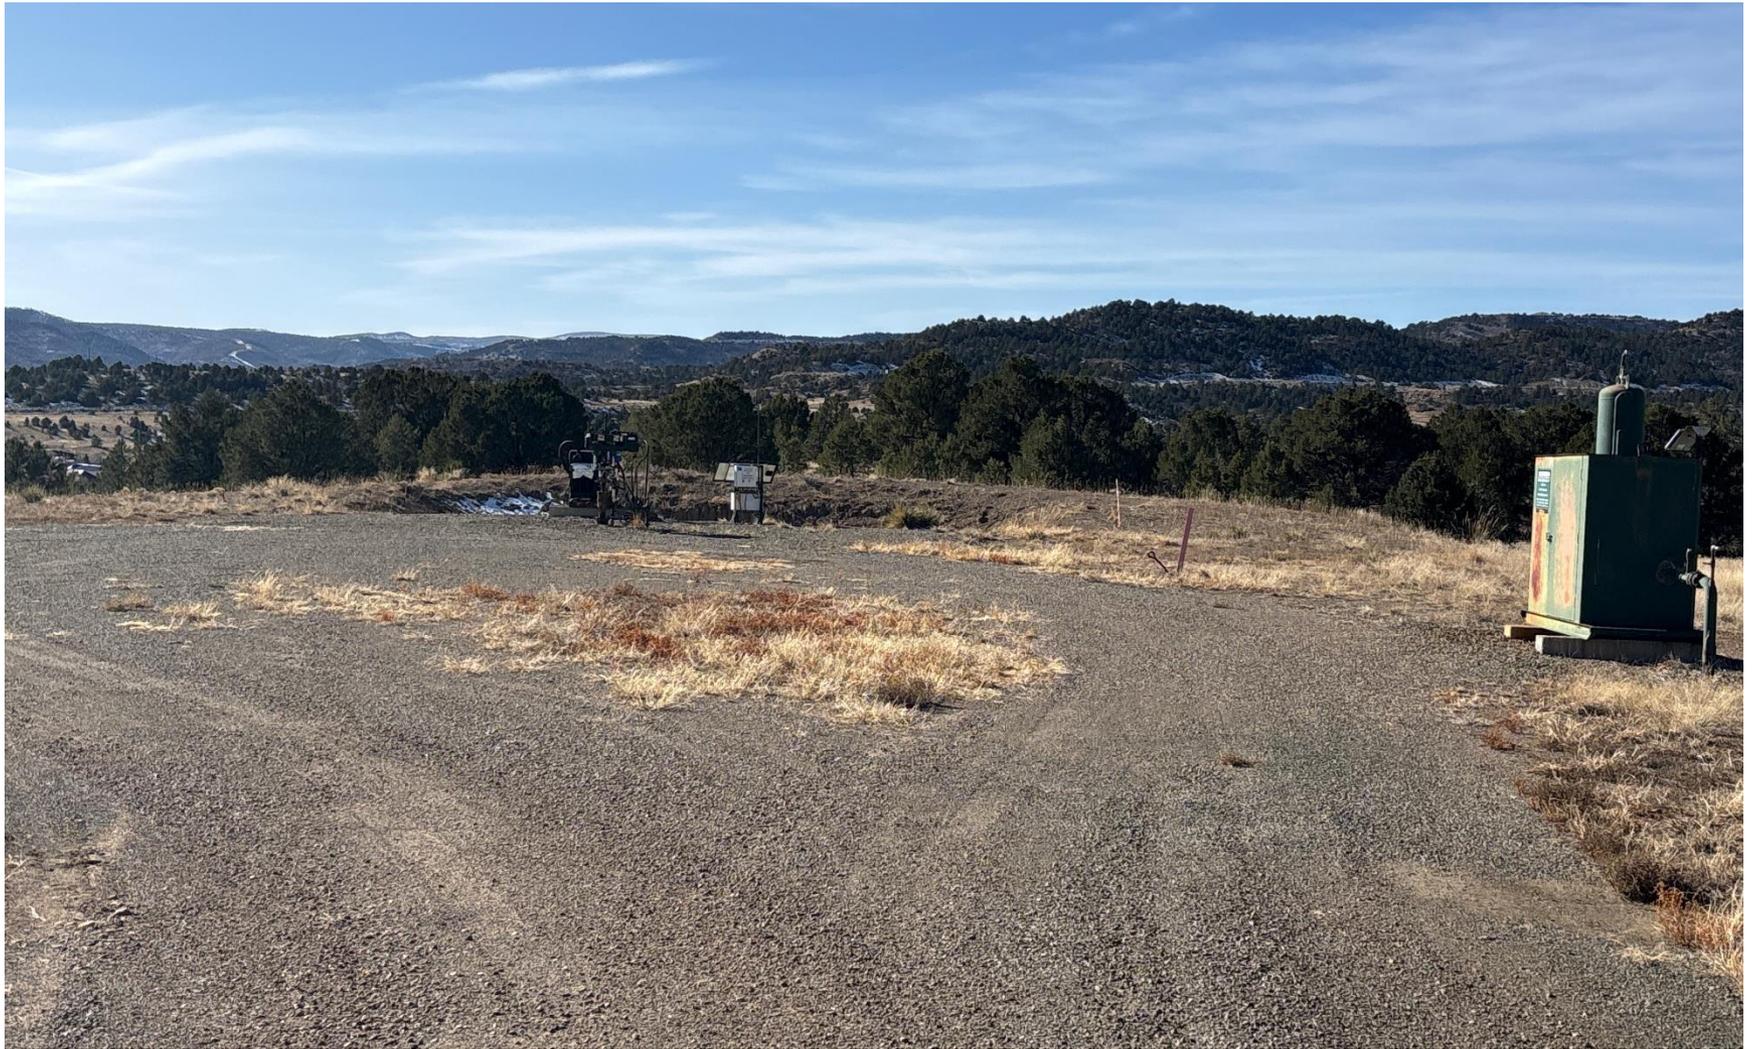
PHOTO 2: LOCATION.

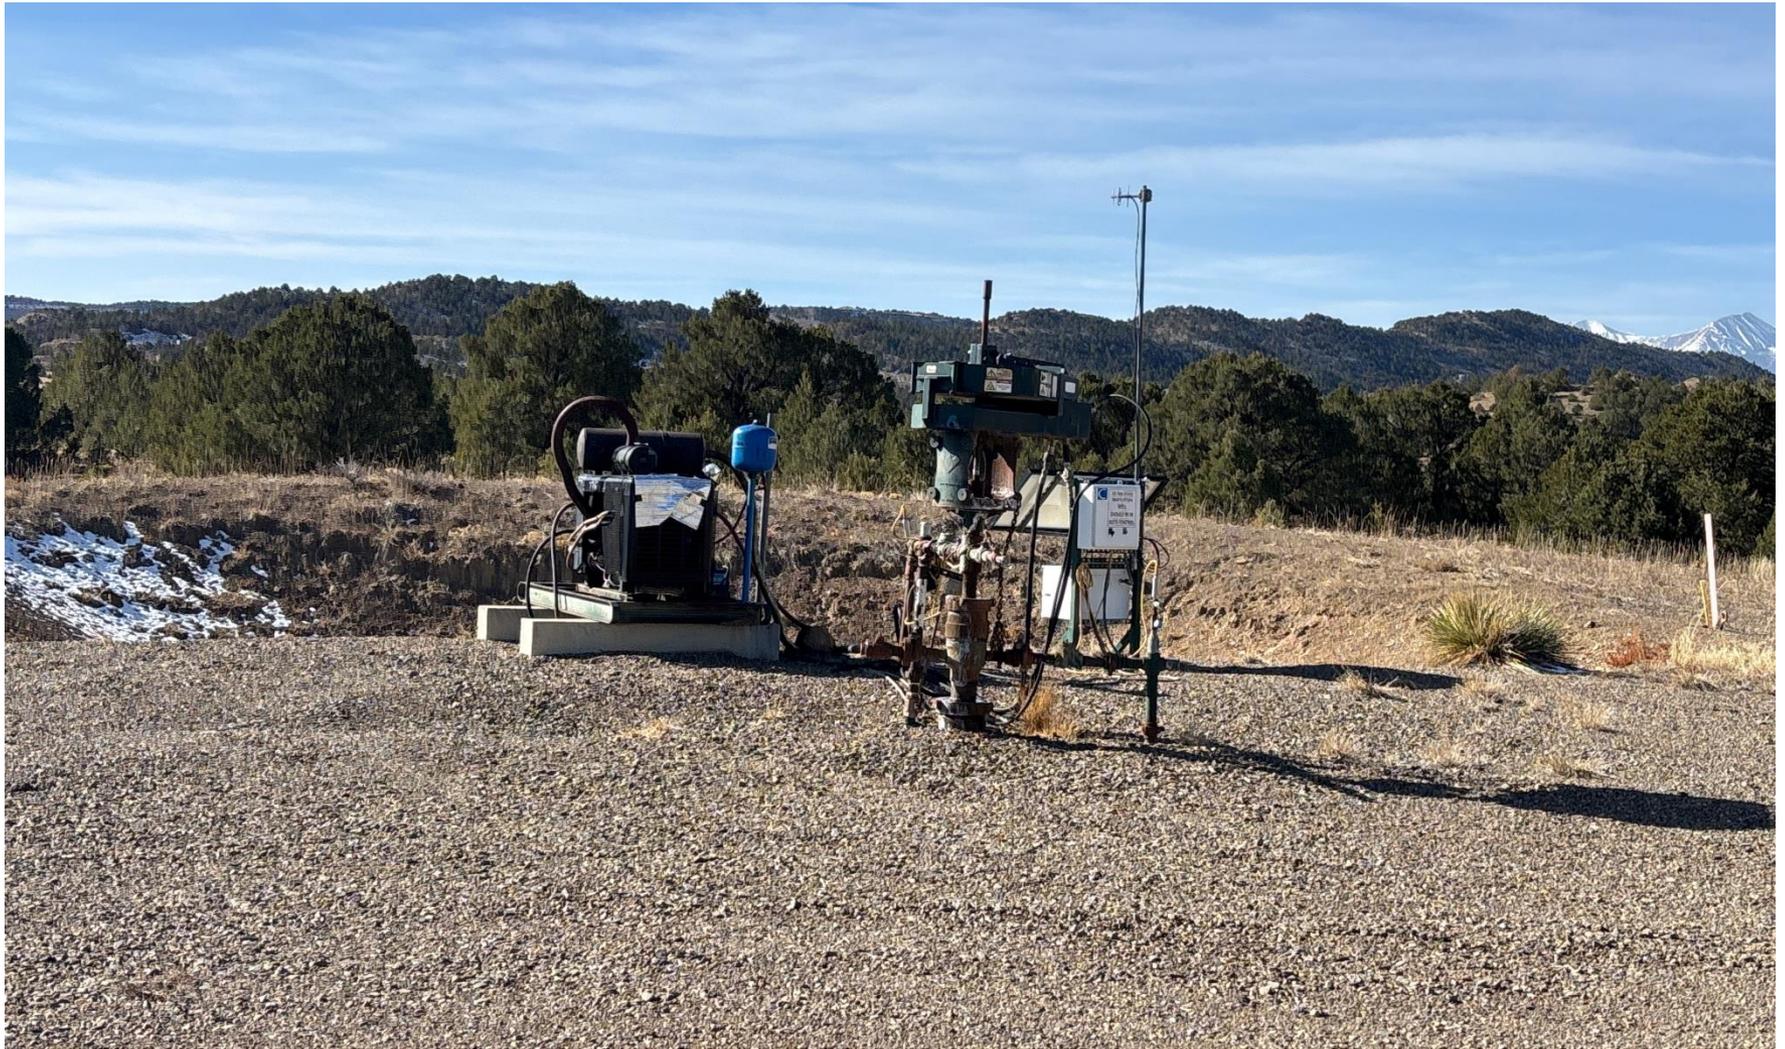
PHOTO 3: WELLHEAD AND EQUIPMENT.

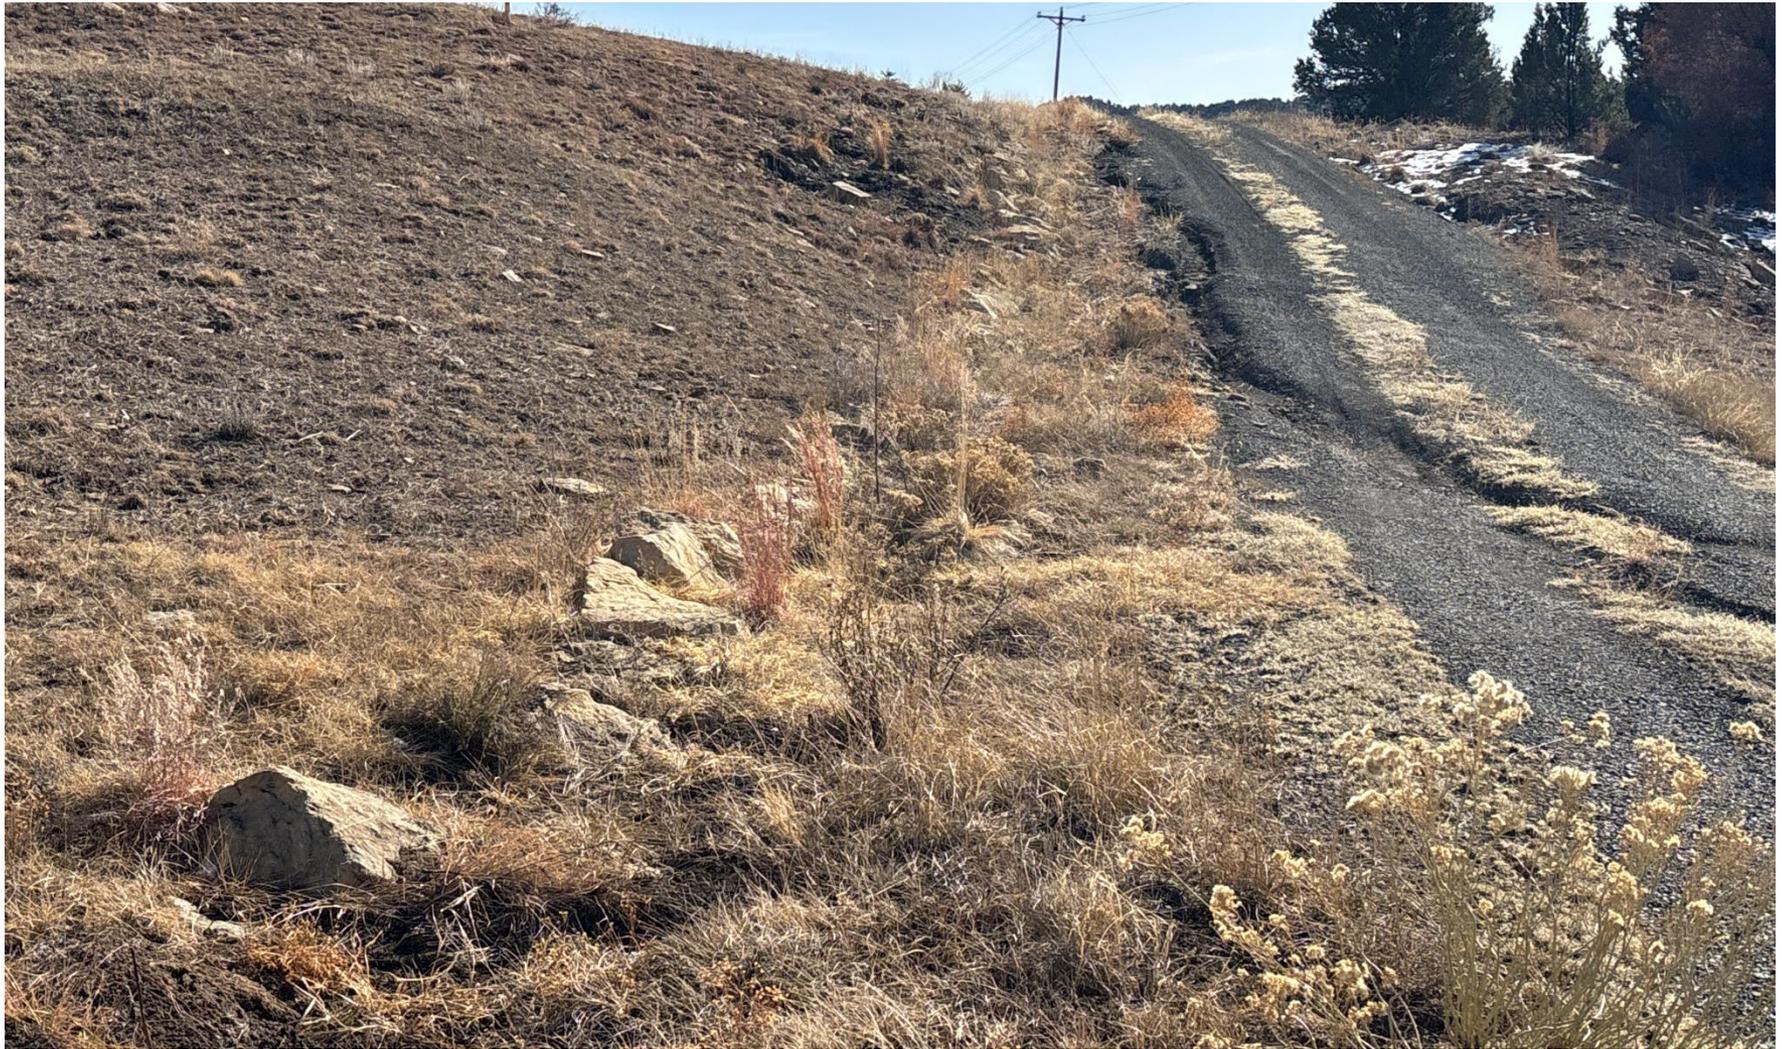
PHOTO 4: STORMWATER HAS ERODED OUT OF BMP DITCH AND HAS CAUSED CHENNELING DOWN AND ACROSS ROW IS MULTIPLE AREAS. **Install or repair required BMPs per Rule 1002.f.(2)C . CA DATE 12/26/2024.**

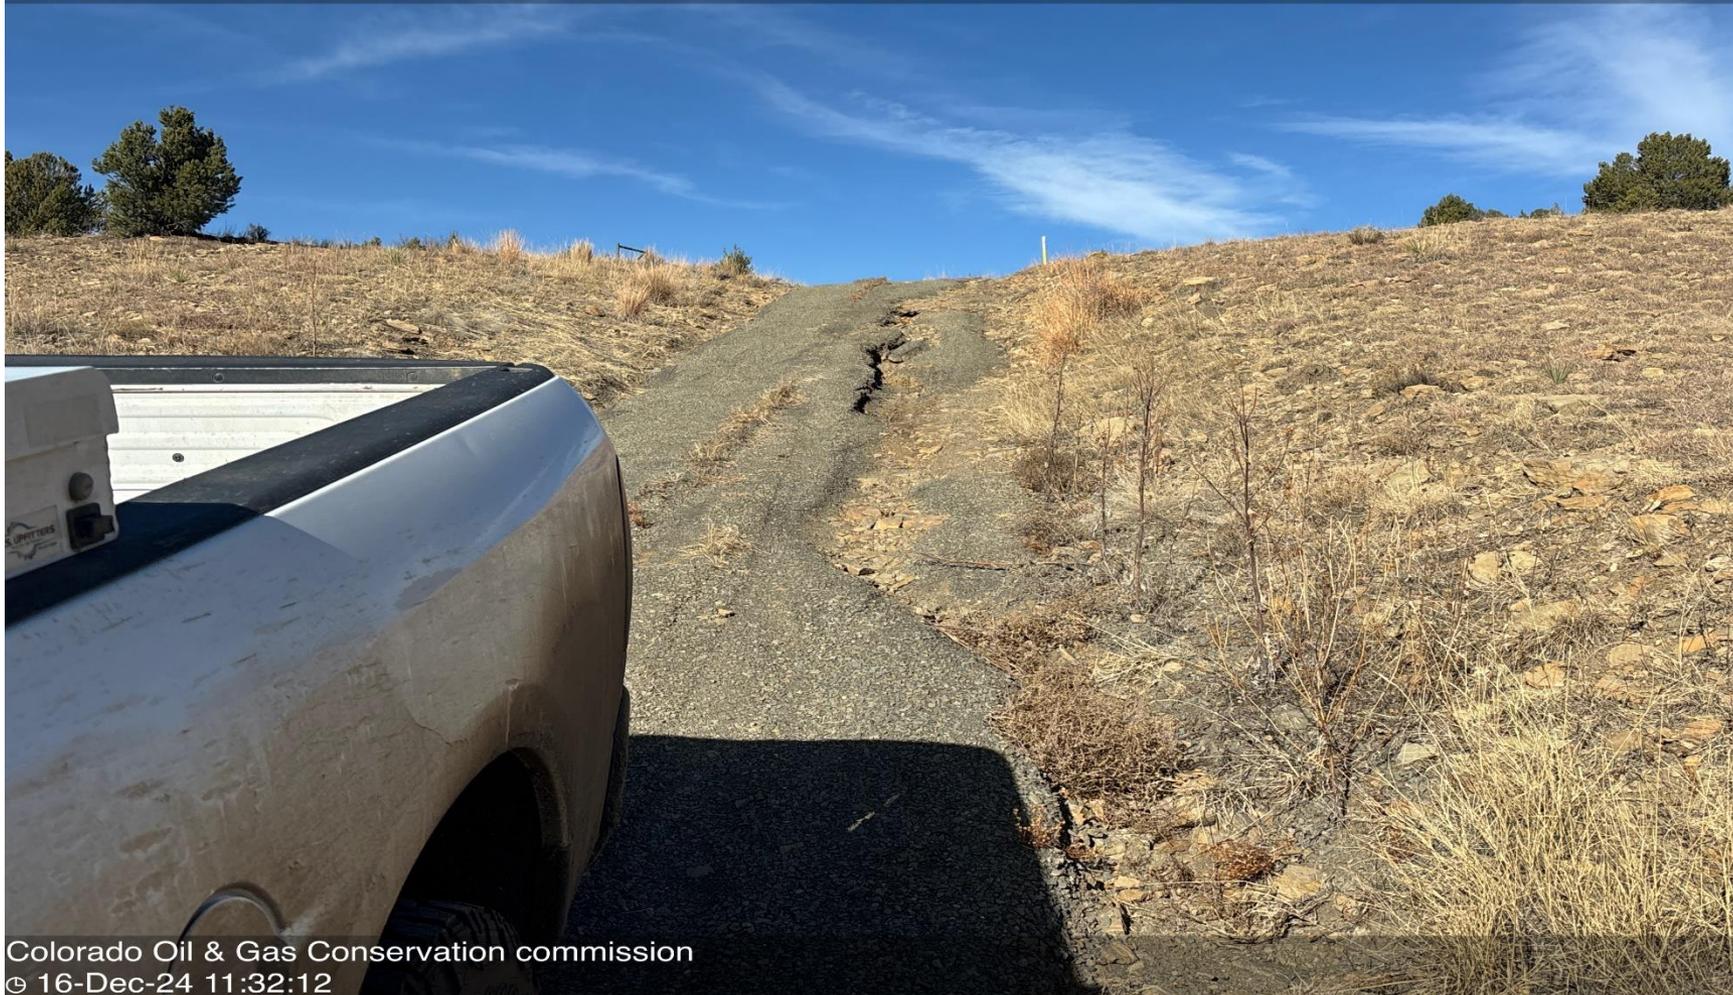
PHOTO 5: STORMWATER HAS ERODED OUT OF BMP DITCH AND HAS CAUSED CHENNELING DOWN AND ACROSS ROW IS MULTIPLE AREAS. Install or repair required BMPs per Rule 1002.f.(2)C . CA DATE 12/26/2024.

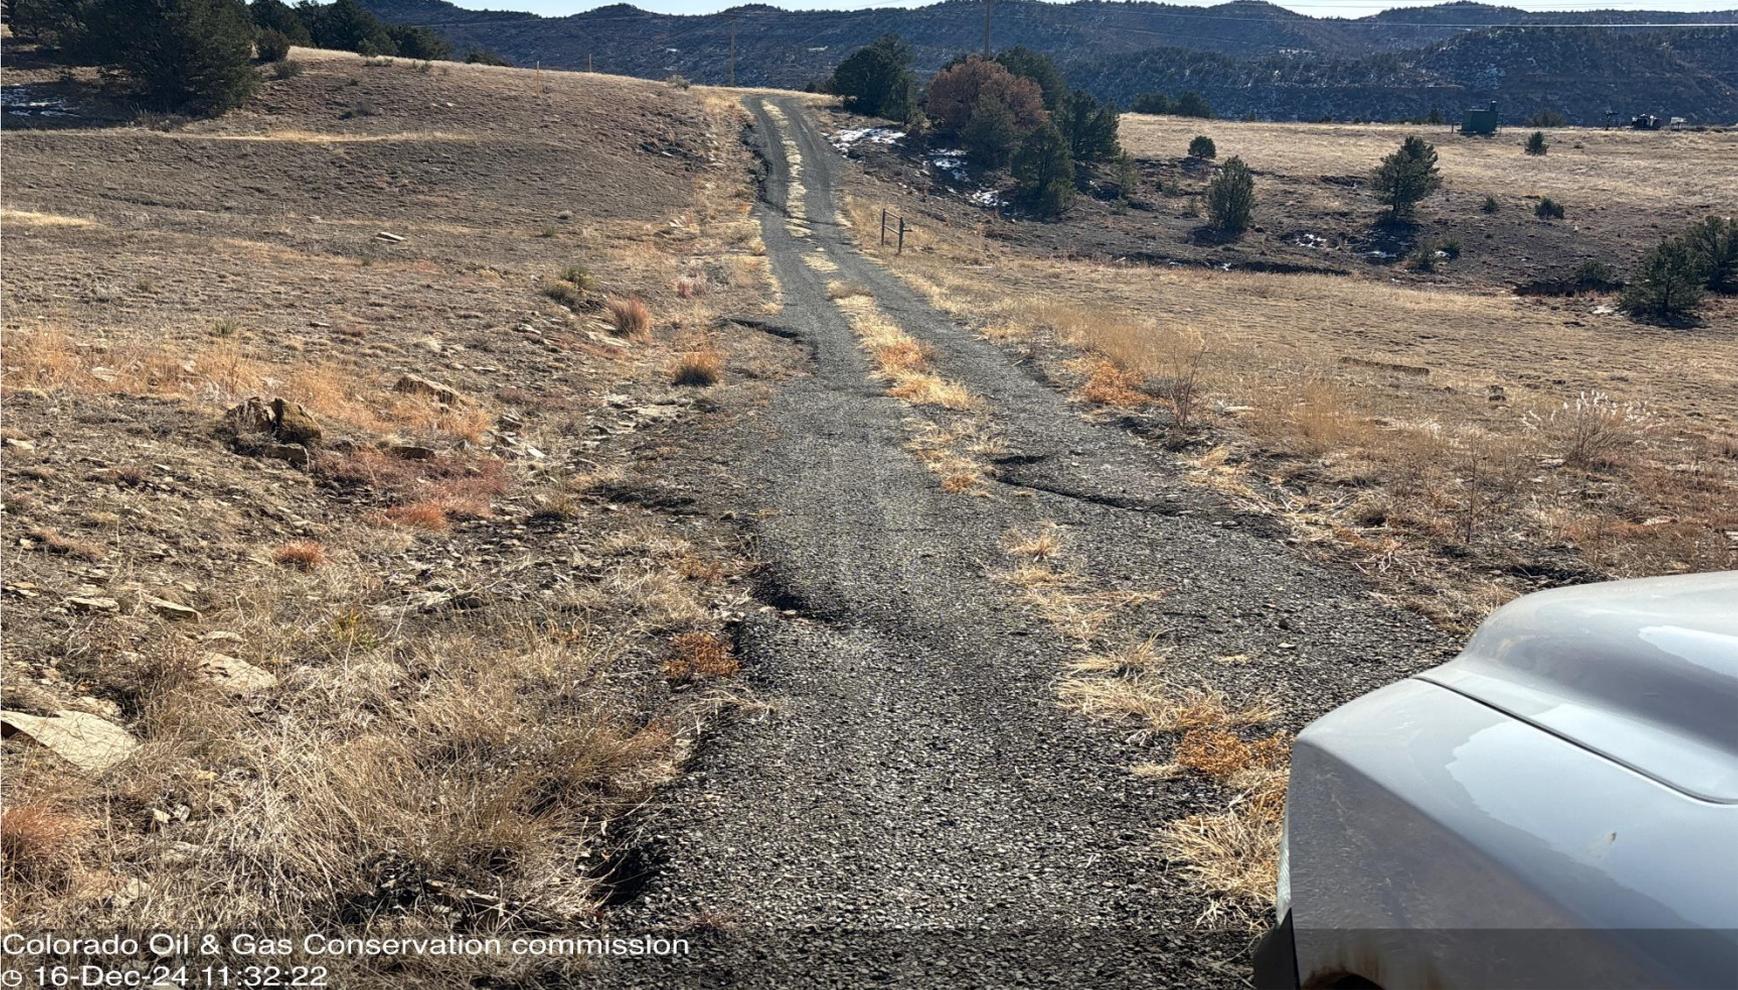
PHOTO 6: STORMWATER HAS ERODED OUT OF BMP DITCH AND HAS CAUSED CHENNELING DOWN AND ACROSS ROW IS MULTIPLE AREAS. *Install or repair required BMPs per Rule 1002.f.(2)C . CA DATE 12/26/2024.*
