Inspection Photos

Loc: 485760

Operator: WAVETECH HELIUM INC

Inspection Date: 12/18/2024

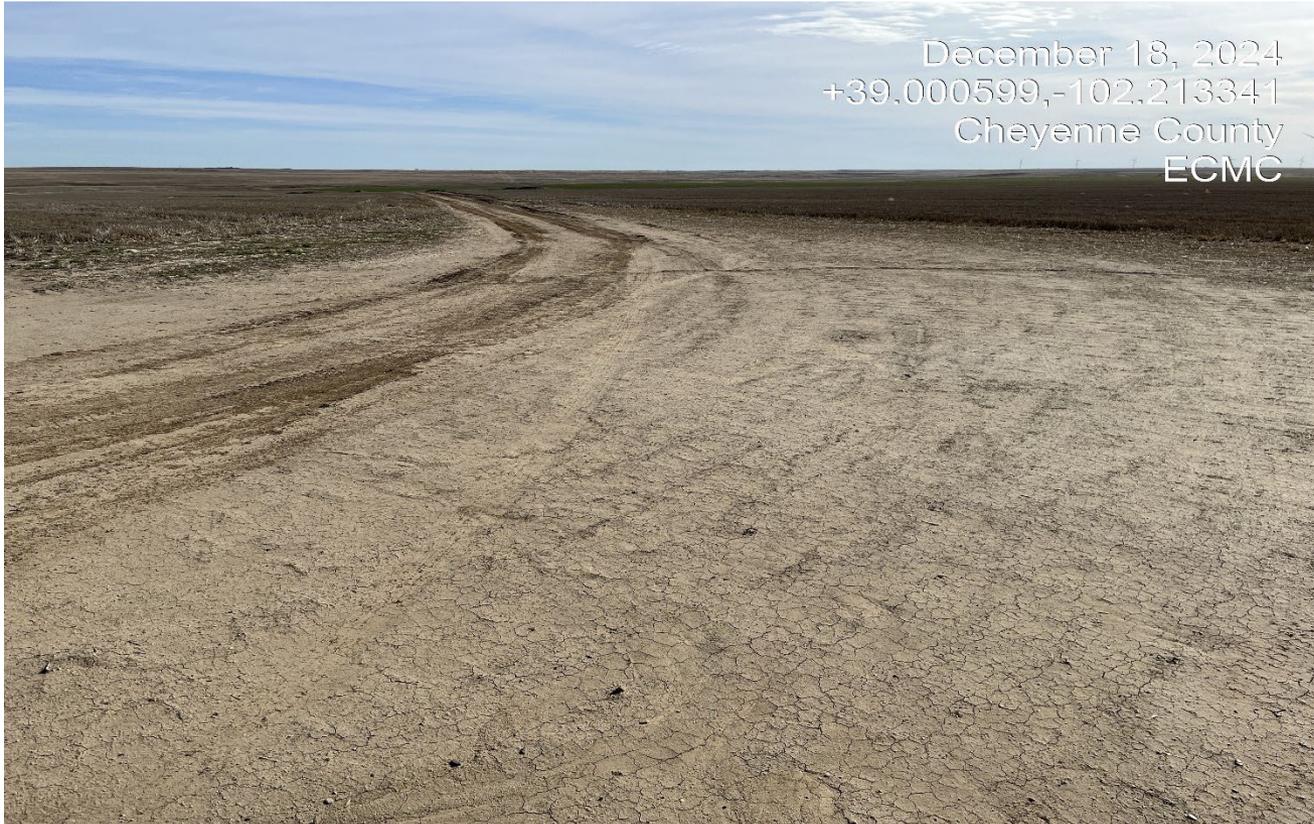
Photo 1. Facing south along the access road. The access road needs to be reduced in size by reclaiming and decompacting soils.

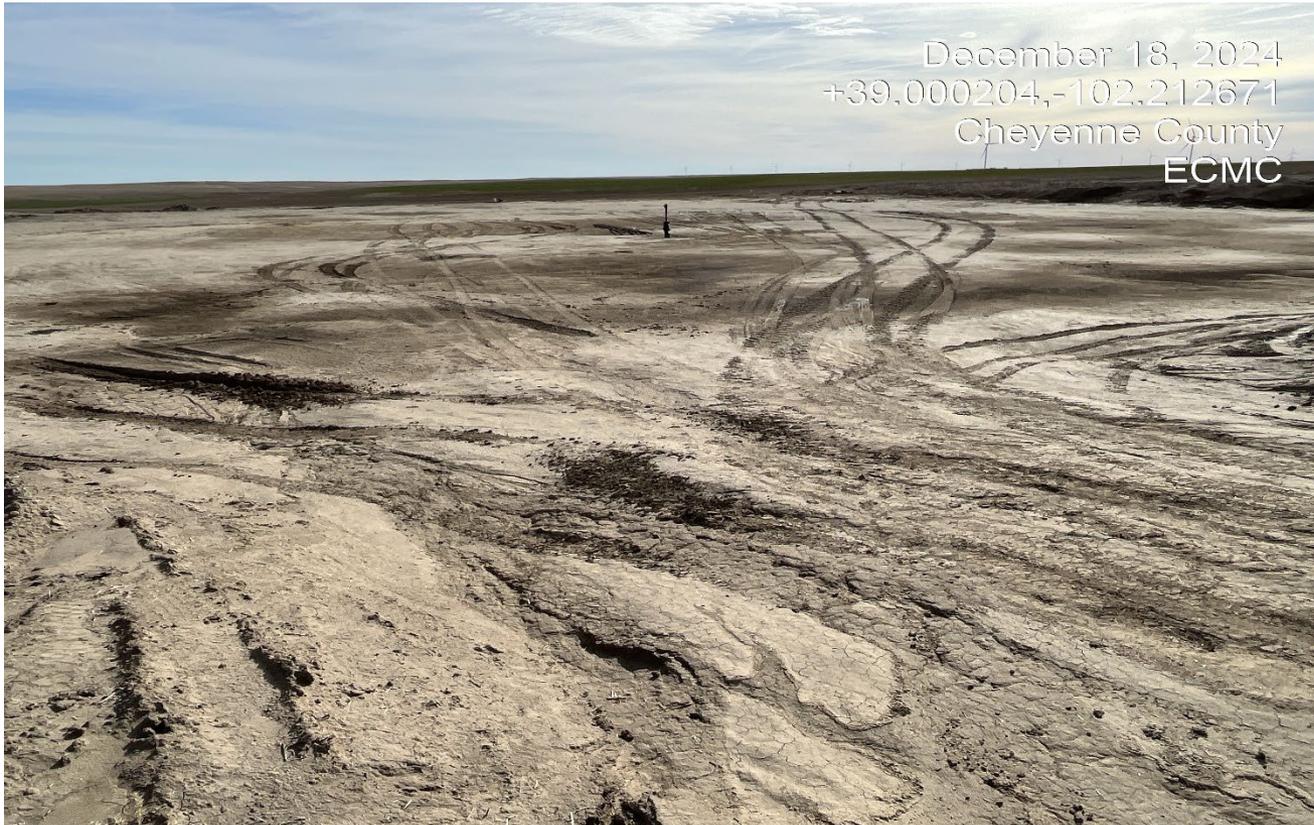
Photo 2. Facing south toward the wellsite..

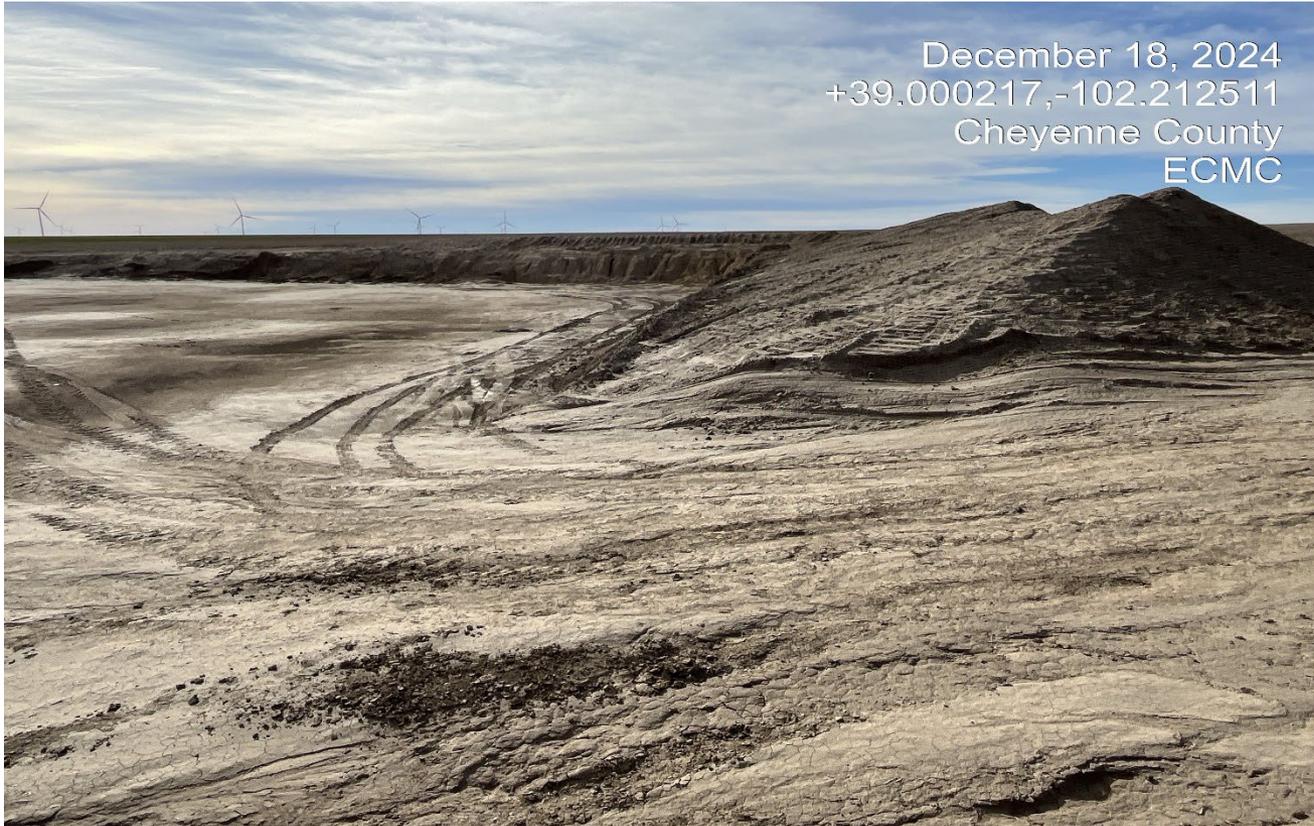
Photo 3. North side of the location facing east. Topsoil is stored along the north side of the location and has not been stabilized or replaced for interim reclamation.

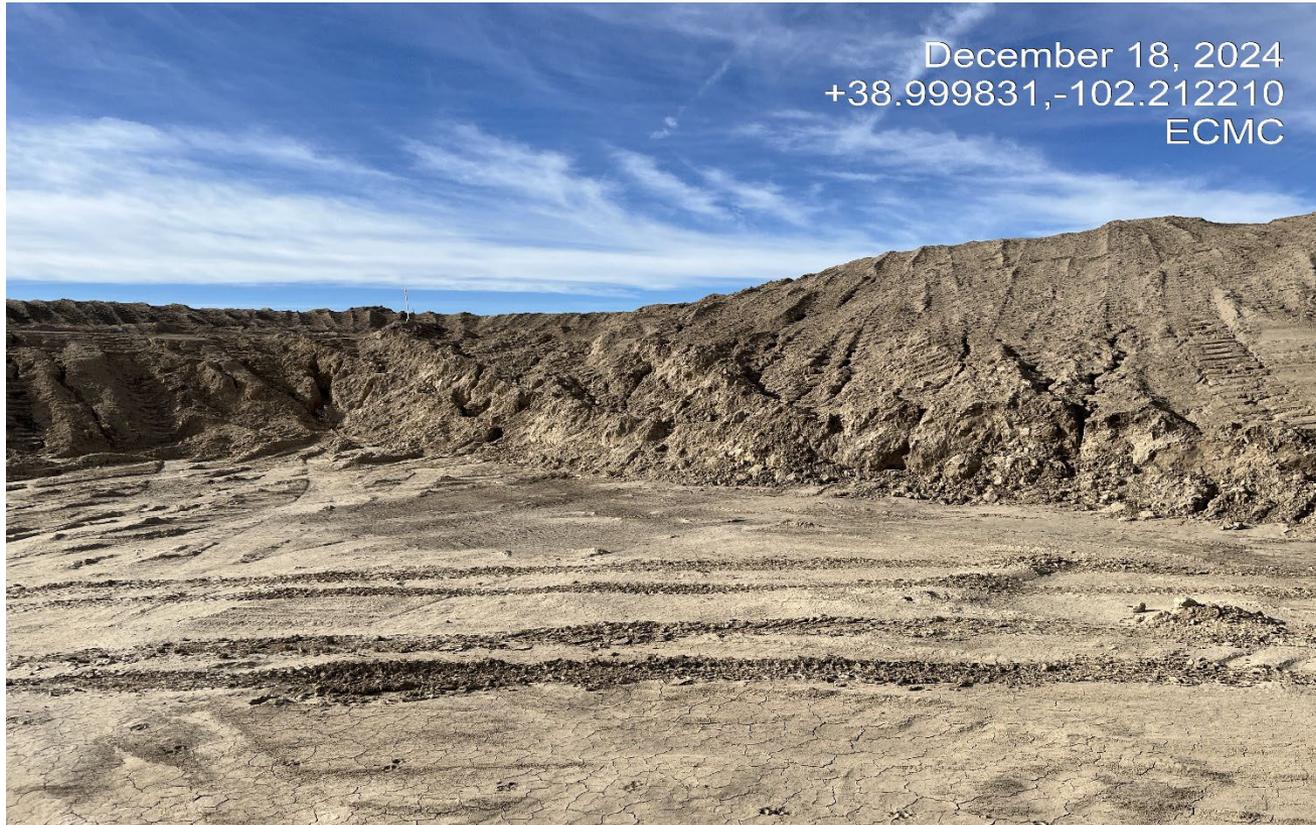
Photo 4. Facing toward the northeast side of the location. There is erosion along the topsoil pile which is mixing soil into the pad surface and subsoils. The topsoil is not stabilized or protected.

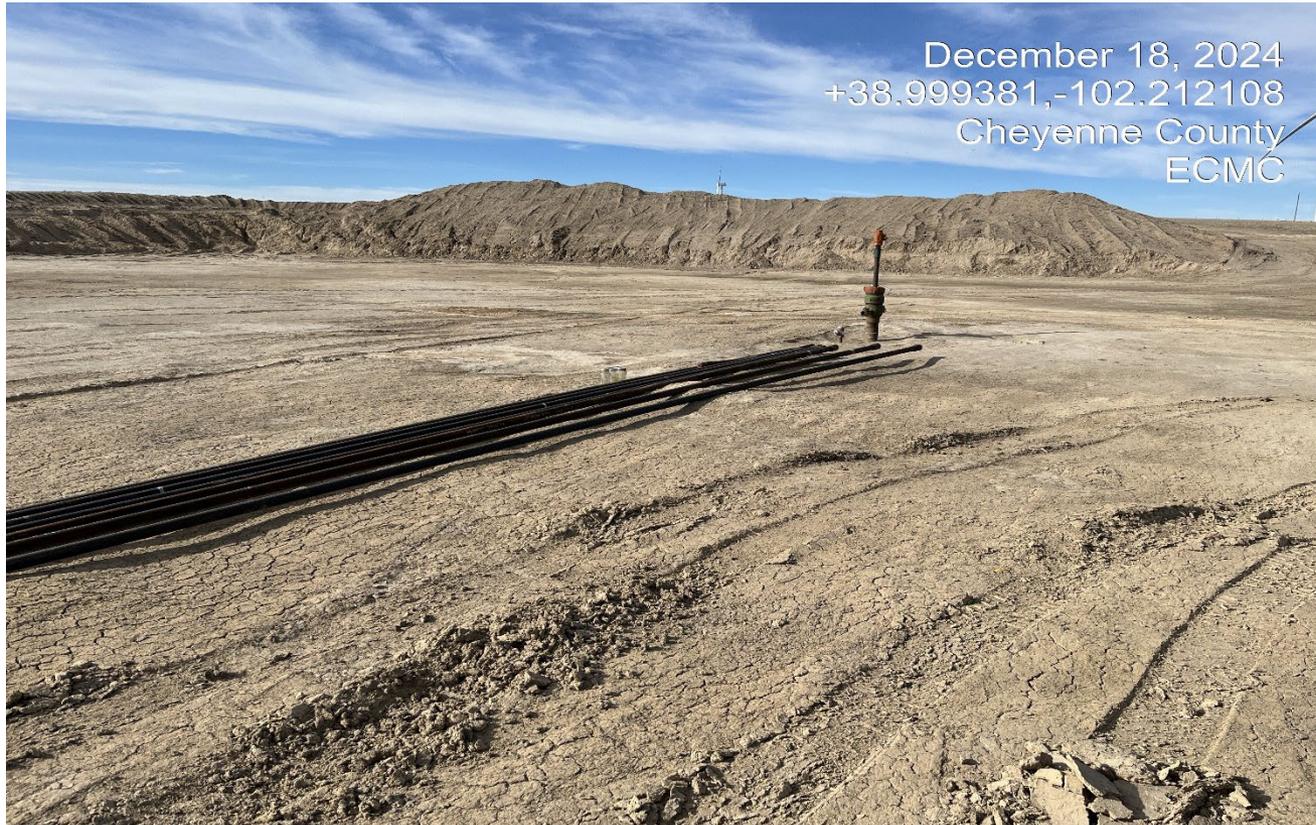
Photo 5. There is unused pipe at the wellhead that needs to be removed. There is no sign posted at the wellhead.

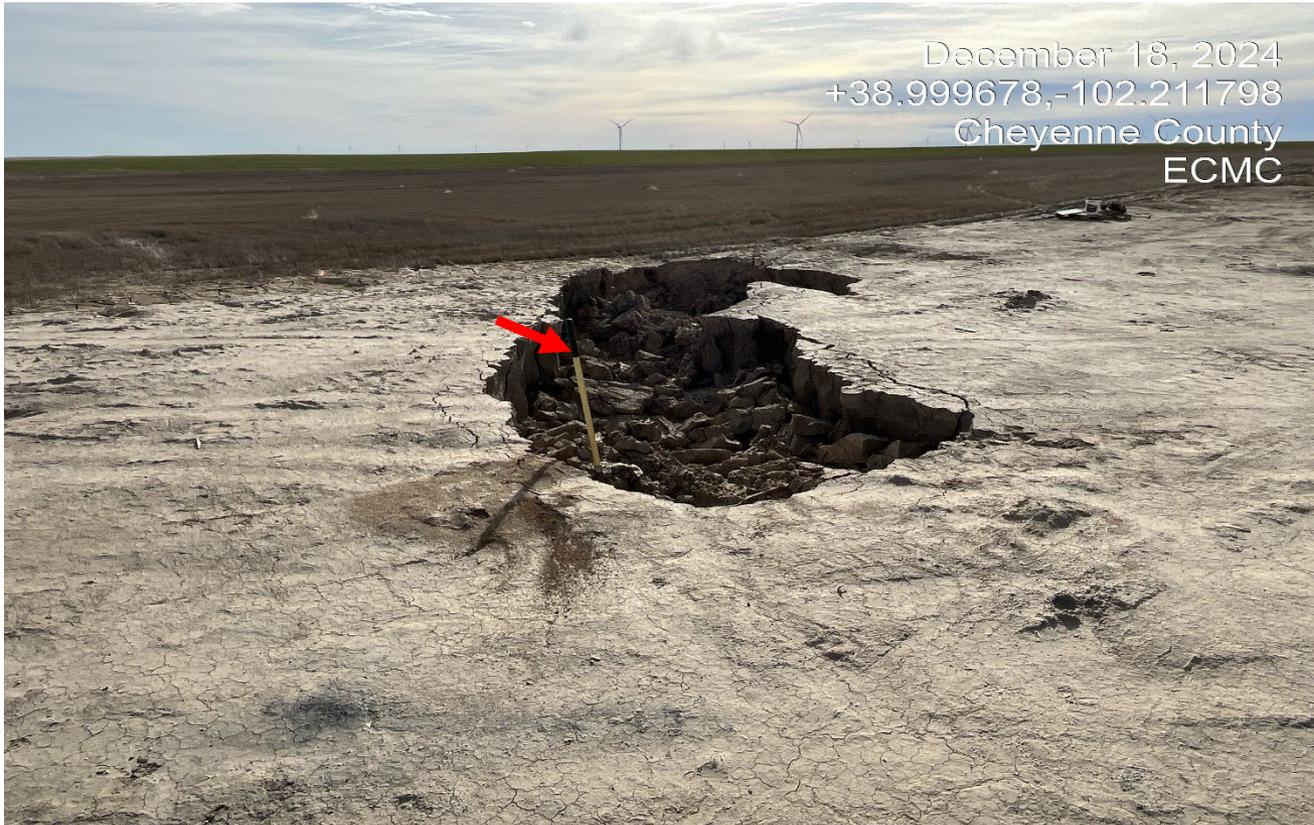
Photo 6. There is significant gully erosion along the fill slope which has washed sediment out into the adjacent crop field. Red arrow points to 4.5 ft. shovel.

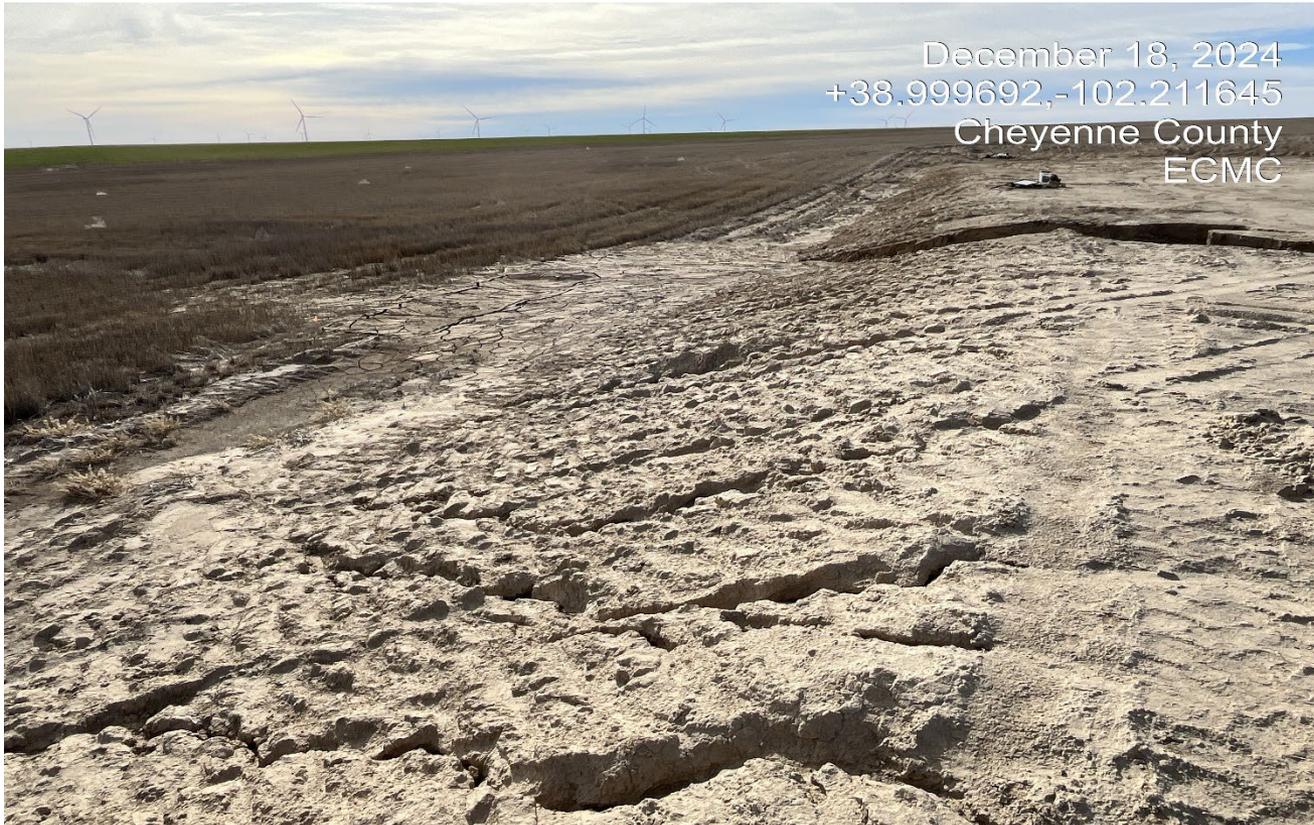
Photo 7. Facing southwest toward the fill slope which has eroded and transported sediment offsite.

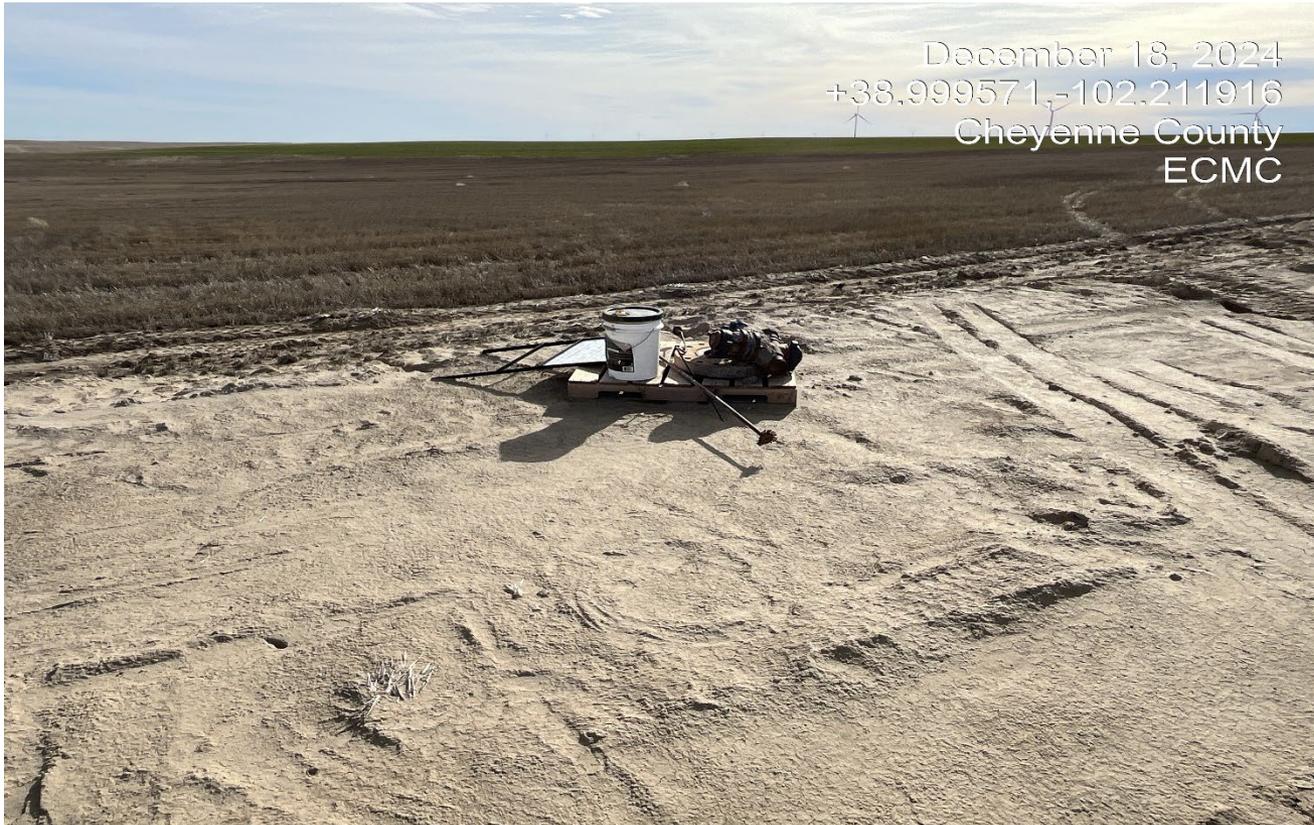
Photo 8. There is a bucket of oil, sign and tools at this south side of the location.

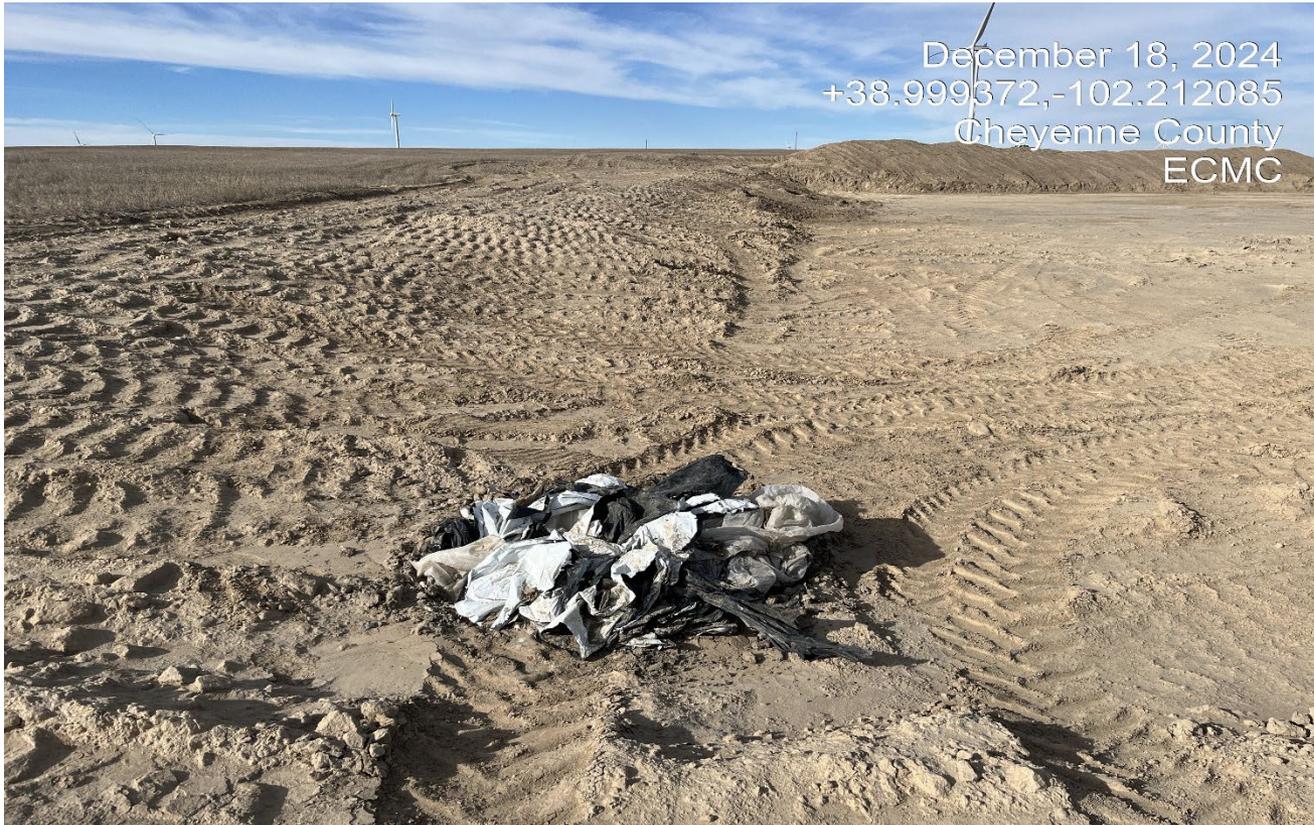
Photo 9. Southwest side of the location facing north. There is plastic trash that need to be removed.

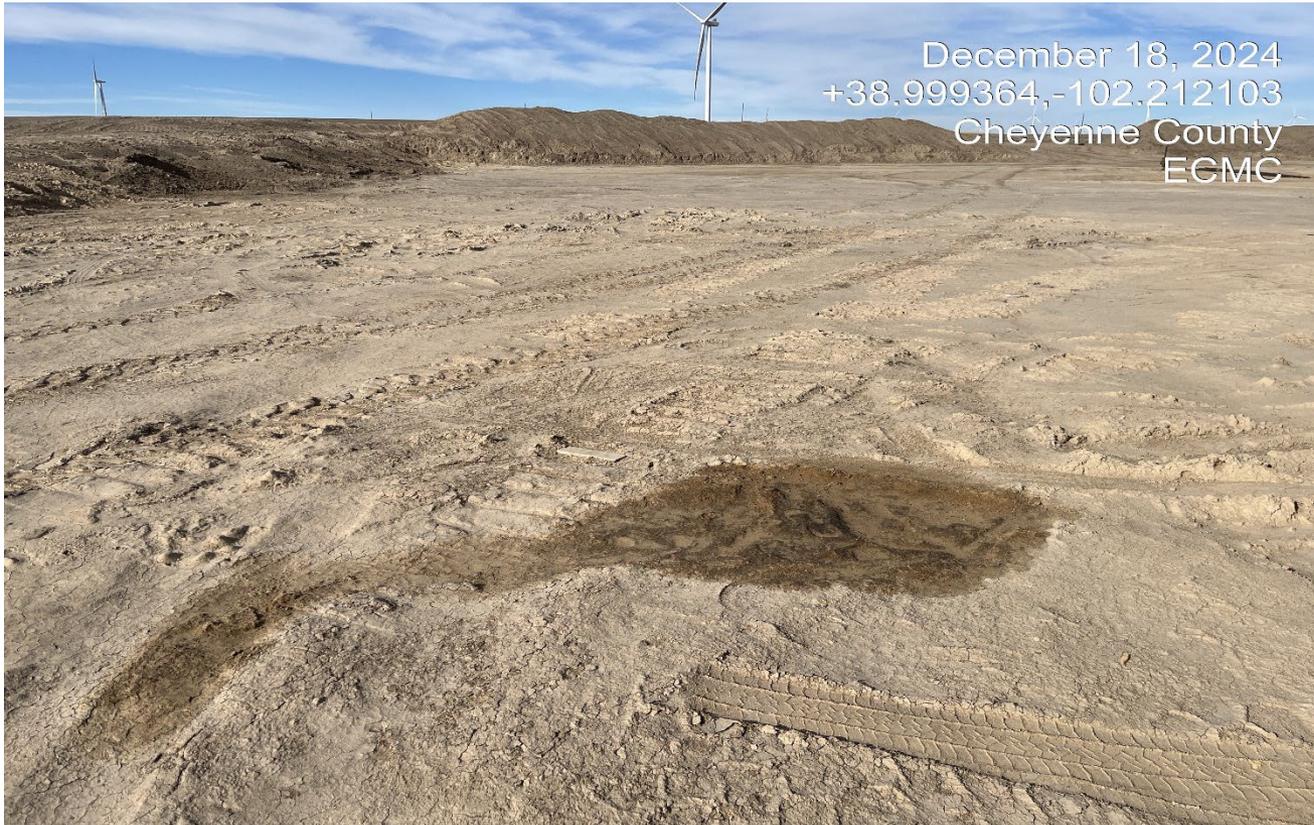
Photo 10. There is a spill and stained soils at the southwest corner that must be cleaned up.
