Construction and Stormwater Inspection

Date: 12/19/2024

Operator: CARBON STORAGE SOLUTIONS LLC -
10786

Inspection Photos
Location Name: Front Range 2
Location ID: 487295

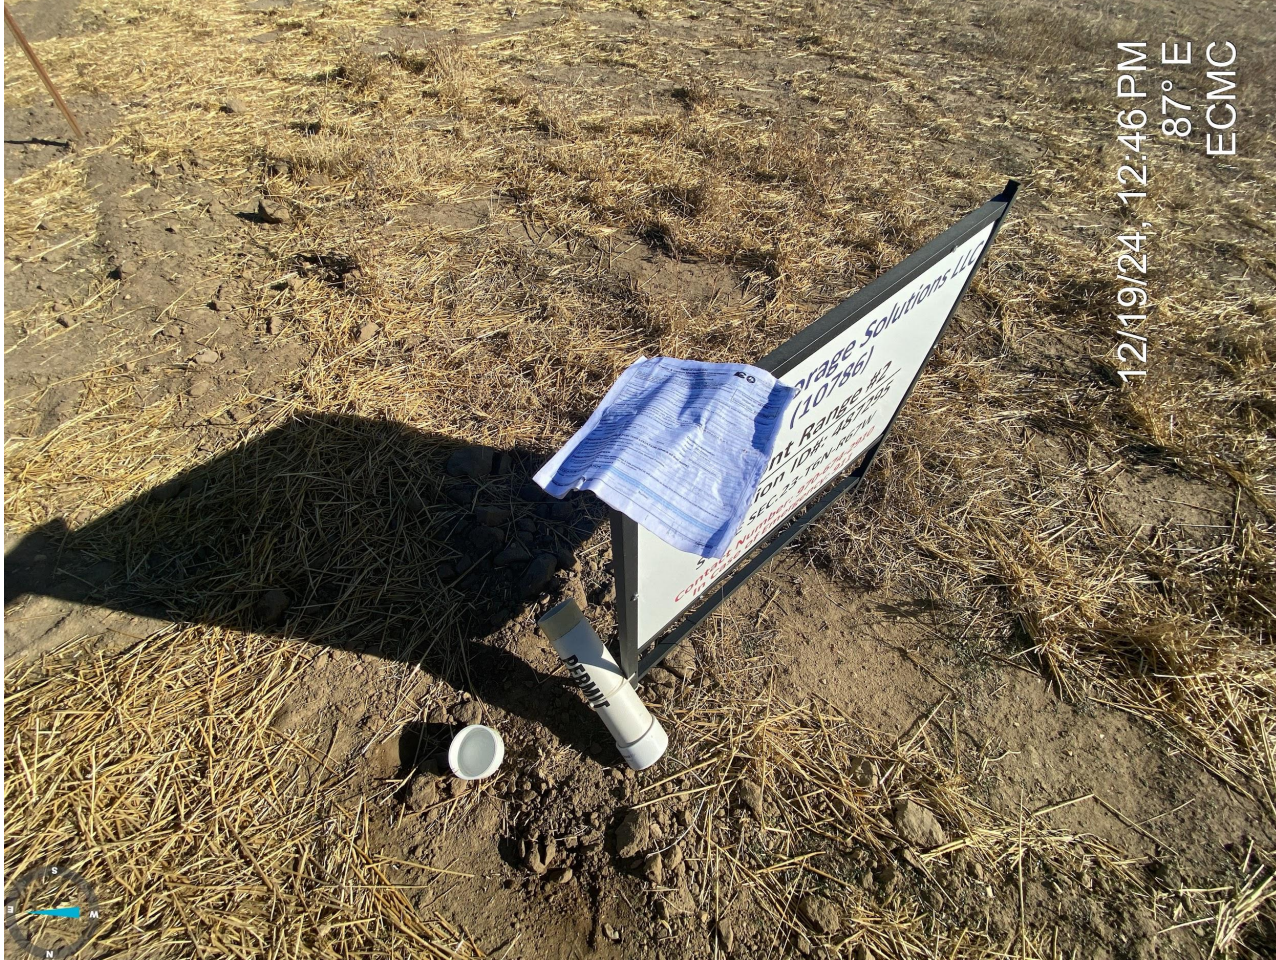
Photo 1. Per Rule 406.c, a copy of the Form 2A was posted on location near the entrance. Note : The Form 2A had water damage, replacement advised.

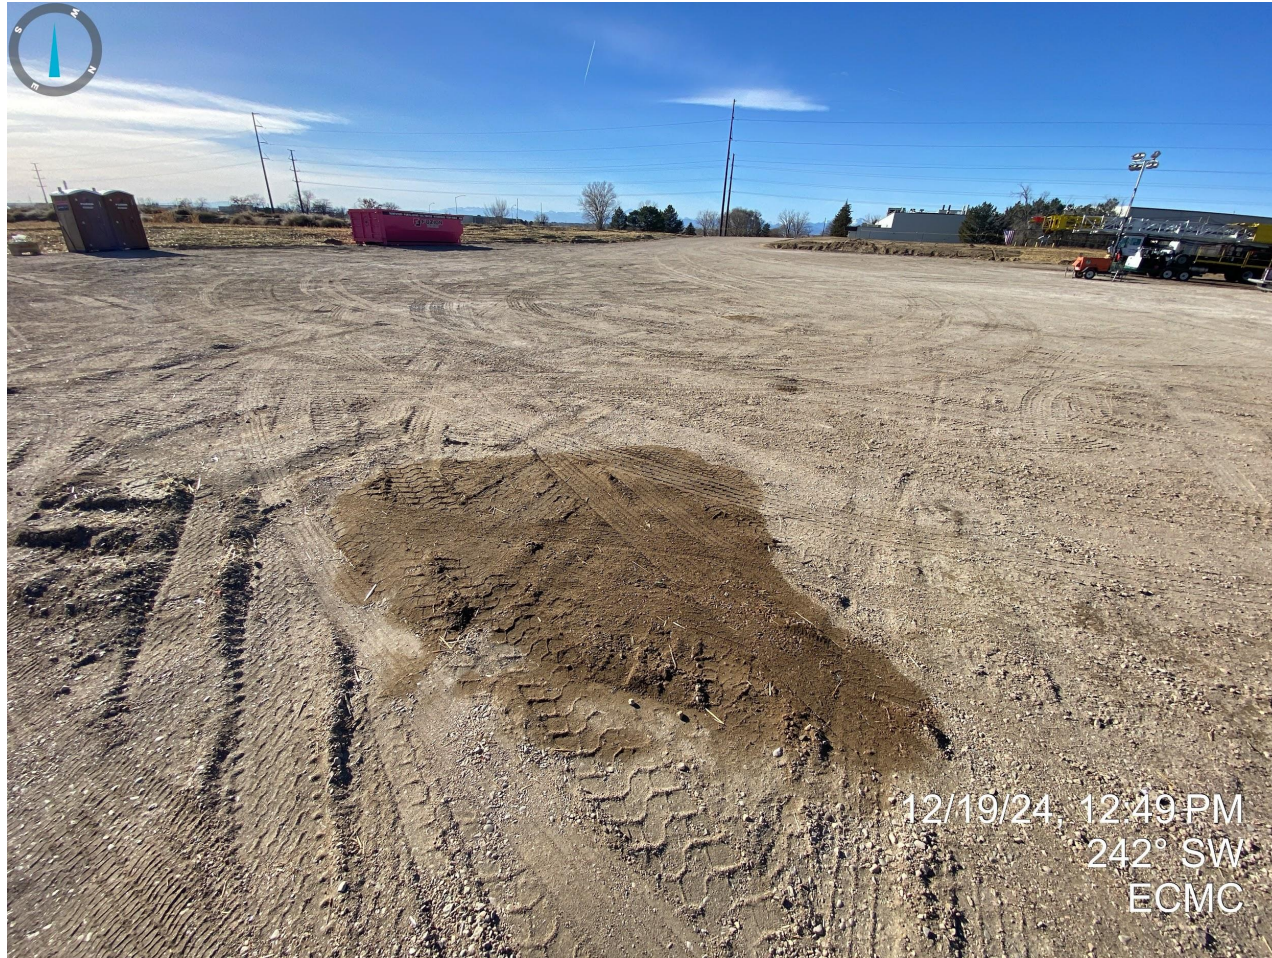
Photo 2. Stained soil observed on the eastern portion of the drilling pad.

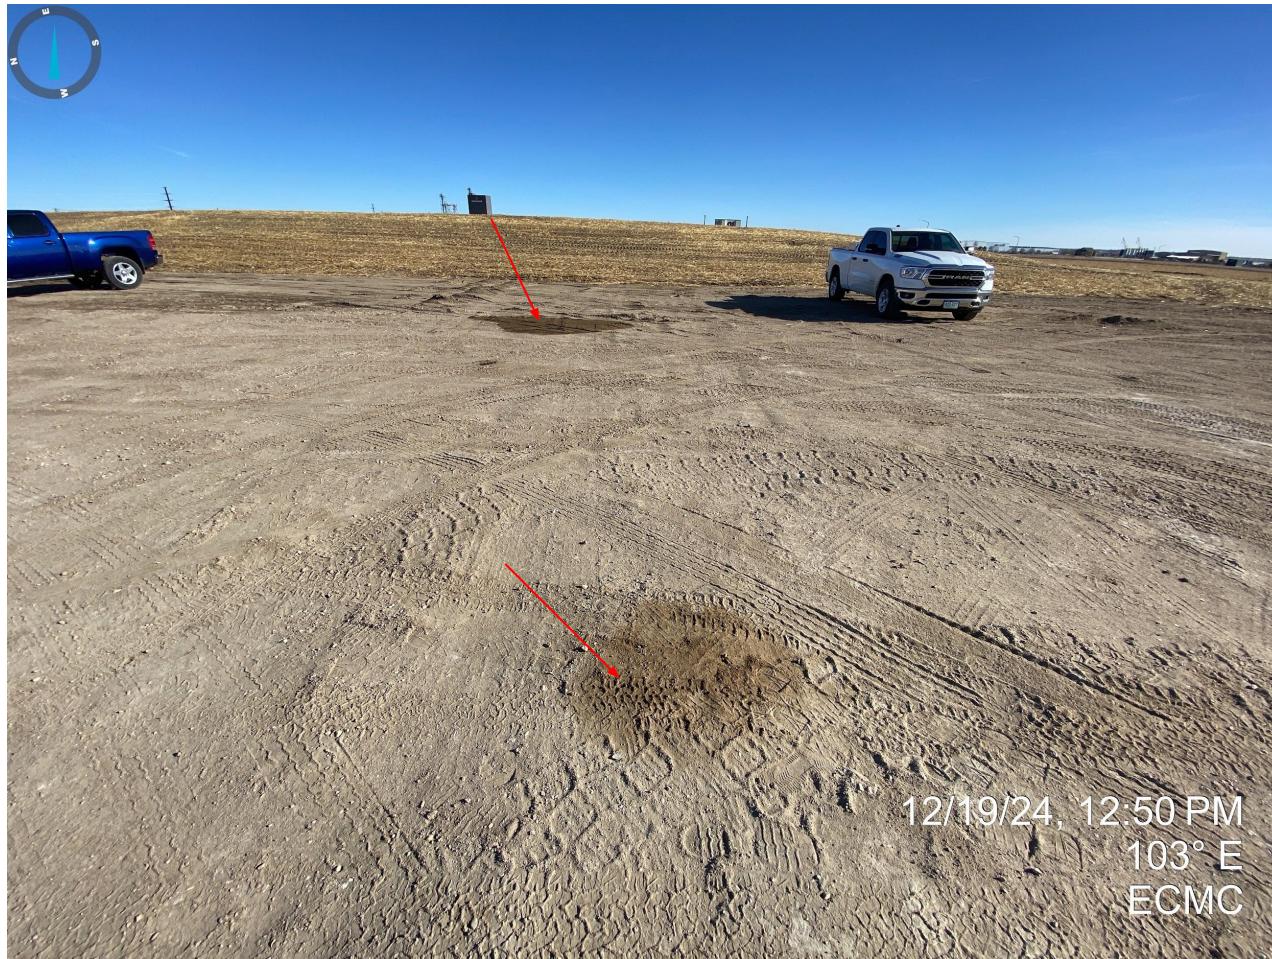
Photo 3. Continued from Photo 2; stained soil observed on the eastern portion of the drilling pad.

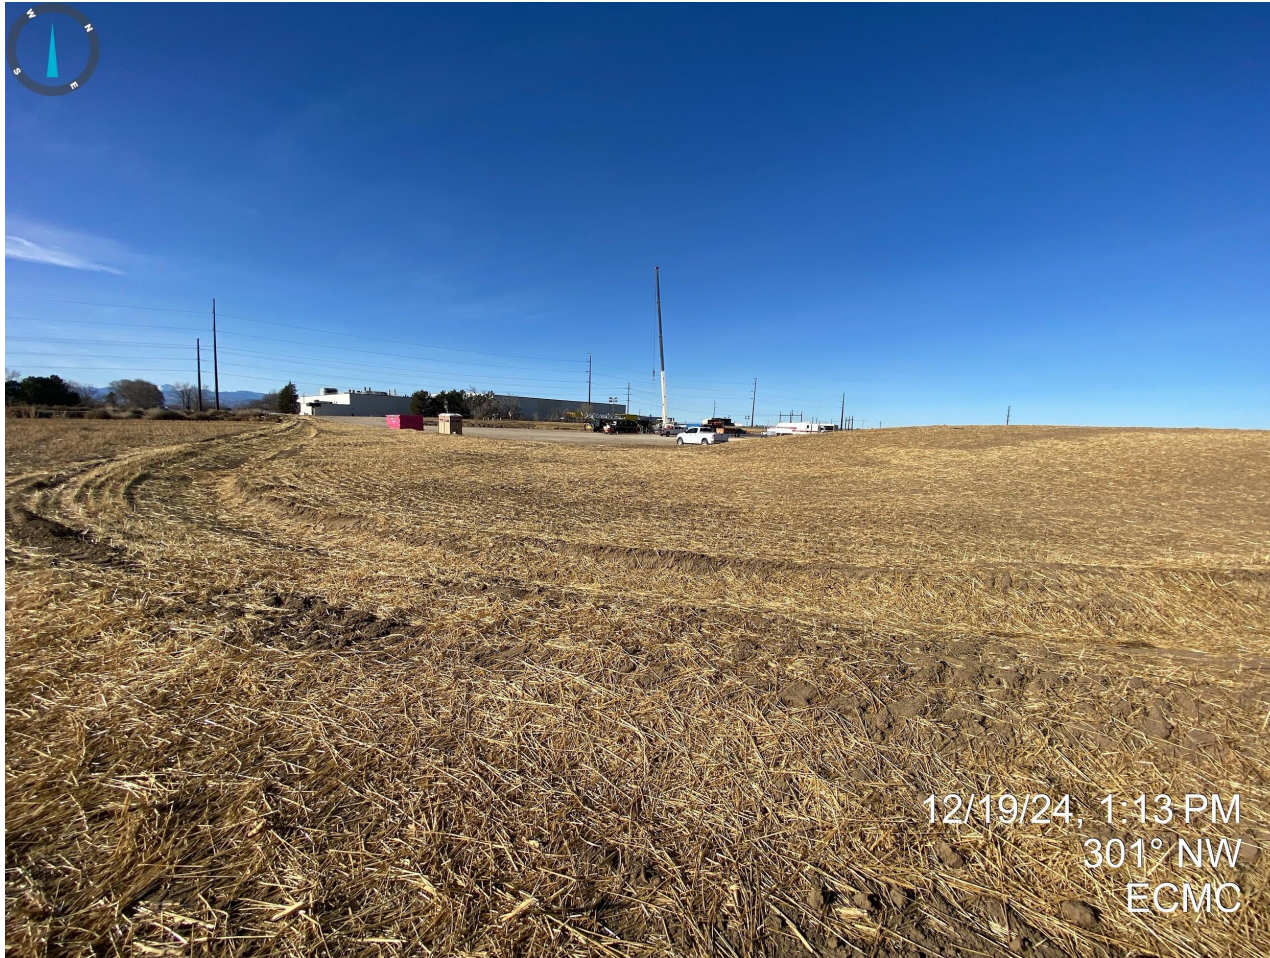
Photo 4. Taken from the southern portion of the disturbance area. Topsoil stockpile and other portions of the disturbance area appear to have been stabilized with drill seeding and crimped straw observed.

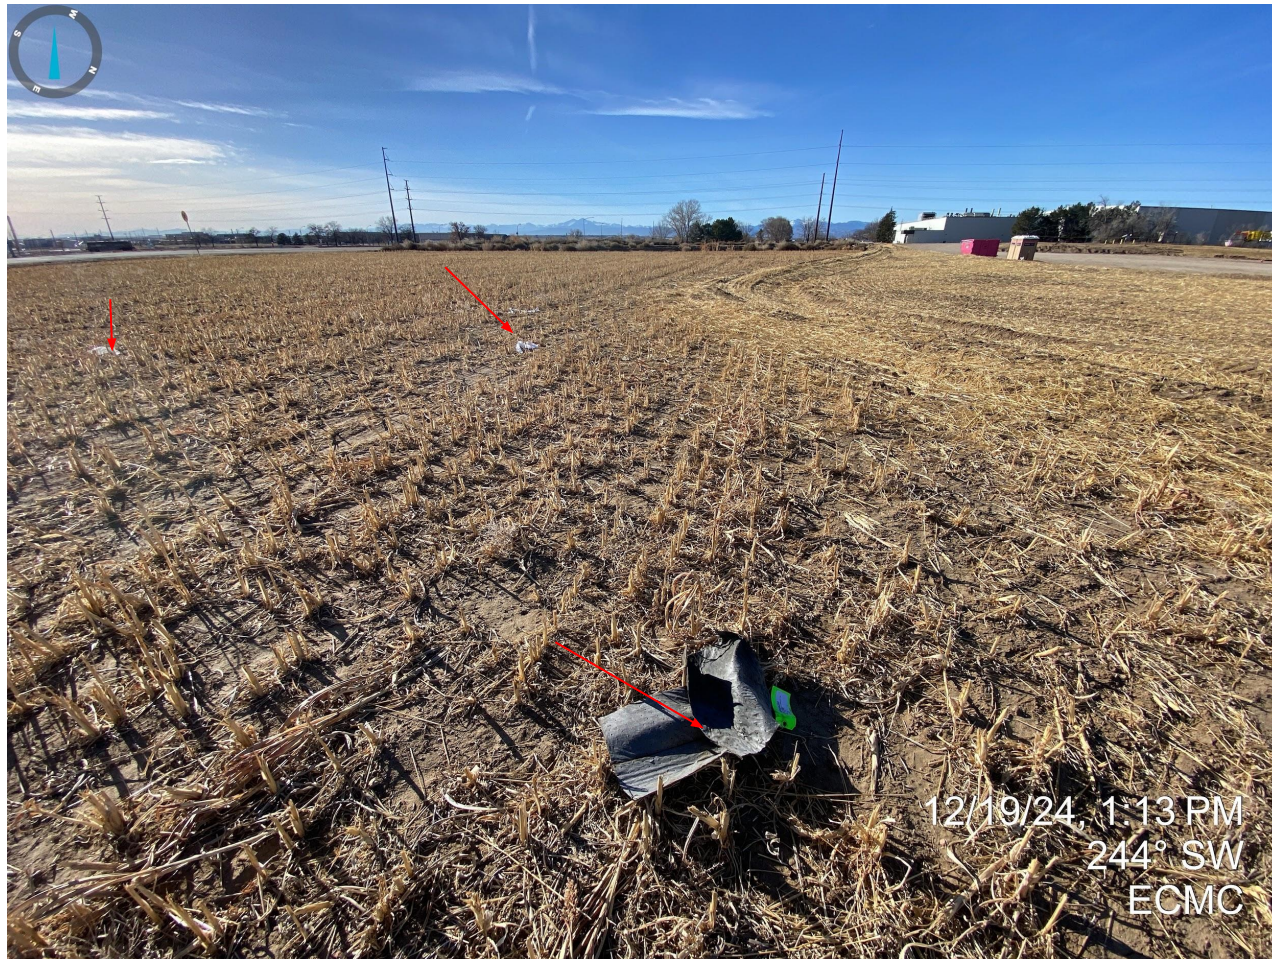
Photo 5. Trash/debris observed on the southern portion of the disturbance areas and off-location.

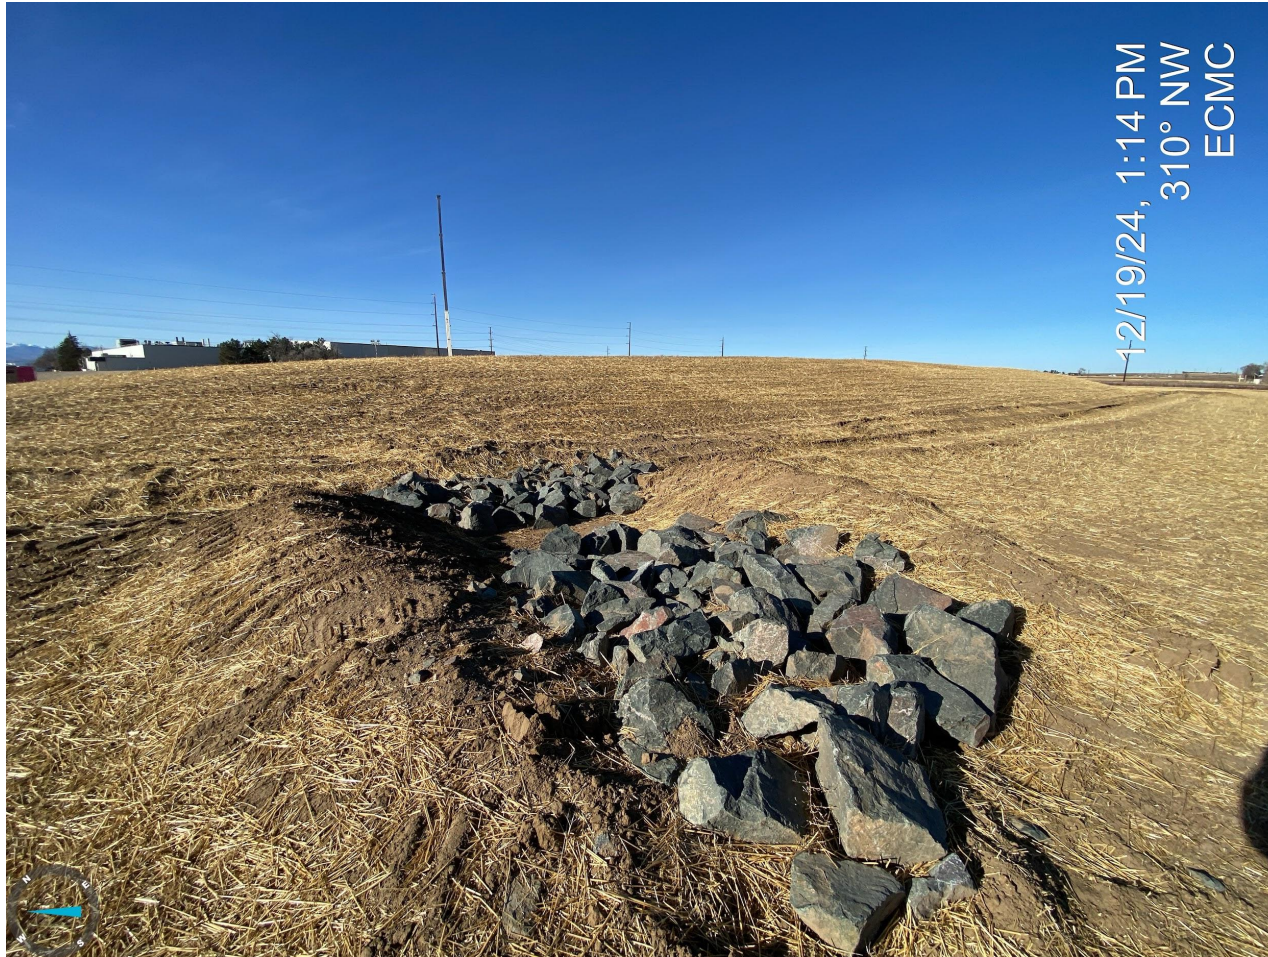
Photo 6. Ditch and berm with sediment trap observed on the east side of the topsoil stockpile.

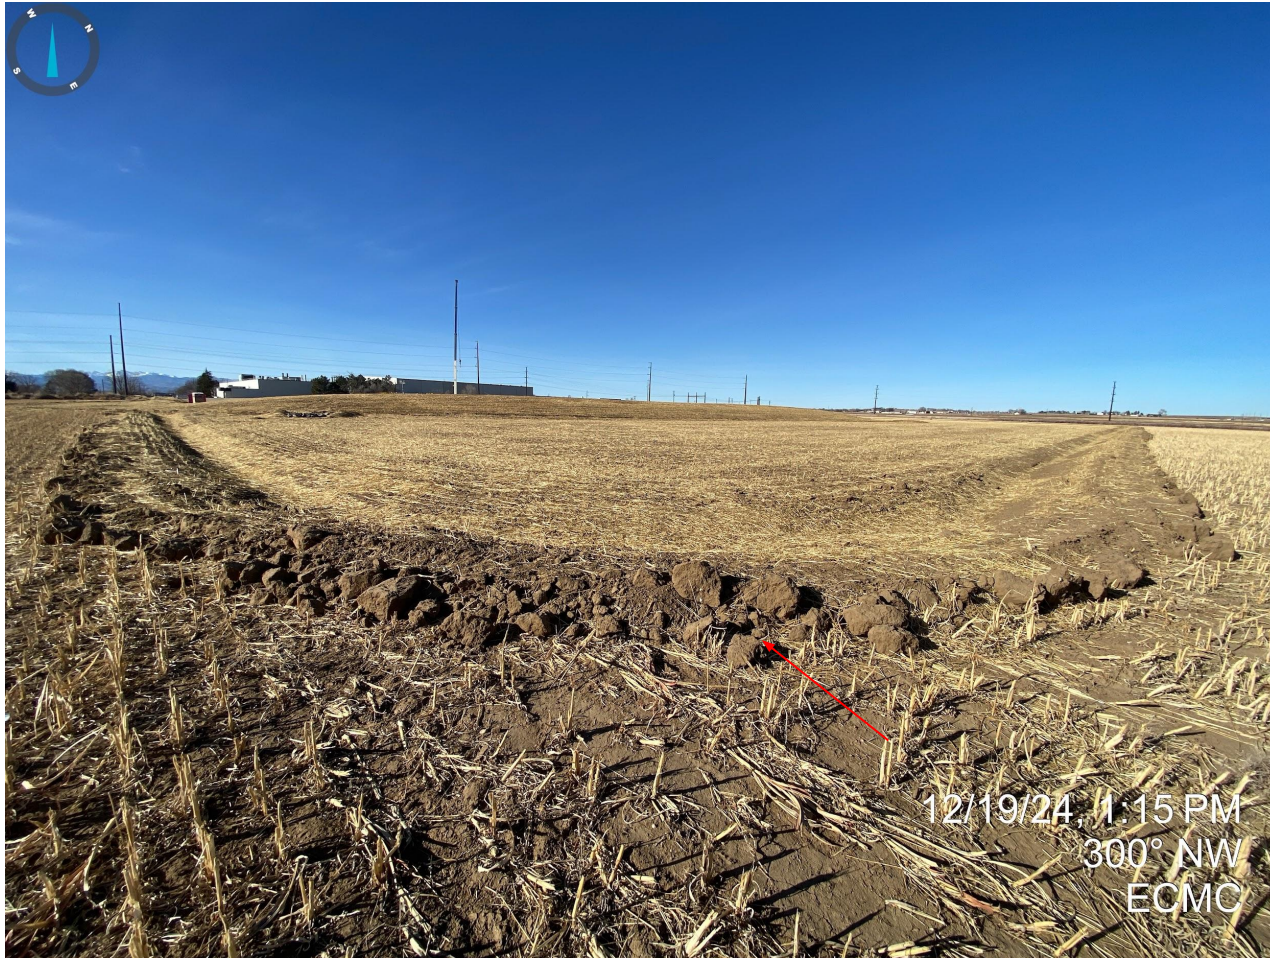
Photo 7. Southeast portion of the disturbance area. Portions of the perimeter berm have evidence of unconsolidated materials which might require additional maintenance to prevent erosion degradation and/or sediment transport.

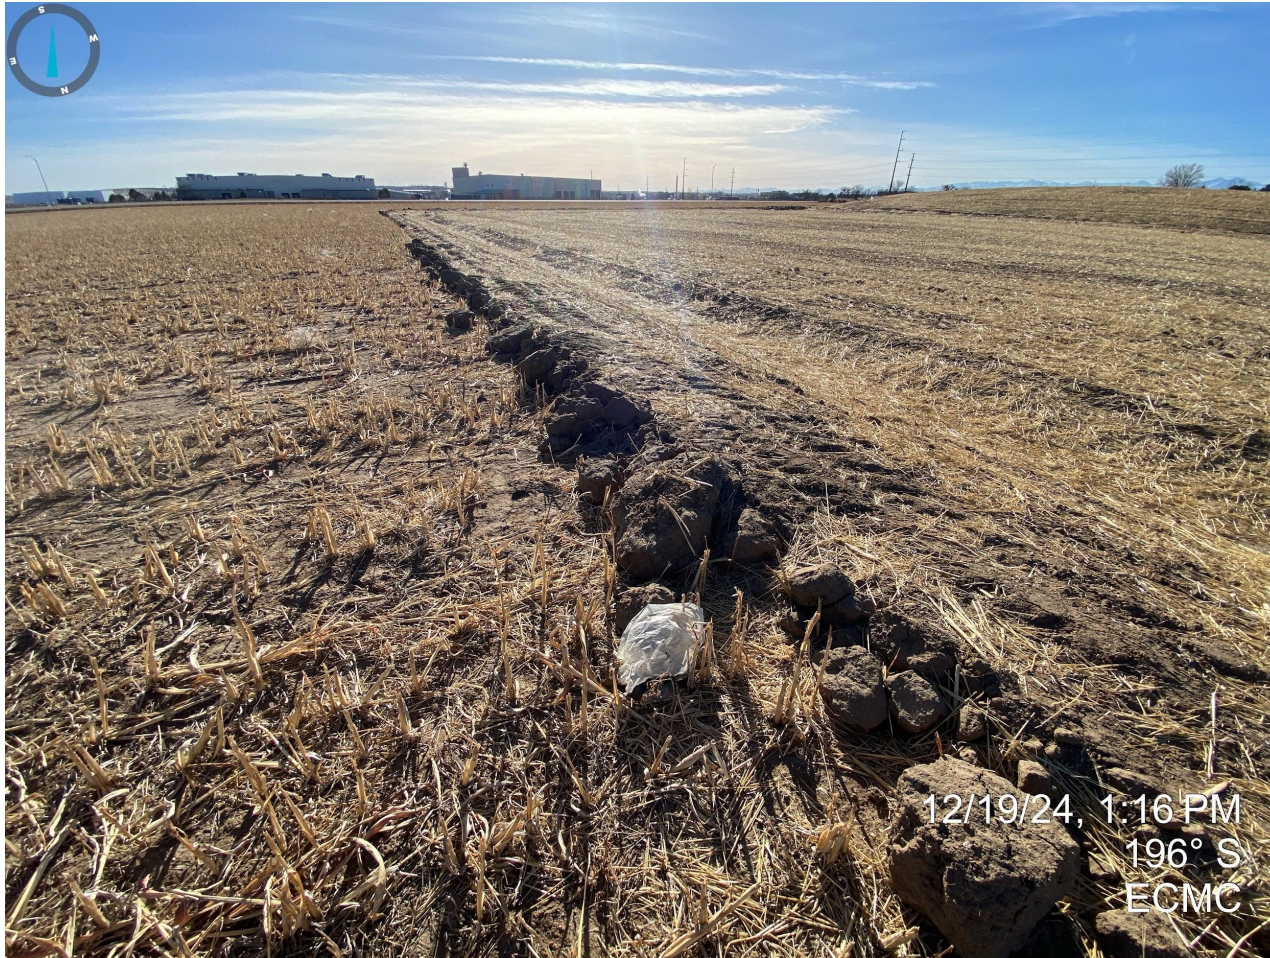
Photo 8. Continued from Photo 7; east side of disturbance area. Unconsolidated material and trash/debris observed.

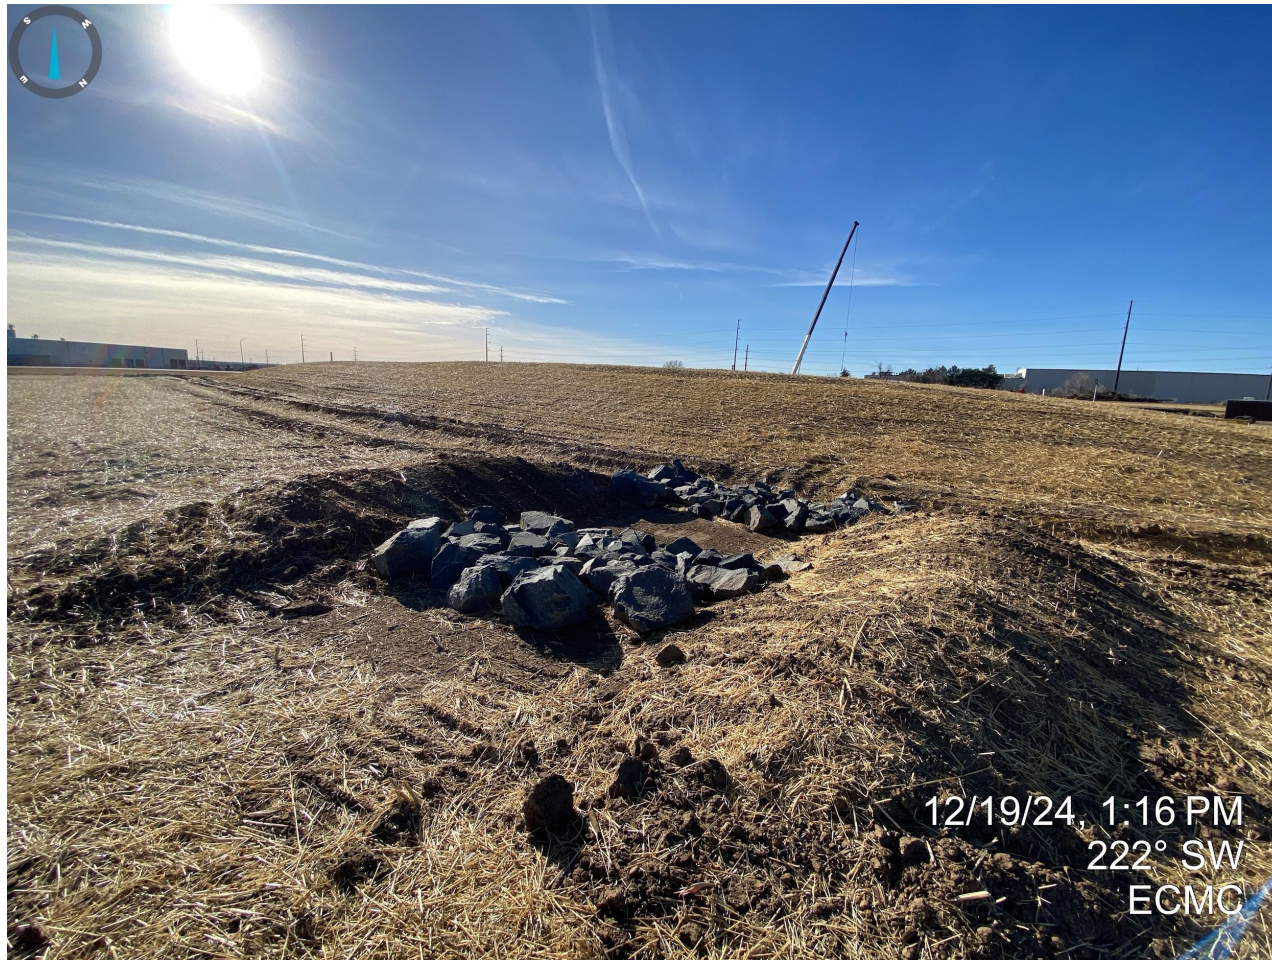
Photo 9. Ditch and berm with sediment trap observed on the east side of the topsoil stockpile.

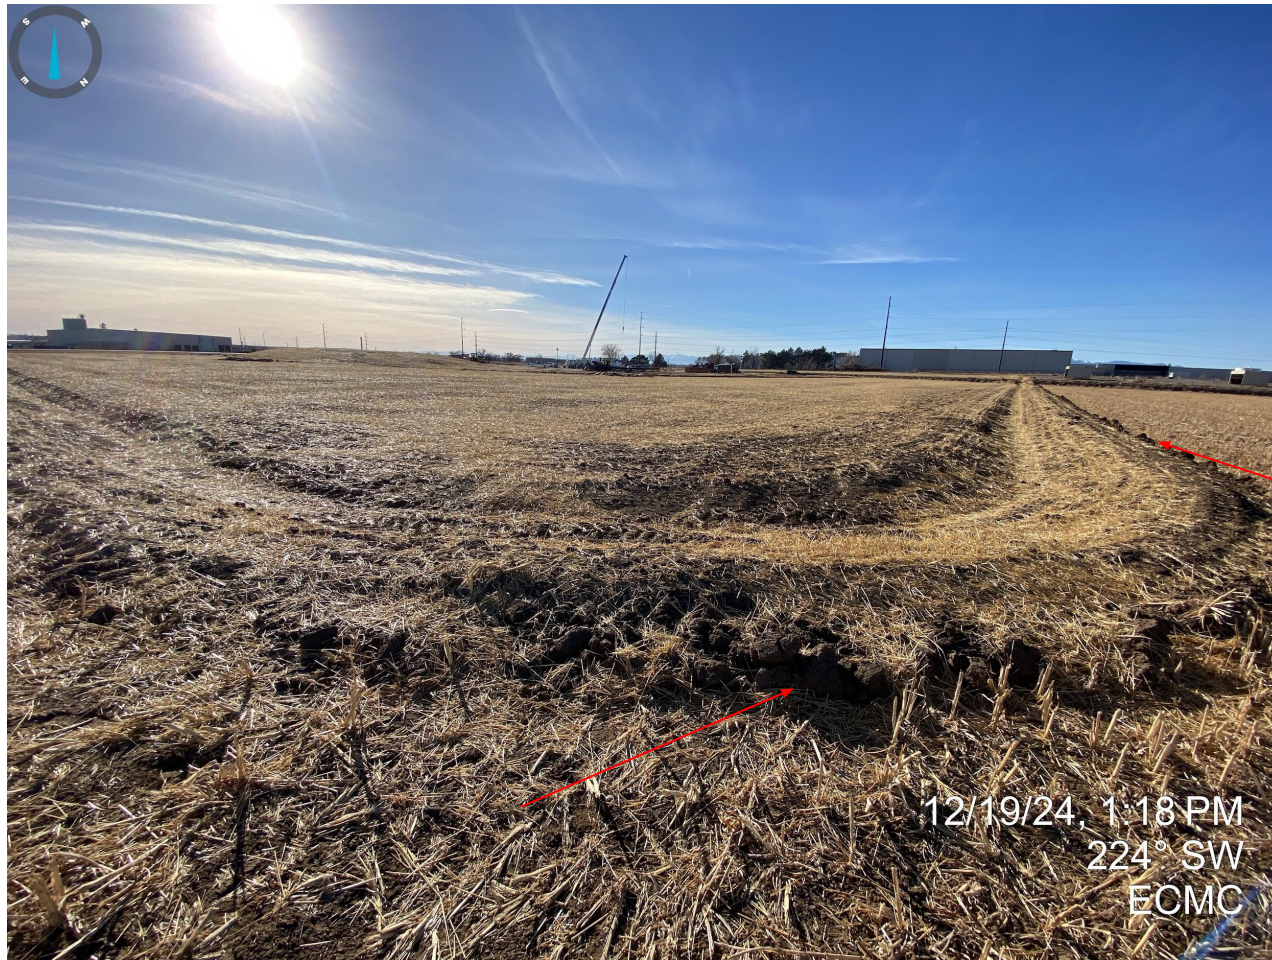
Photo 10. Northeast portion of the disturbance area. Portions of the perimeter berm have evidence of unconsolidated materials which might require additional maintenance to prevent erosion degradation and/or sediment transport.

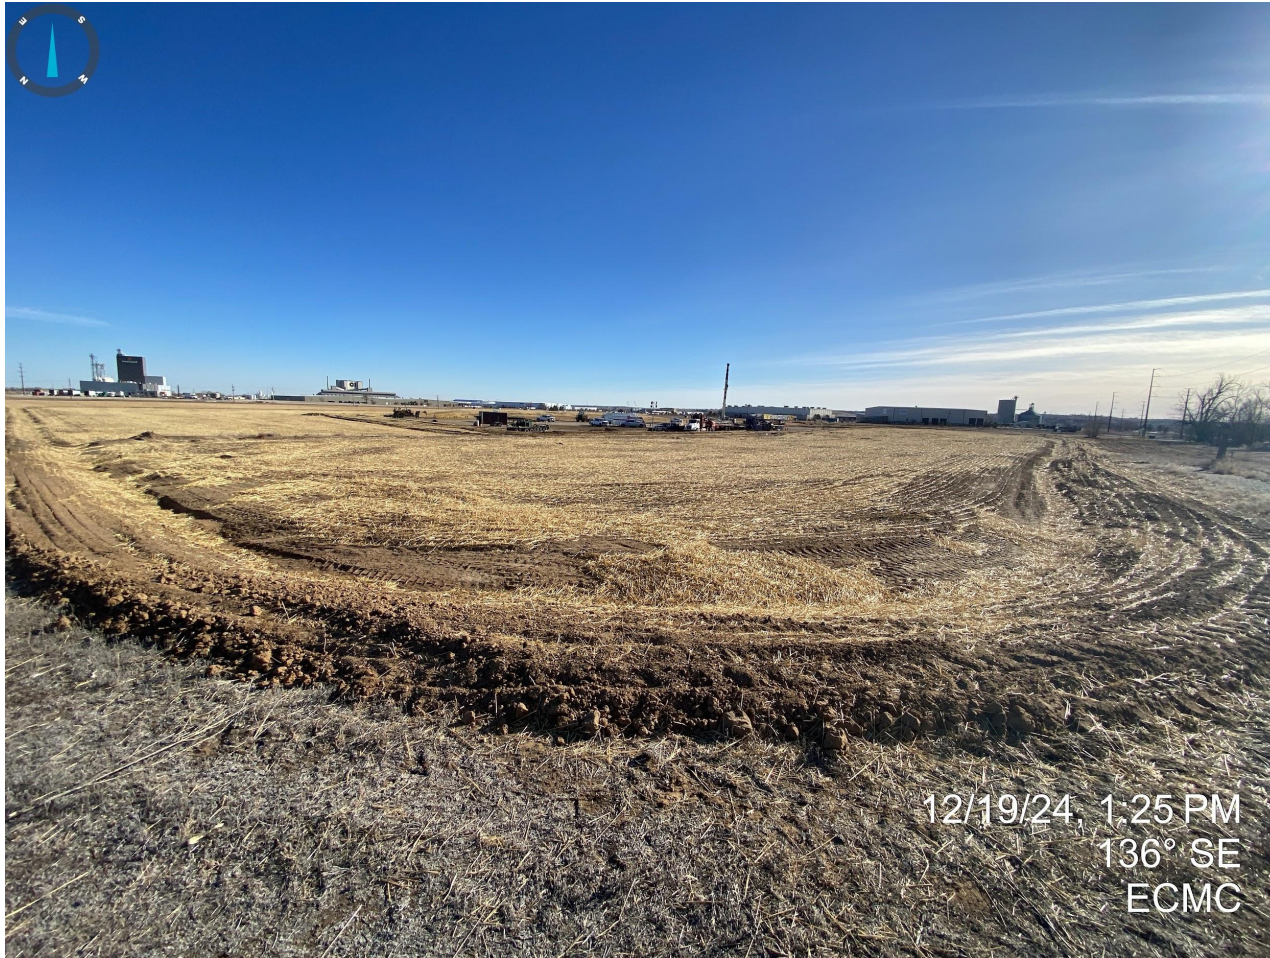
Photo 11. Northwest portion of the disturbance area. Perimeter stormwater control measures have been installed and disturbance areas appear to be stabilized with seeding and mulch.

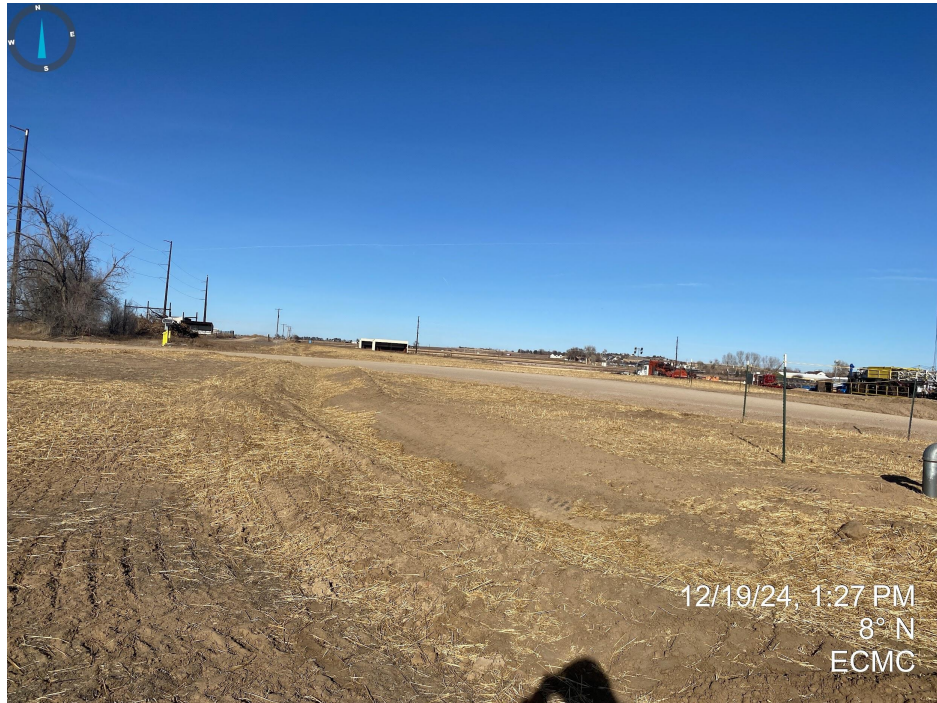
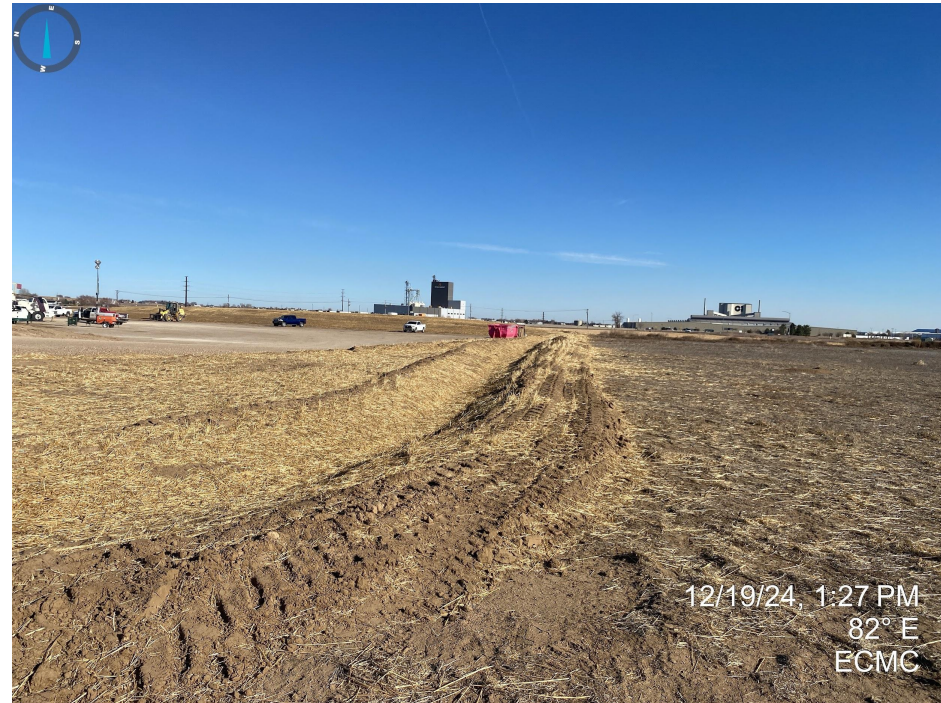
Photos 12 & 13. Southwest portion of the disturbance area. Perimeter stormwater control measures have been installed and disturbance areas appear to be stabilized with seeding and mulch.
