# Inspection Photos

**Operator:** LARAMIE ENERGY LLC #10433

**Location ID:** 487592

**Inspection Doc:** 718100118

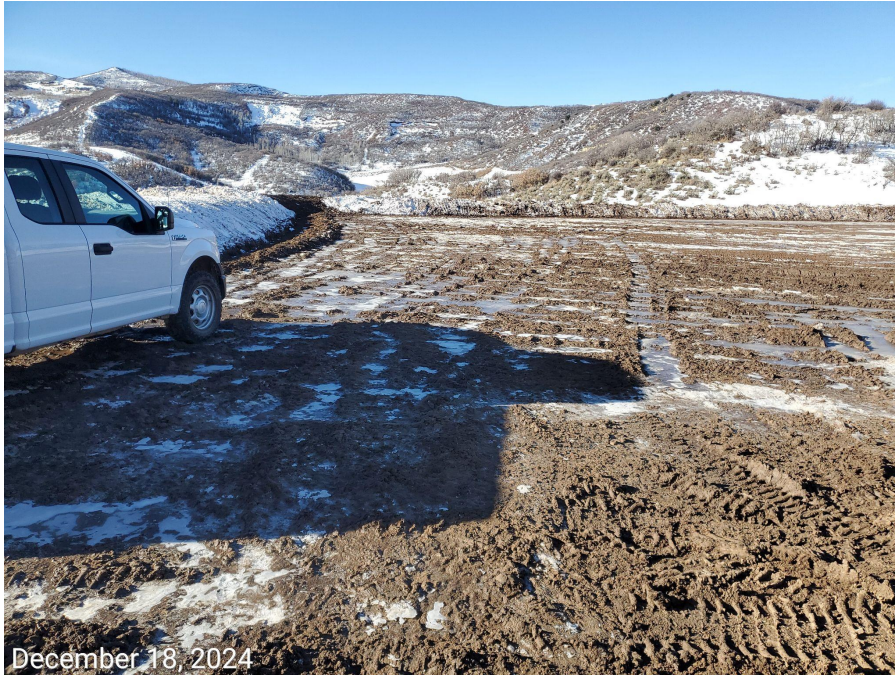
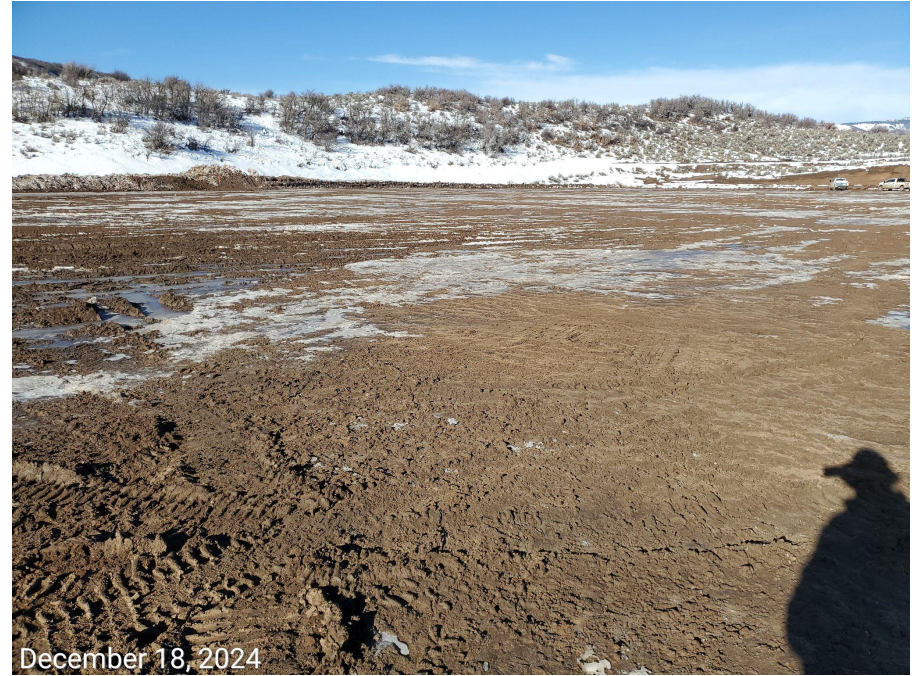
**Photo 1:** Photos 1-2 taken from the south end of the Location. Photos provide an overview from west, northwest, northeast to east.

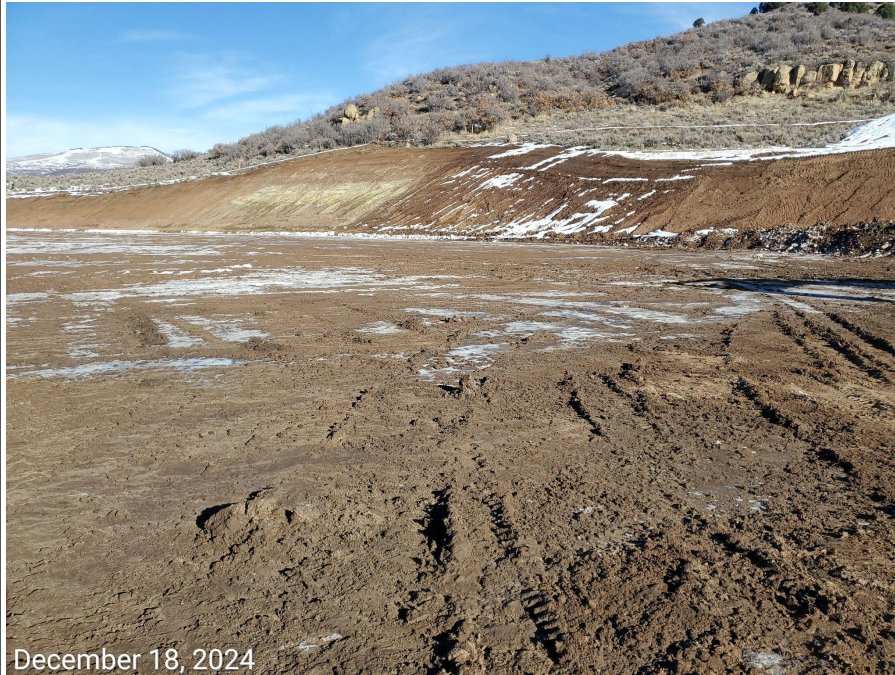
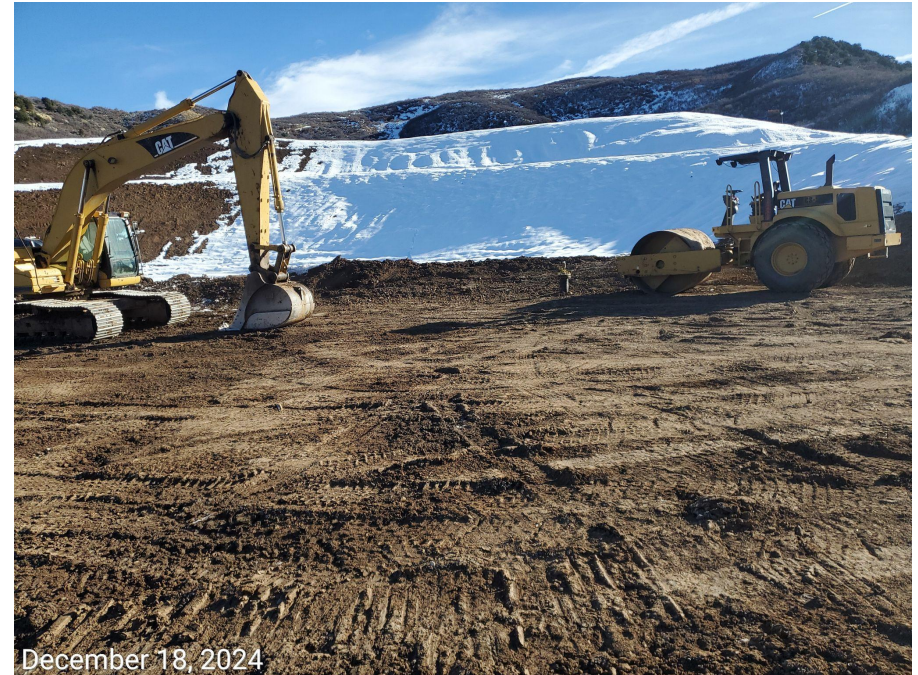
**Photo 2:** See comments under photo 1.

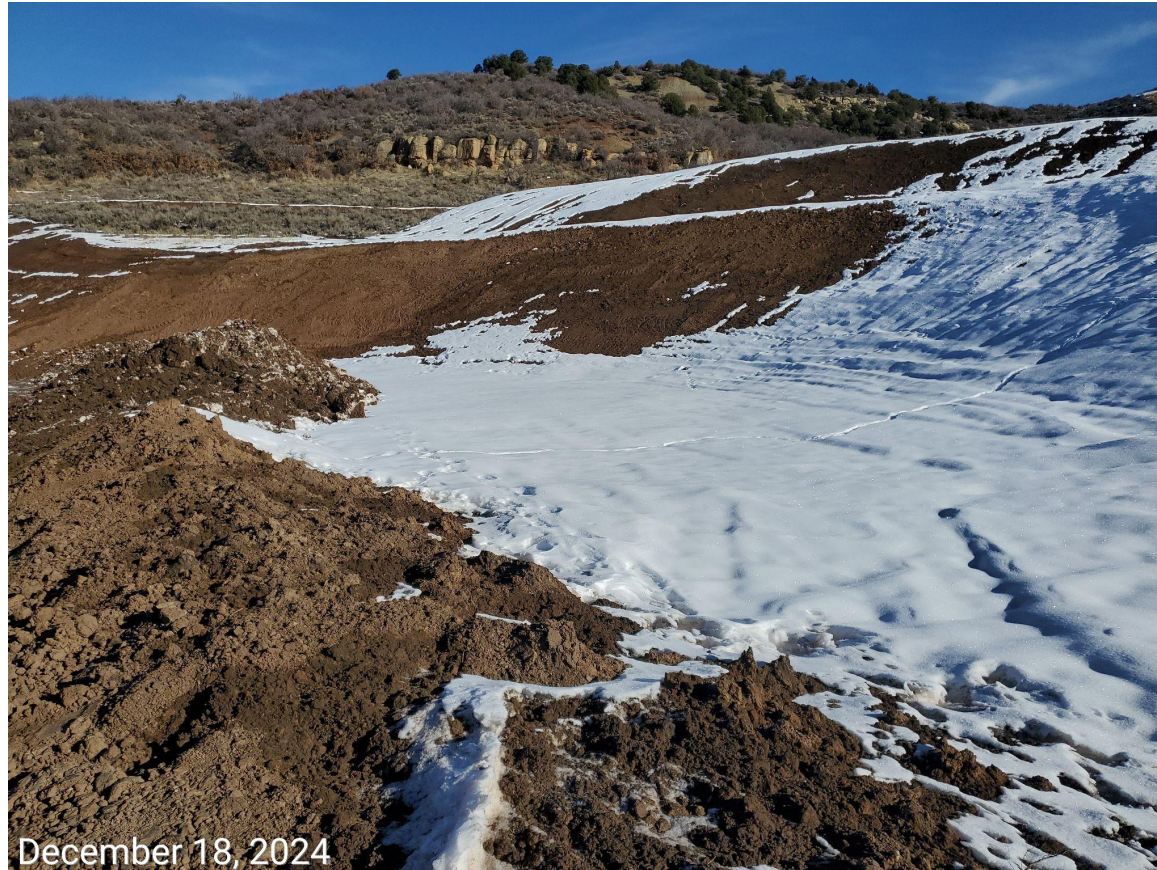
**Photo 3:** Photo shows cuttings trench constructed on the east end of the Location.

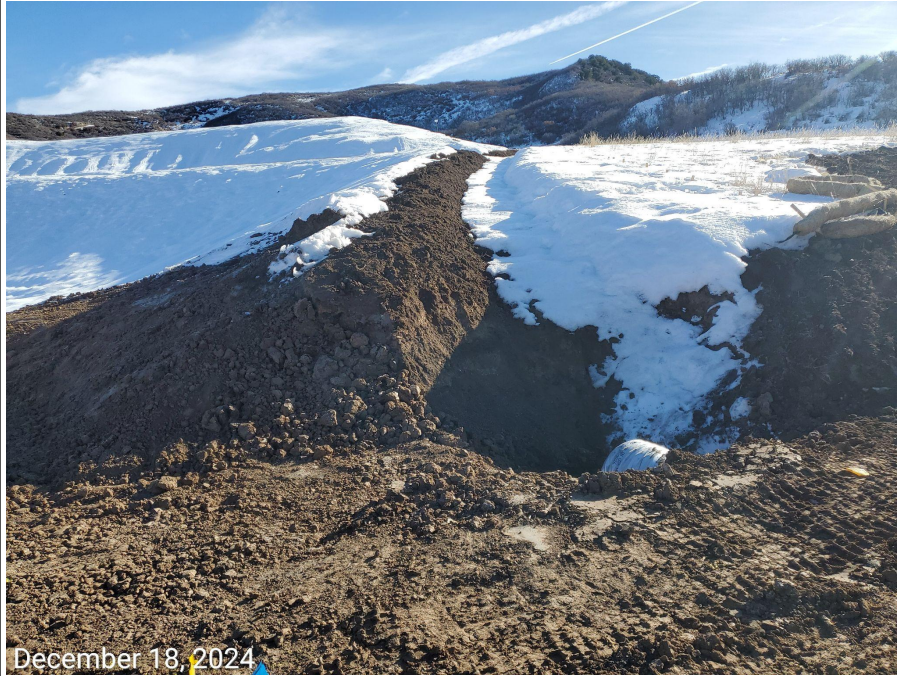
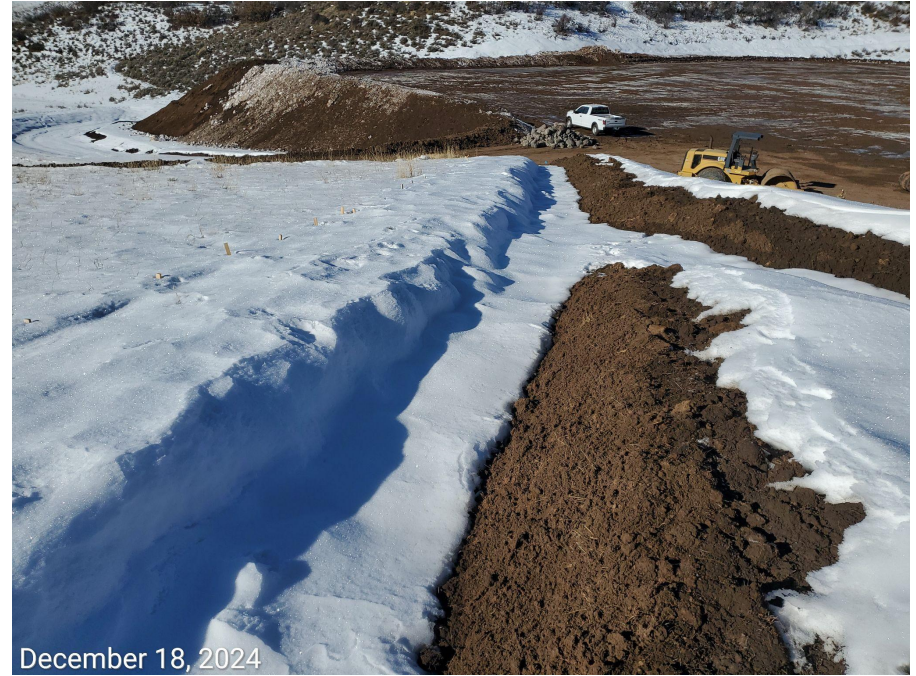
**Photo 4:** Photos taken from the southeast end of the Location. Photo shows perimeter stormwater diversion ditch has been completed. Photo right also shows culvert and sediment trap installed at ditch/location entrance; BMP has not been constructed with properly engineered inlet/outlet protections.

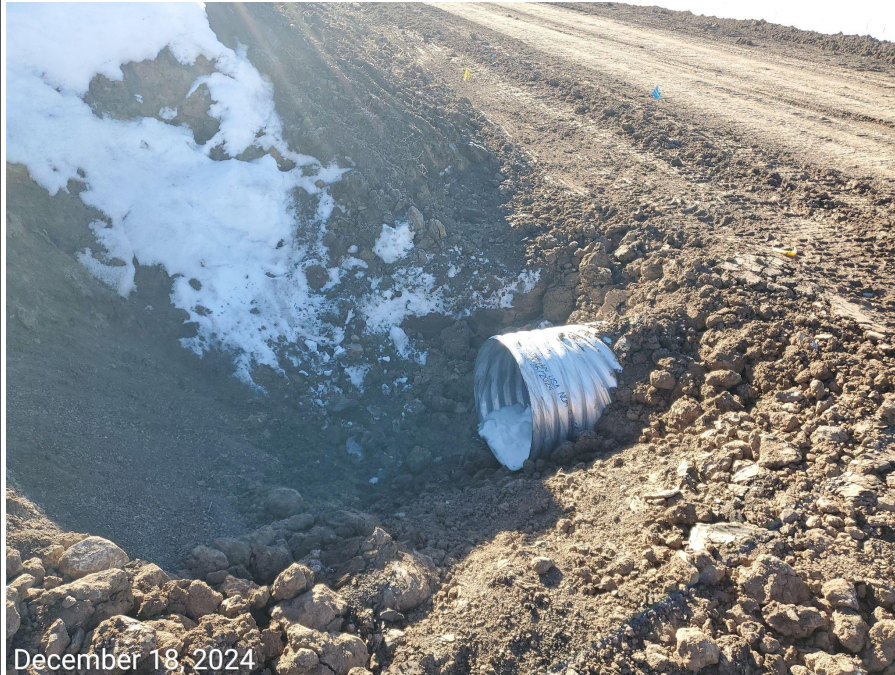
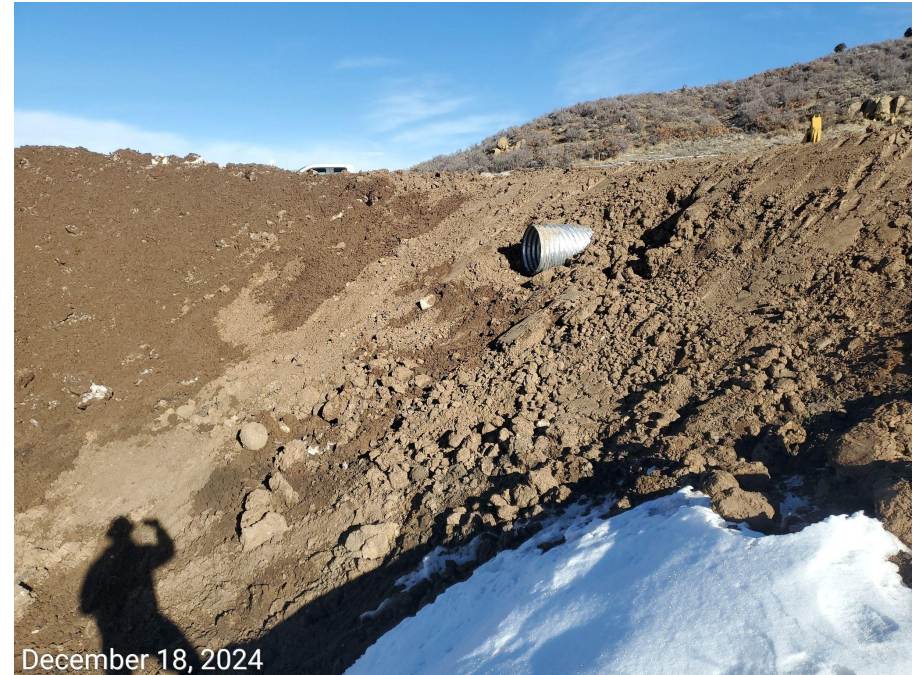
**Photo 5:** Photos taken from the Location entrance on the south end of the Location. Photos show culvert and sediment trap(s) have been installed at the location entrance; BMP has not been constructed with properly engineered inlet/outlet protections.

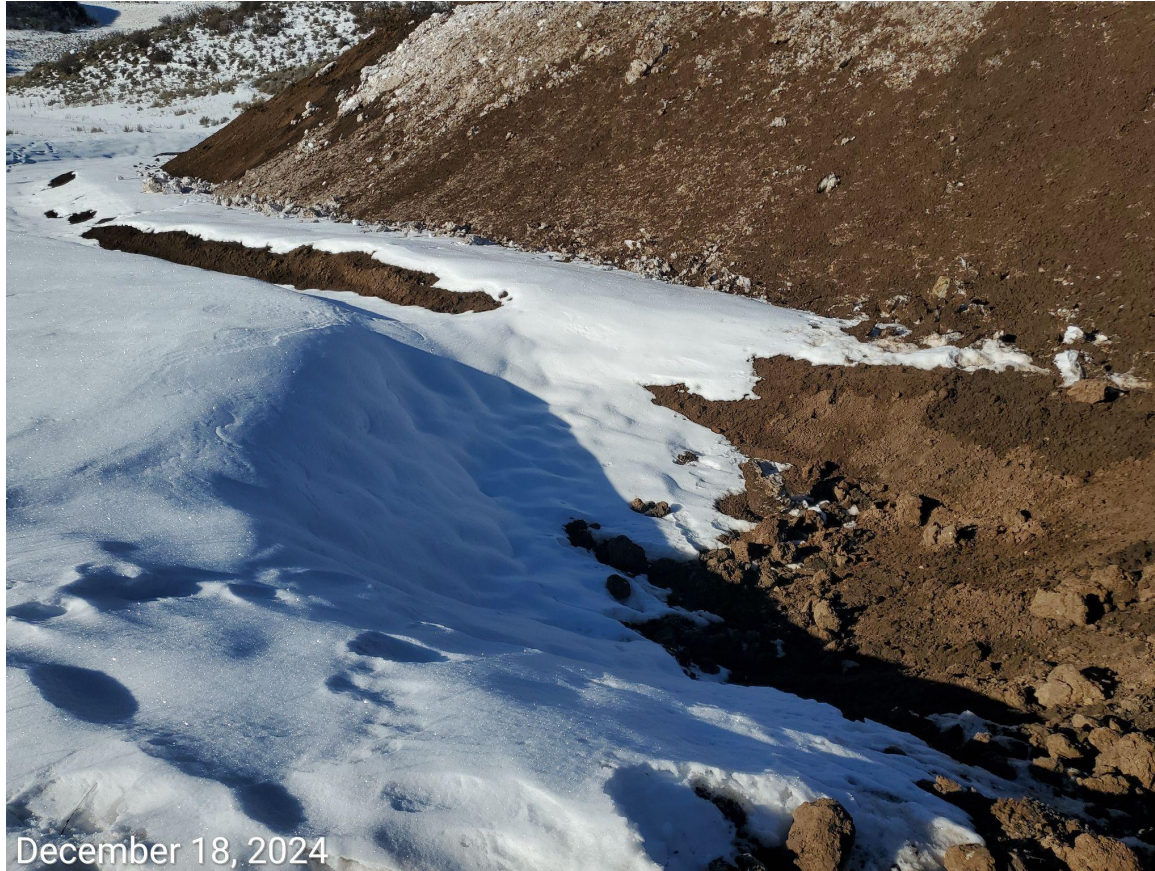
**Photo 6:** Continued from photo 5. Sediment trap at culvert has not be installed/constructed with properly engineered inlet/outlet protections.

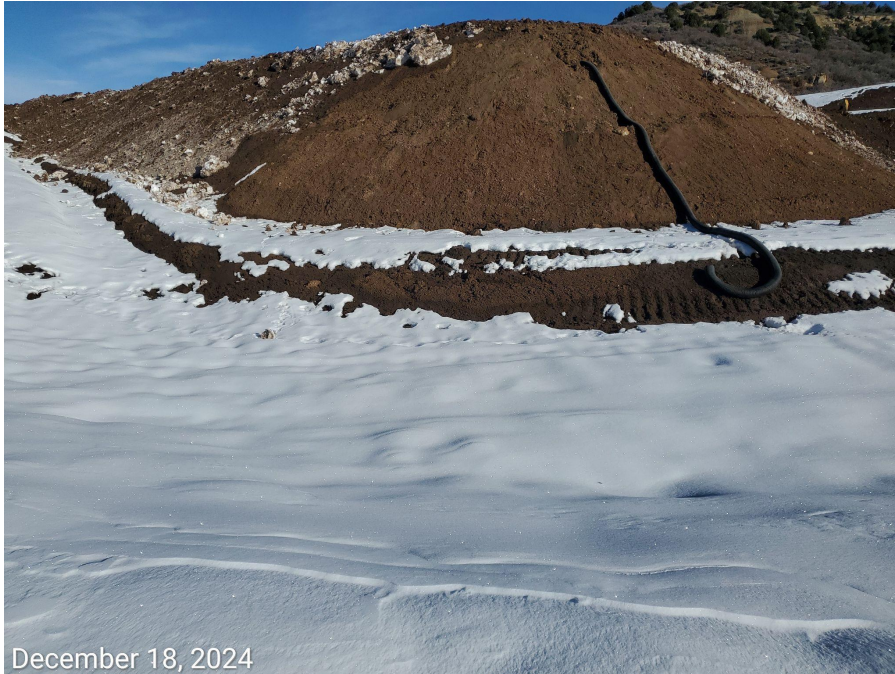
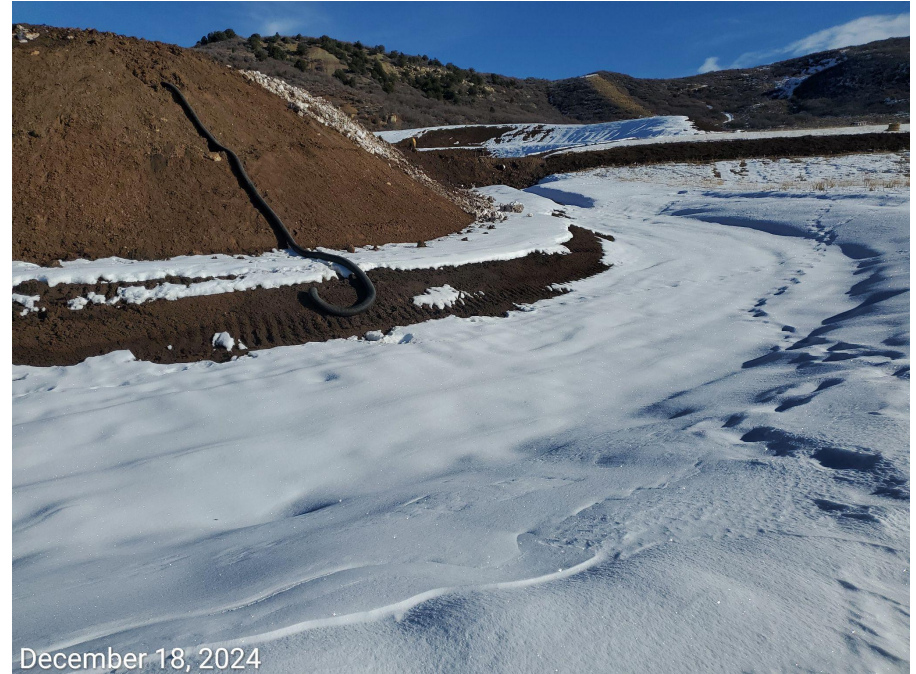
**Photo 7:** Photo taken from the sediment trap on the southwest end of the Location, facing northeast and east.

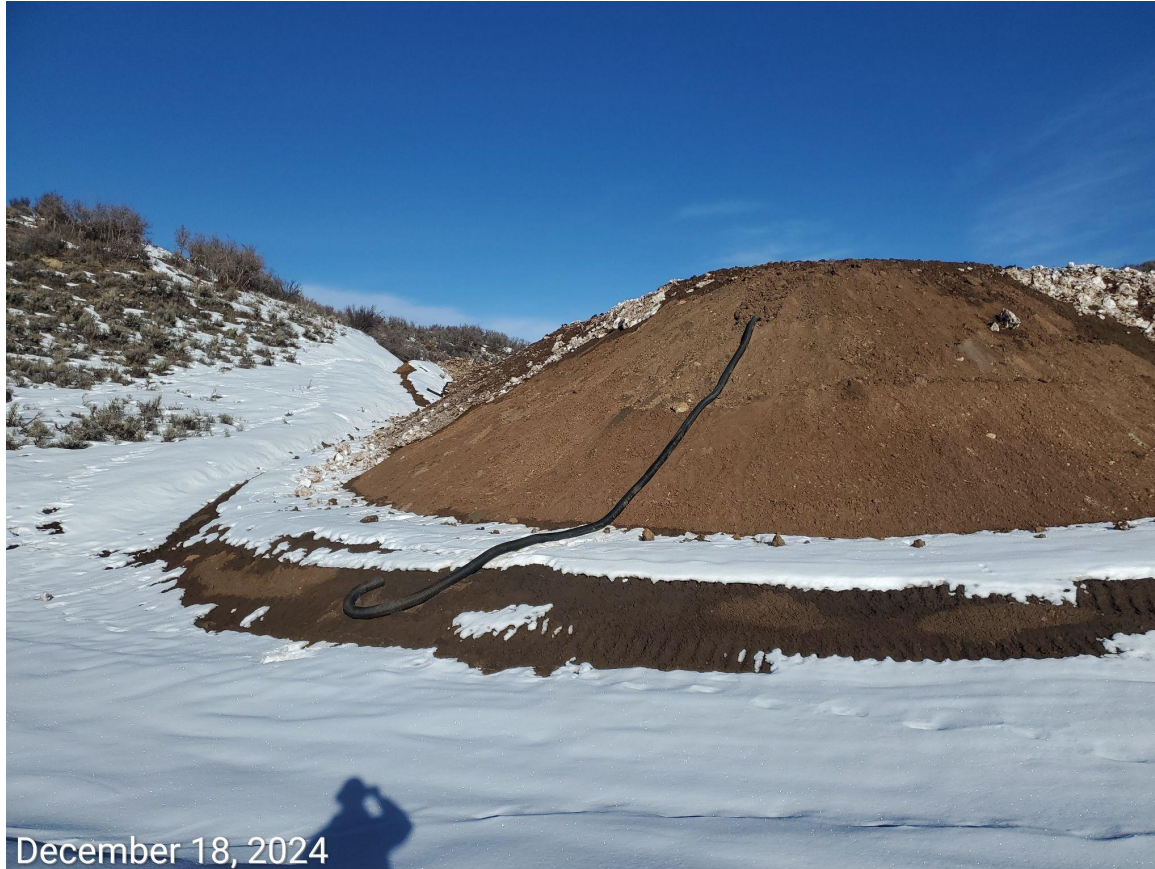
**Photo 8:** Photo taken from the southwest end of the Location. Operator has installed a slope drain; BMP has not been secured, or constructed with a properly engineered and armored outlet.

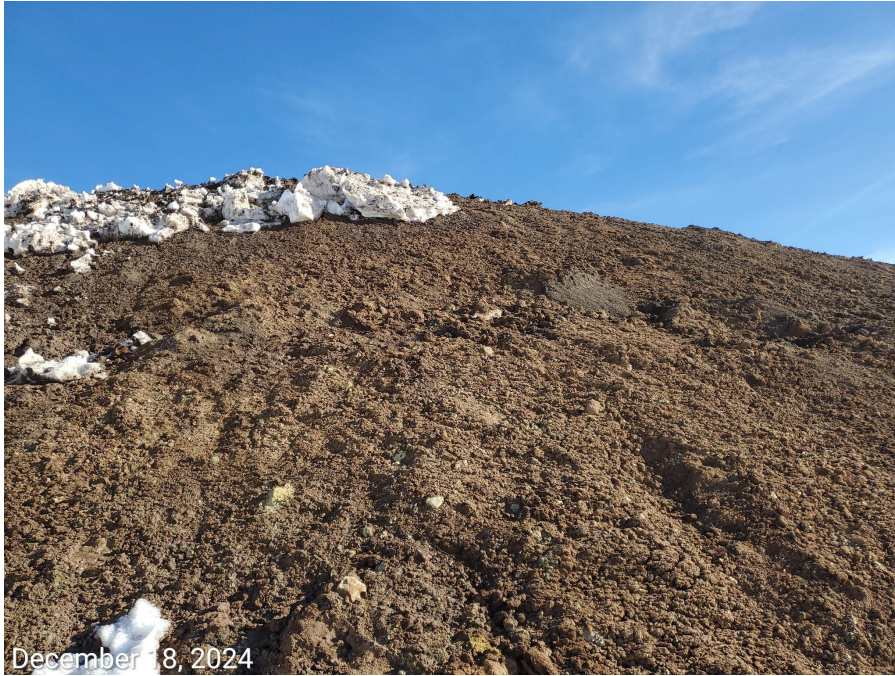
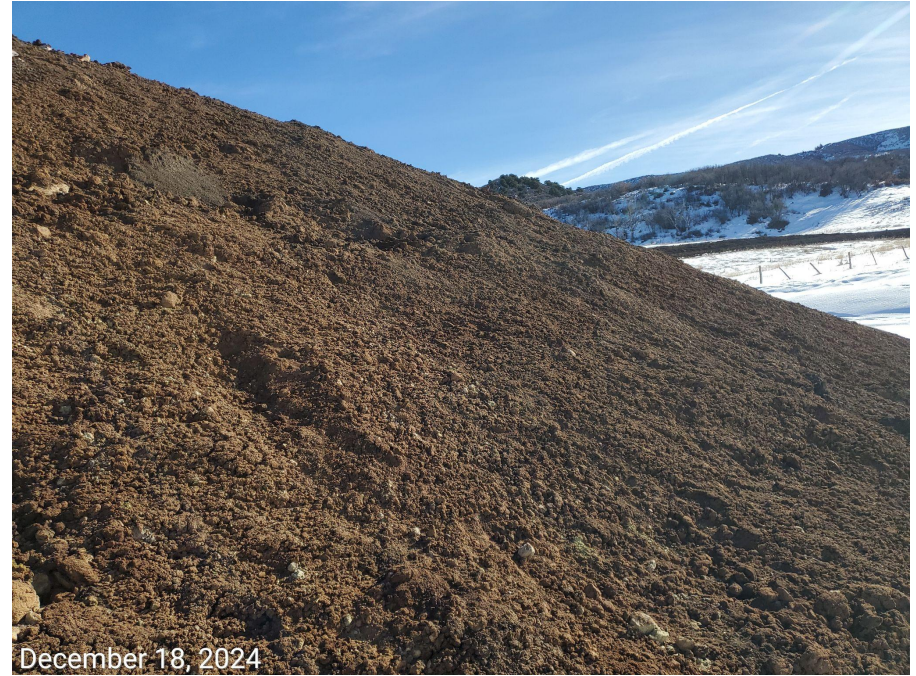
**Photo 9:** Photos taken from the fill slopes on the southwest end of the Location. Photos examples showing BMPs to stabilize the slopes, as well as to minimize erosion and degradation remain missing or insufficient.

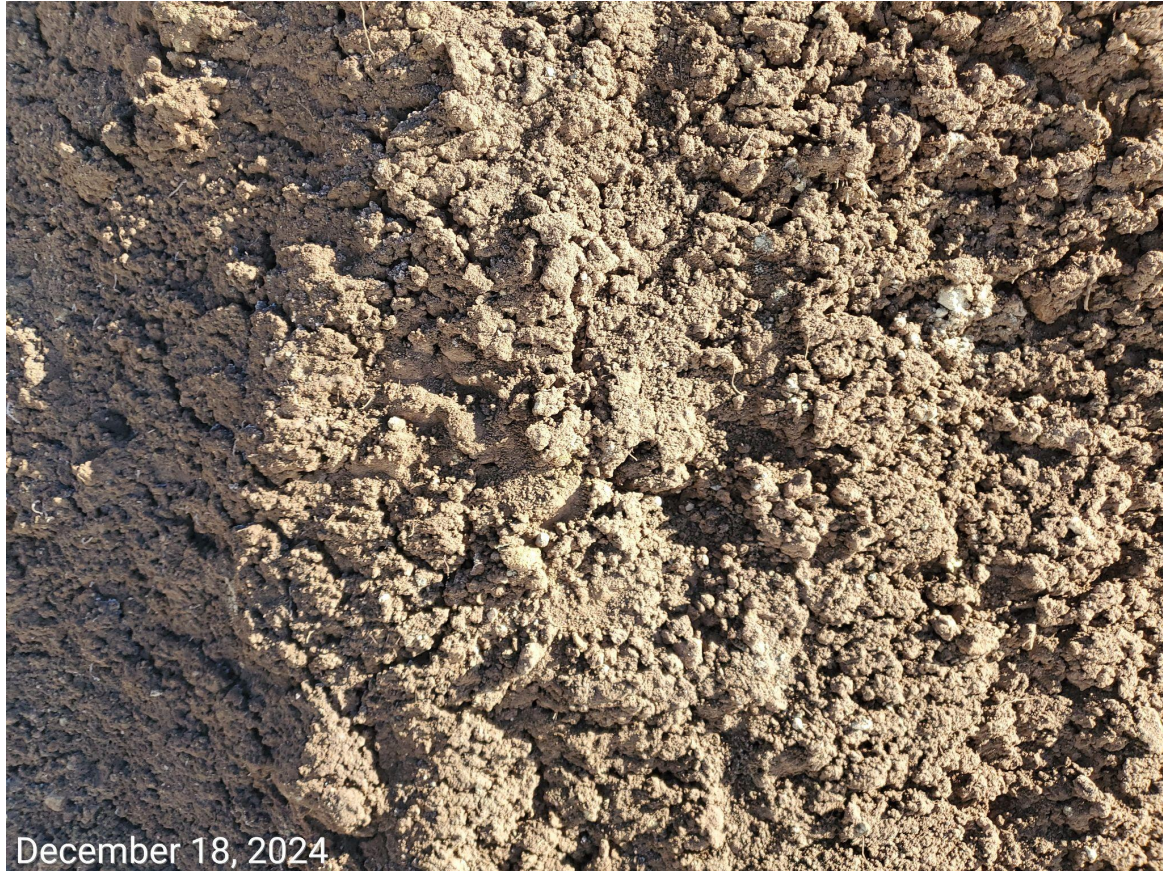
**Photo 10:** Photo taken from the fill slopes on the southwest end of the Location. Photo example showing BMPs to stabilize the slopes, as well as to minimize erosion and degradation remain missing or insufficient.

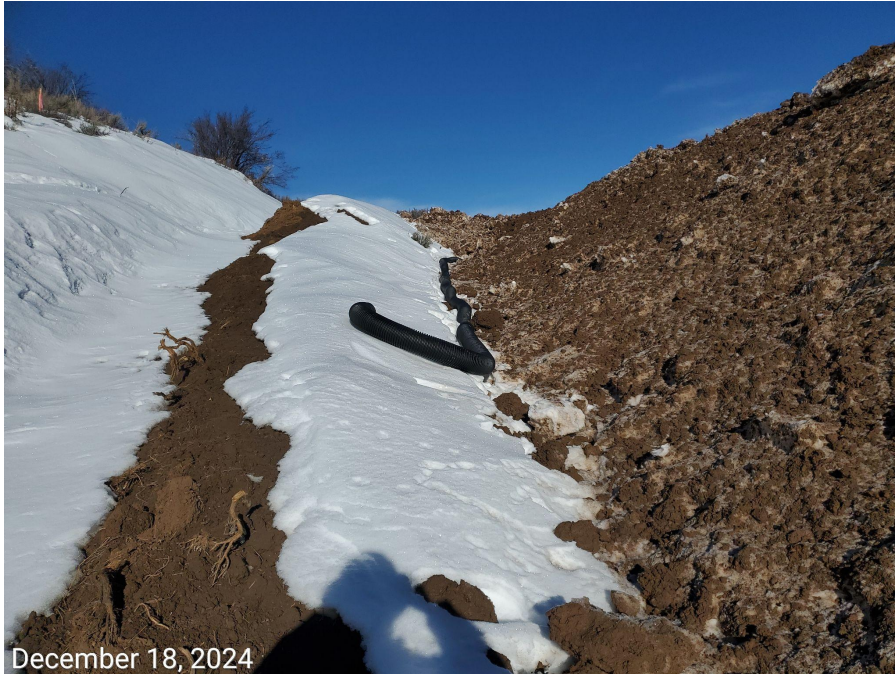
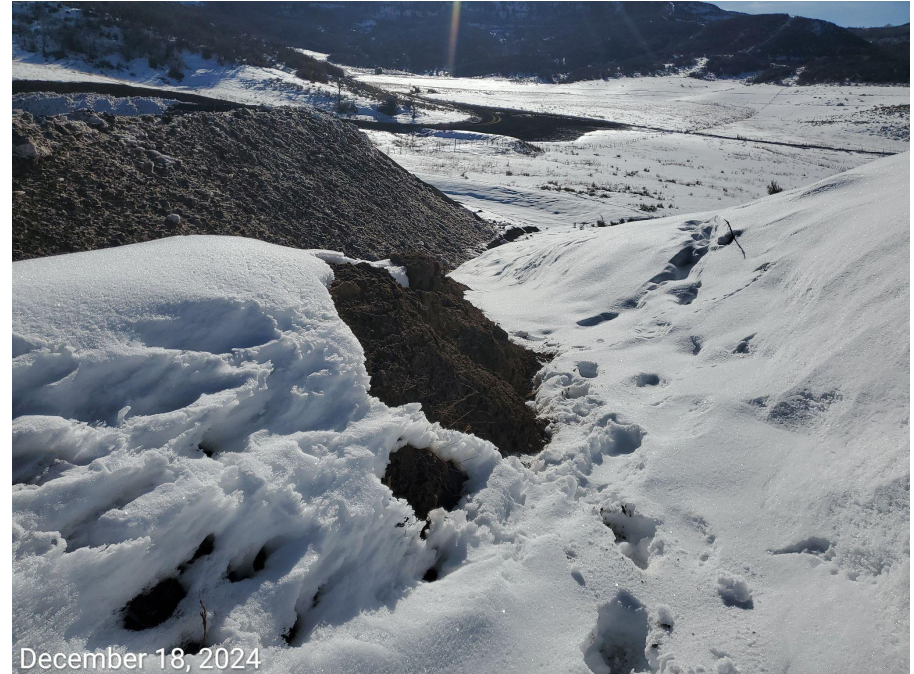
**Photo 11:** Photos show stormwater diversion ditch along the western perimeter of the Location has been completed. Photo left also shows Operator has installed a slope drain on the west end of the pad; BMP has not been secured, or constructed with a properly engineered and armored outlet per good engineering practice.

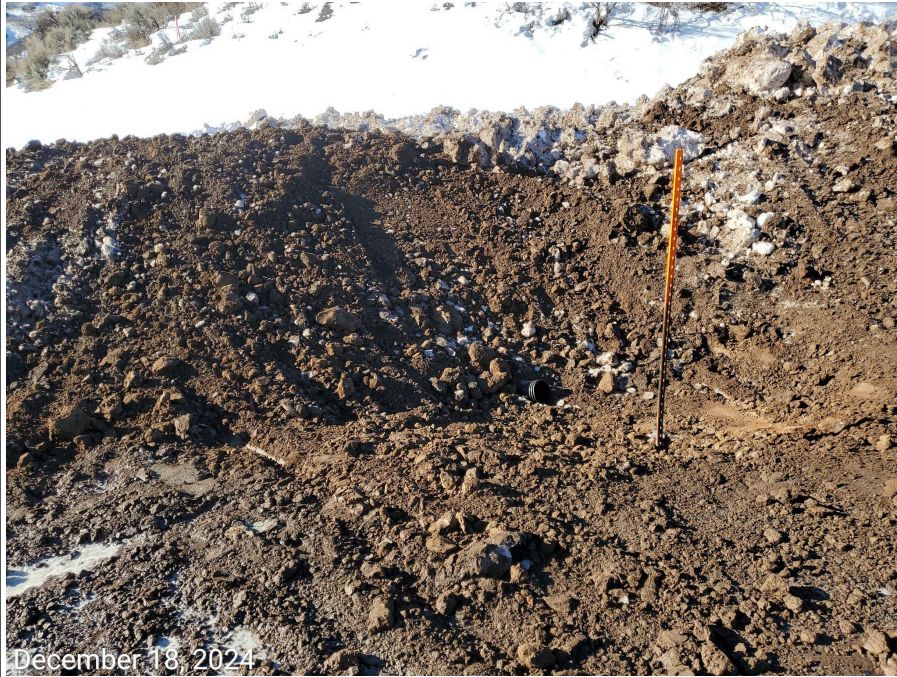
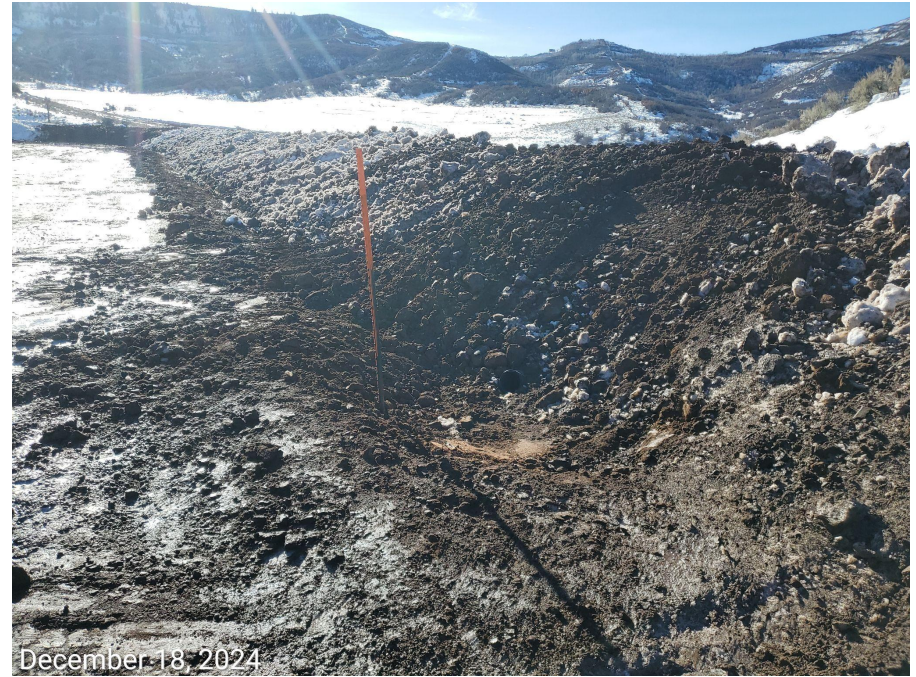
**Photo 12:** Photos show slope drain at the west end of the pad. Slope drains on the Location have not been installed with a properly engineered and armored Inlet/outlet, including inlet/outlet protections

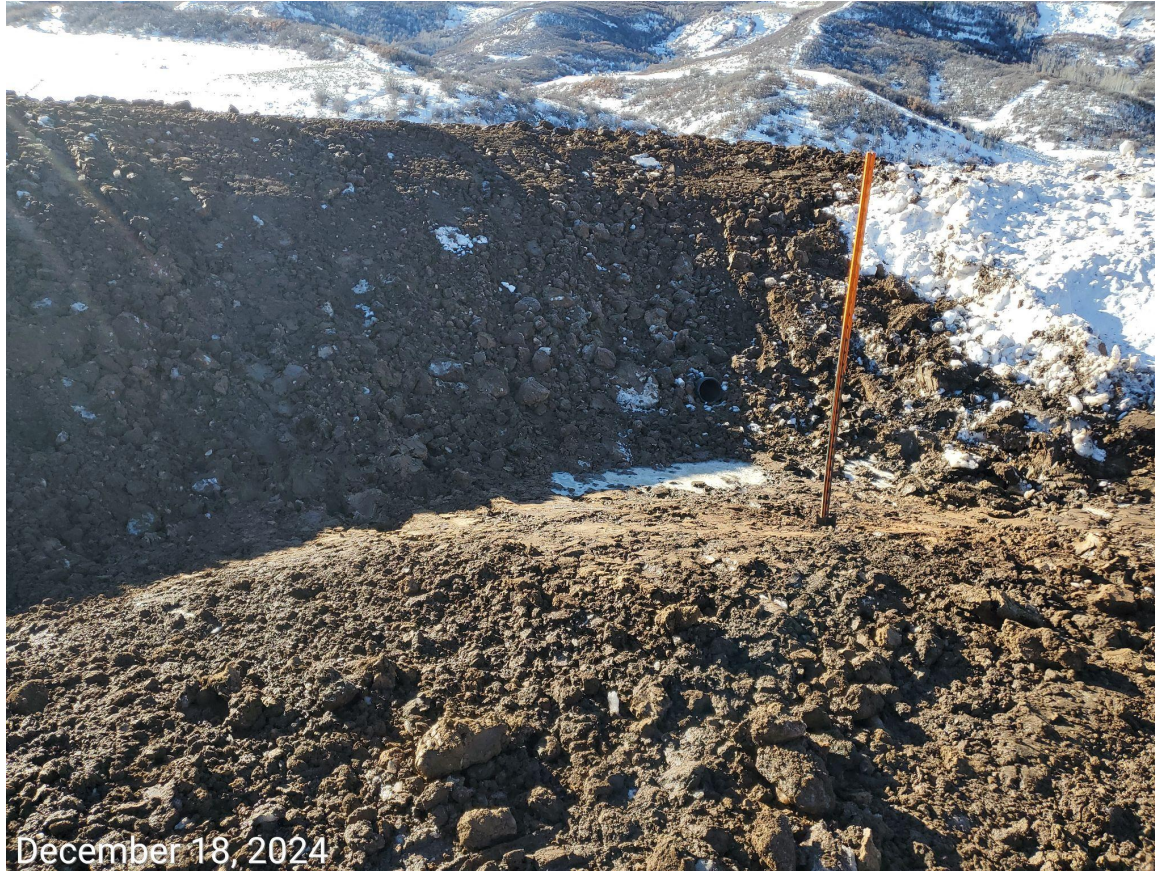
**Photo 13:** Photo shows slope drain installed on the southwest end of the pad. Slope drains on the Location have not been installed with a properly engineered and armored Inlet/outlet, including inlet/outlet protections.

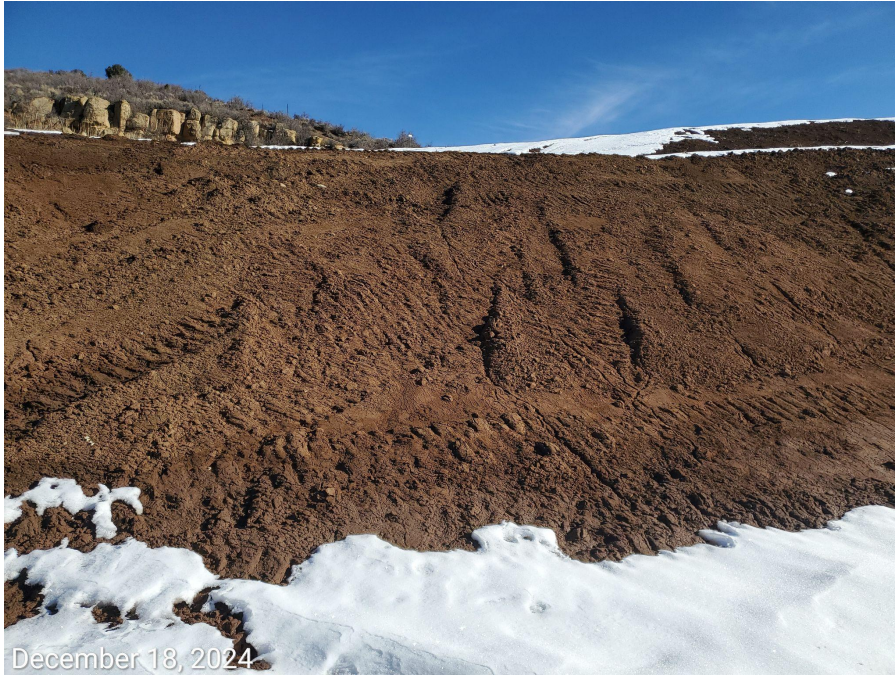
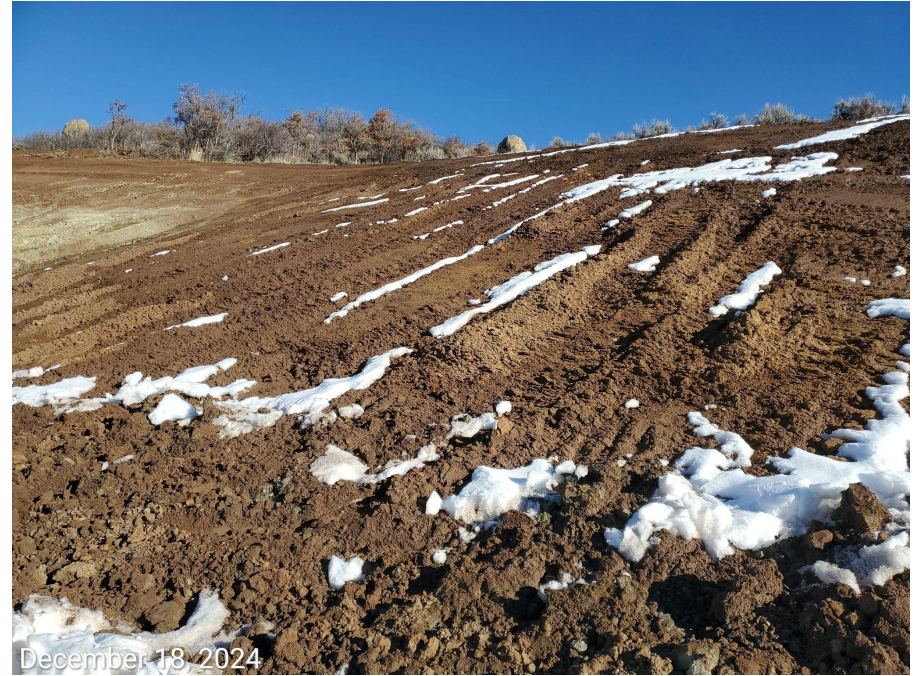
**Photo 14:** Photos taken from the cut slopes on the east/northeast end of the Location. Photos examples showing BMPs to stabilize the slopes, as well as to minimize erosion and degradation remain missing or insufficient.

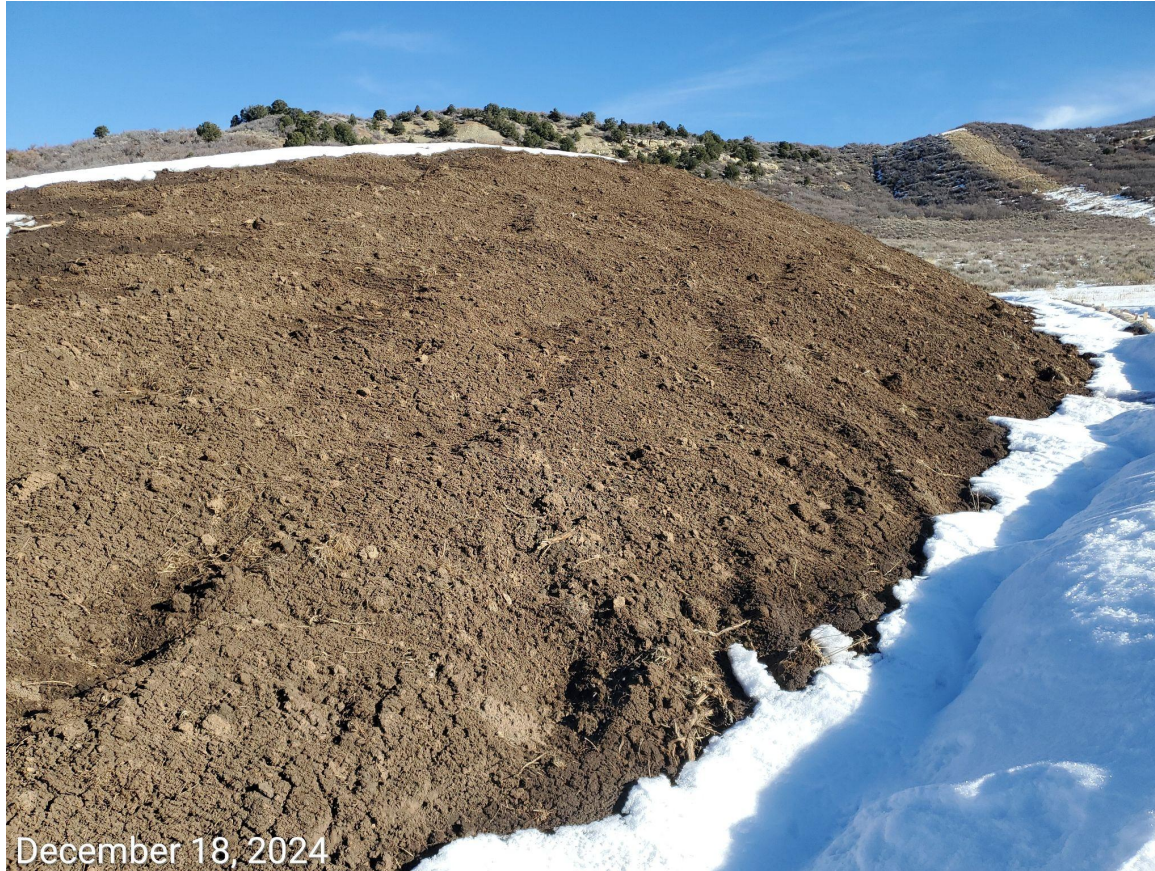
**Photo 15:** Photo taken from the topsoil stockpile on the east end of the Location. Photos examples showing BMPs to stabilize the slopes, as well as to minimize erosion and degradation remain missing or insufficient.

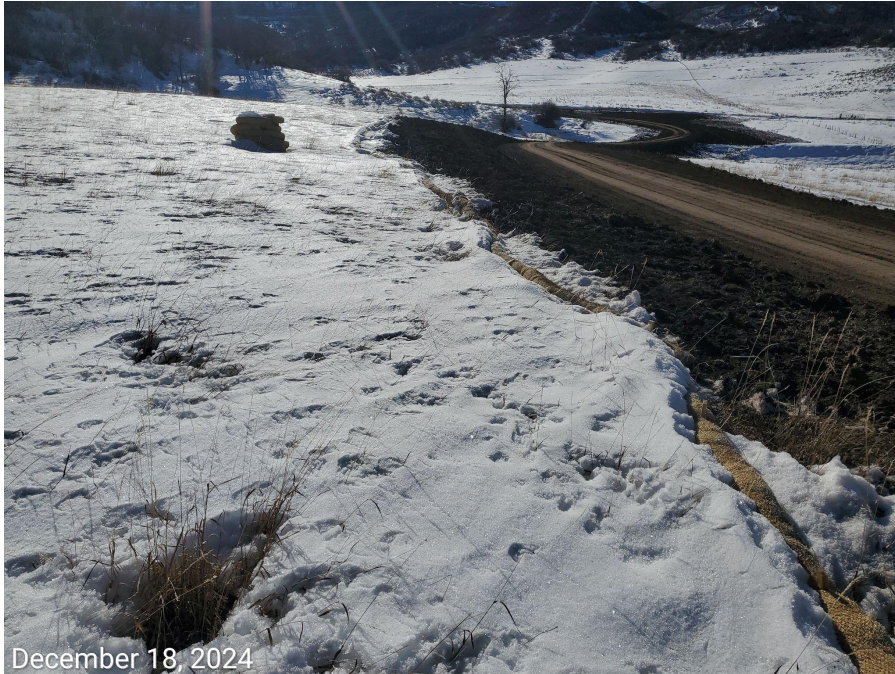
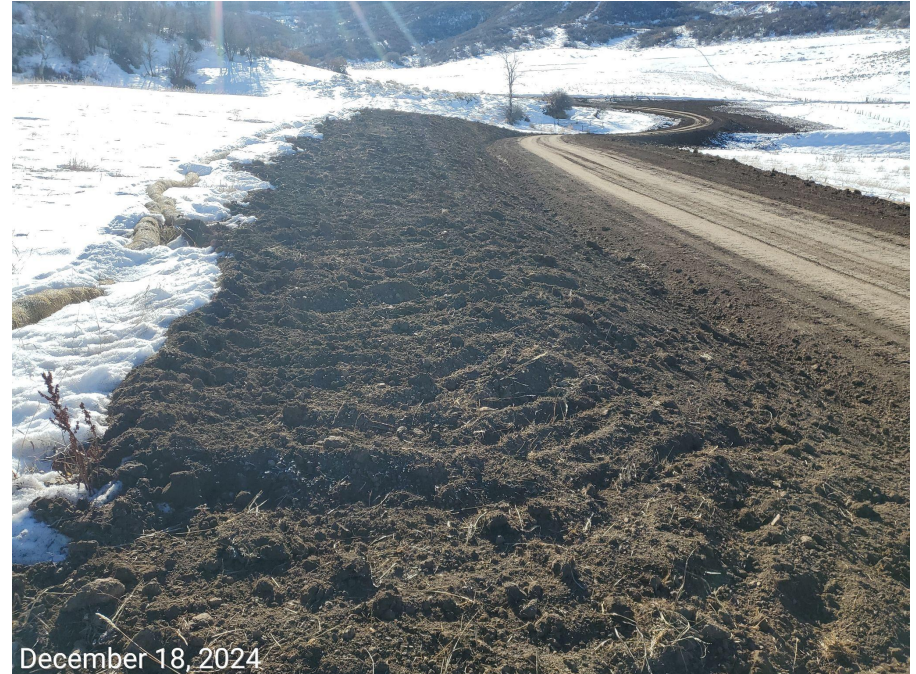
**Photo 16:** Photos taken from the access road. Road has been contoured and erosion logs have installed upslope. Photos also show that the topsoil remains bare and exposed; BMPs to stabilize the slopes, as well as to minimize erosion and degradation remain missing or insufficient.

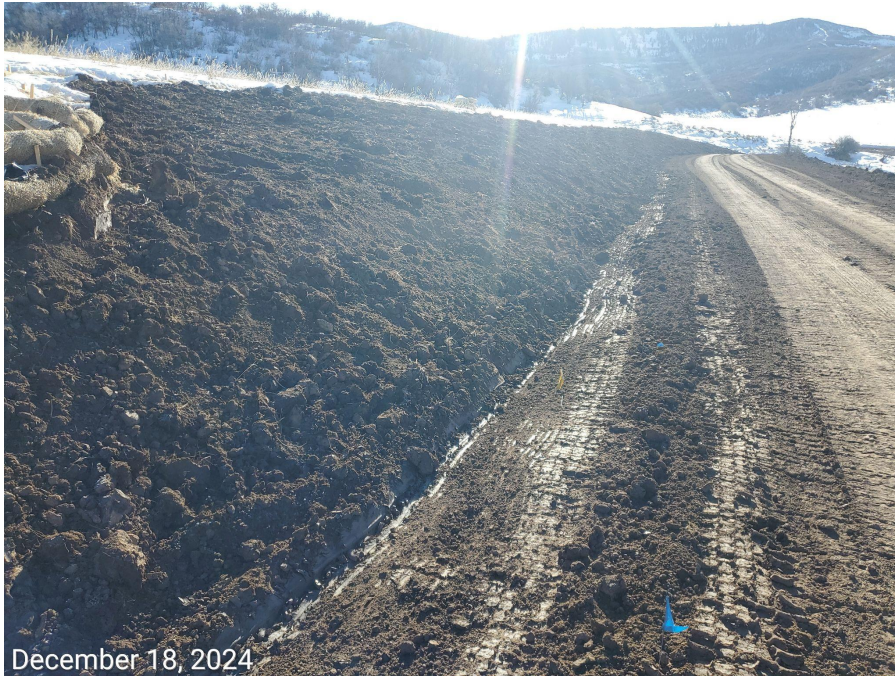
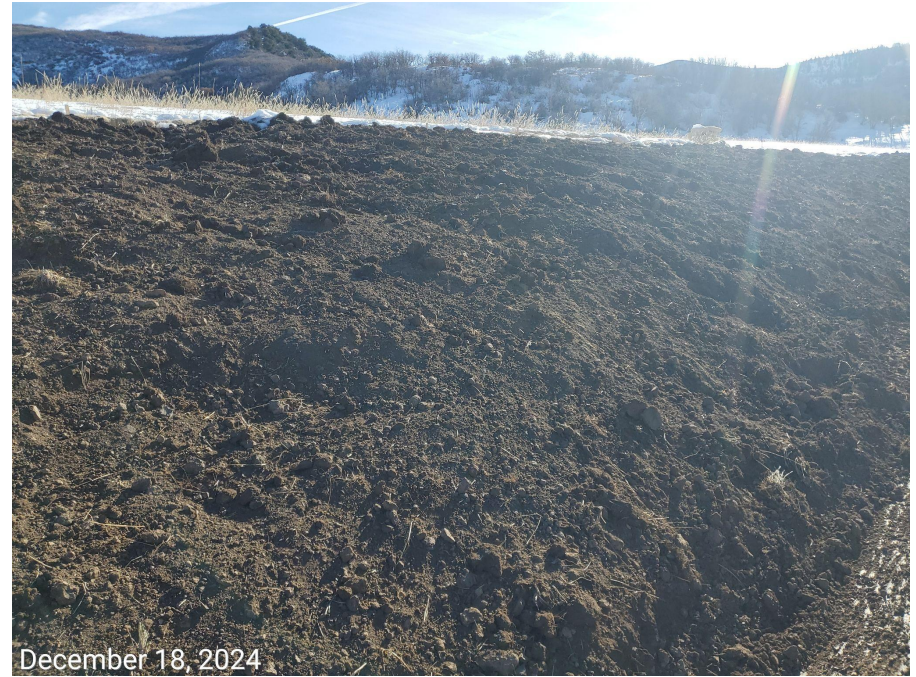
**Photo 17:** See comments under photo 16.

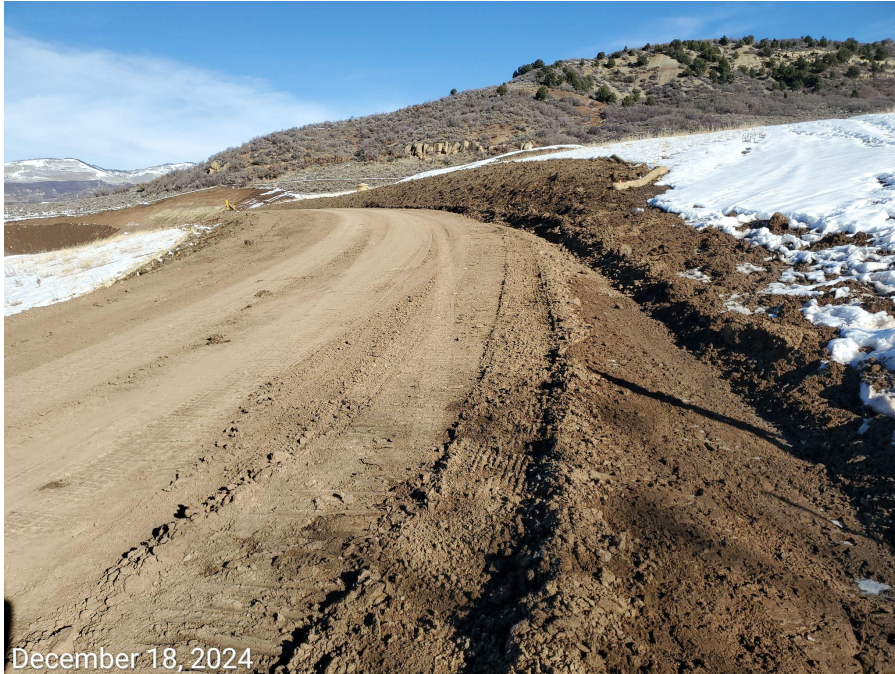
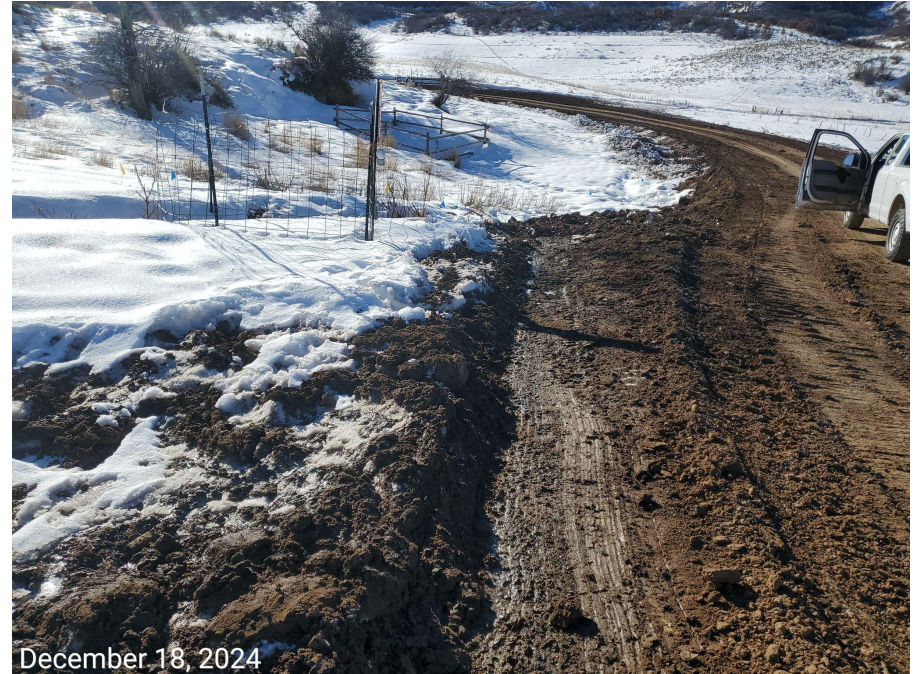
**Photo 18:** Photos taken from along the access road. Photo shows that the 24" Culvert in conjunction with "Trap w/ rock armored rundown" has not been installed along the access road between the stockpond and the Location entrance pursuant to the Form 2A permitted SWMP and Layout Drawing.

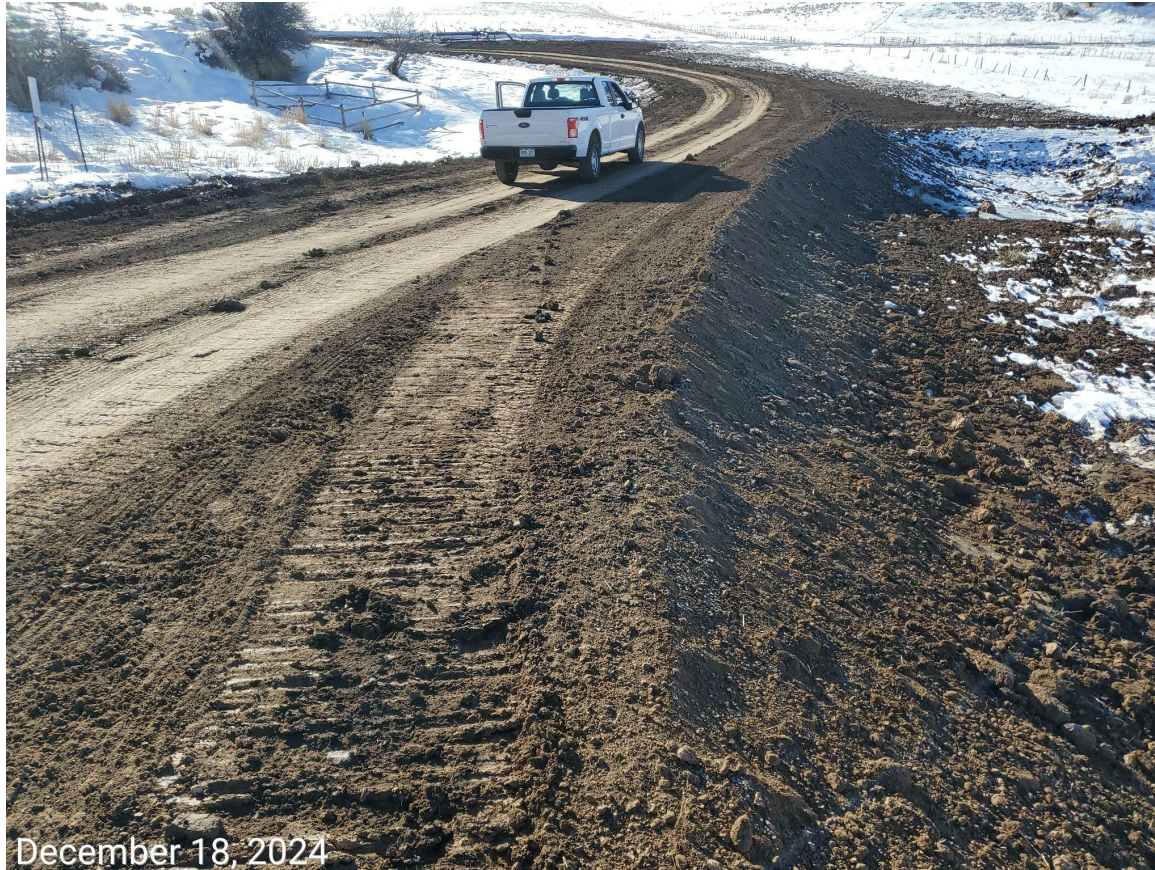
**Photo 19:** See comments under photo 18.
