# Inspection Photos

**Operator:** LARAMIE ENERGY LLC #10433

**Location ID:** 487592

**Inspection Doc:** 718100118

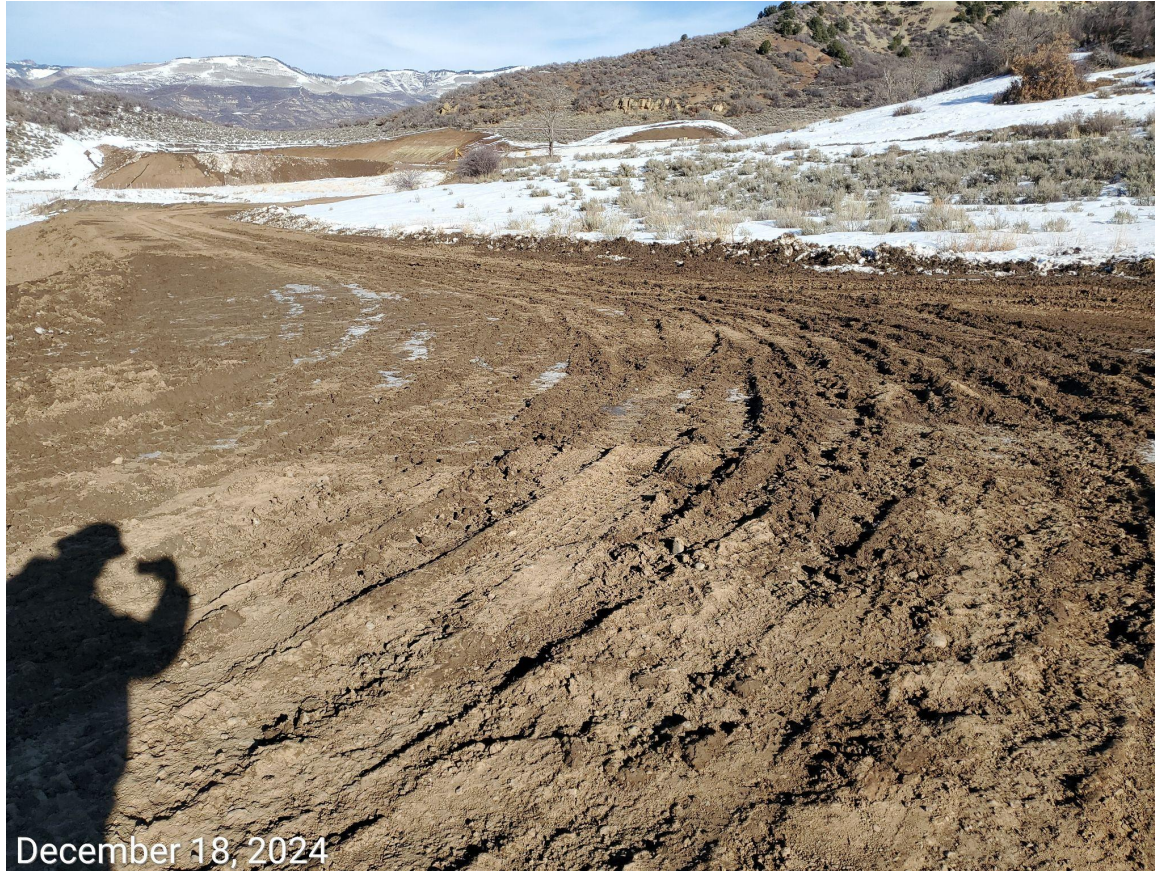
**Photo 20:** Photo taken from the access road. BMPs to stabilize, as well as to minimize tracking, degradation and sediment transport remains missing or insufficient.
