Inspection Photos

Loc: 380903

Operator: WAVETECH HELIUM INC

Inspection Date: 12/18/2024

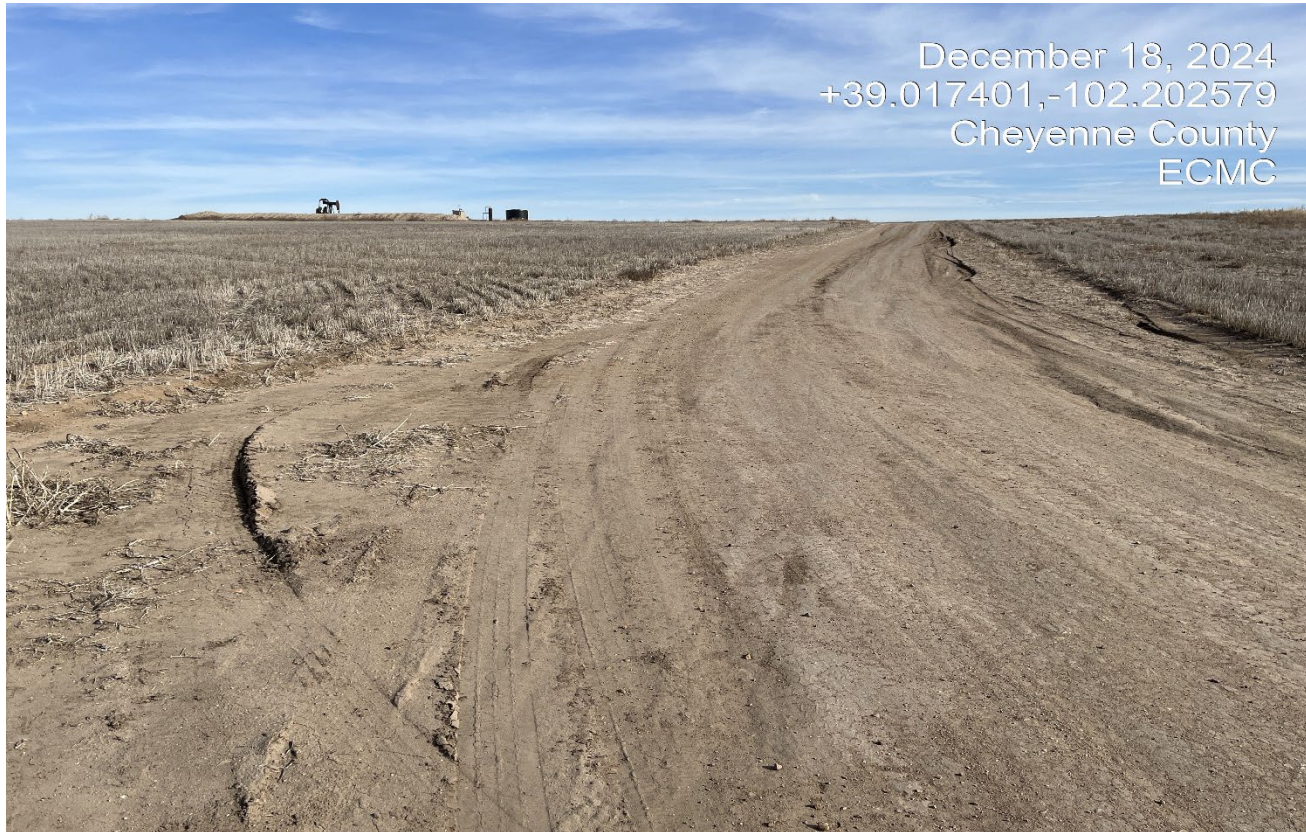
Photo 1. Facing east at the location. The access road needs to be reduced in size by reclaiming and decompacting soils..

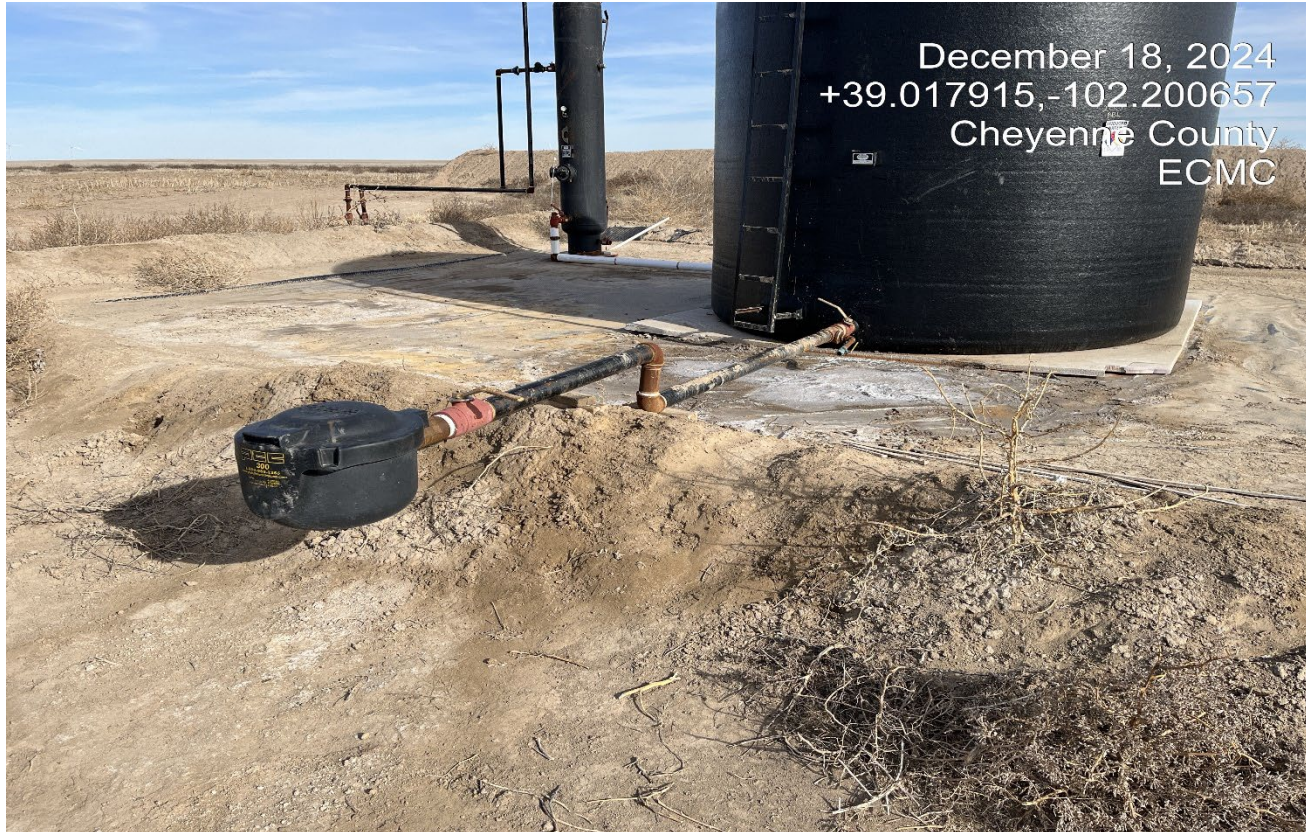
Photo 3. Facing toward the tank loadout area. The berm is worn down in this area. This berm is not designed to resist degradation from erosion.

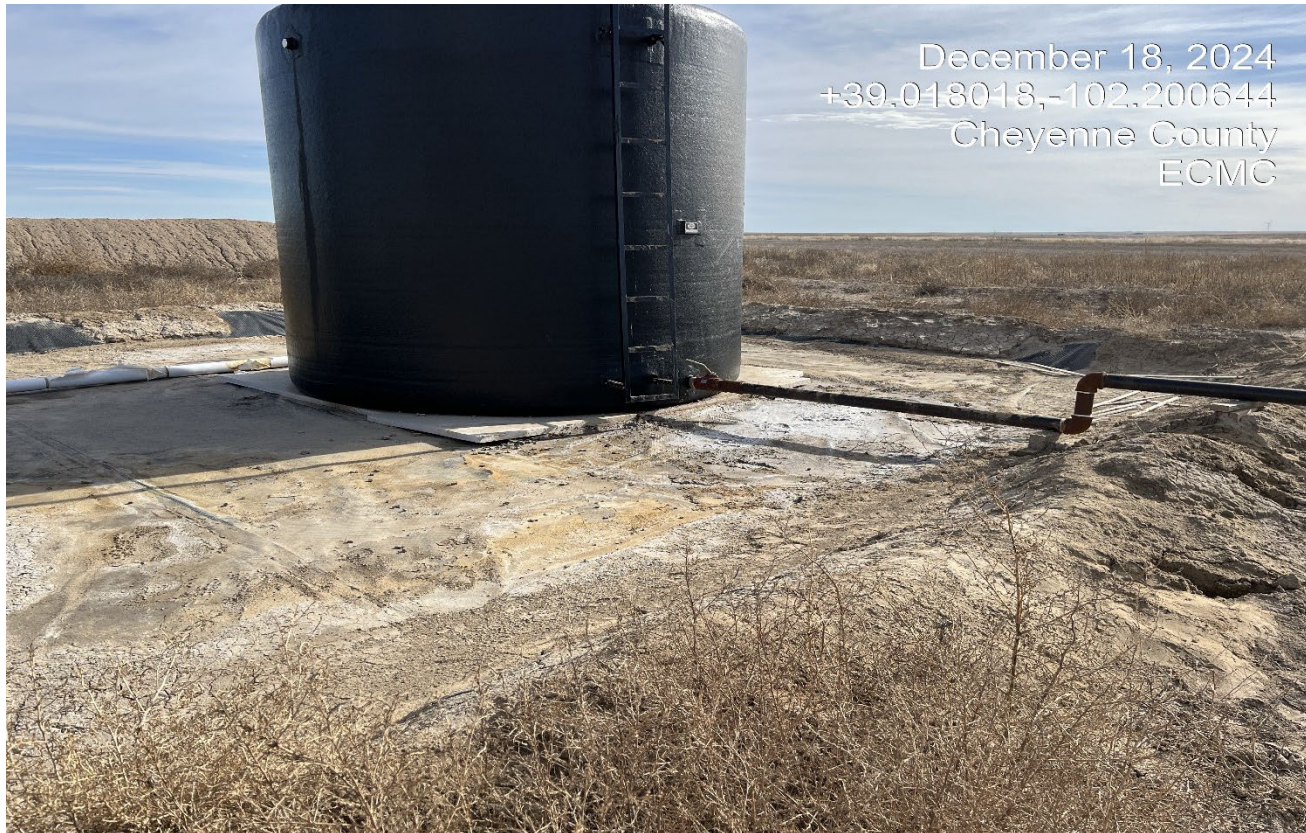
Photo 4. There is a leak that occurred at the tank and there are white and red stains.

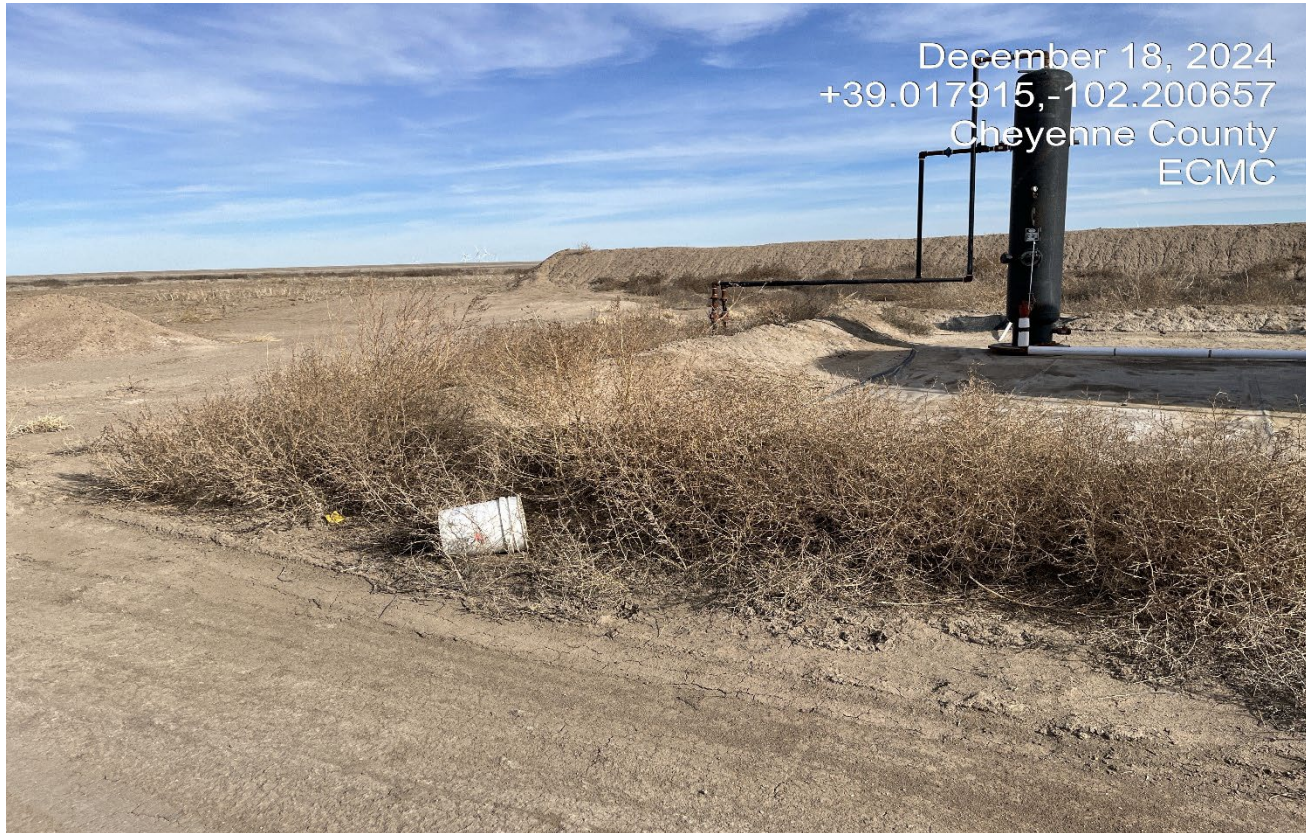
Photo 5. There are undesirable weeds growing along the berm that must be controlled. The white bucket needs to be removed as well.

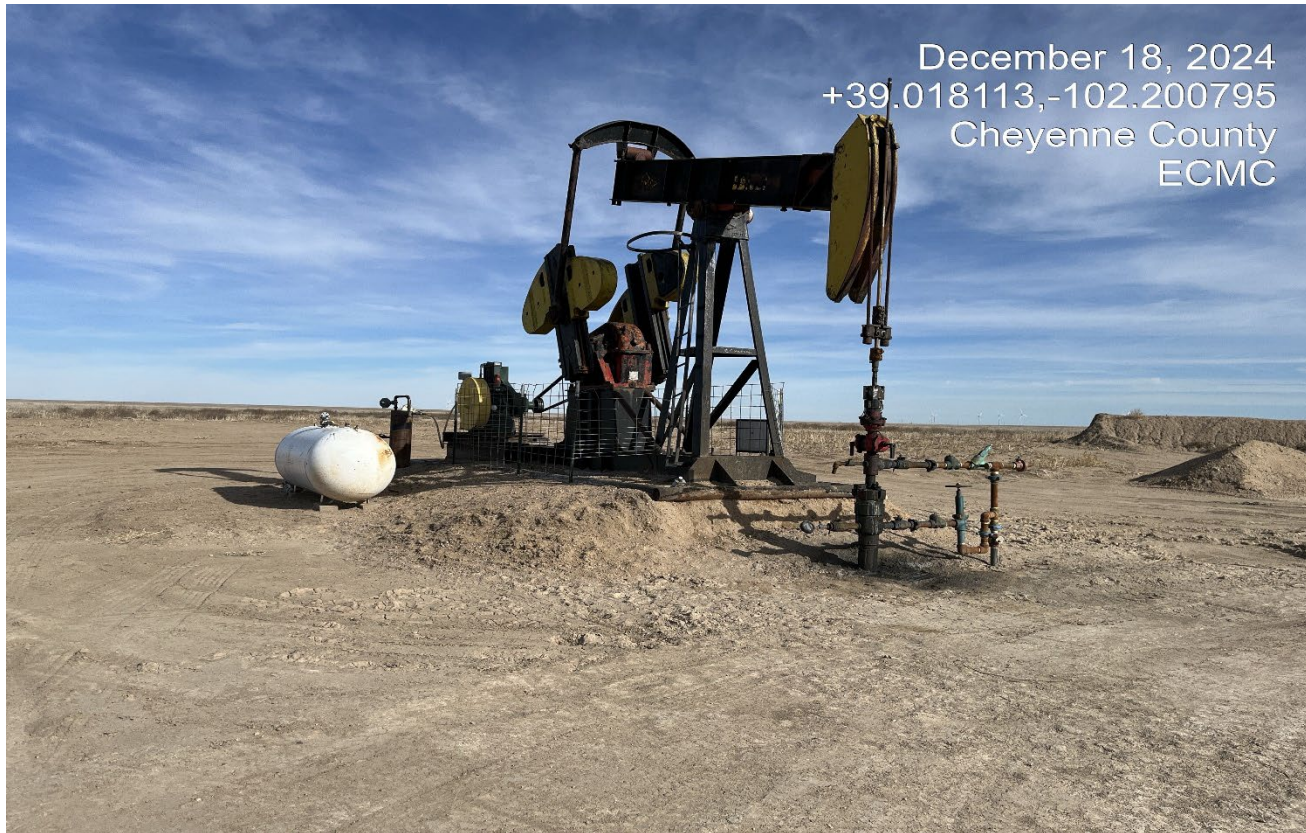
Photo 6. Facing toward the producing well. There is stained soils at the wellhead that must be cleaned up..

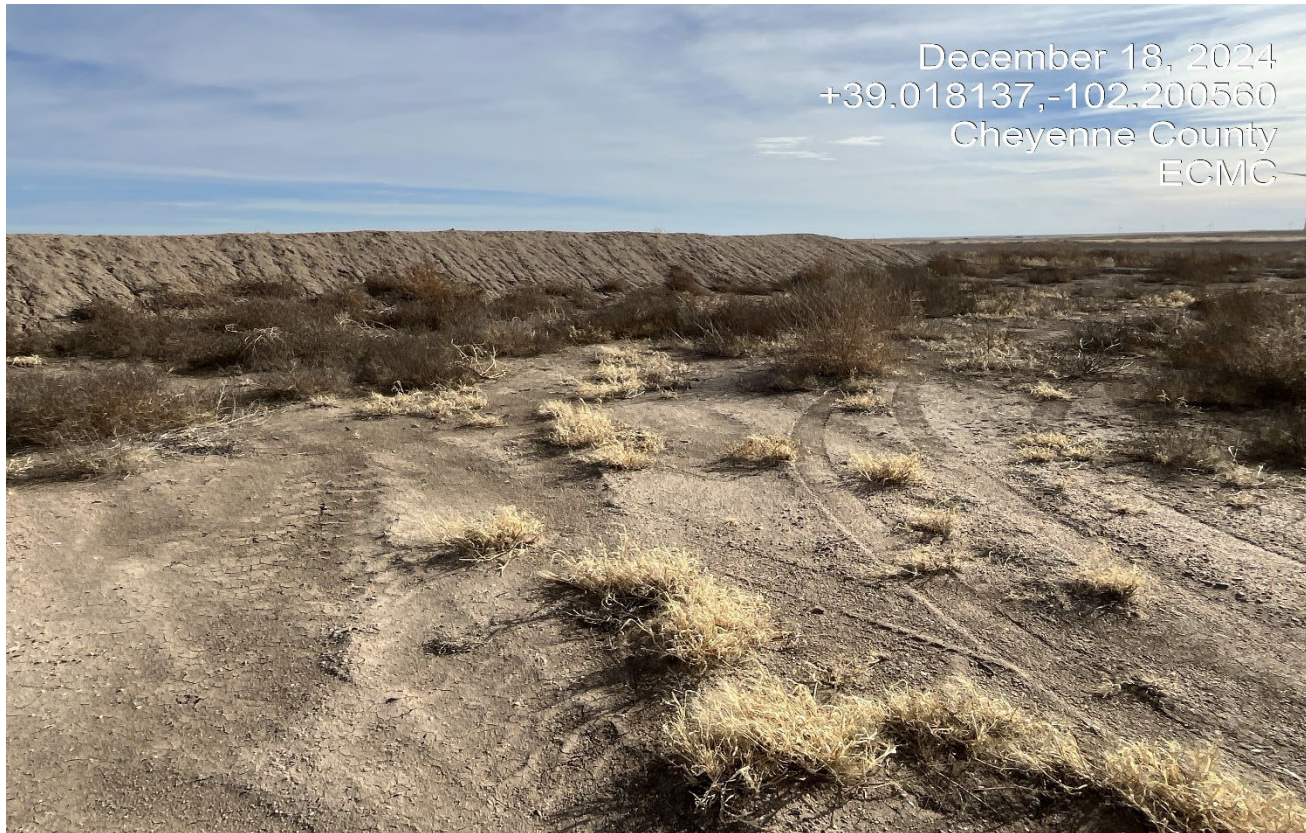
Photo 7. Facing southeast at the location. The topsoil pile at the east side of the location has not been replaced and there is erosion and weed infestation.

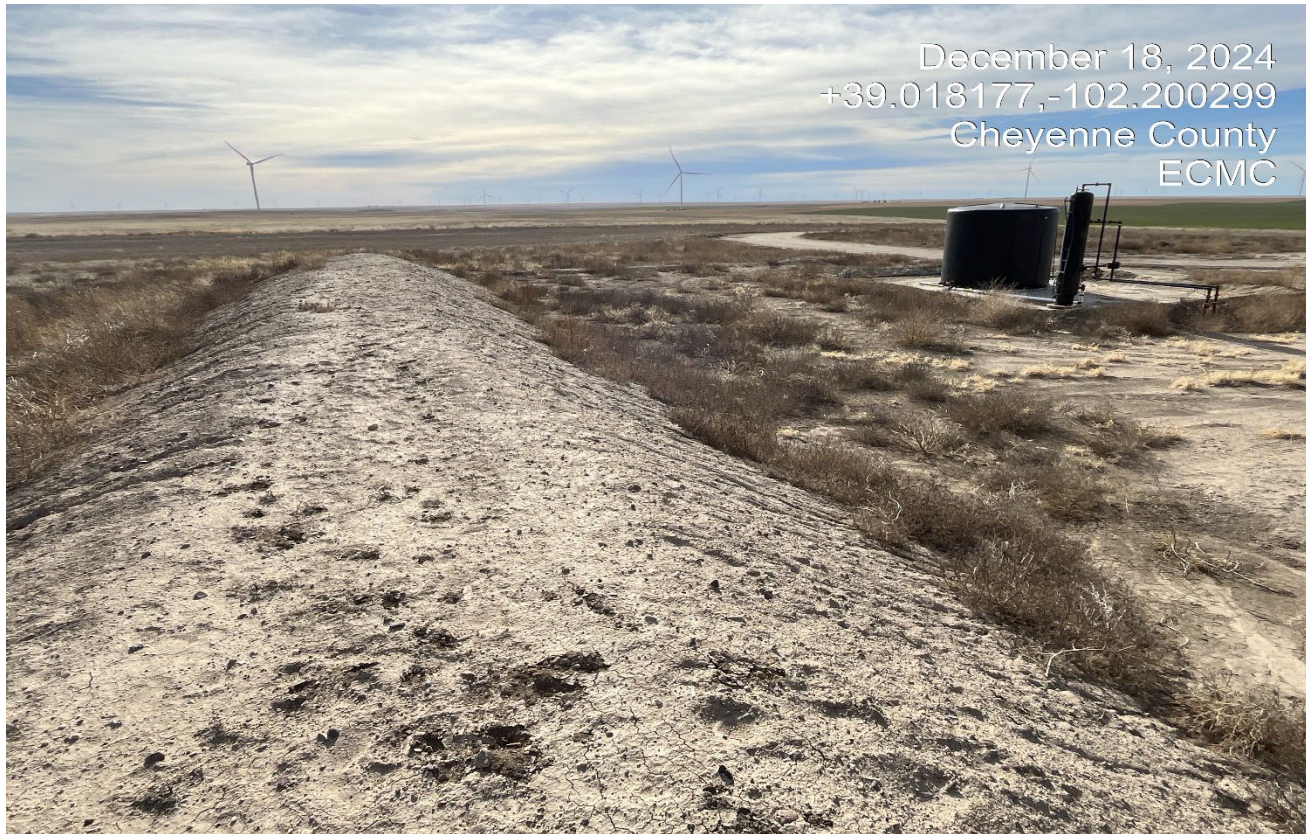
Photo 8. Facing south at the topsoil pile at the east side of the location. Topsoil is not being protected and needs to be replaced for interim reclamation.

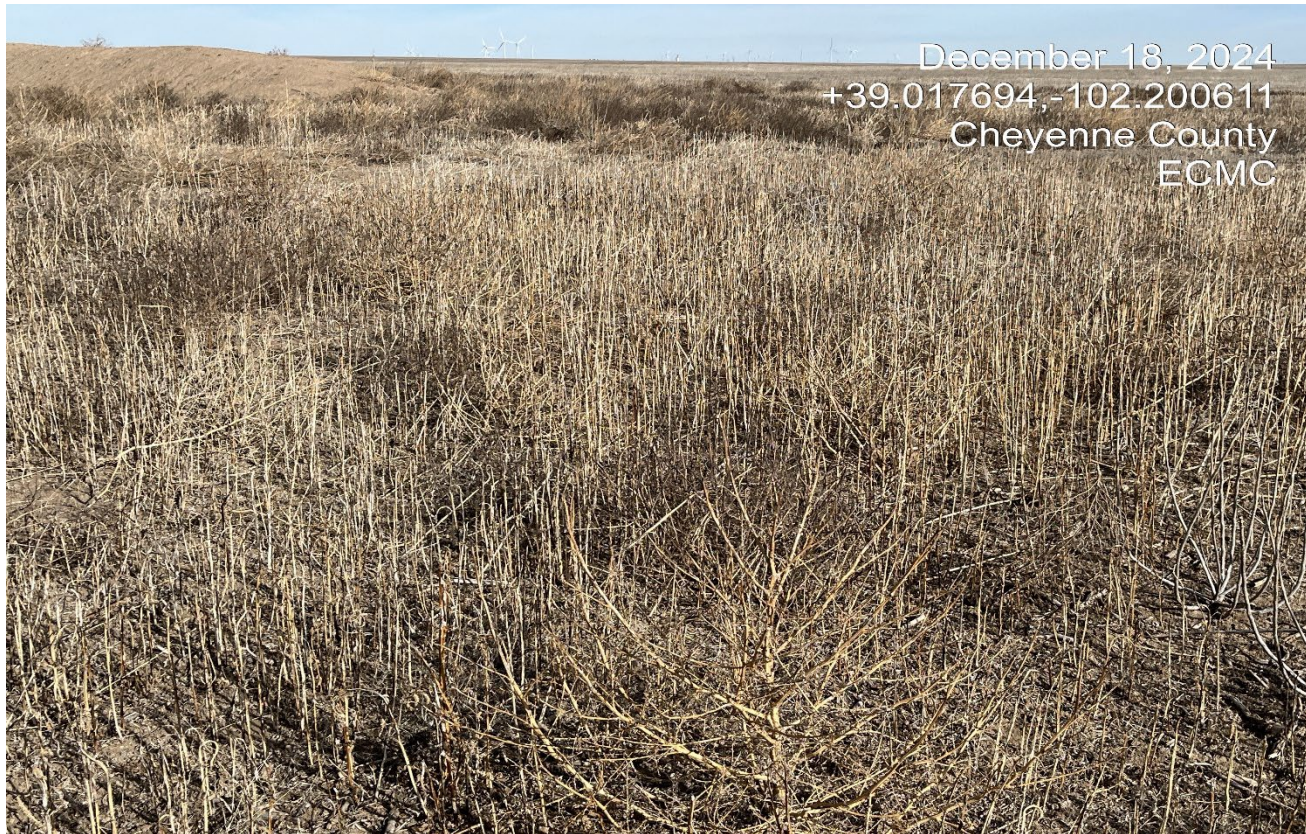
Photo 9. View of undesirable weeds growing throughout the disturbance area. The weed debris will need to be removed and weed control will need to be performed.
