# Inspection Photos

Loc: 485672

Operator: WAVETECH HELIUM INC

Inspection Date: 12/18/2024

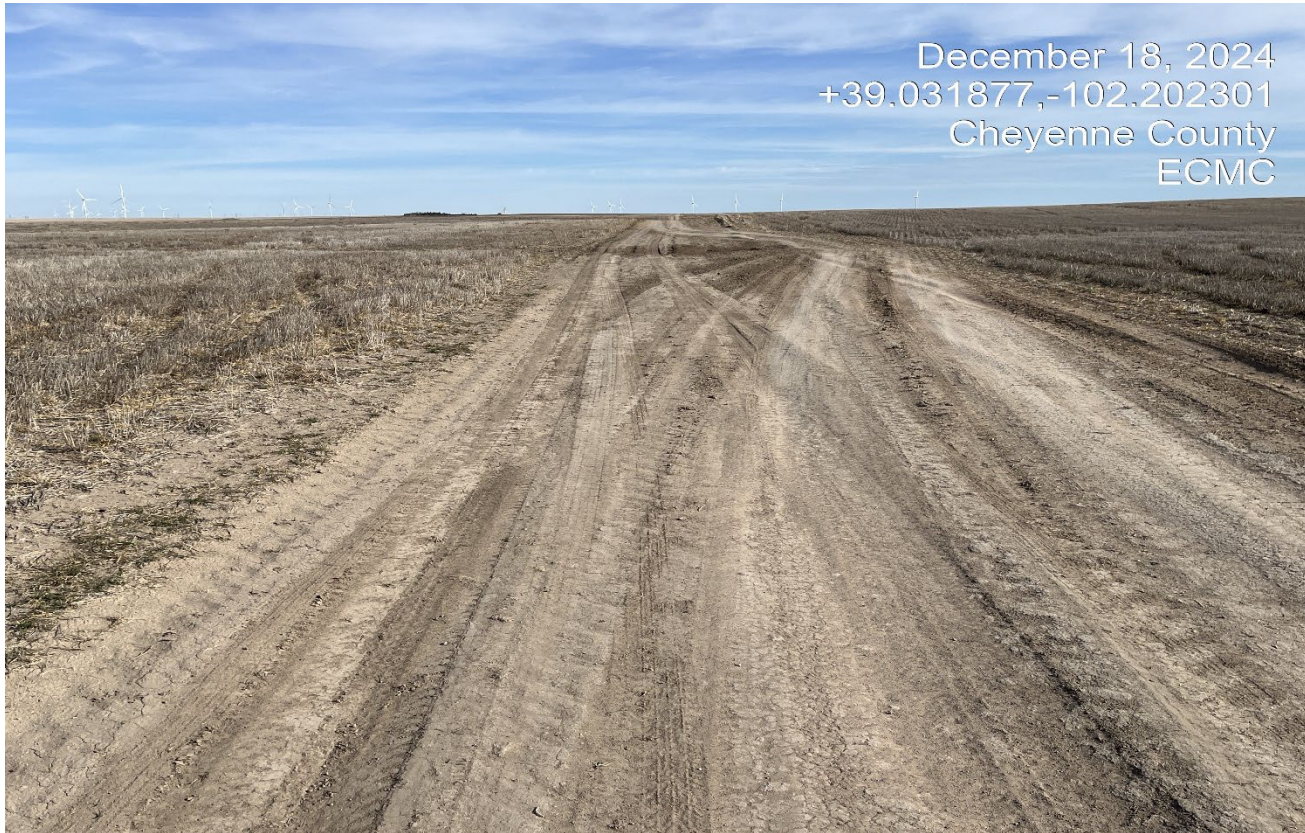
**Photo 1.** Facing east along the access road. Vehicles are avoiding the eroded area of the road causing unnecessary disturbance. The road needs to be repaired and stabilized.

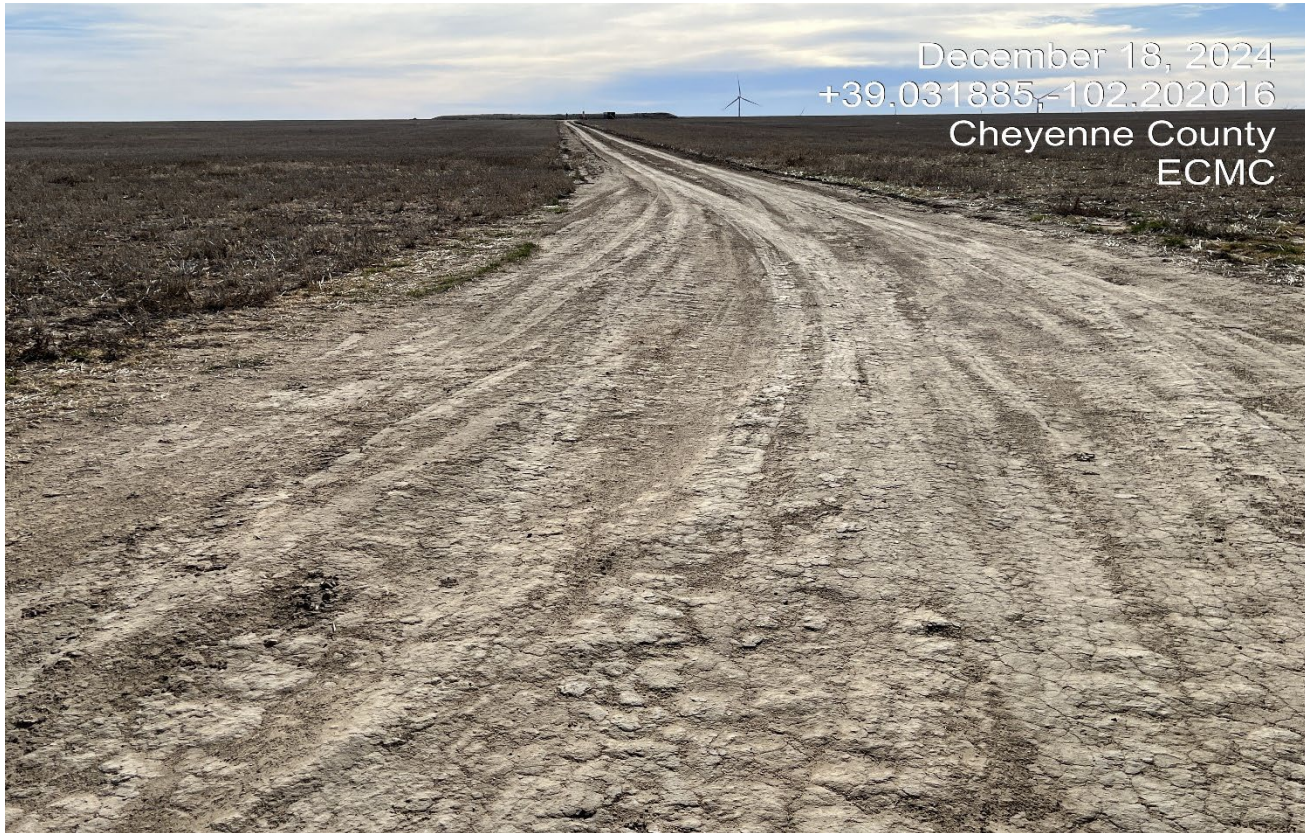
**Photo 2.** Facing south along the access road. The access road needs to be reduced in size by reclaiming and decompacting soils.

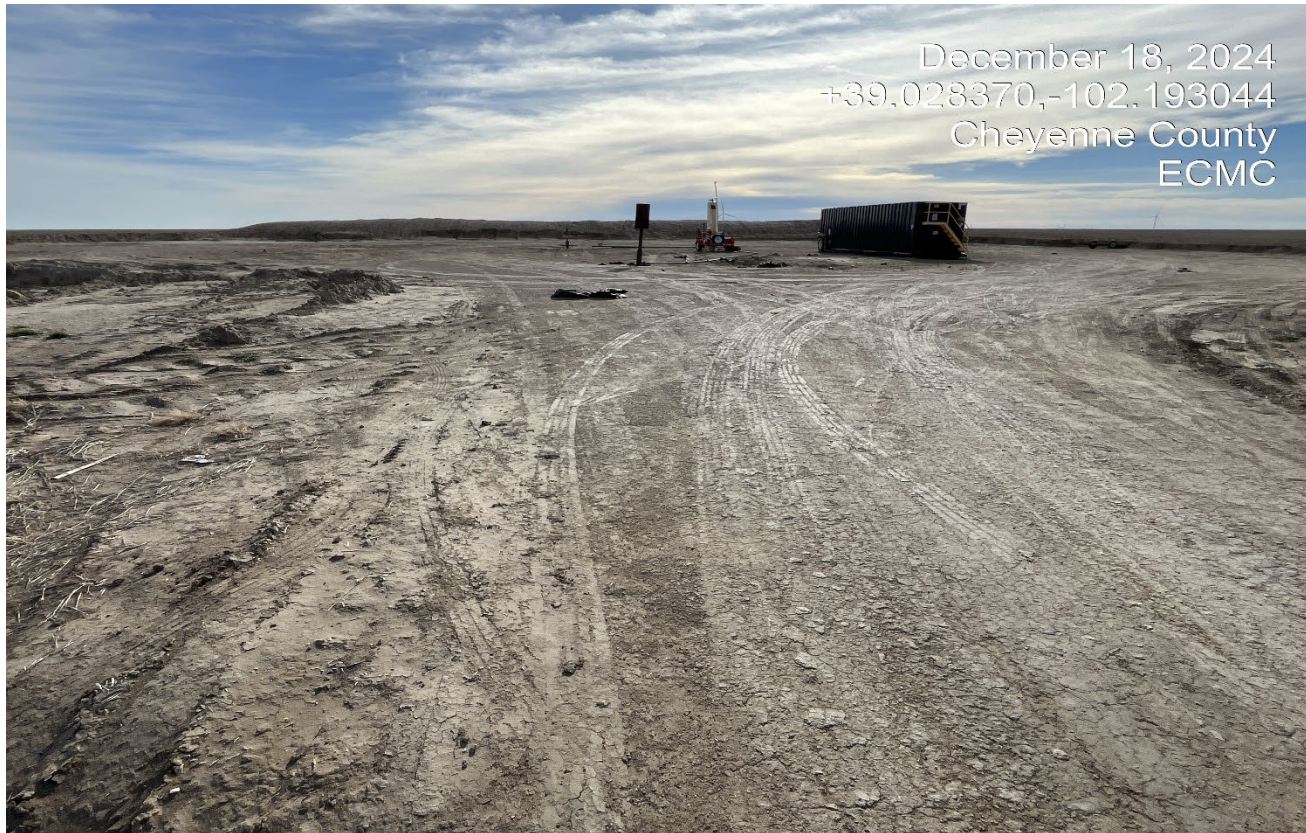
**Photo 3.** Facing south toward the wellsite..

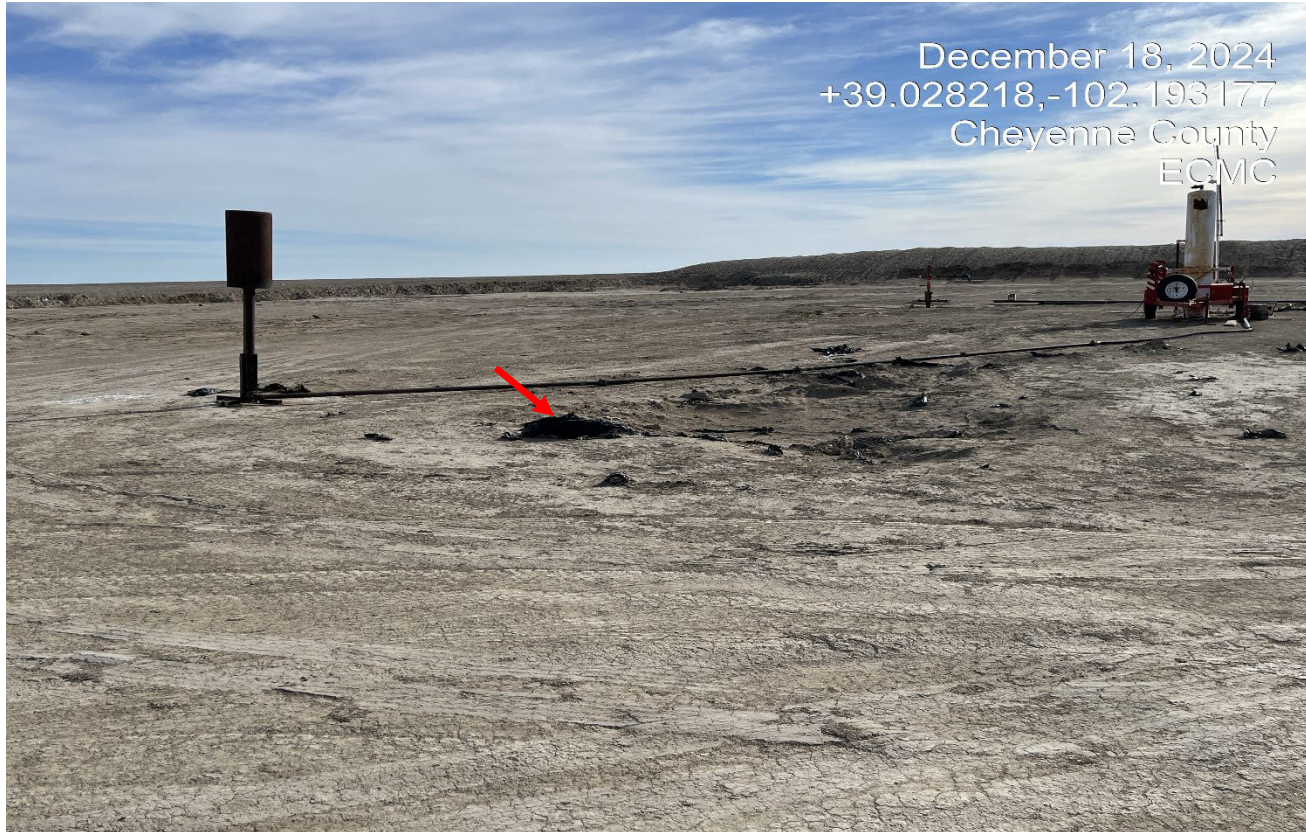
**Photo 4.** There is a flaring unit at the location which was approved for 96 hours of use. There is torn plastic liner throughout this area shown at red arrow.

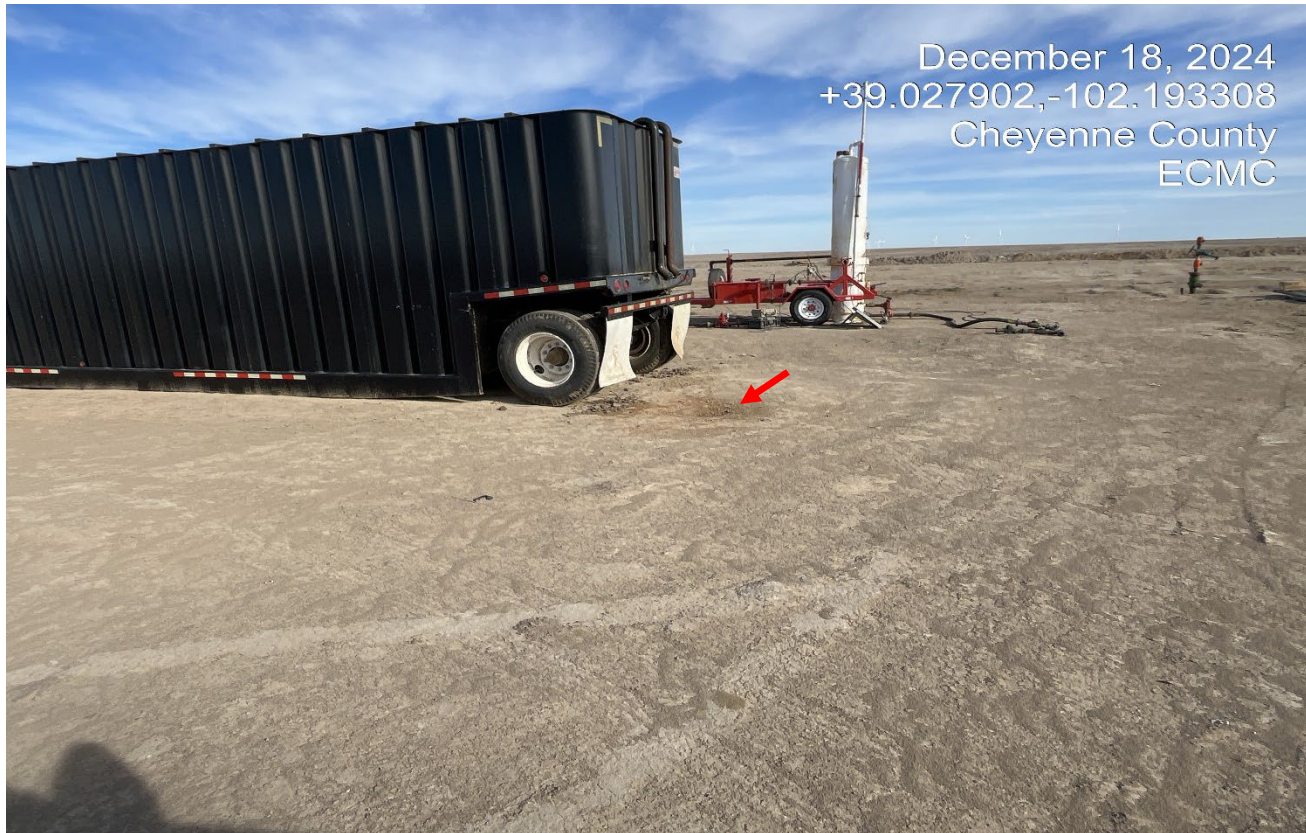
**Photo 5.** There is no secondary containment around this tank and there are stained soils shown at red arrow.

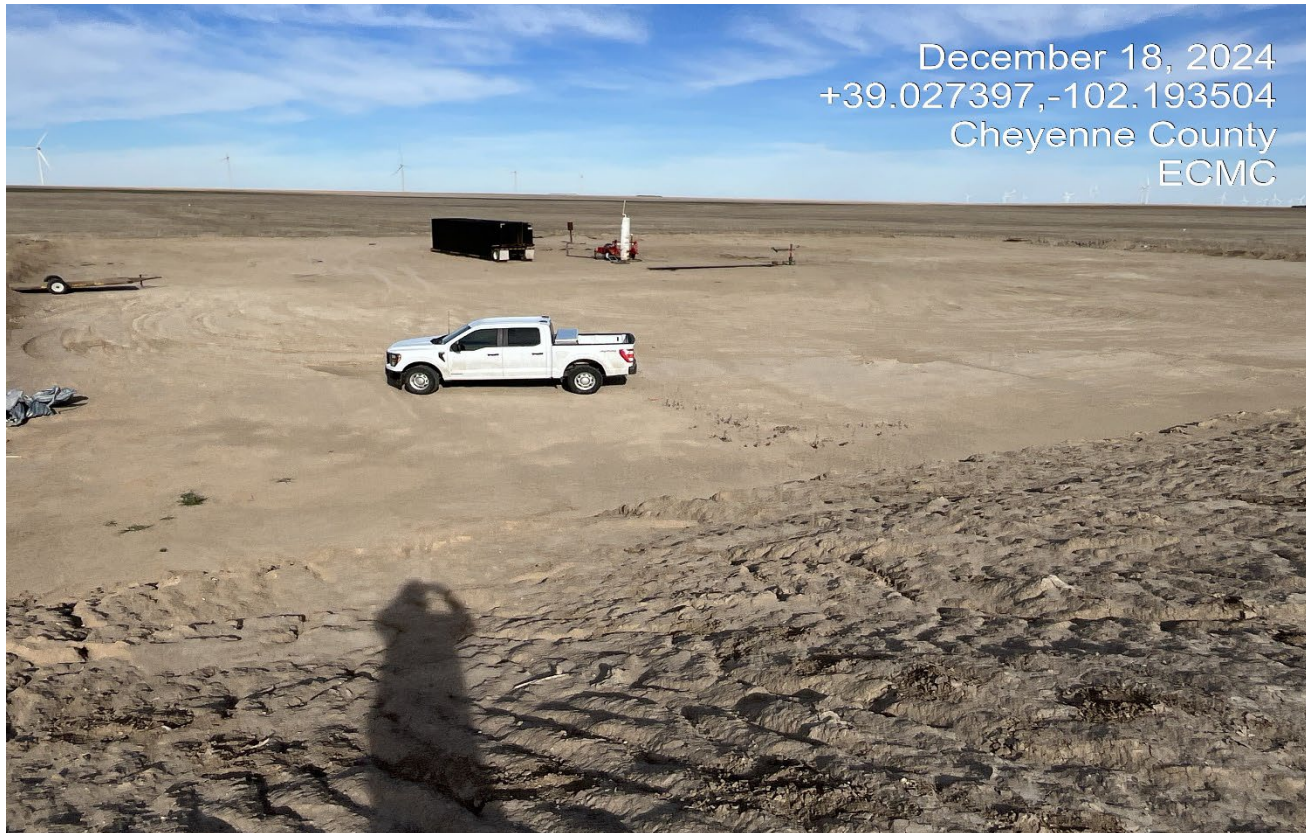
**Photo 6.** Facing northeast overlooking the location.

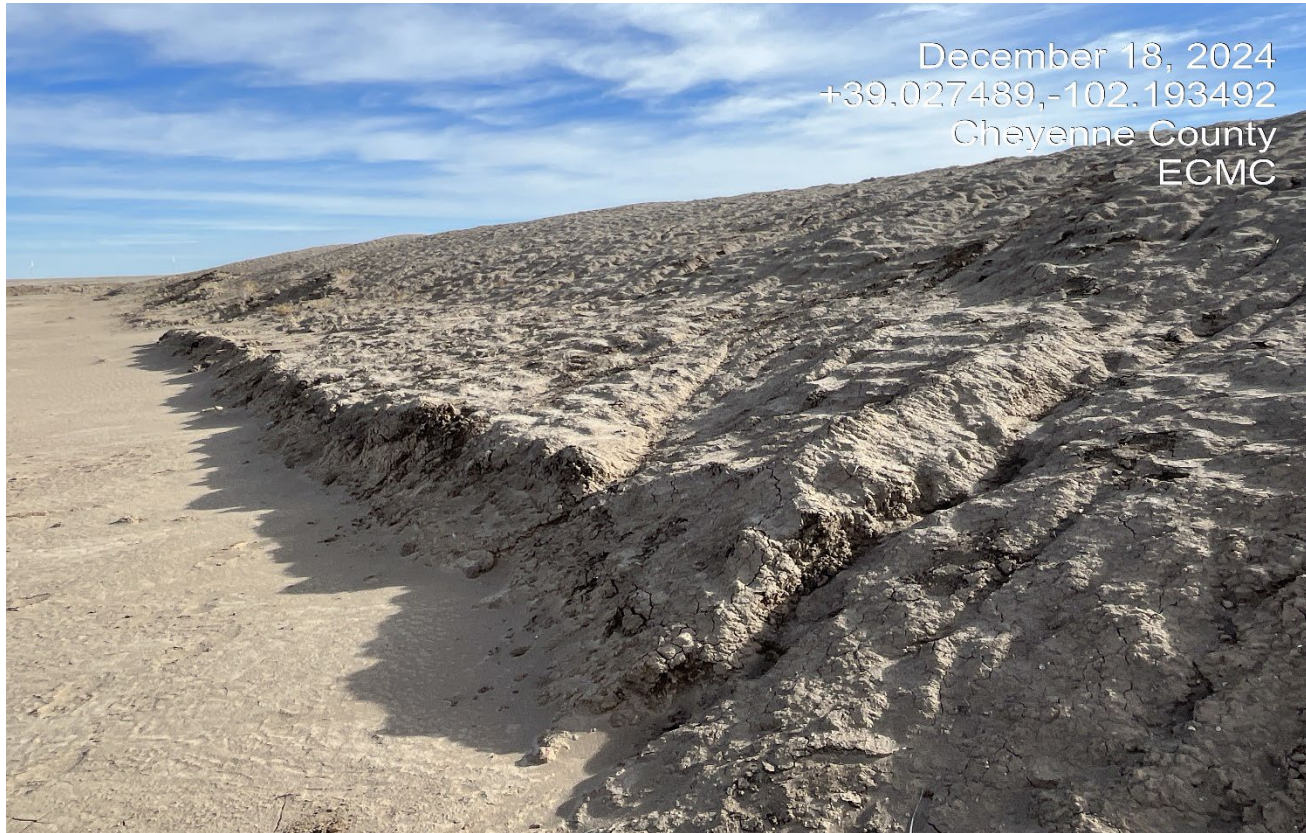
**Photo 7.** There is erosion along the topsoil pile at the south side of the location.

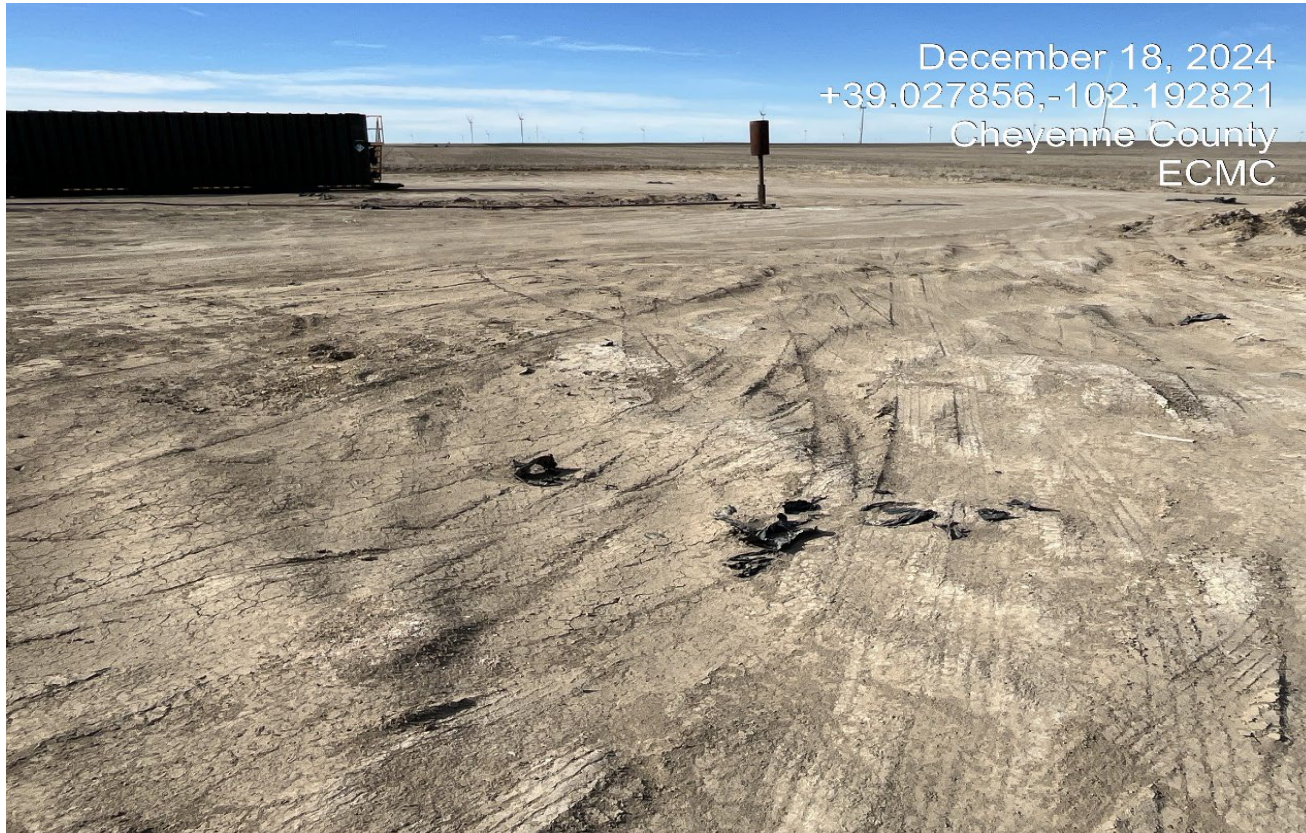
**Photo 8.** Facing northwest at the location. There are more pieces of plastic liner exposed on the surface.

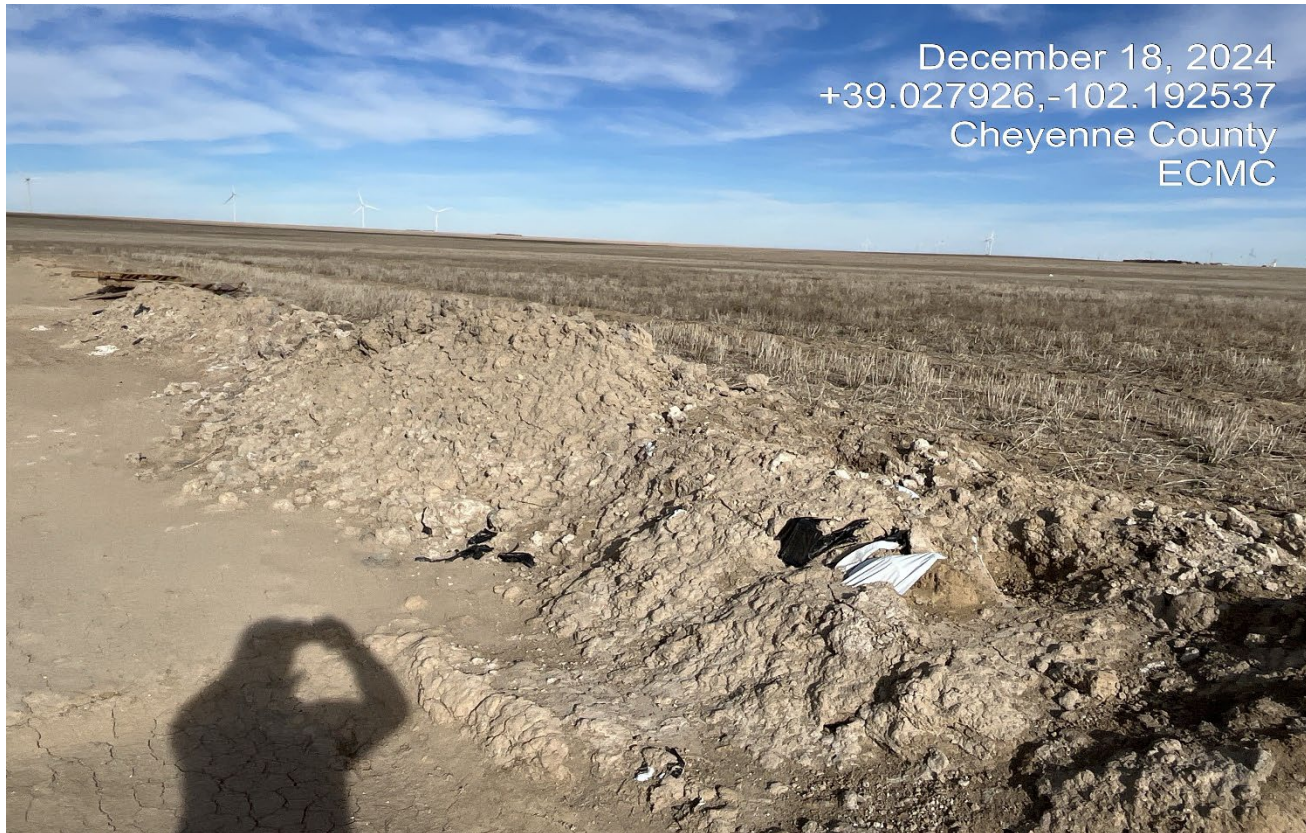
**Photo 9.** Facing toward the east side of the location. There is plastic liner mixed in with this material piled up along the side of the location.

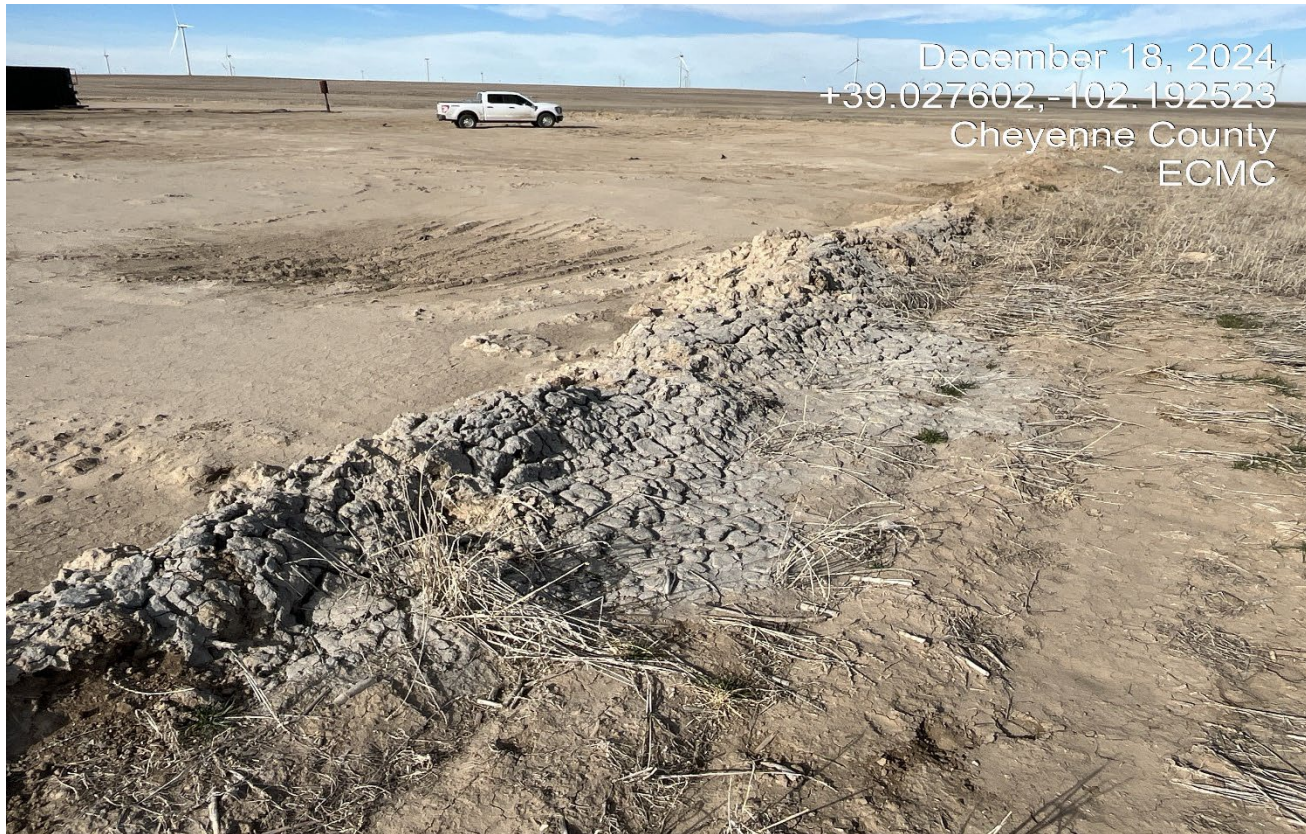
**Photo 10.** The material along the east side of the pad has grey and reddish color indication this material is drill cuttings that were not properly disposed.

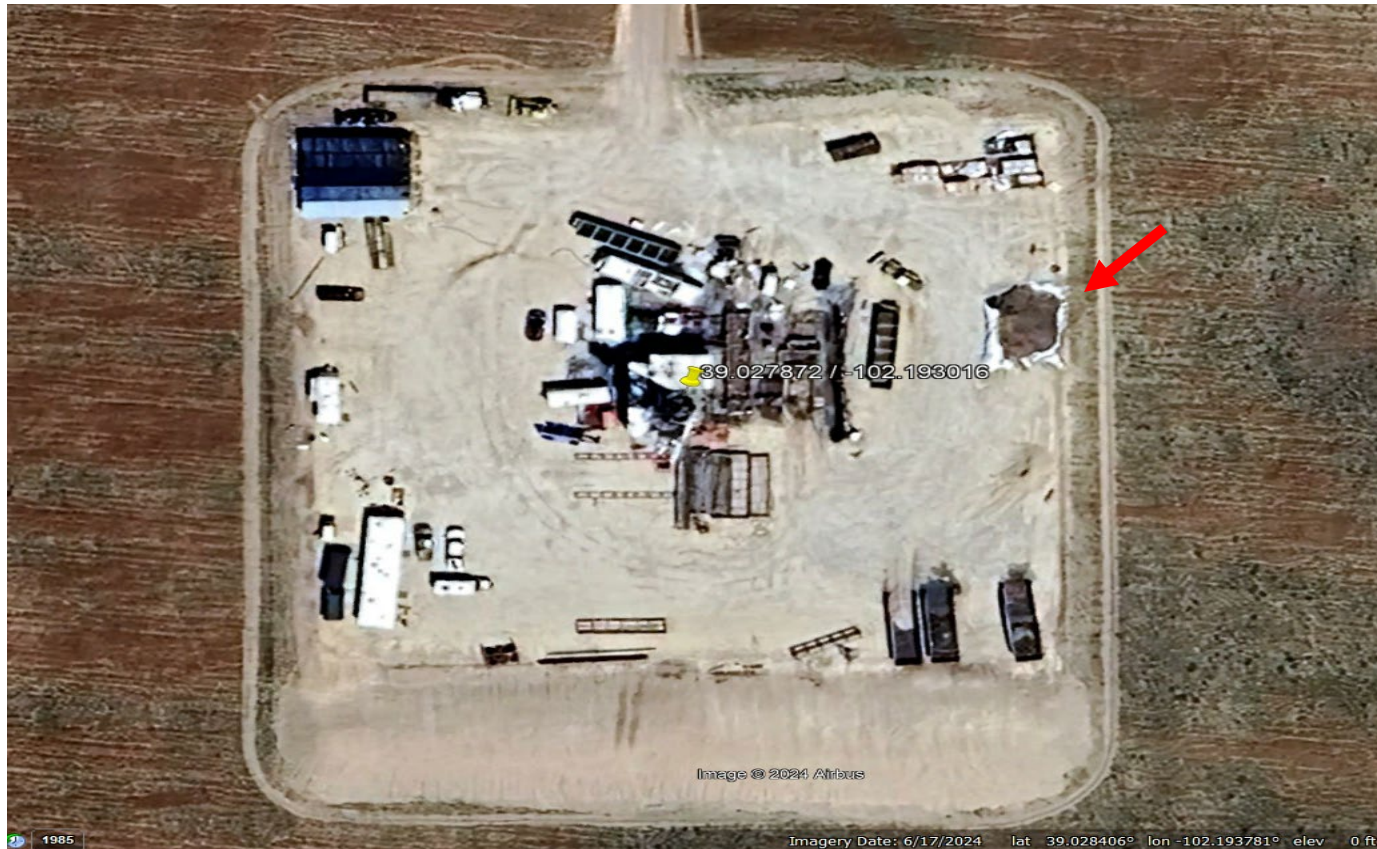
**Photo 11.** Satellite imagery taken during the drilling process shows the plastic liner and cuttings stored at the same area where cutting remain in previous photo..

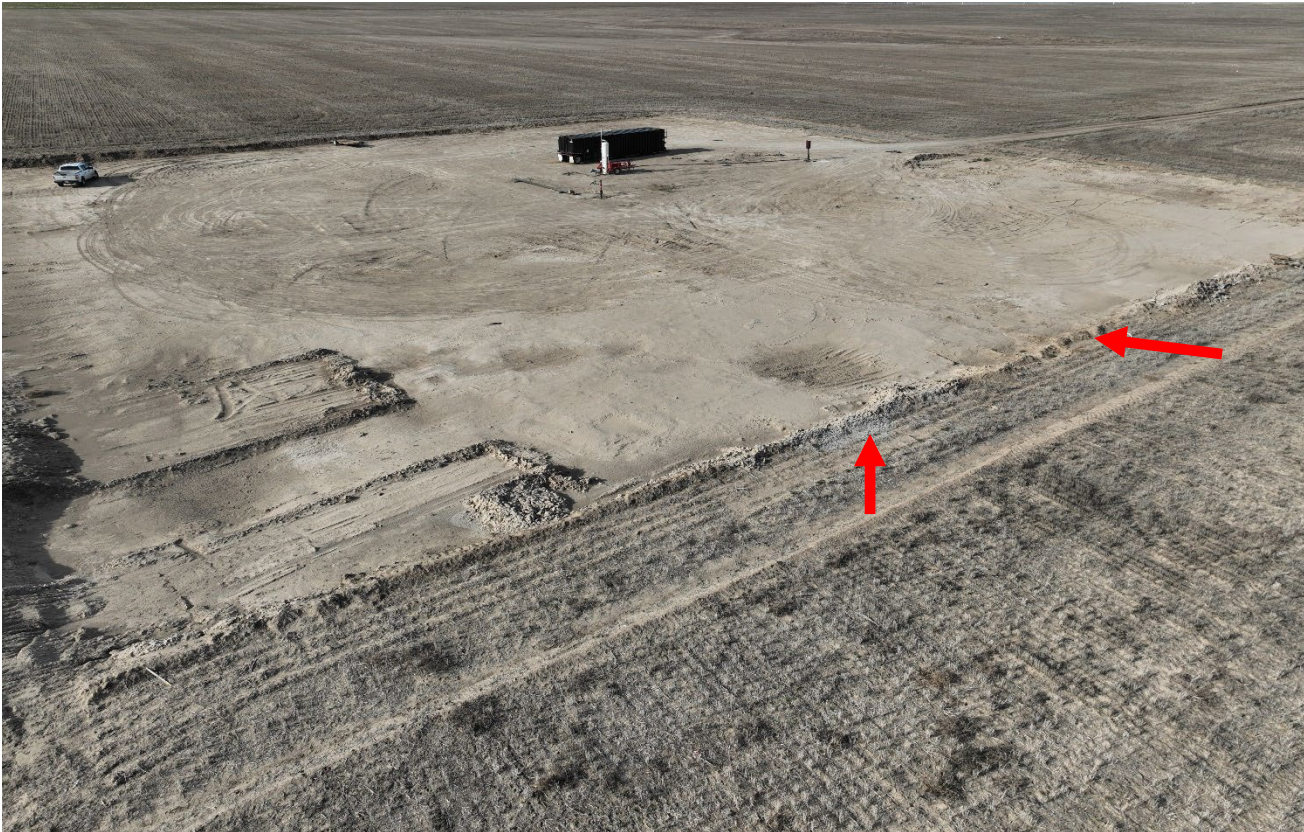
**Photo 12.** East side of the location facing northwest. Red arrows point to where cuttings was observed along the side of the location.

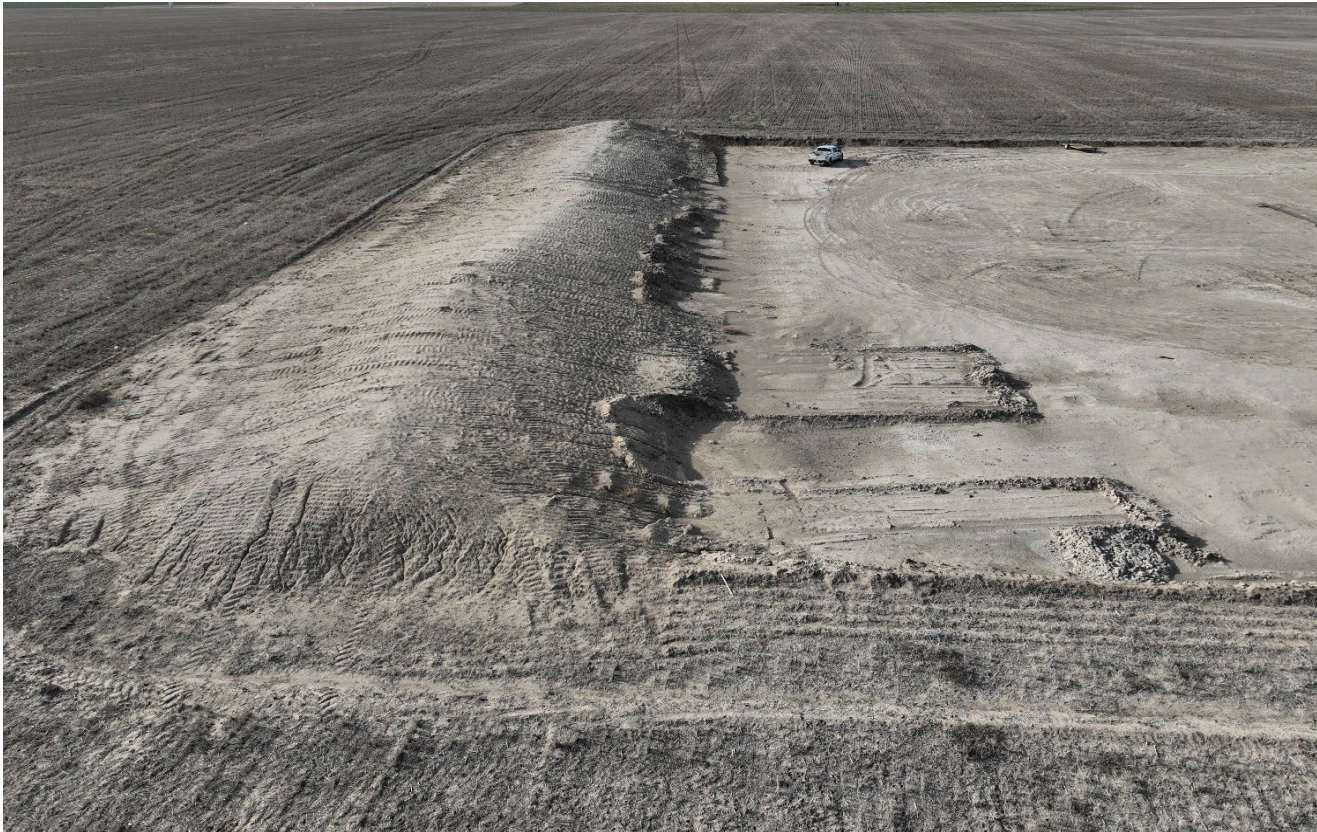
**Photo 13.** Drone aerial photo facing west toward the topsoil pile.
