Inspection Photos

Location Name: TEP ROCKY MOUNTAIN LLC SPECIALTY 23A-21-692 Pad

Location #: 413900

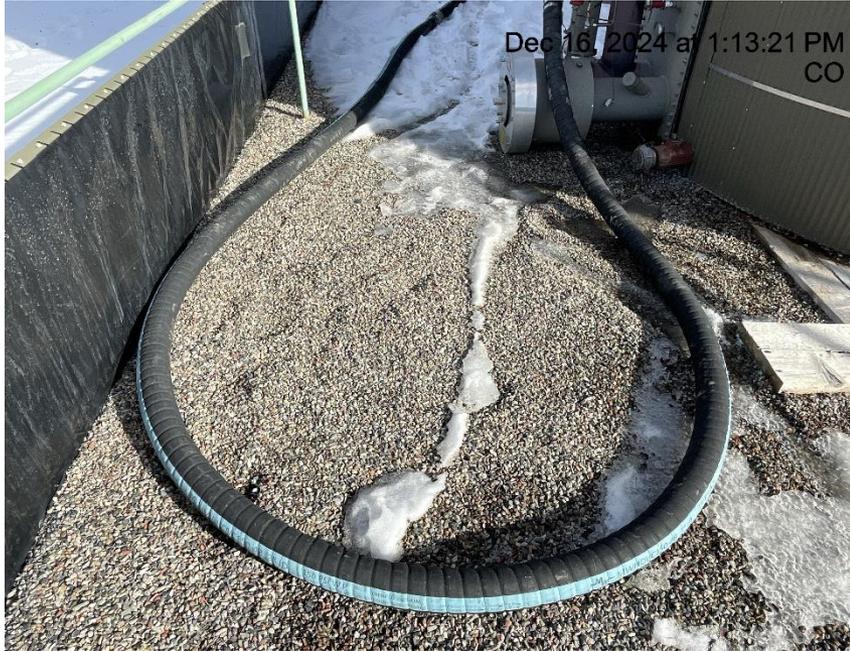
Photo # 3850 Unused hoses in secondary containment

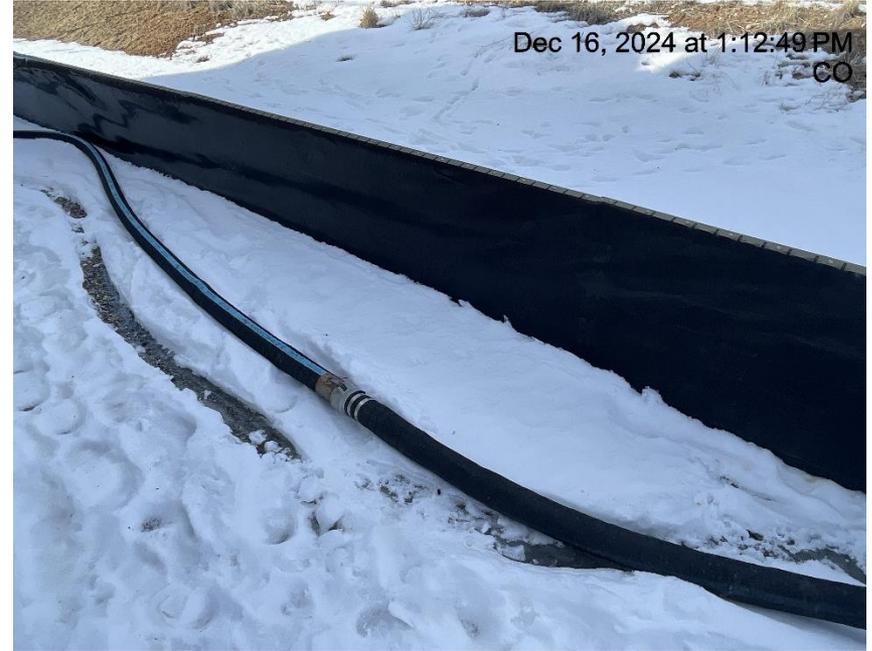
Photo # 3851 Unused hoses in secondary containment

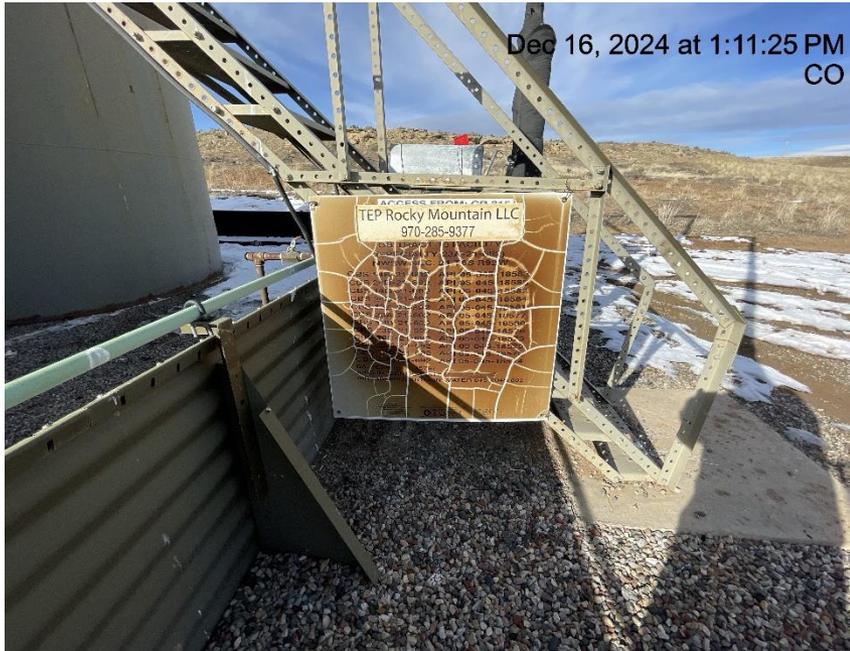
Photo # 3852 Battery sign weathered & cracking/some info is illegible/sign does not comply with CECMC rules

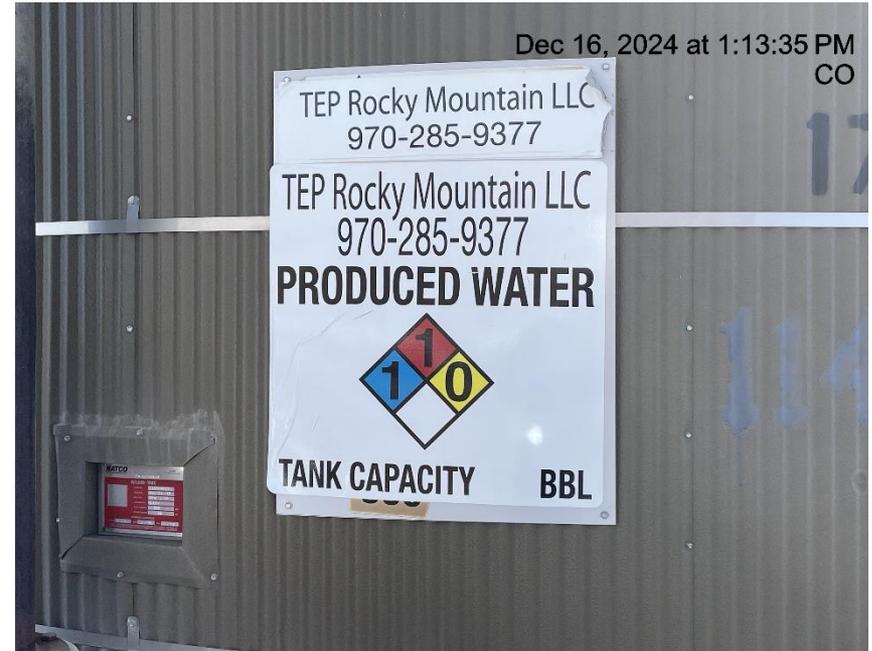
Photo # 3853 Tank label lacks capacity

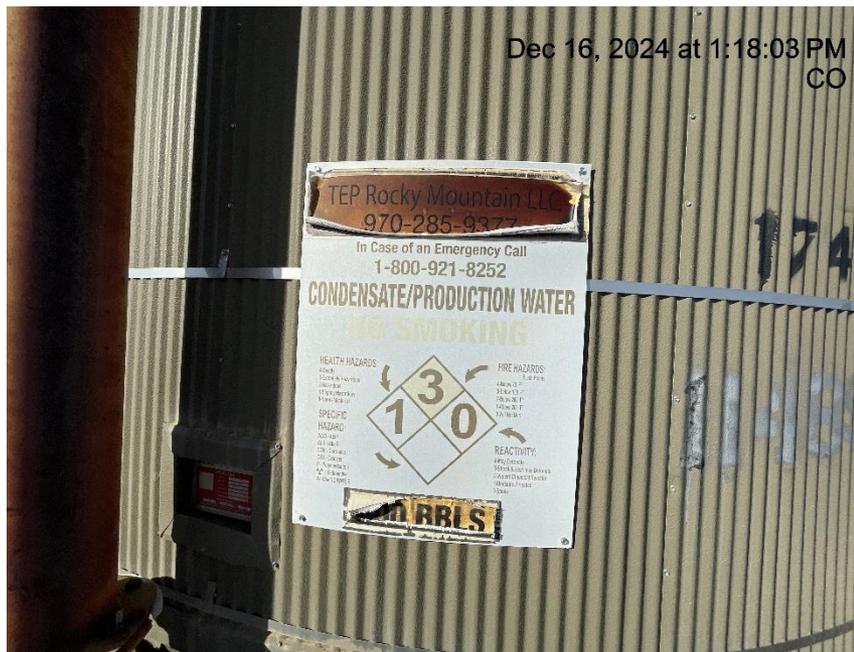
Photo # 3854 Tank label weathered & some required info is illegible/does not comply with CECMC rules

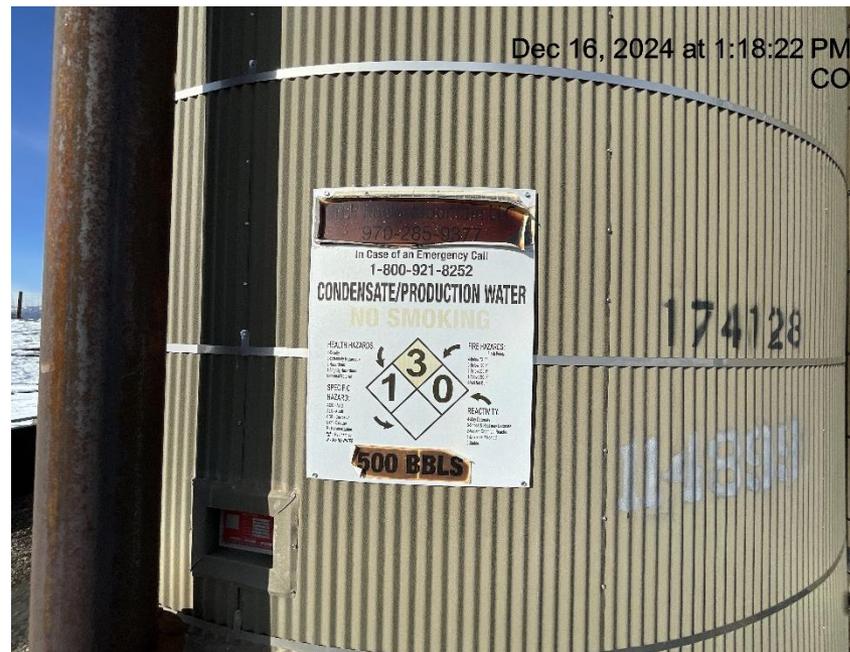
Photo # 3855 Tank label weathered & some required info is illegible/does not comply with CECMC rules

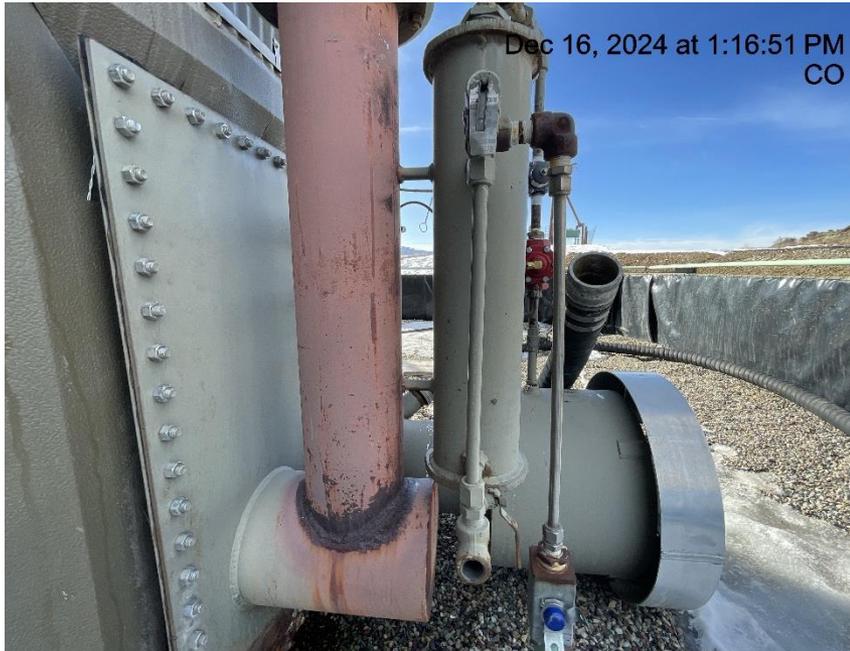
Photo # 3856 PRV vent line on tank burner does not comply with CECMC pressure safety device rules

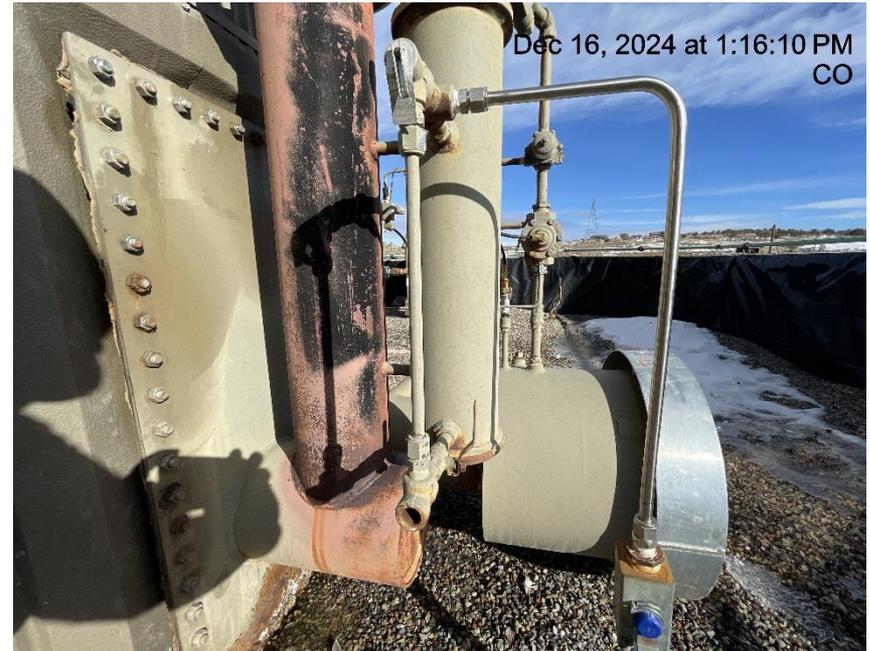
Photo # 3857 PRV vent line on tank burner does not comply with CECMC pressure safety device rules

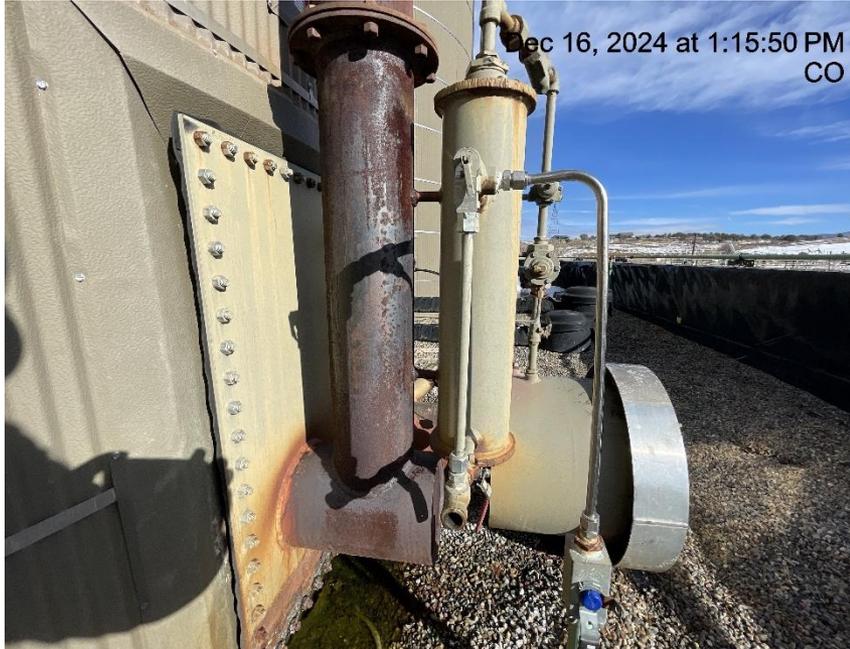
Photo # 3858 PRV vent line on tank burner does not comply with CECMC pressure safety device rules

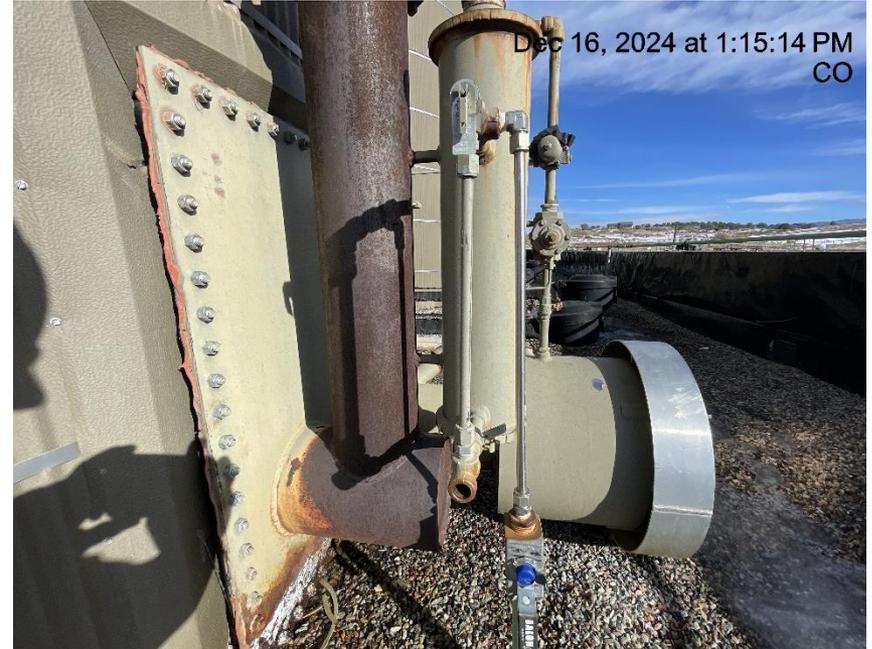
Photo # 3859 PRV vent line on tank burner does not comply with CECMC pressure safety device rules
