## Inspection Photos

Location: TEP ROCKY MOUNTAIN LLC GUCCINI Pad

Location ID: 335083

Date: 12/16/2024

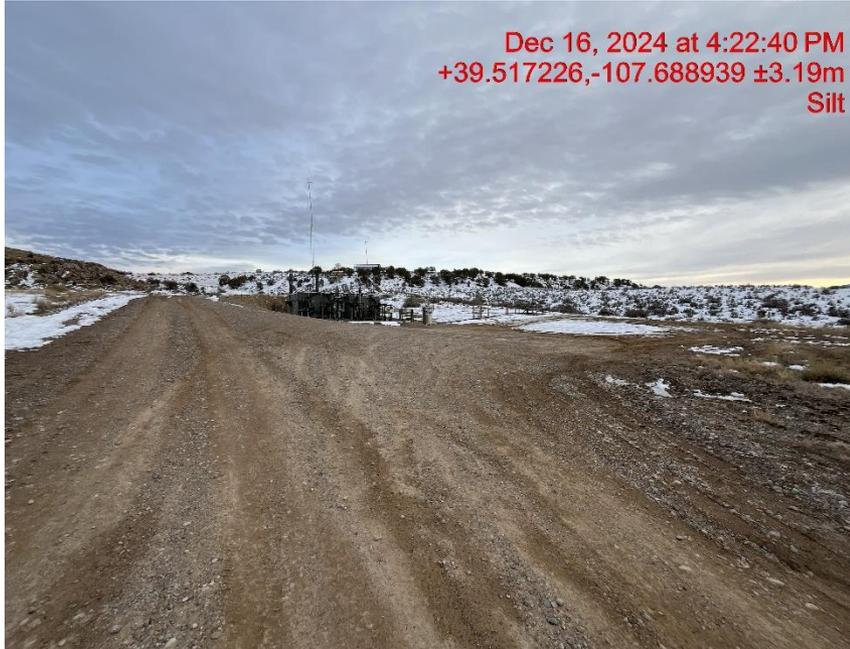
Photo # 1267 Entrance to location

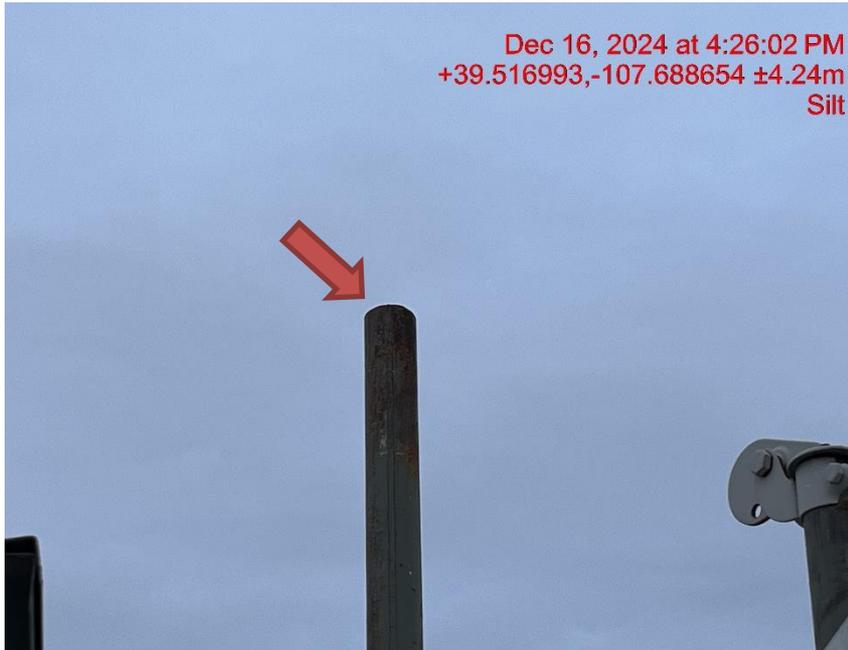
Photo # 1271 PRV vent line does not comply with CECMC pressure safety device rules

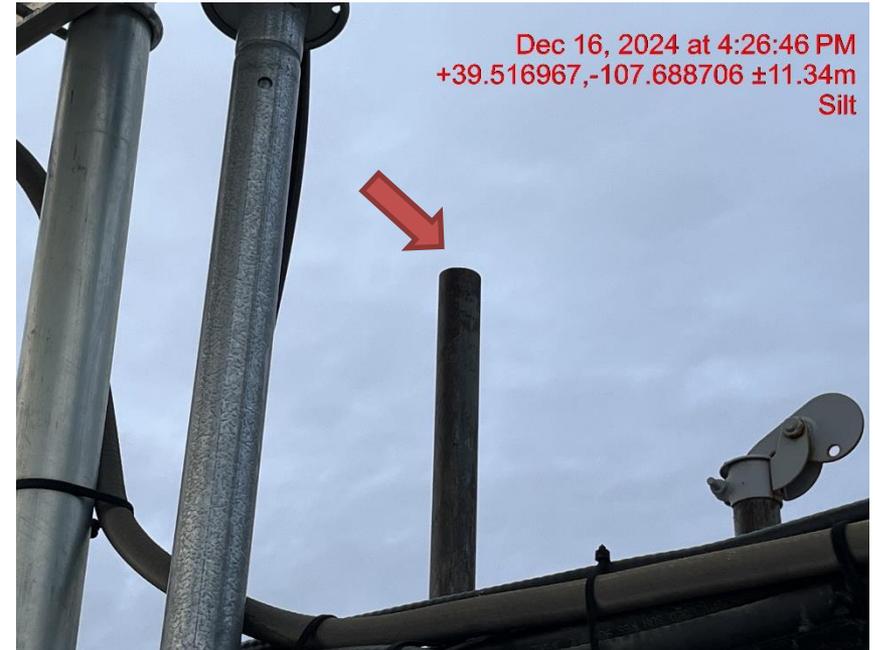
Photo # 1273 PRV vent line does not comply with CECMC pressure safety device rules

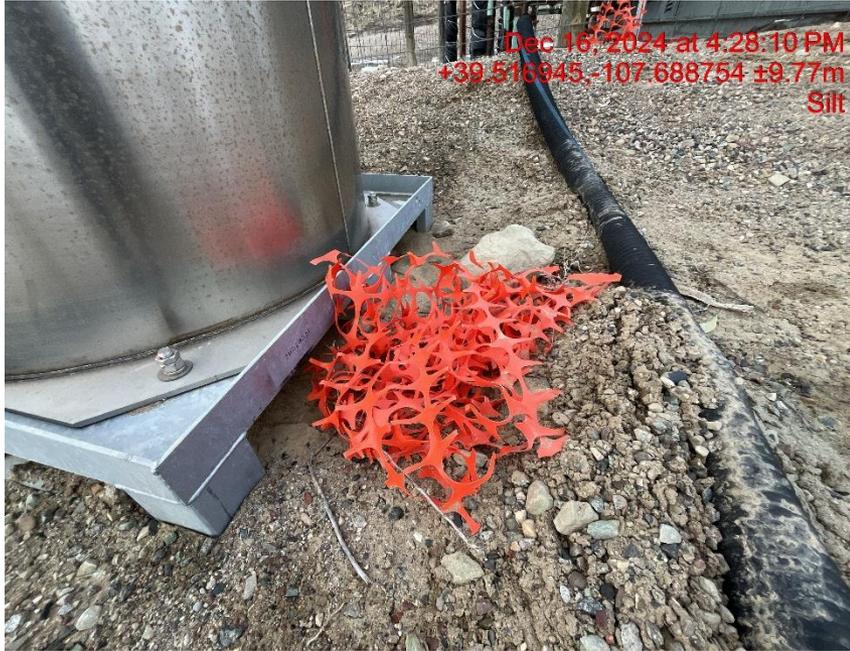
Photo # 1277 Debris

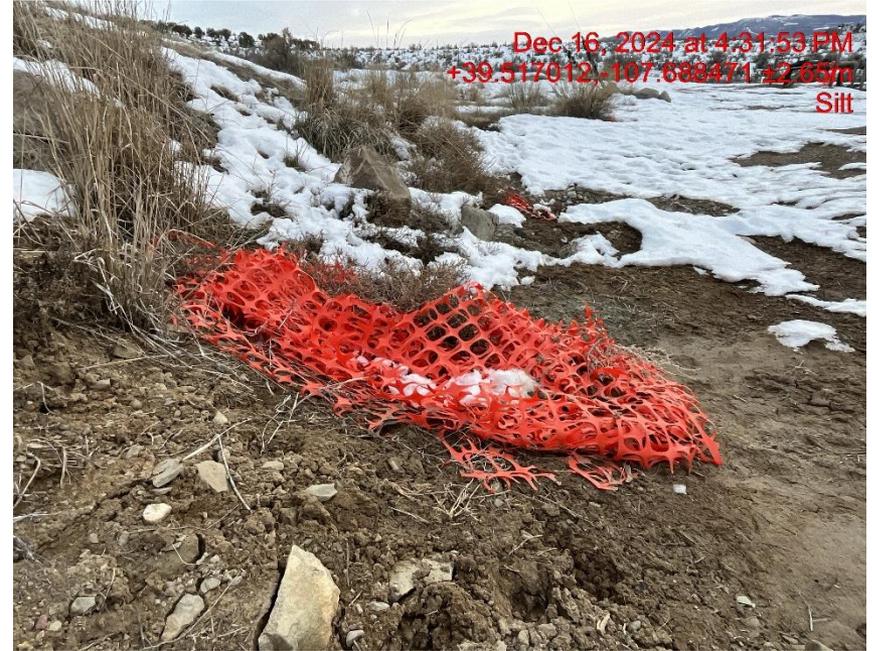
Photo # 1285 Debris

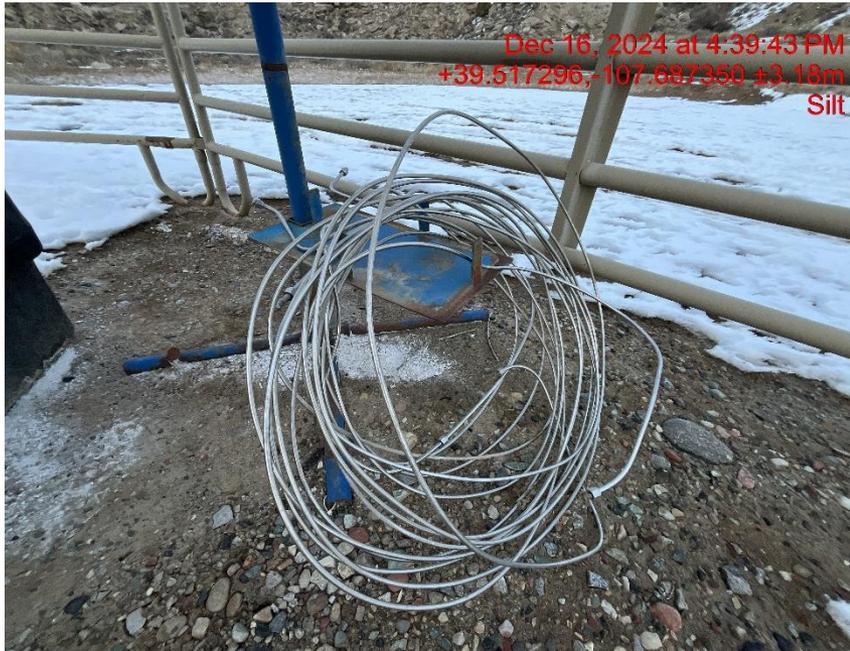
Photo # 1301 Debris

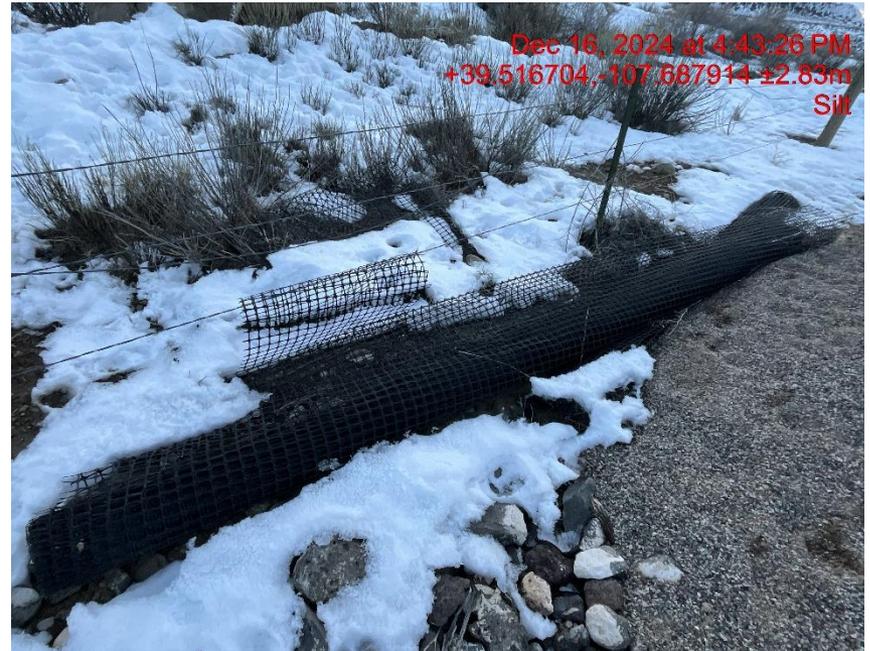
Photo # 1037 Debris
