# Inspection Photos

**Operator:** CAERUS PICEANCE LLC 10456  
(QB ENERGY OPERATING LLC - 10844)

**Location ID:** 418660

**Inspection Doc:** 718100131

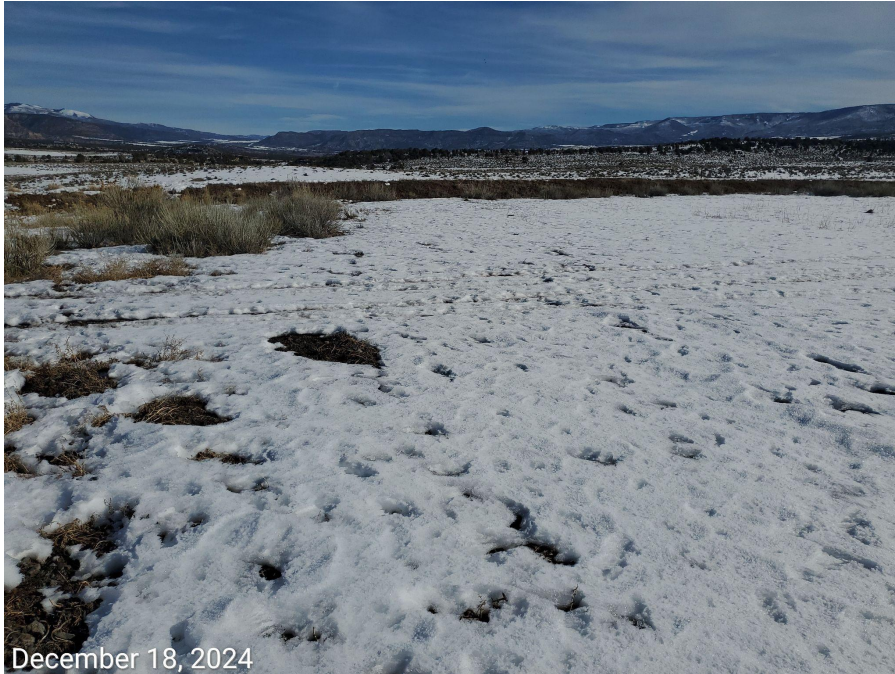
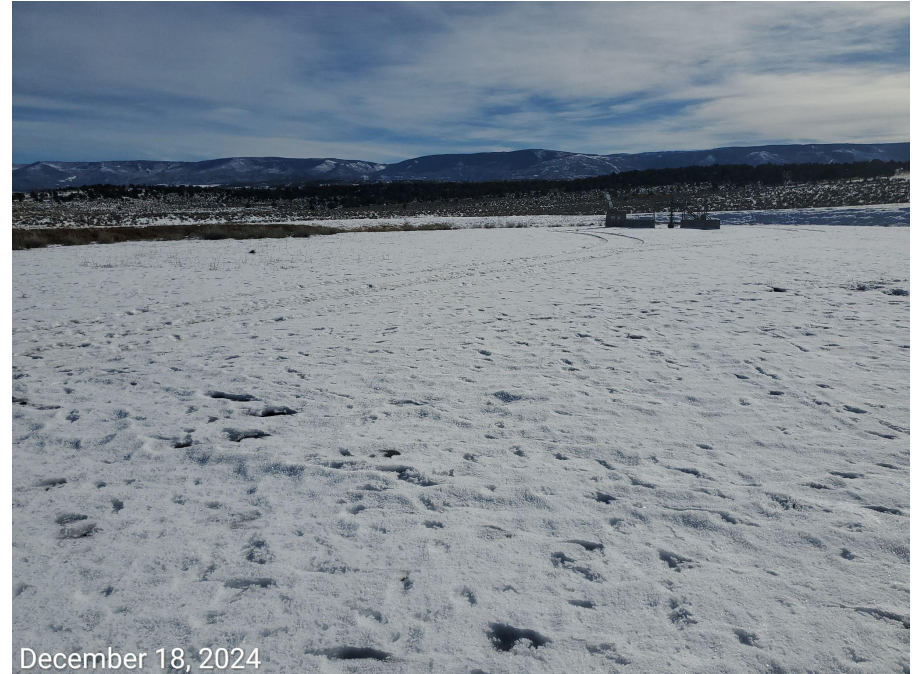
**Photo 1:** Photos 1-2 taken from the south end of the Location. Photos provide an overview of the Location from east, southeast, southwest to west. Photos show reclamation of areas not necessary for production have not been performed in accordance with 1003 requirements.

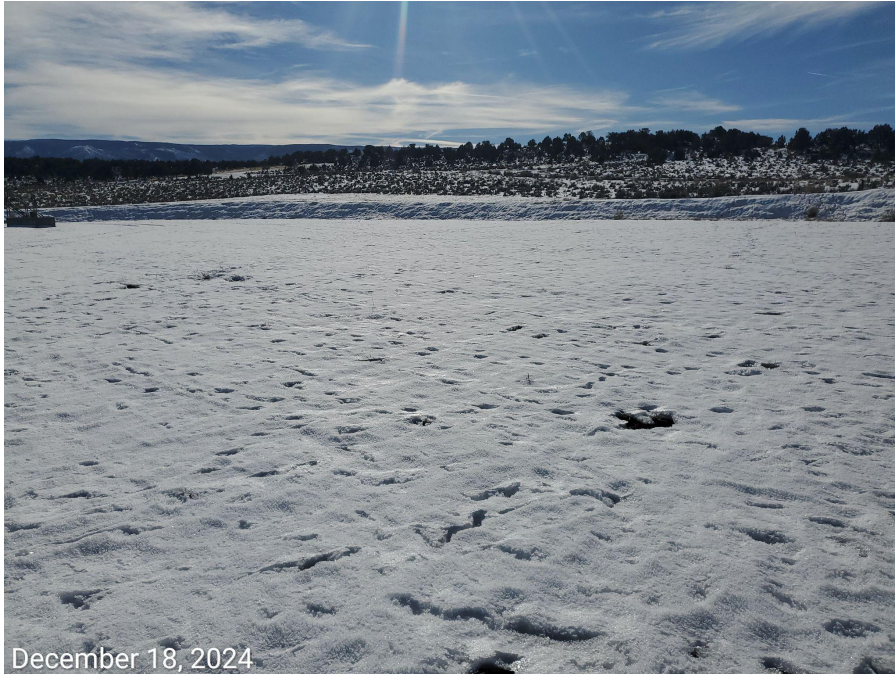
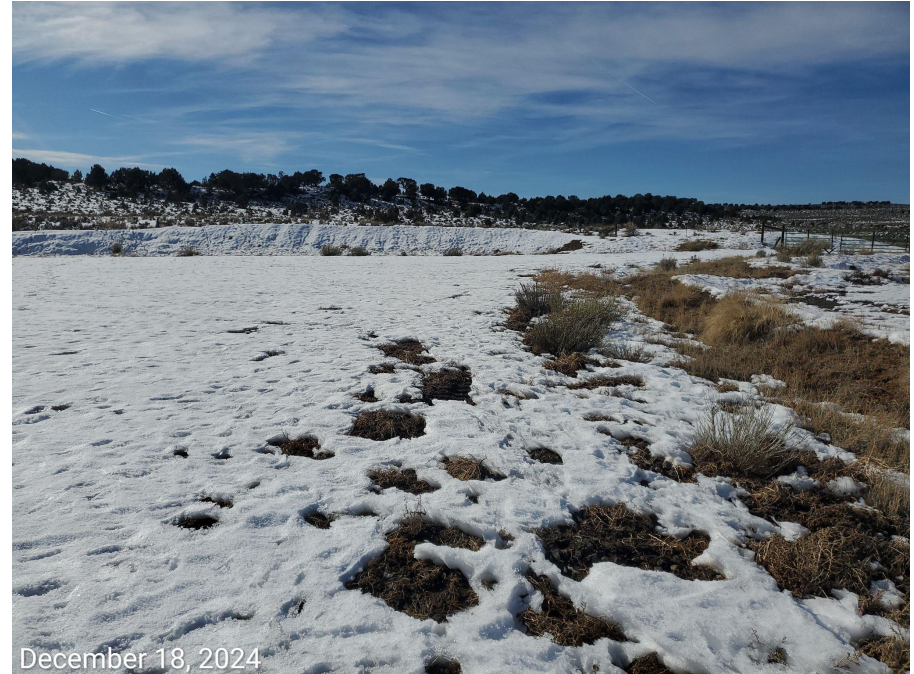
**Photo 2:** See comments under photo 1.

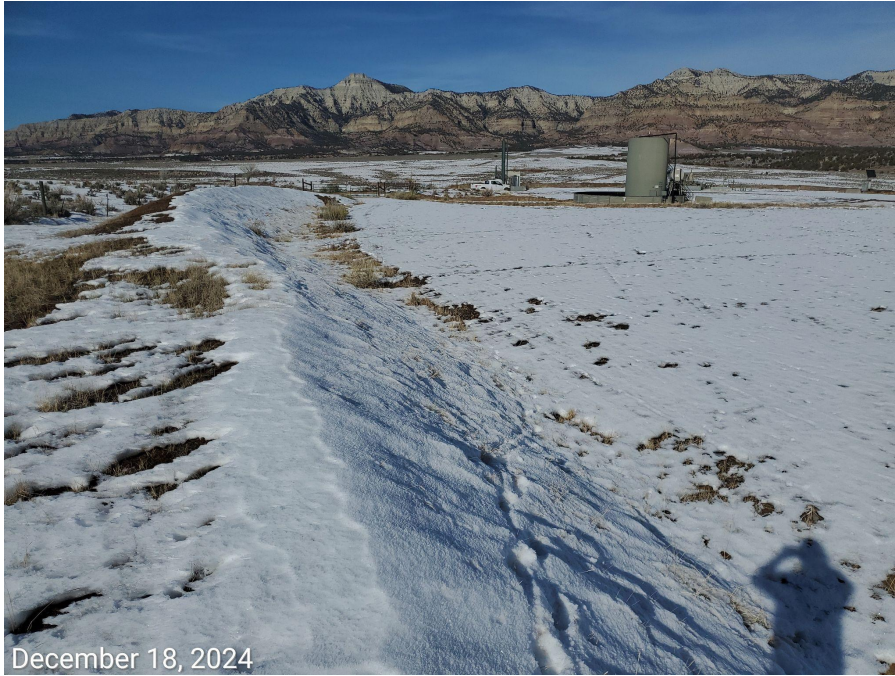
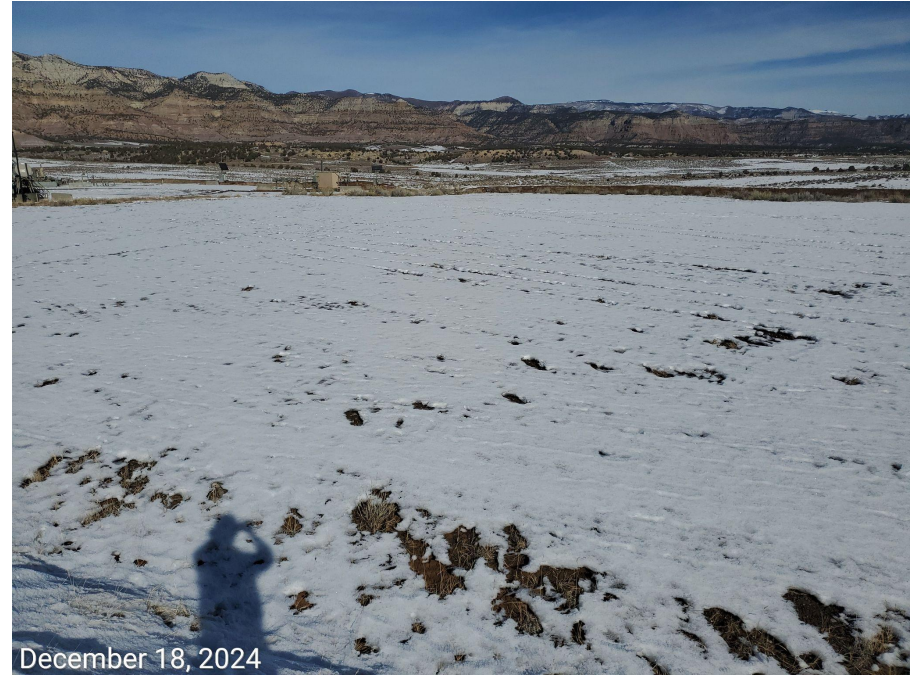
**Photo 3:** Photos 3-4 taken from the west end of the Location. Photos provide an overview of the Location from northwest, north, east to southeast. Photos show reclamation of areas not necessary for production have not been performed in accordance with 1003 requirements.

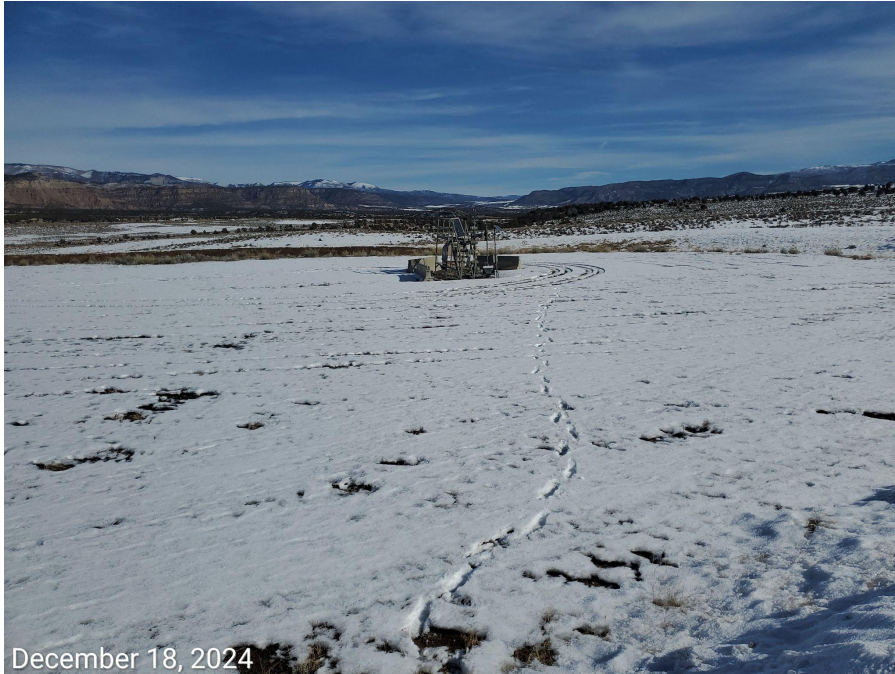
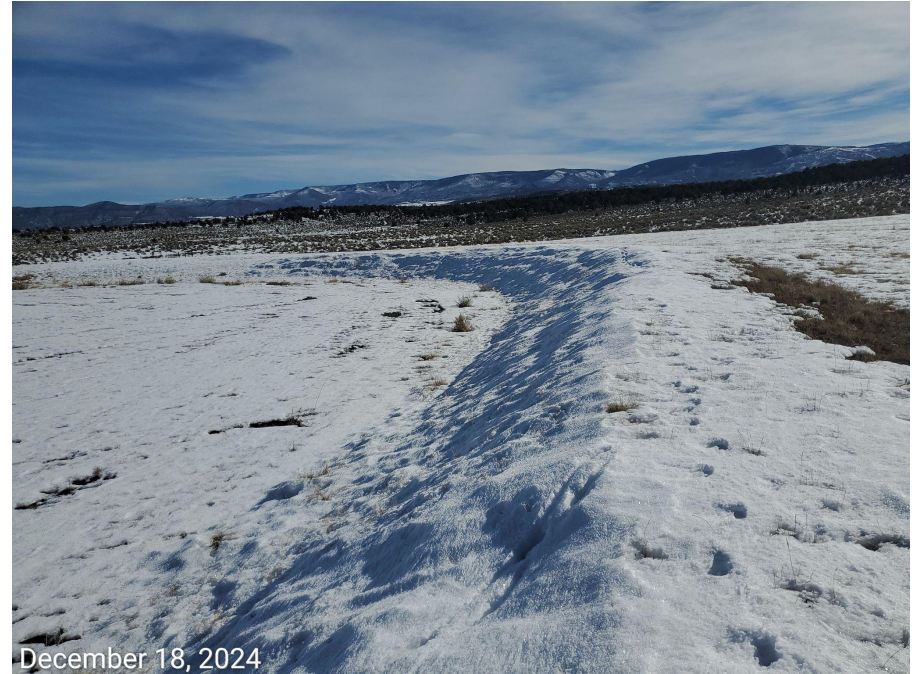
**Photo 4:** See comments under photo 3.

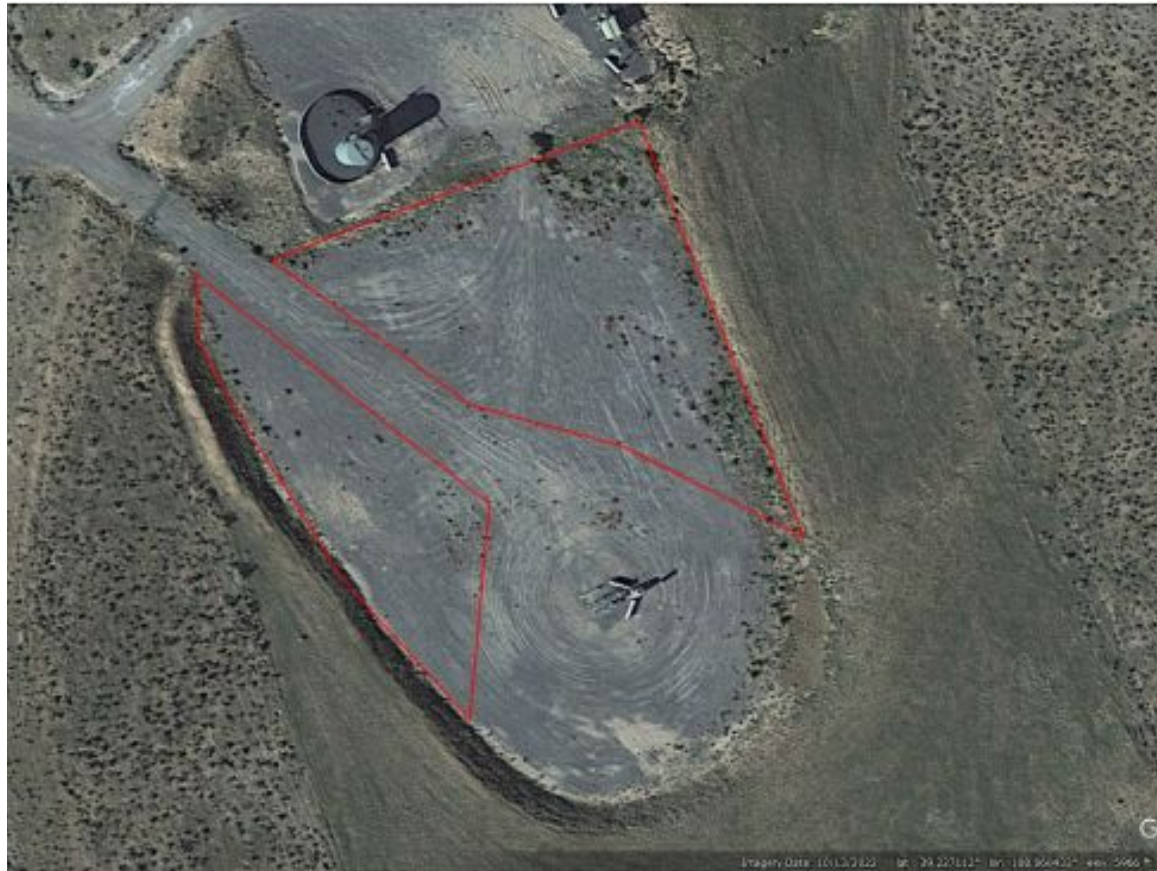
**Photo 5:** 2022 Google Earth aerial imagery. Photo provides an overview of the Stewart #36-13H Location (#418660). Production facilities (not including the well) have not been installed on the Location, rather, produced fluids travel via Off-Location flowline to the Stewart Compressor/(PL36SW) Location north. Red polygons represent approximate areas of the Location that are not necessary for production, and are subject to 1003.b reclamation requirements.

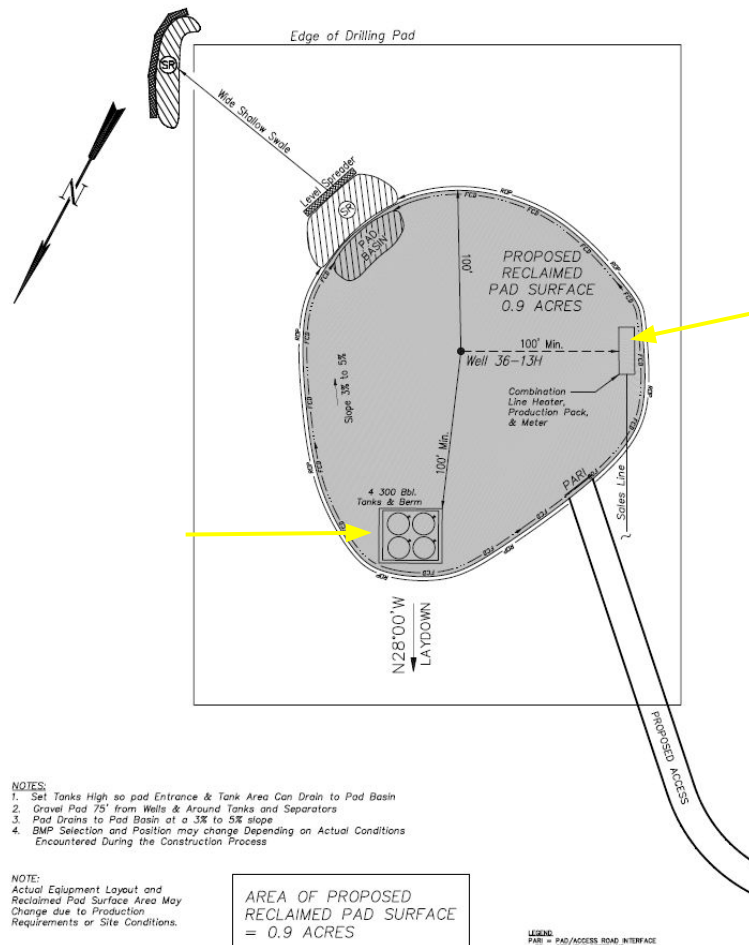
**Photo 6:** Figure taken from the Form 2A Layout Drawing (#400062072). Image shows production areas were to be reduced to ~0.9 acres. Note- tank and other production facilities (arrow) were not installed, resulting in additional areas (~75 foot buffer beyond the well) not necessary for production at this Location, requiring reclamation.
