Inspection Photos
Location Name: Kammerzell 2-16
Location ID: 322571

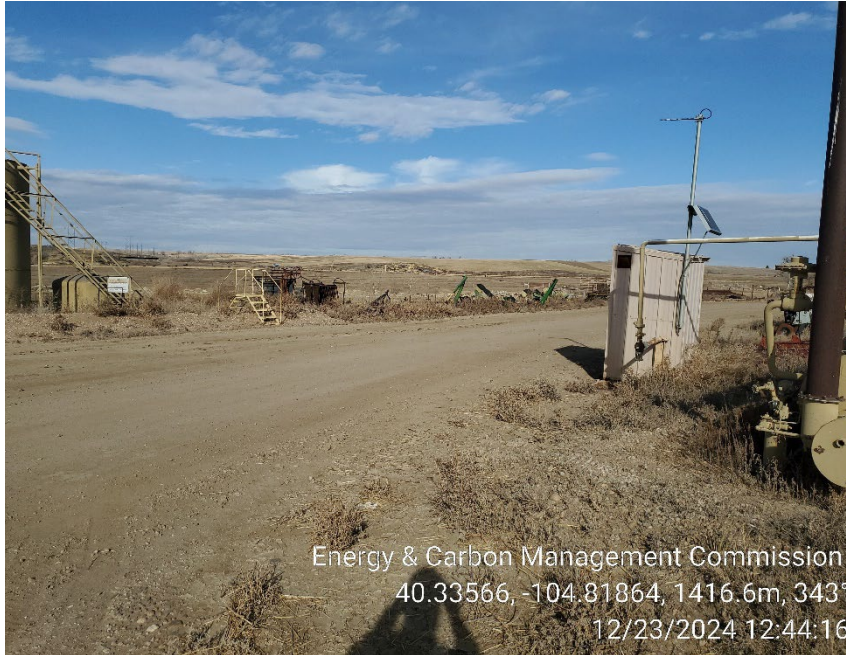
Production facility

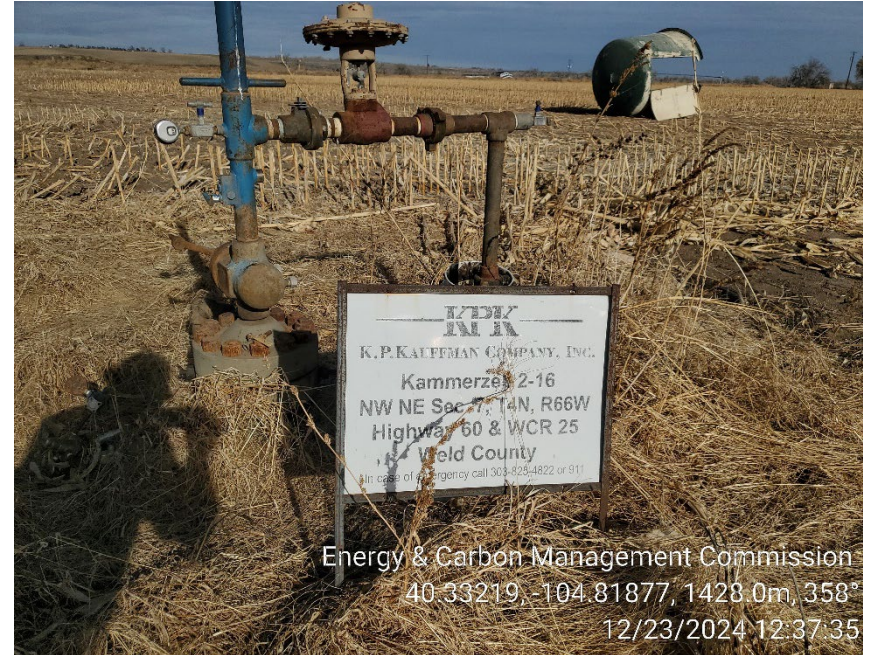
Wellhead

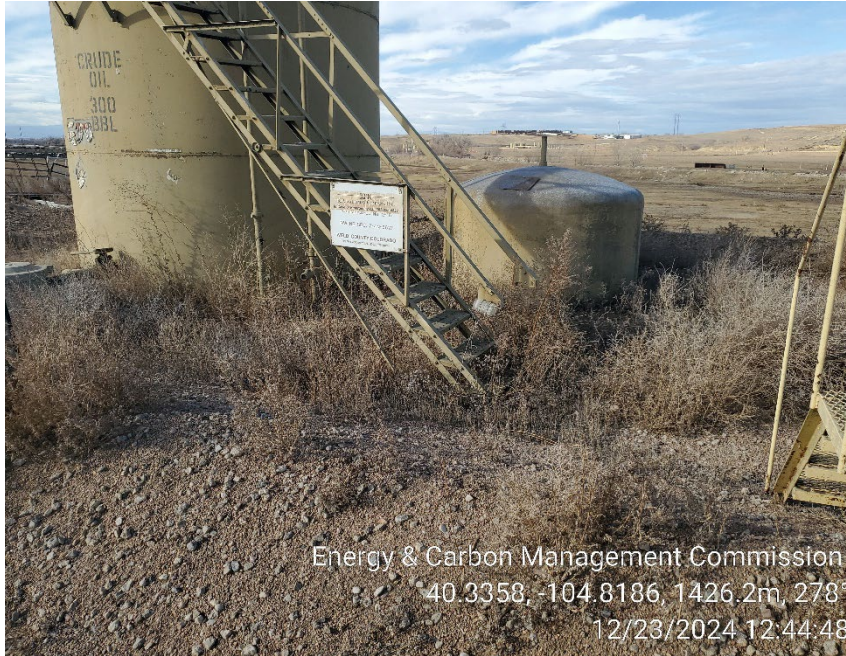
Debris

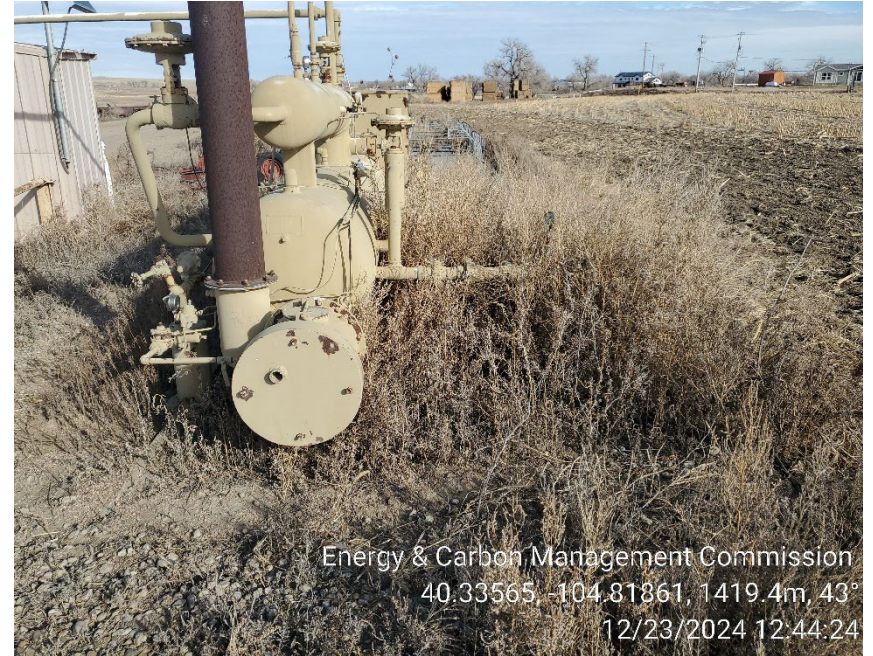
Debris

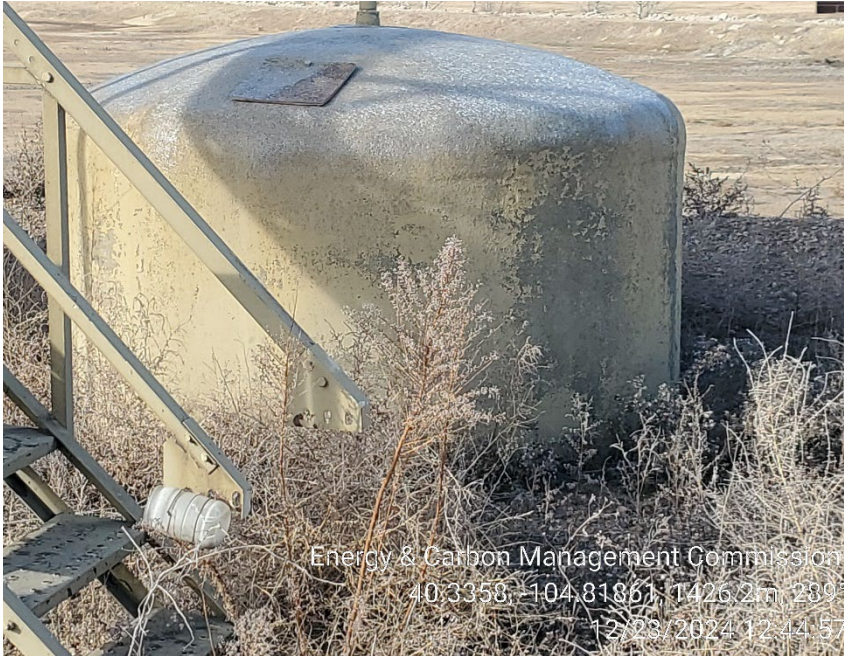
Produced water tank placards

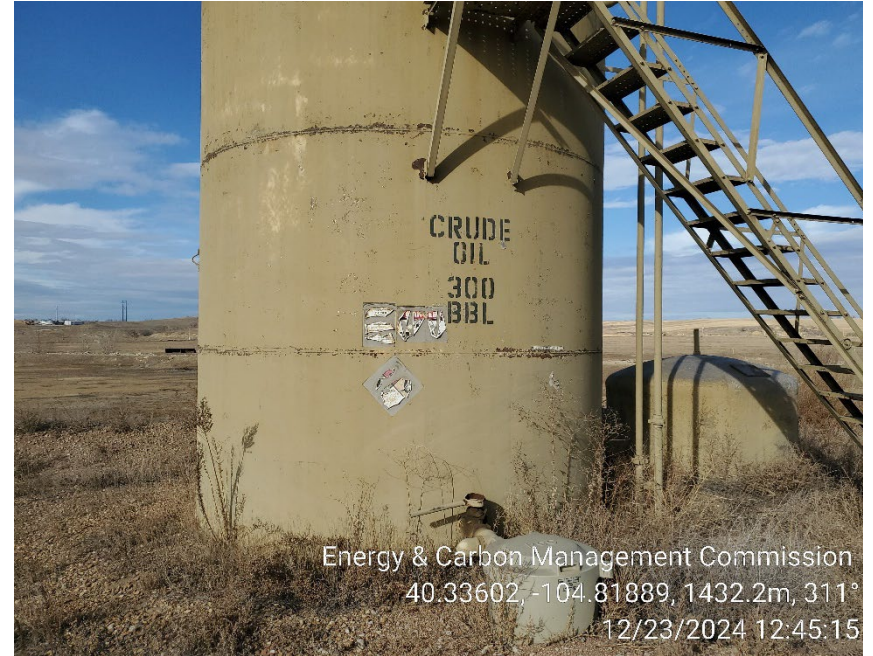
Crude oil tank placards
