# Interim Reclamation and Stormwater Inspection

Operator: KP KAUFFMAN COMPANY INC - 46290

Well Name: DORIS #12-34

Inspection Document #: 718600084

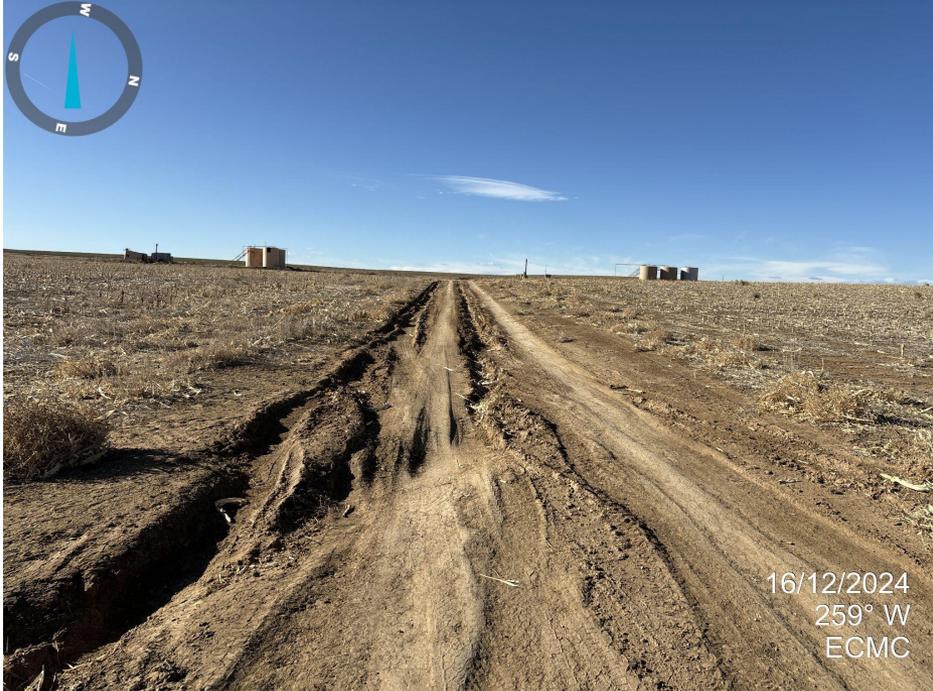
**Photo 1.** Photo taken Looking west along access road. Deep ruts in access road have resulted in widening of access road.

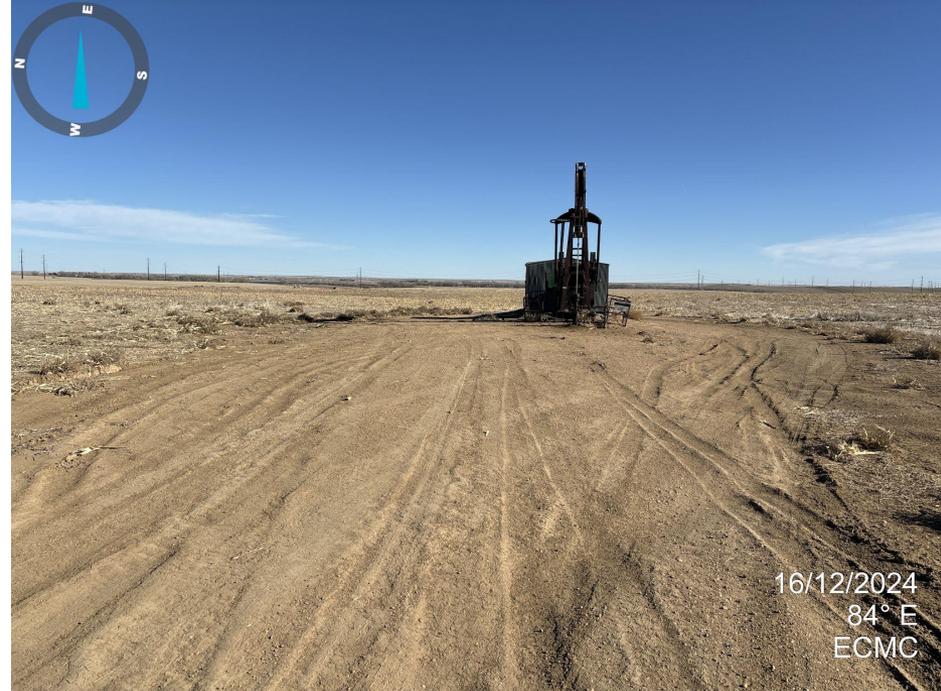
**Photo 2.** Looking east across well site. Undesirable weedy plant species are present on location.

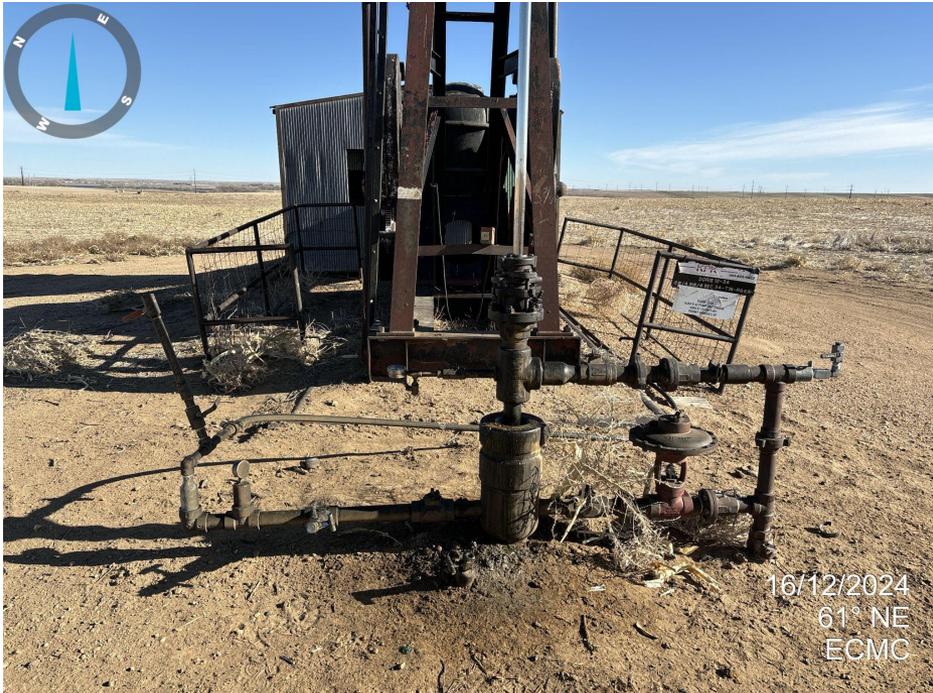
**Photo 3.** Wellbore is leaking. Stained soil is present around wellbore.

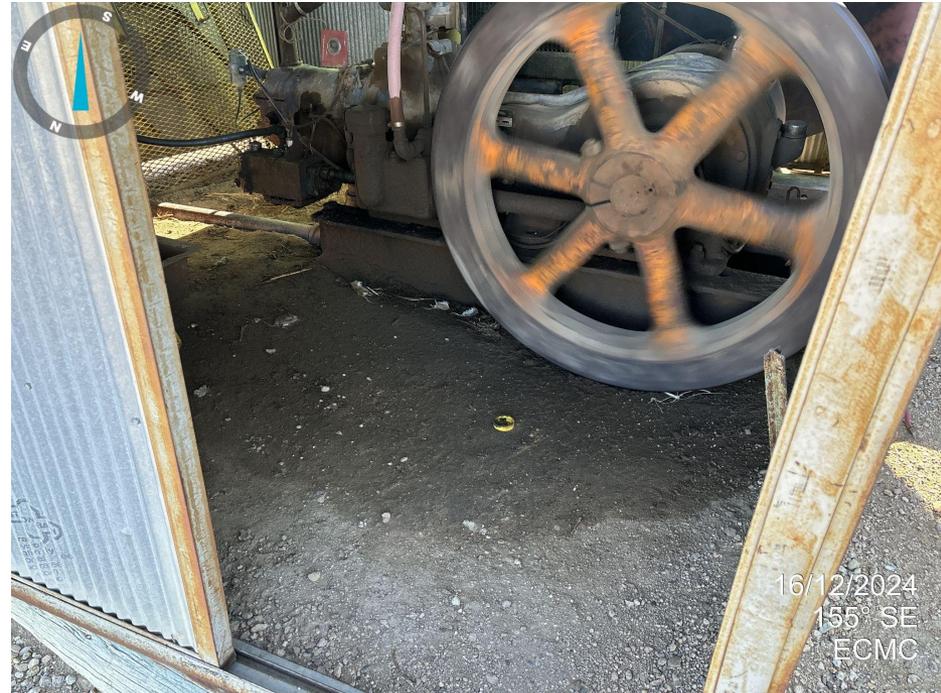
**Photo 4.** Stained soil present around engine. Close engine shed door to prevent unauthorized access. Flywheel does not have cover installed.

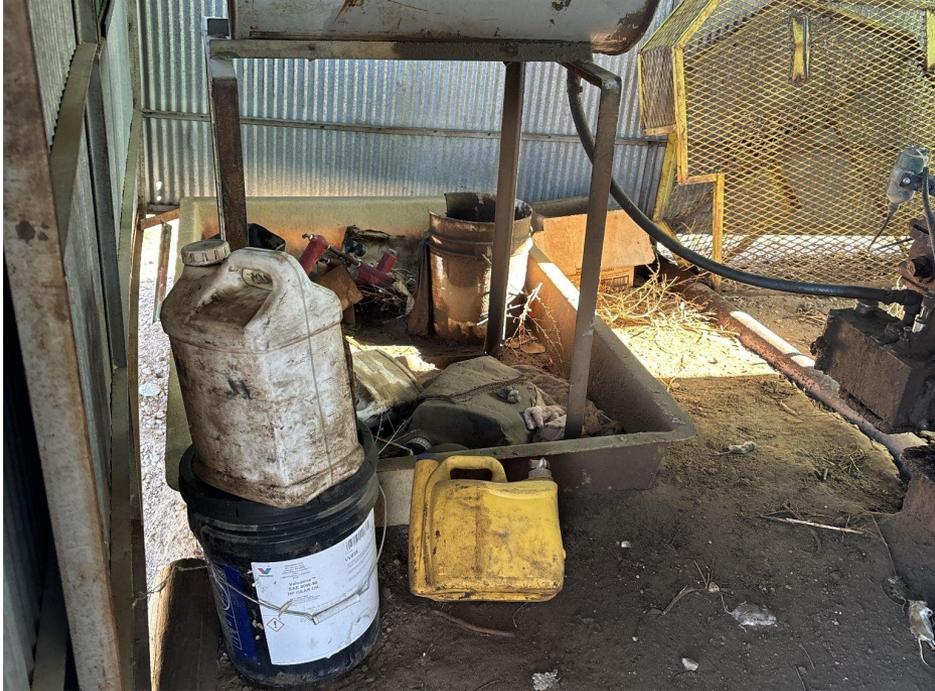
**Photo 5.** Trash and unused equipment being stored in and out of secondary containment.

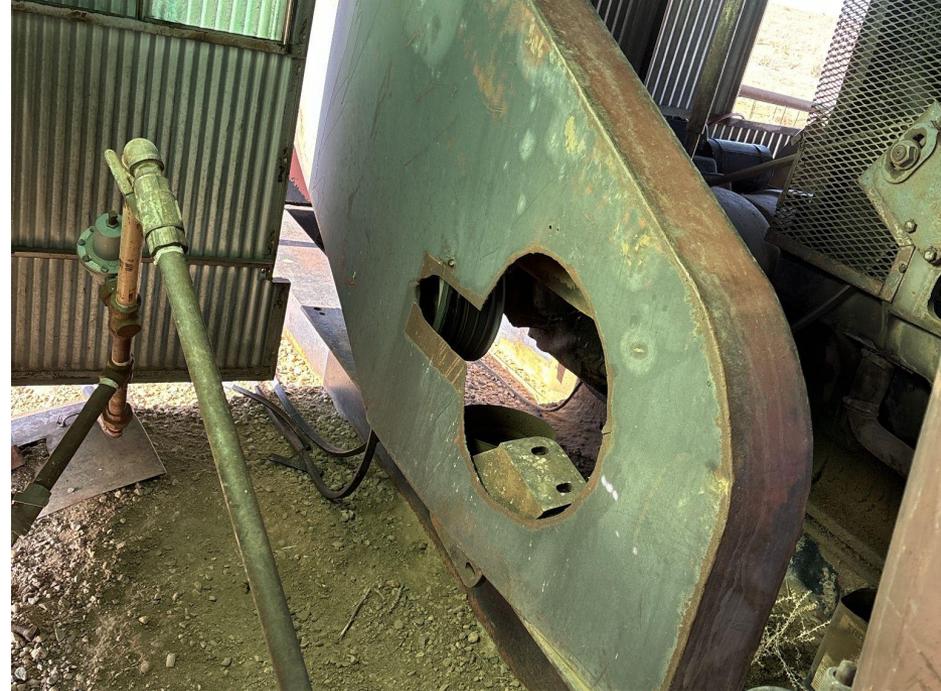
**Photo 6.** Broken belts left in place around pulley.

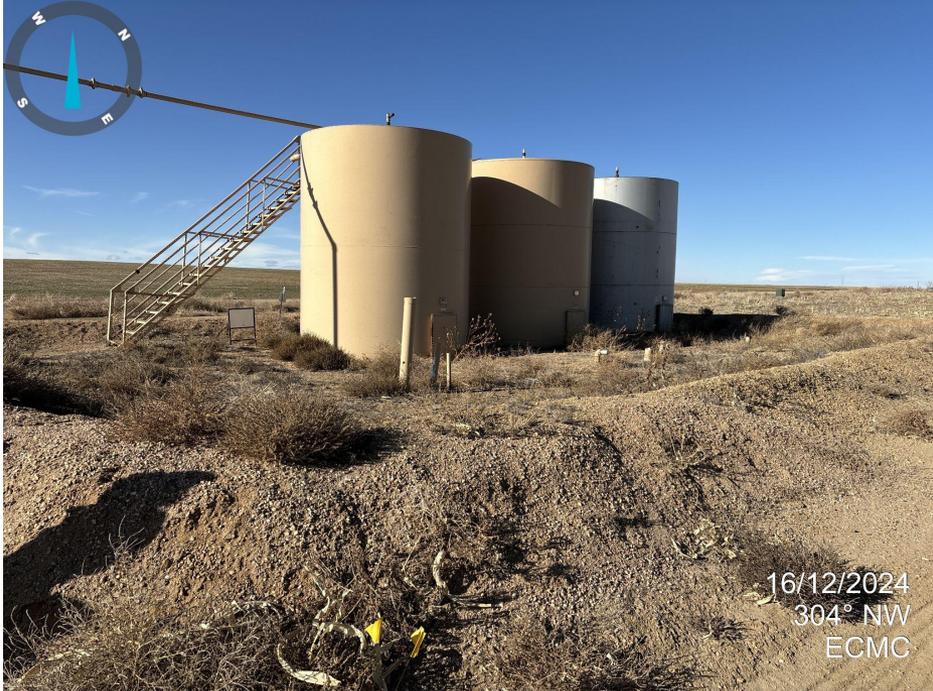
**Photo 7.** Looking northwest across tank battery. Weedy annual plant species were present throughout location (Kochia, Russian thistle).

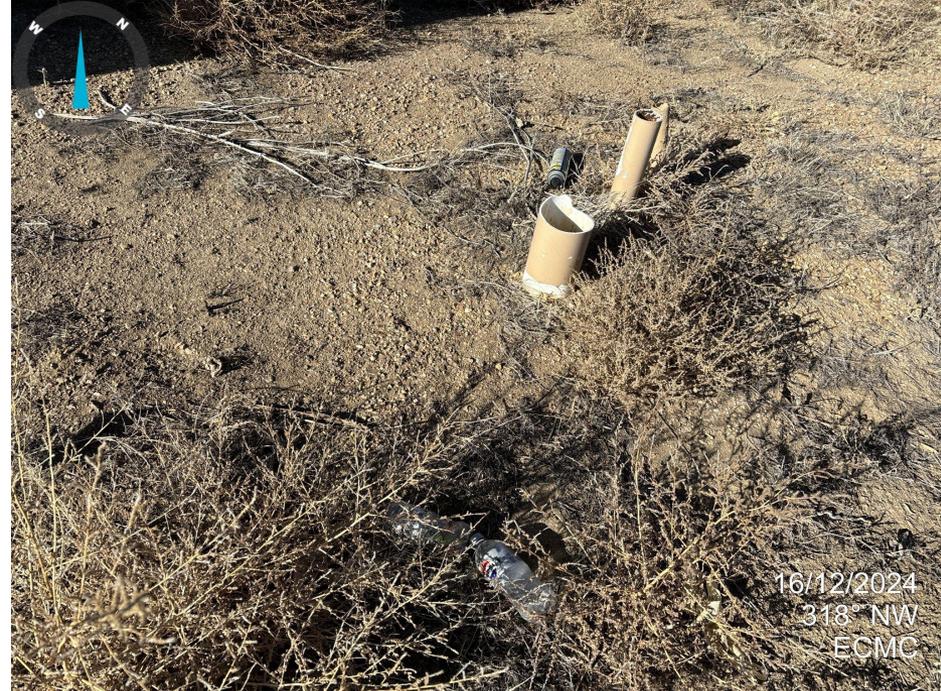
**Photo 8.** Uncapped pipes and trash at tank battery.

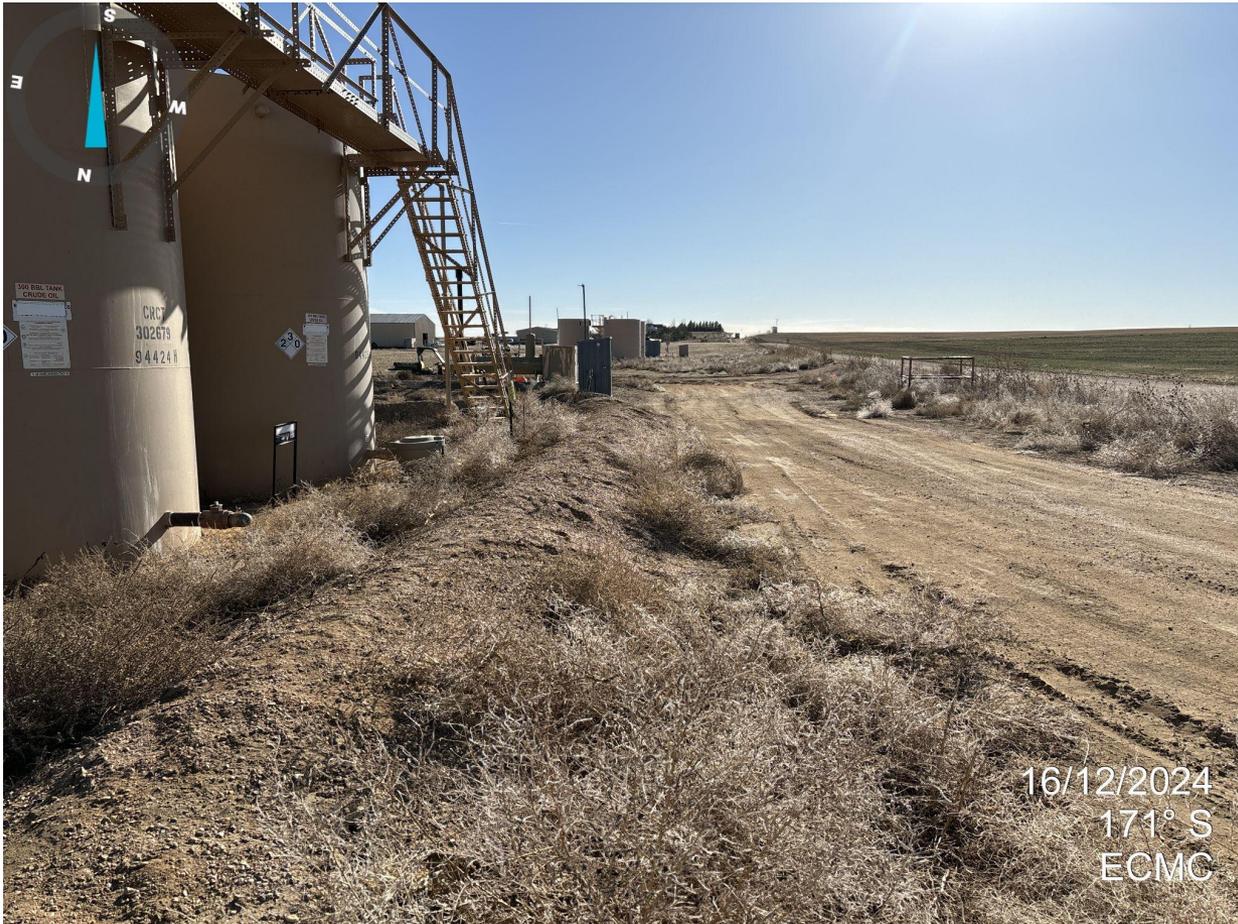
**Photo 9.** Looking south across tank battery. This tank battery location is shared with Dottie Doris #11, 12-34 (Loc # 464916) See Photo 7 comments.

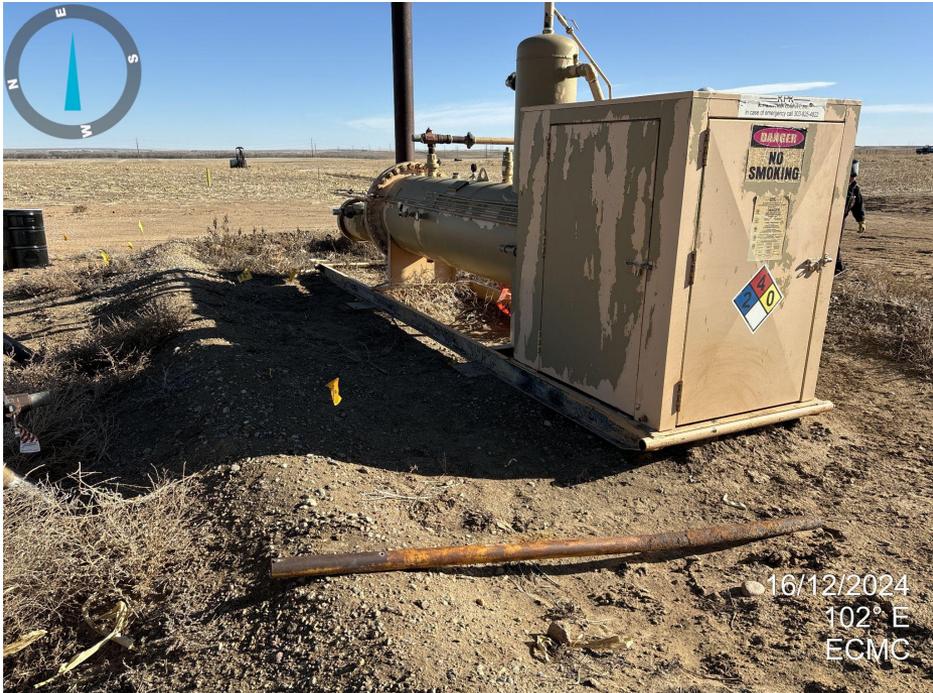
Photo 10. Unused equipment (pipe) near separator.

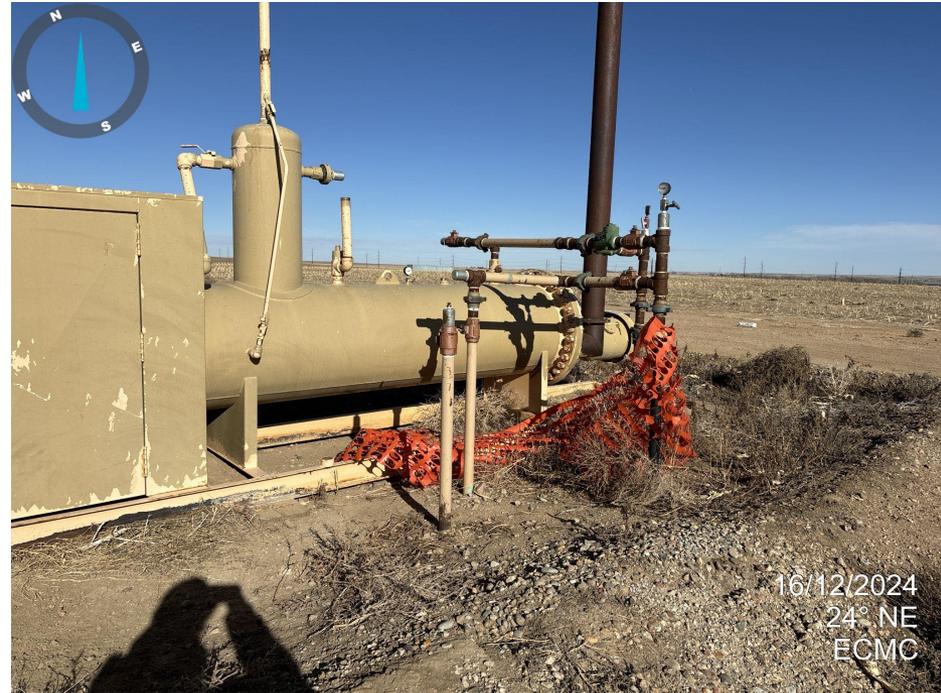
Photo 11. Trash and weeds are present near separator.
