Interim Reclamation and Stormwater Inspection

December 16, 2024

Operator: DCP OPERATING COMPANY LP - 4680

Location ID: 464916

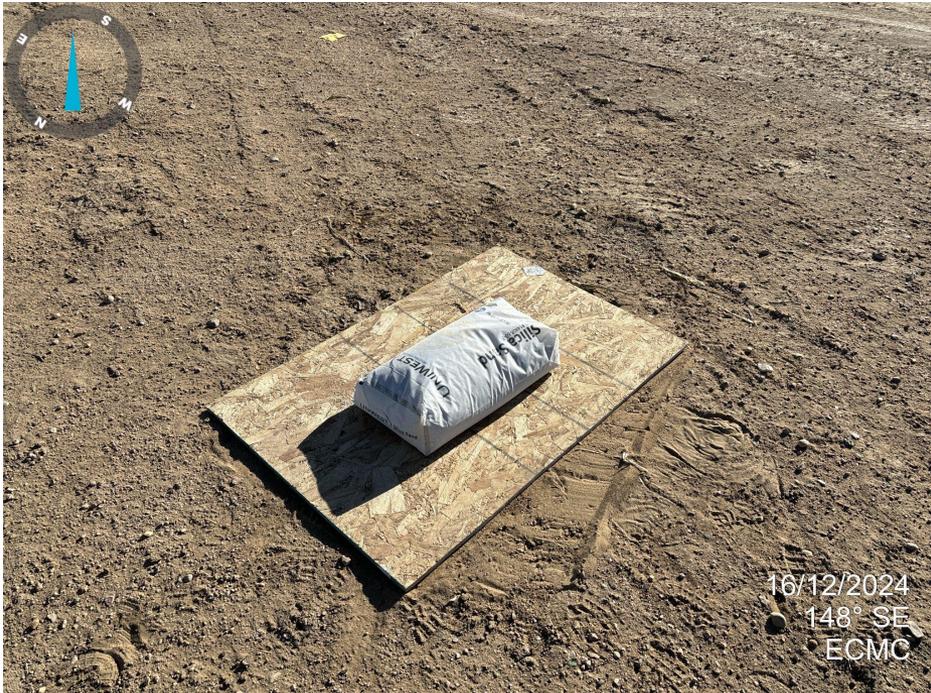
Photo 1. Proposed monitoring well holes appear to have been dug.

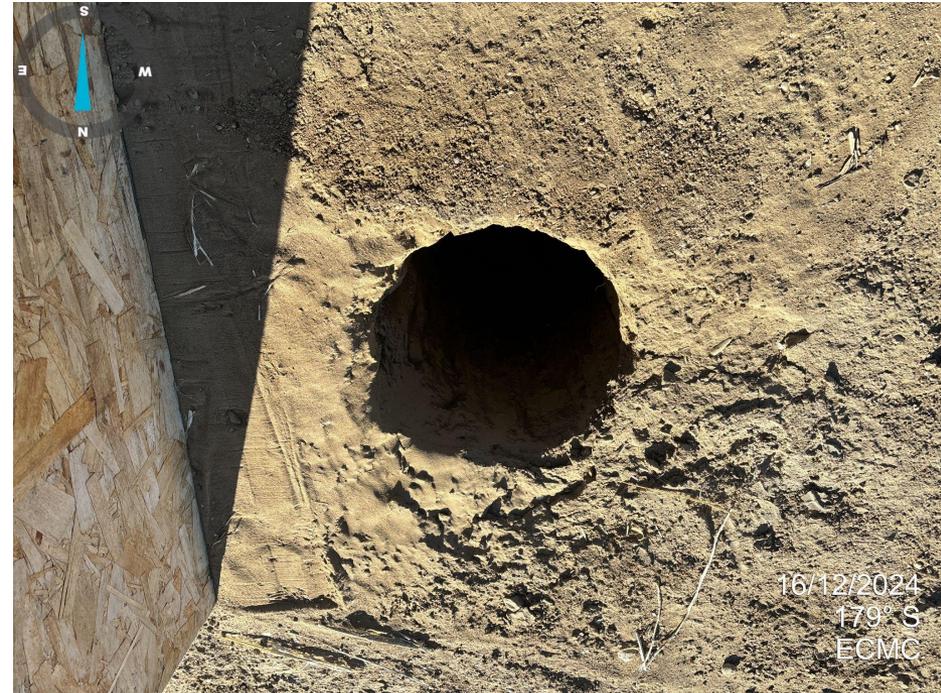
Photo 2. See Photo 1 comments.

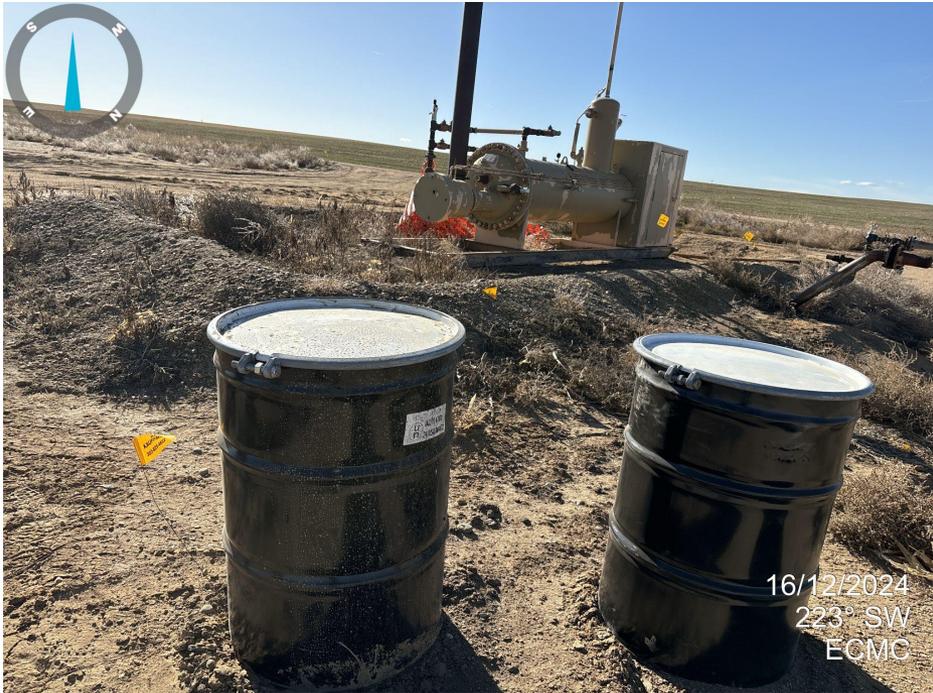
Photo 4. Unlabeled barrels potentially associated with groundwater monitoring project.

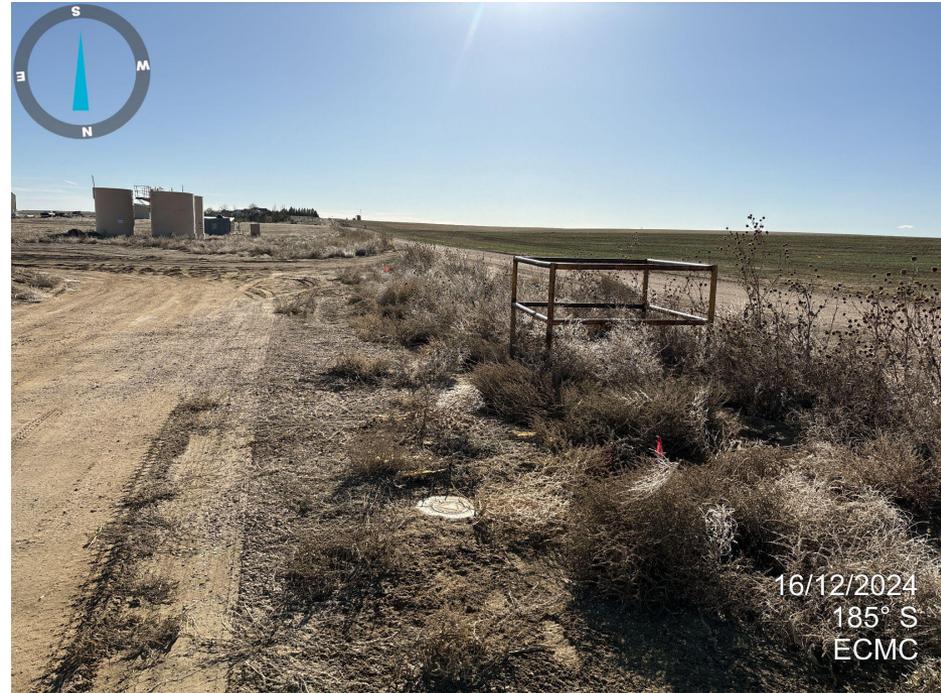
Photo 5. Photo taken west of Dottie-Doris separator looking south.

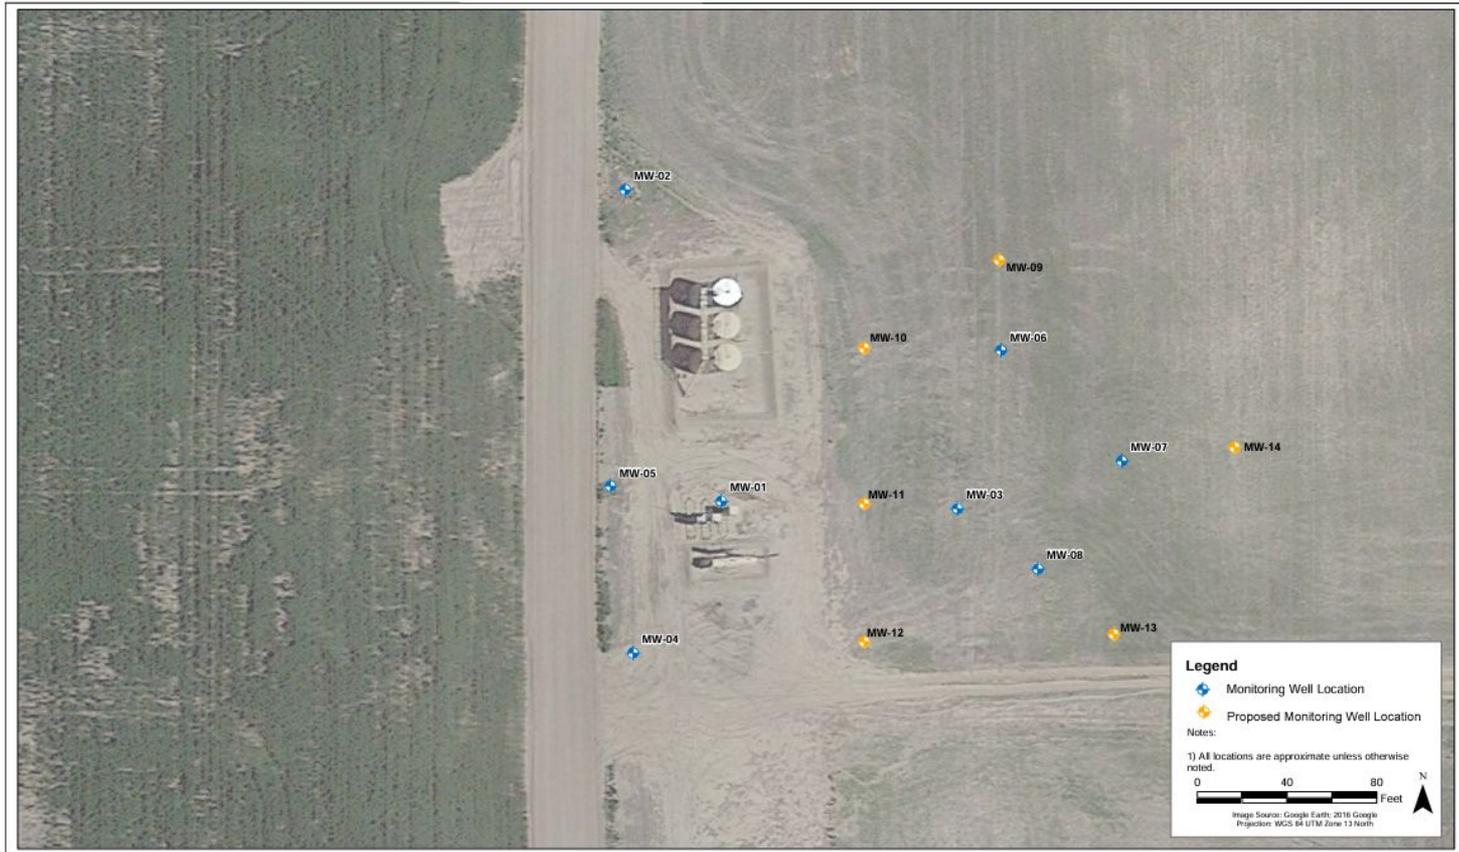
Photo 5. Operator submitted site map of current and future monitoring wells.

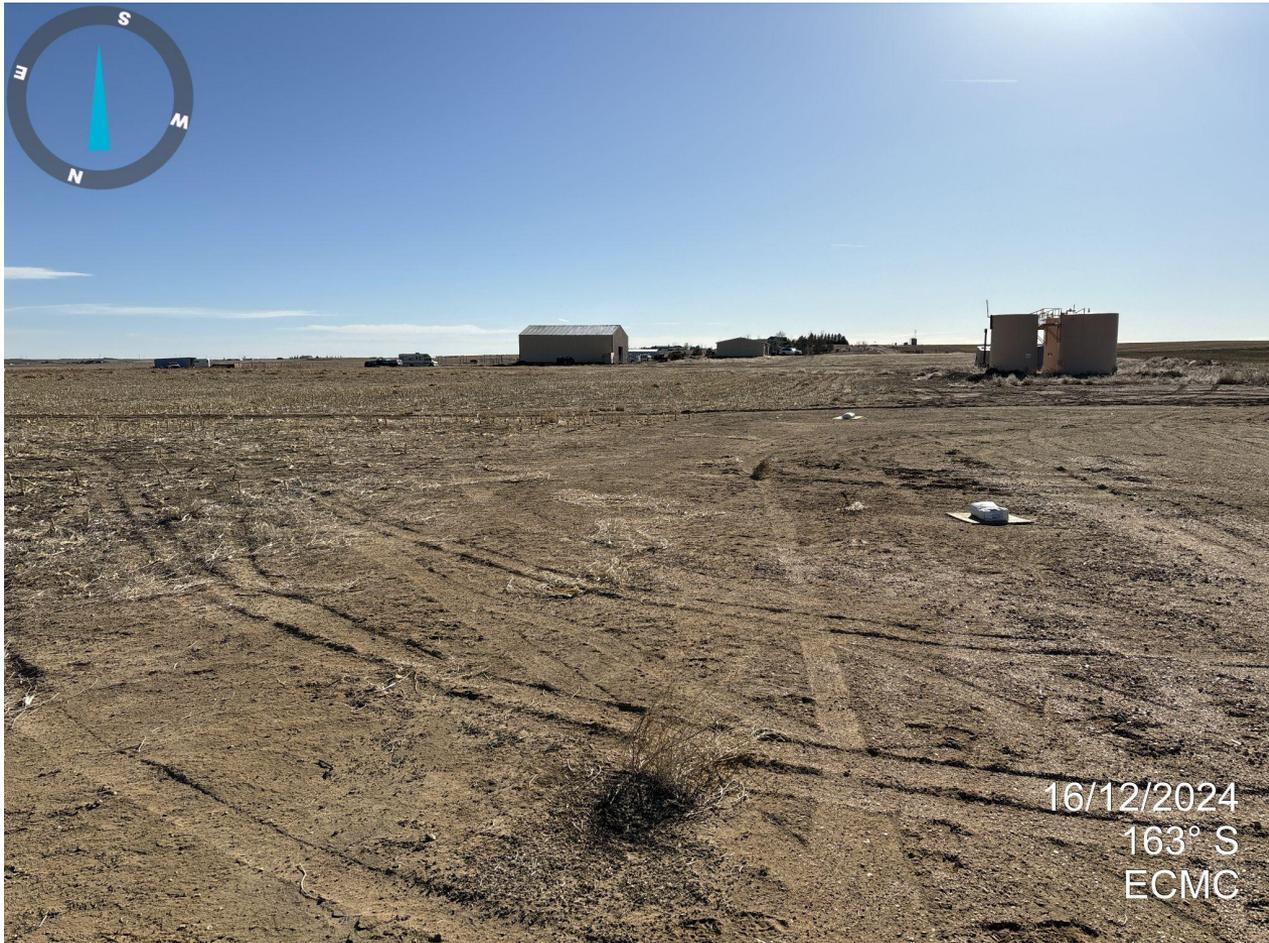
Photo 6. Looking south from east of the tank battery.

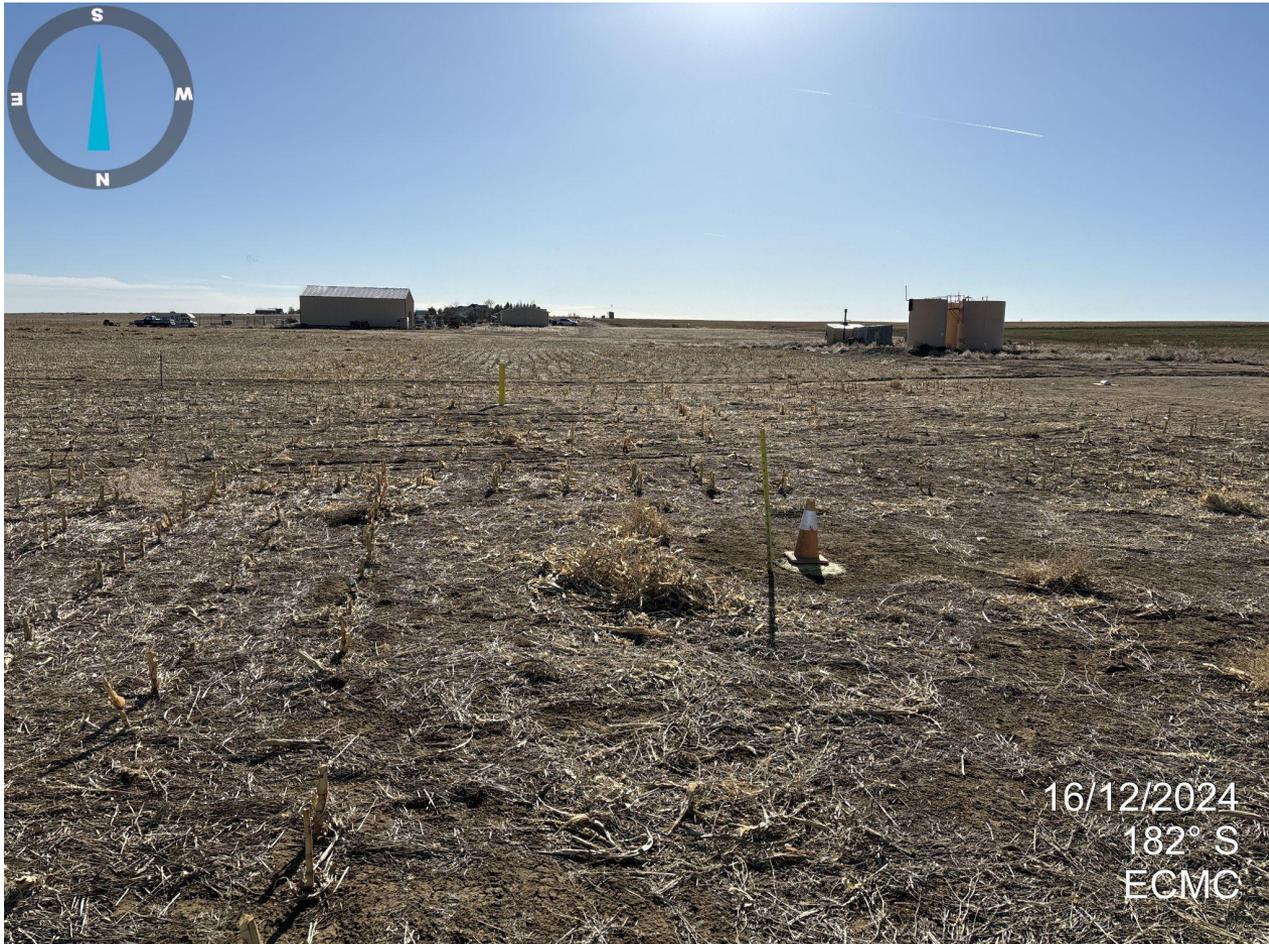
Photo 7. Monitoring wells in place. Photo looking south near MW-03.

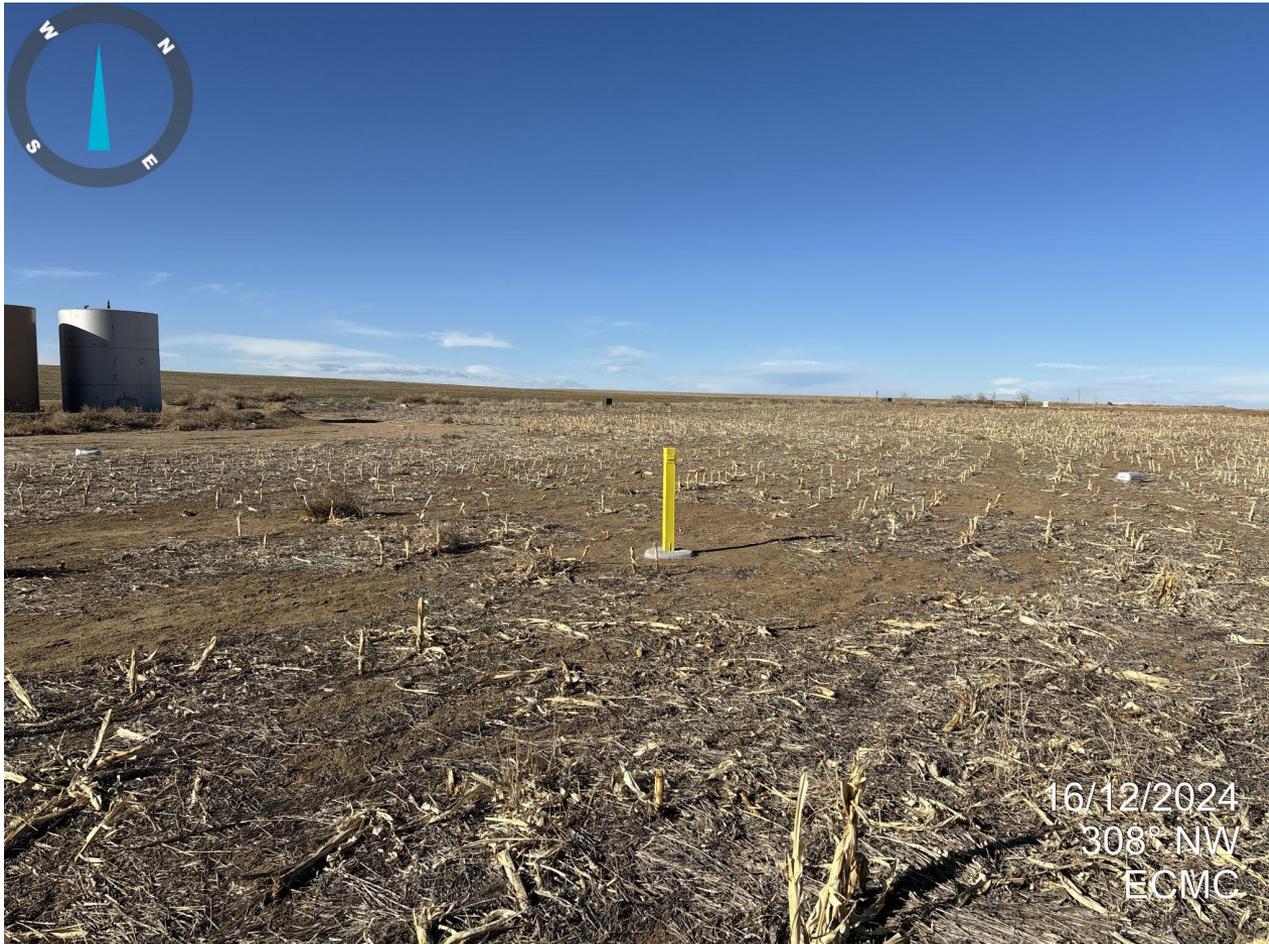
Photo 8. Photo looking northwest near MW-06.
