Storm Water Management and Erosion control
Location Name: TEP ROCKY MOUNTAIN LLC WARE SR 23-12 Pad
Location ID: 449385

Location Overview: Location is within Black Bear Habitat area & in close proximity to High Priority/NSO Habitat areas. Location is within Rule 411a Surface Water Internal & Intermediate Buffers. Location is approximately 343 yards from Beaver Creek.
Section/Township/Range: 12 7S94W

COLORADO
Energy & Carbon Management
Commission
Department of Natural Resources

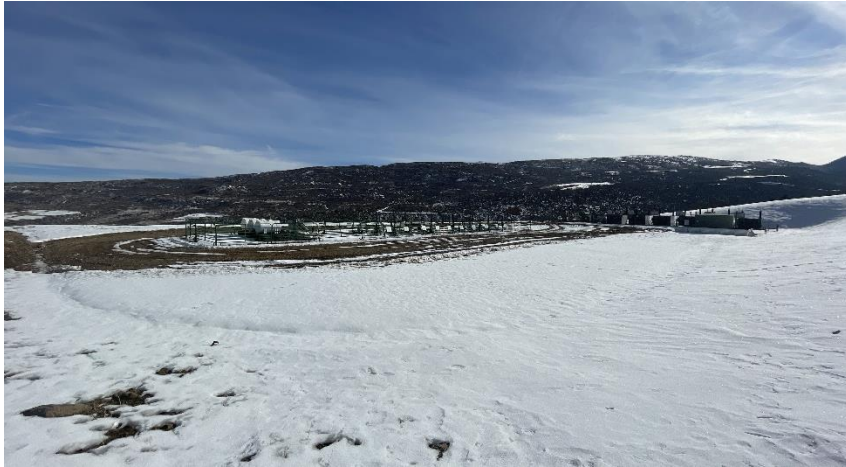
North West corner of location.

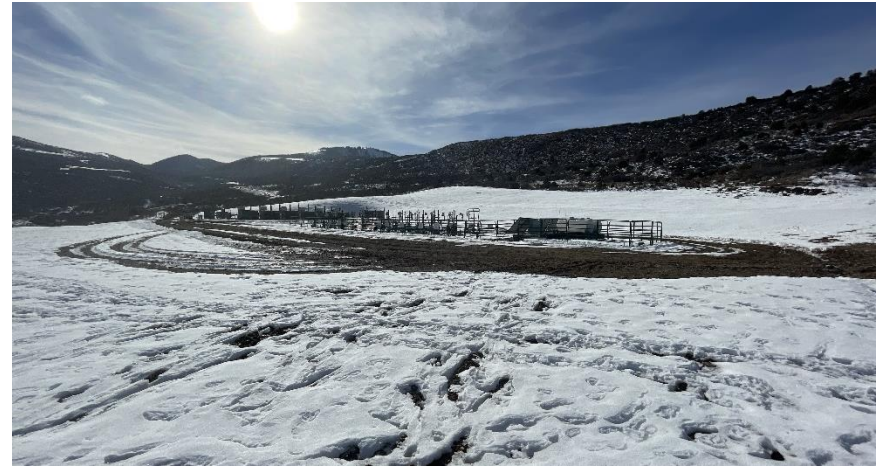
North East corner of location.

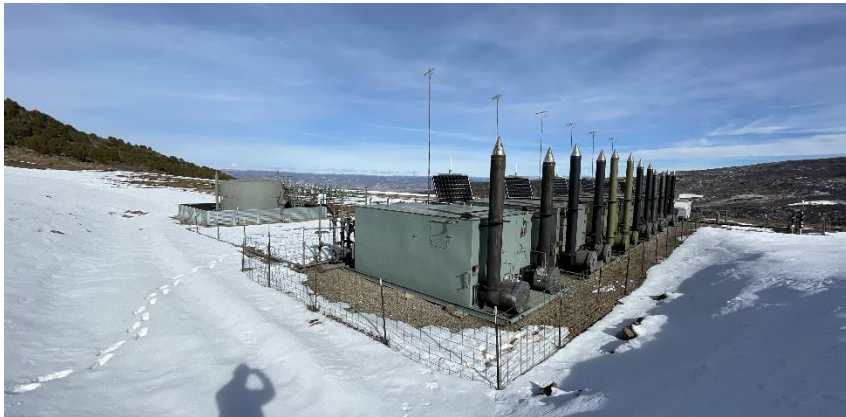
South West corner of location.

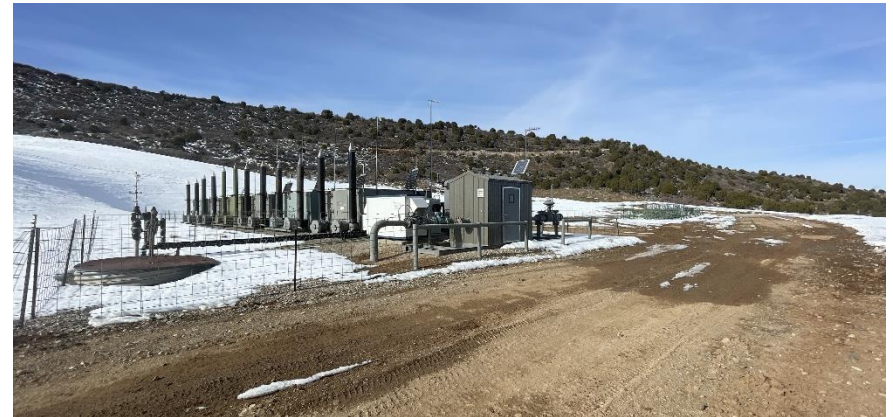
South East corner of location.

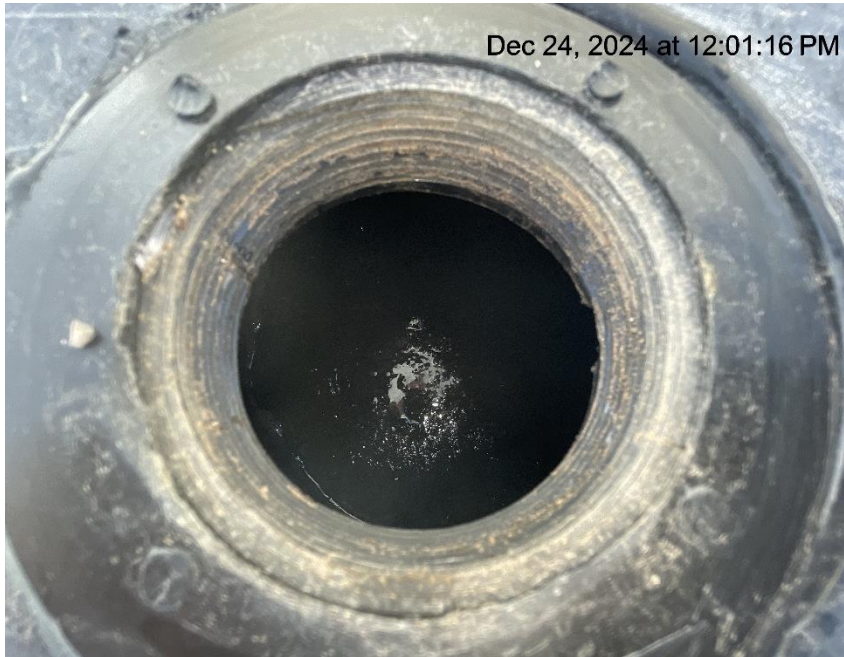
Photo # 5281 Failure to maintain chemical BMP - Chemical tank containment approximately 2/3 to 3/4 full of fluid/BMP insufficient to contain possible spill

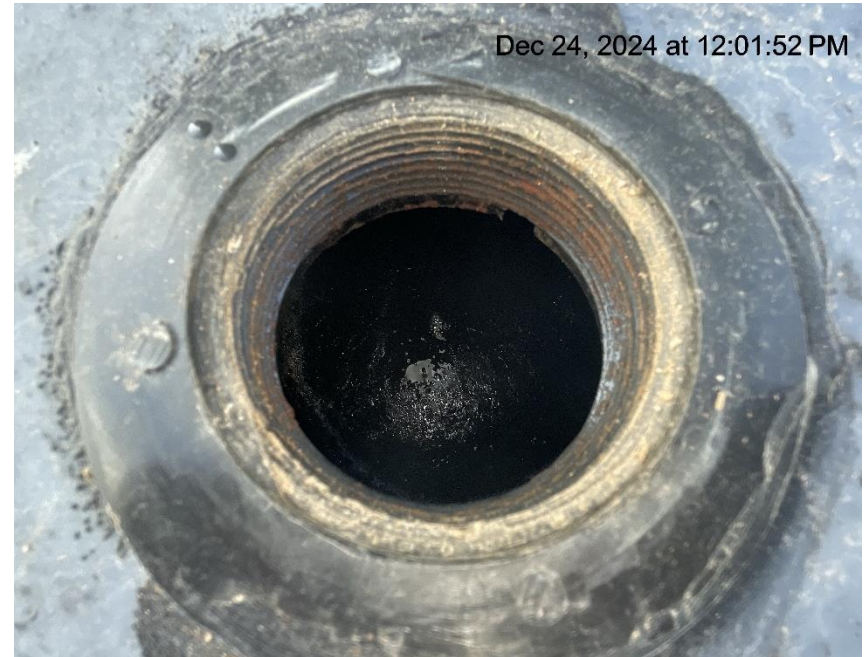
Photo # 5282 Failure to maintain chemical BMP - Chemical tank containment approximately 2/3 to 3/4 full of fluid/BMP insufficient to contain possible spill

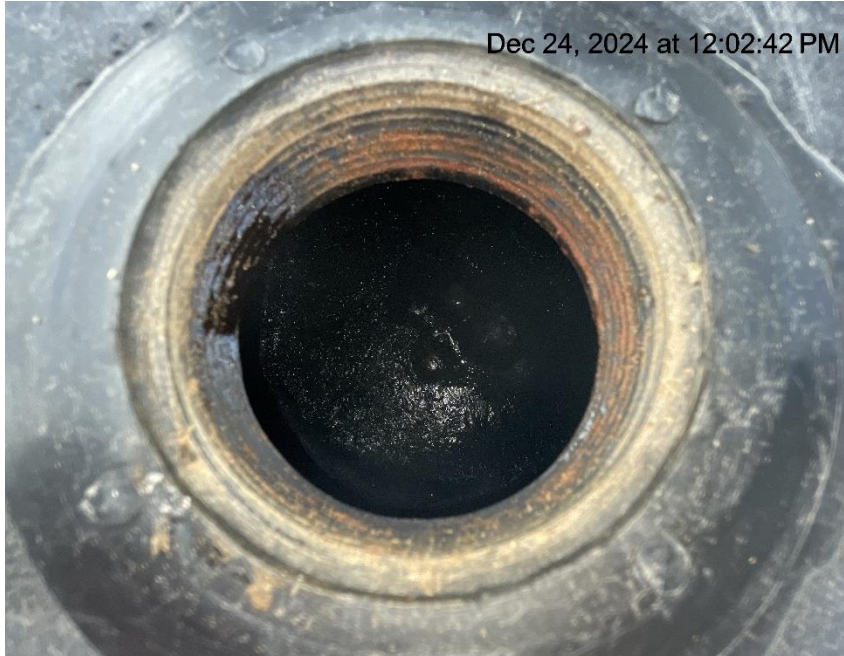
Photo # 5283 Failure to maintain chemical BMP - Chemical tank containment approximately 2/3 to 3/4 full of fluid/BMP insufficient to contain possible spill
