Inspection Photos

Location Name: TEP ROCKY MOUNTAIN LLC WARE SR 23-12 Pad

Location ID: 449385

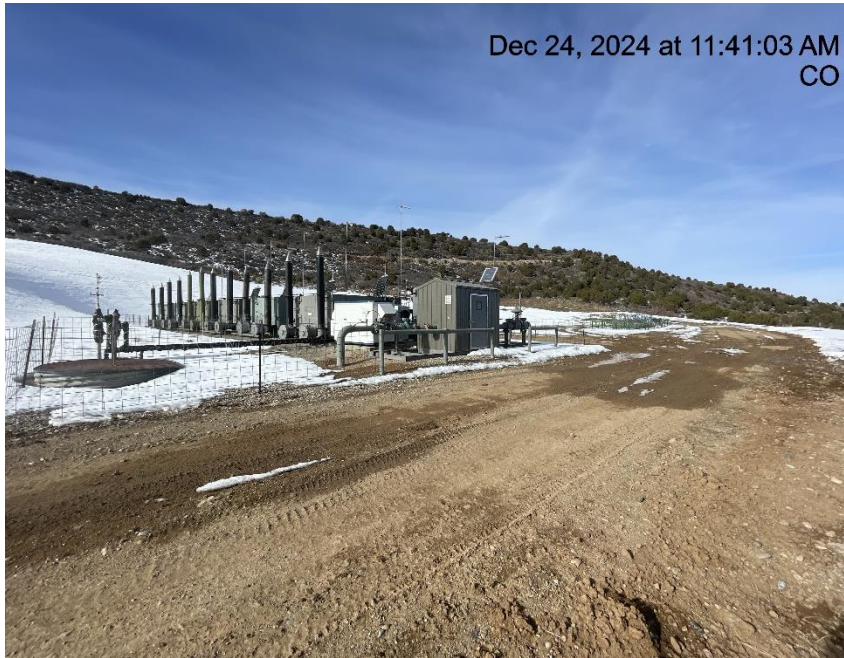
Photo # 5263 From entrance to location

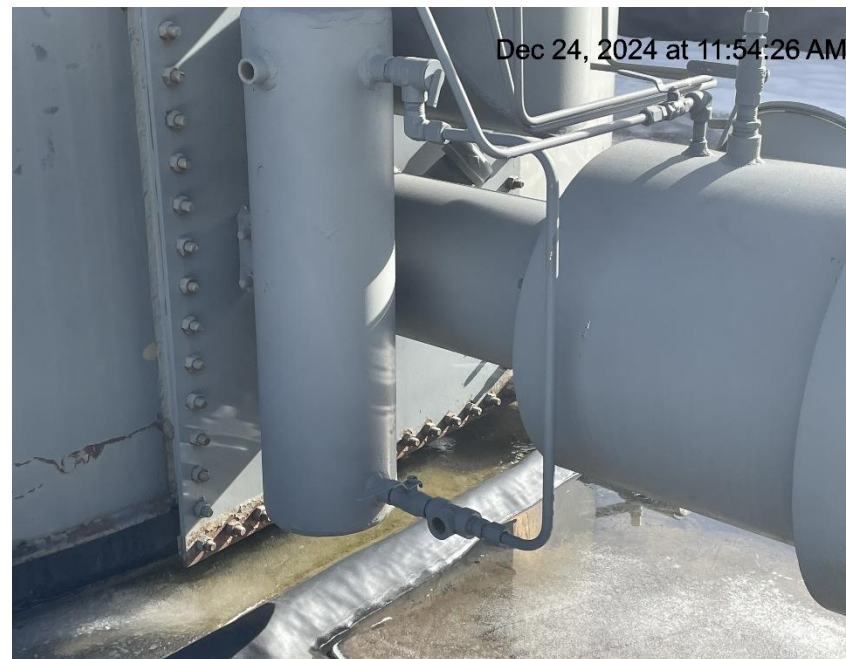
Photo # 5274 PRV vent line does not comply with CECMC pressure safety device rules

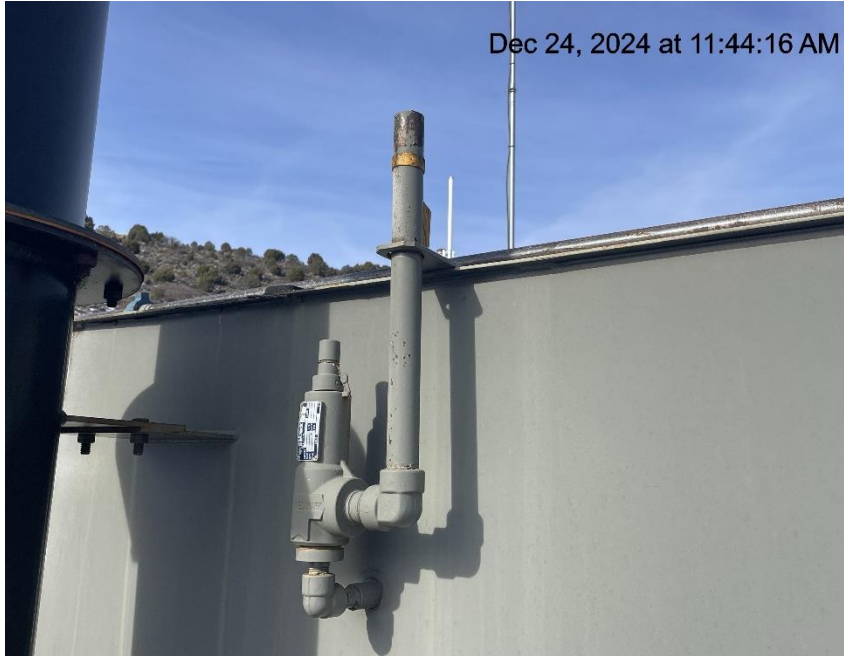
Photo # 5275 PRV vent line does not comply with CECMC pressure safety device rules

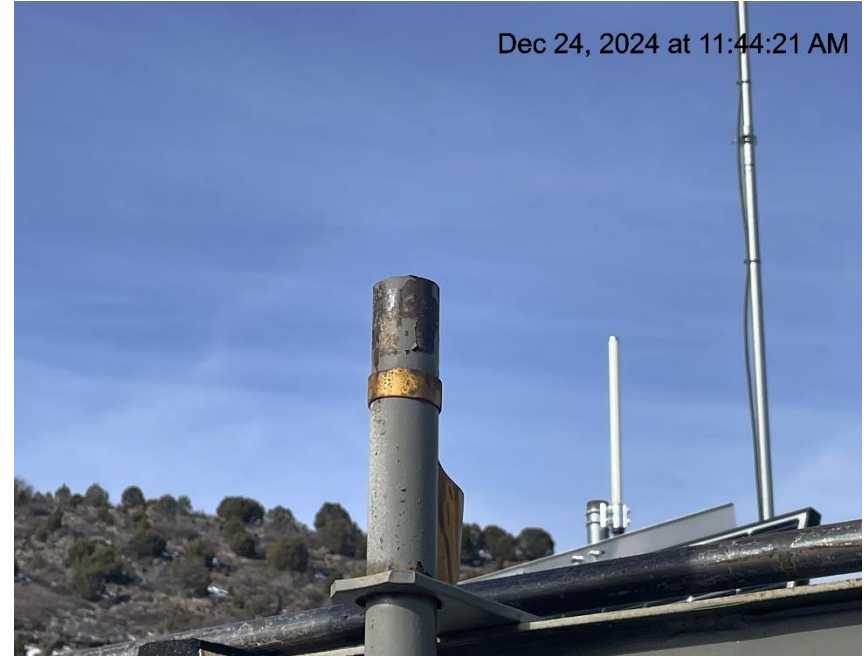
Photo # 5276 PRV vent line does not comply with CECMC pressure safety device rules

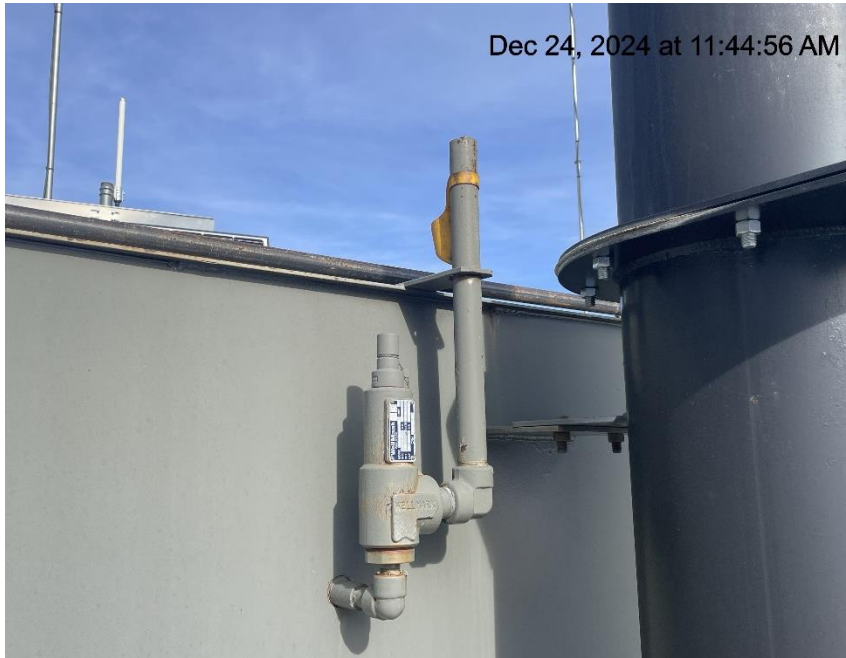
Photo # 5277 PRV vent line does not comply with CECMC pressure safety device rules

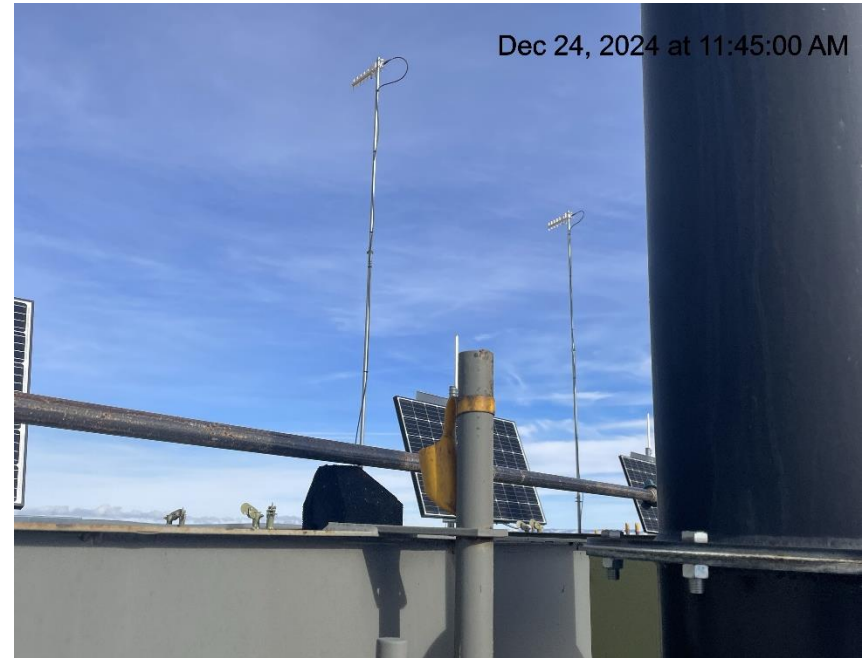
Photo # 5278 PRV vent line does not comply with CECMC pressure safety device rules

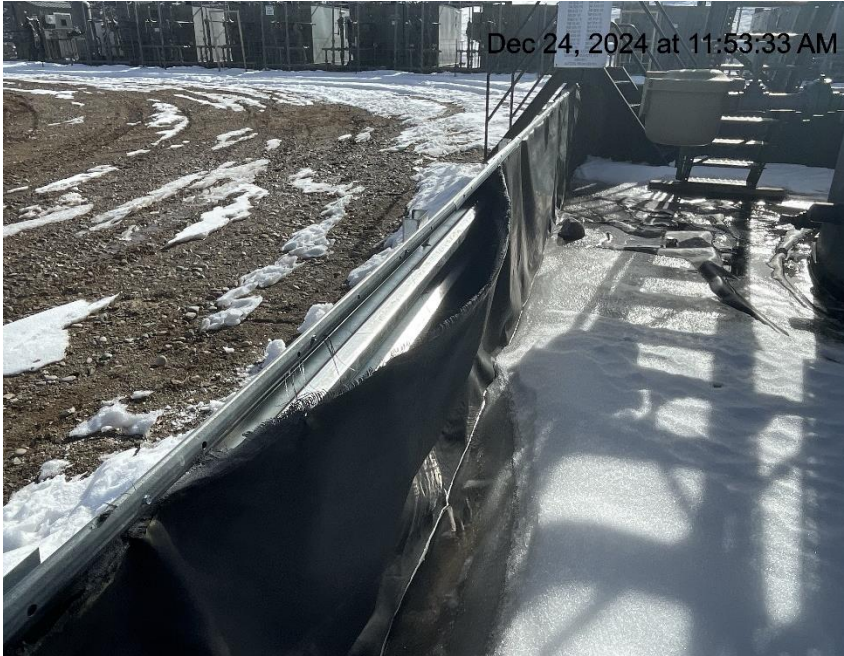
Photo # 5279 Secondary containment liner showing signs of damage/disrepair near top of metal containment ring

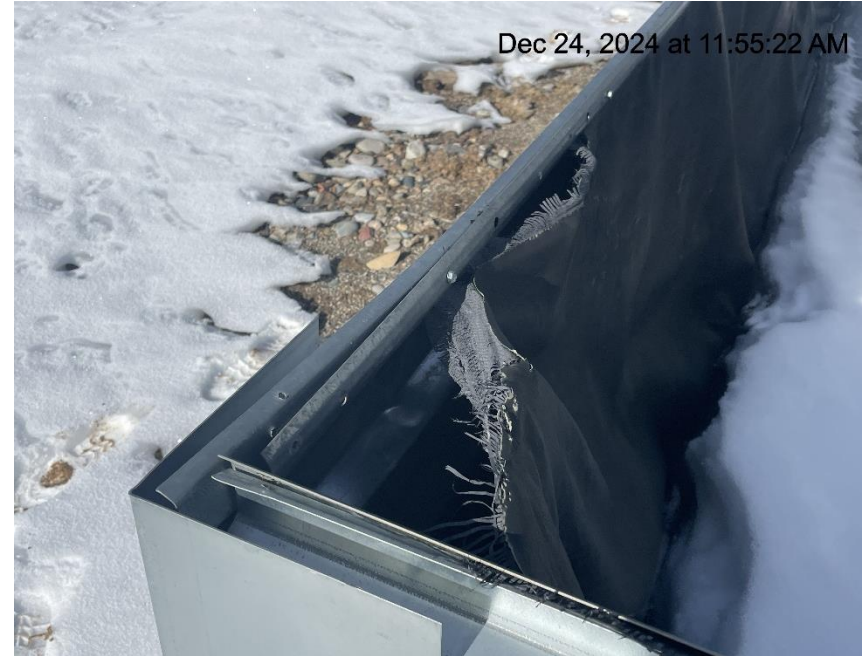
Photo # 5280 Secondary containment liner showing signs of damage/disrepair near top of metal containment ring
