Inspection Photos

Location Name: TEP ROCKY MOUNTAIN LLC Clough RWF 12-20 Tank Pad

Location ID: 457490

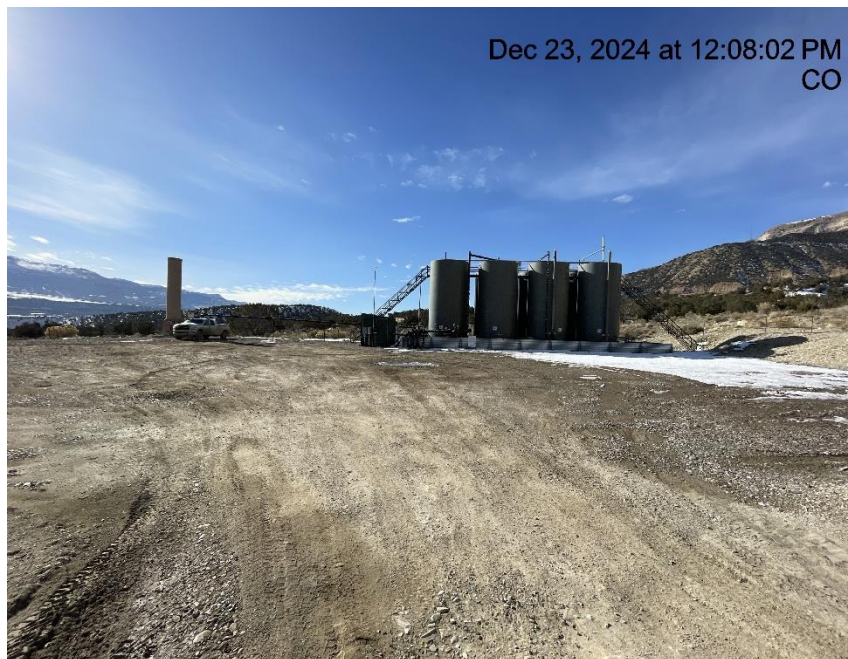
Photo # 4968 From entrance to location

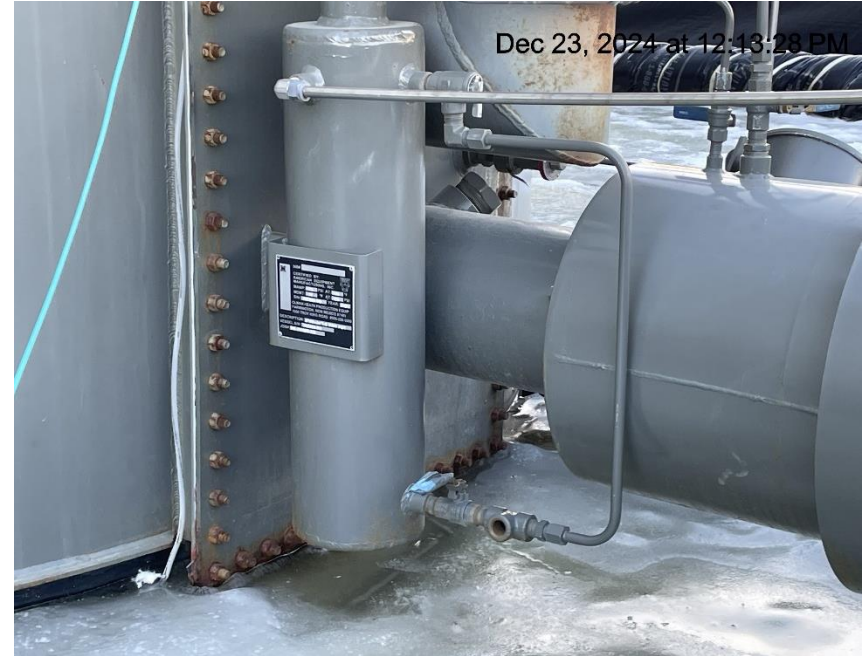
Photo # 4975 PRV vent line does not comply with CECMC pressure safety device rules

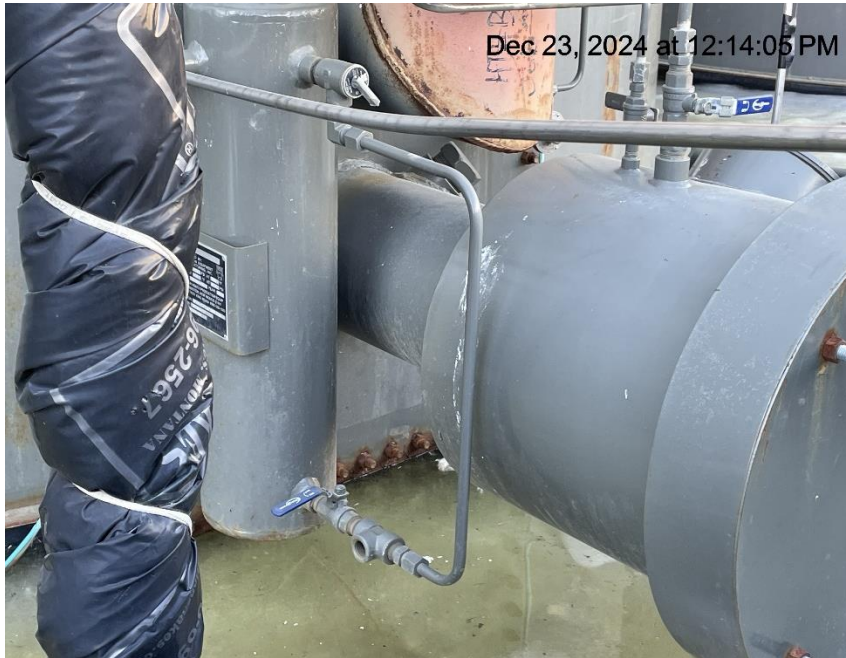
Photo # 4976 PRV vent line does not comply with CECMC pressure safety device rules

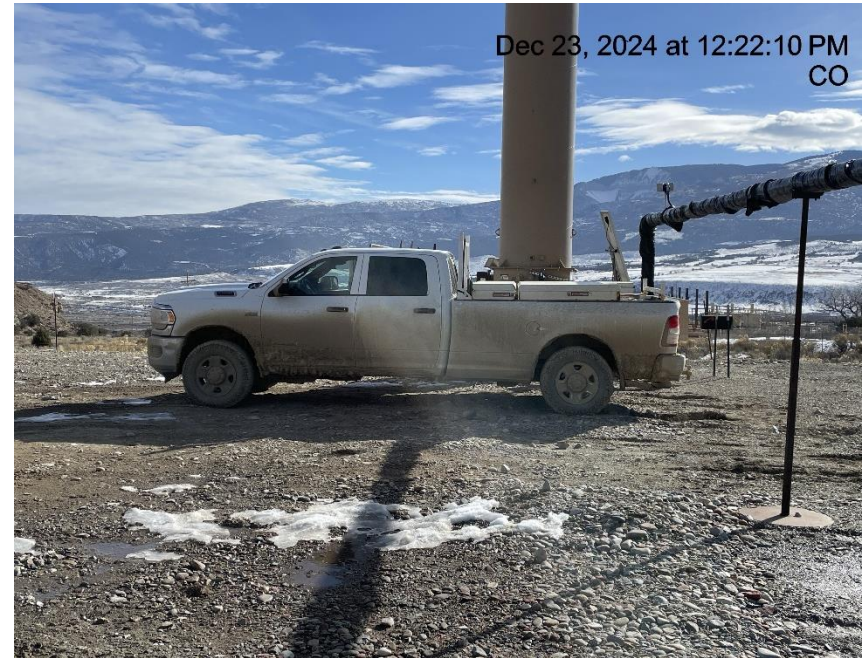
Photo # 4977 Pickup truck parked on location
