Inspection Photos

Location Name: TEP ROCKY MOUNTAIN LLC, Burckle/A Pad

Location ID: 335540

Date: 12/23/2024

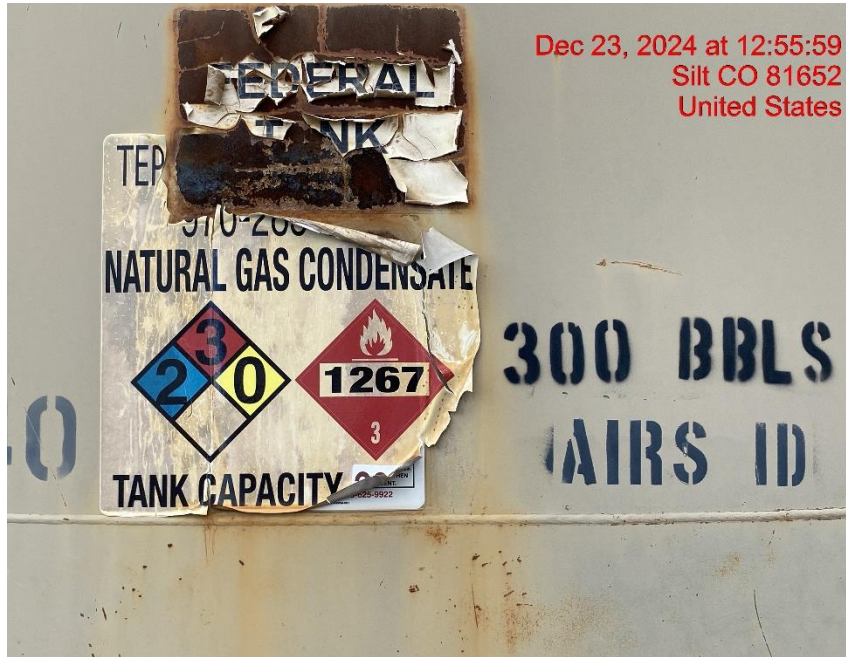
Weathered Tank Label Needs Replaced – Photo #05556

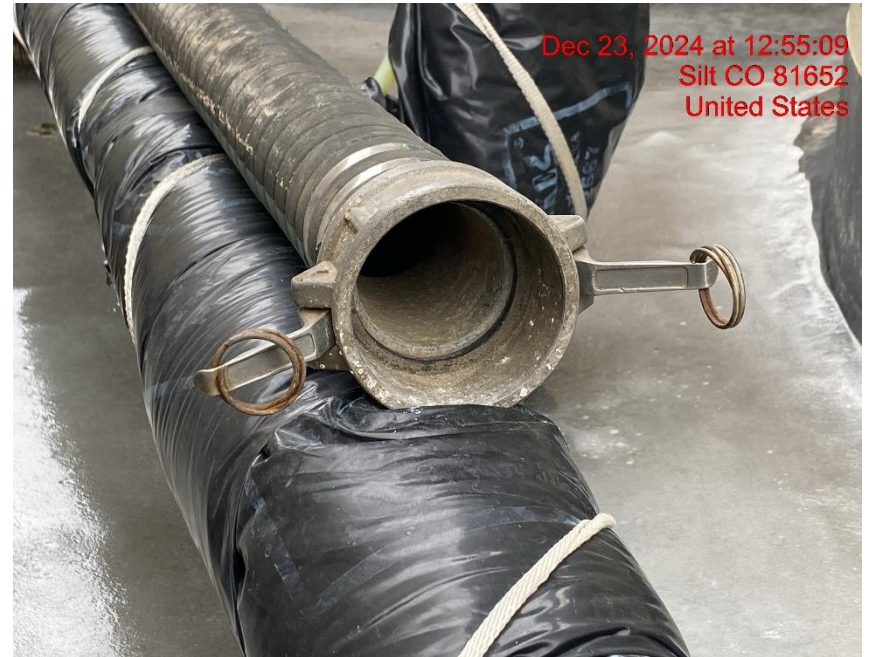
Stored Supplies/Wildlife Entry Hazard – Photo #05553

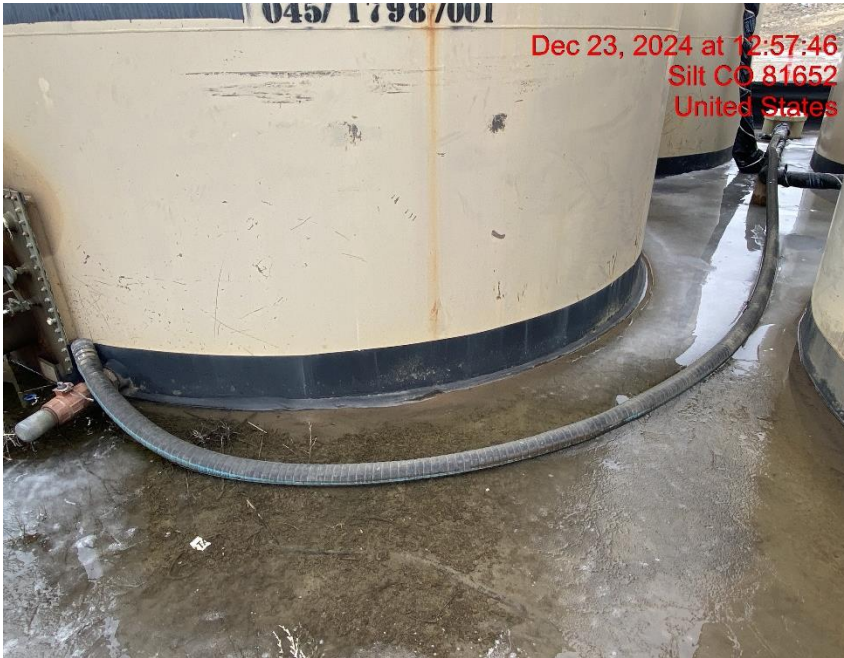
Stored Supplies/Wildlife Entry Hazard – Photo #05560

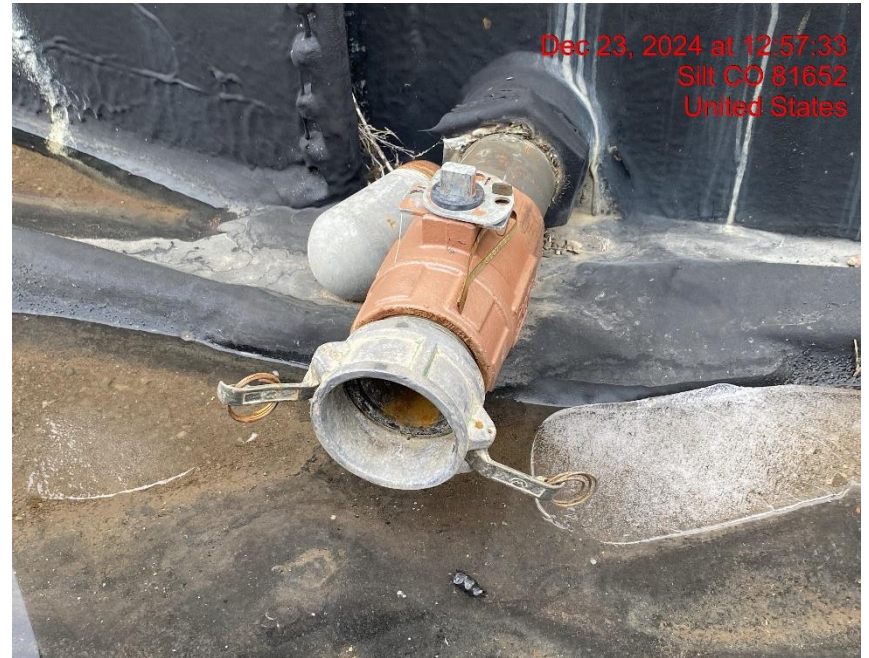
Open-Ended Line on Tank – Photo #05559

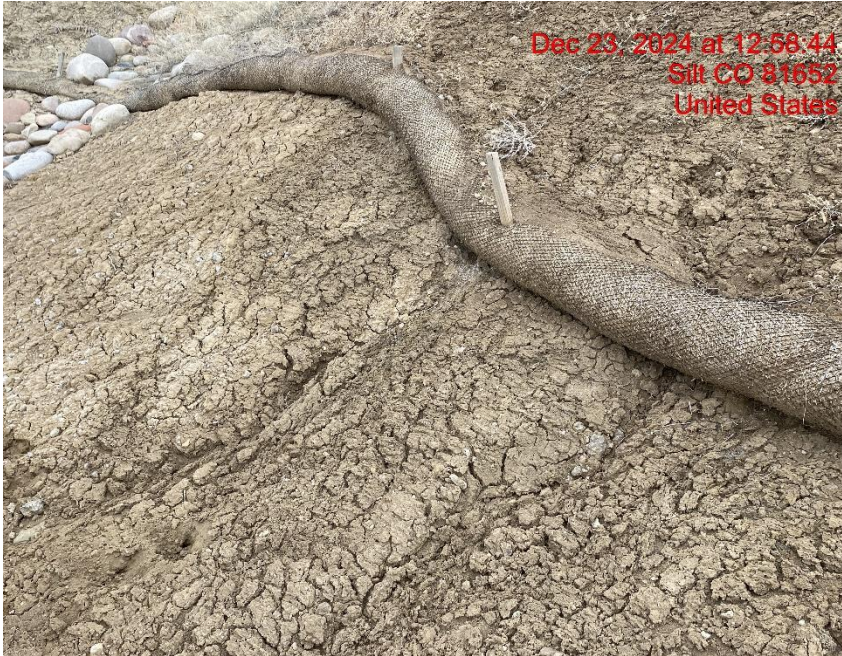
Rill Erosion Undercutting BMP – Photo #05564

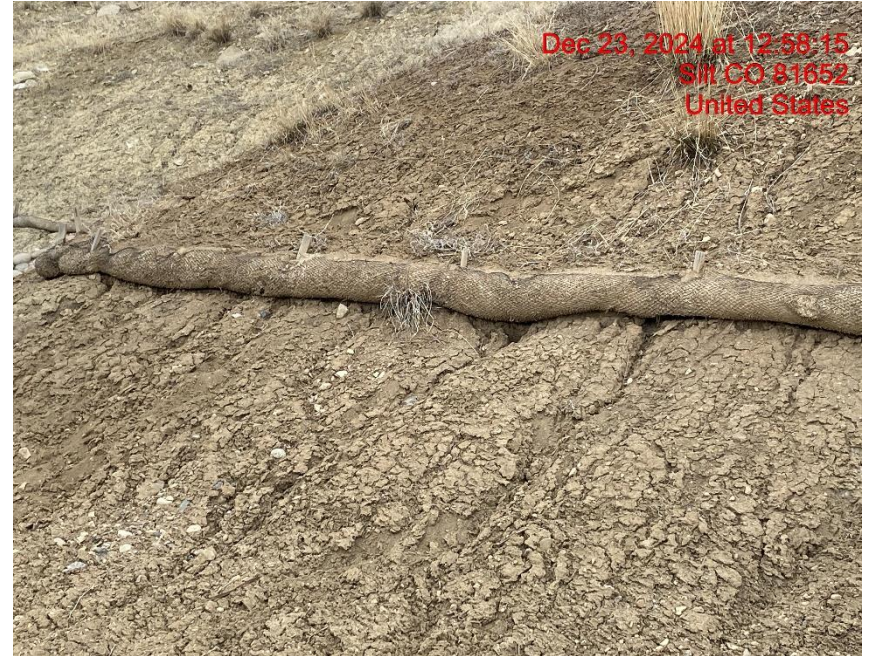
Rill Erosion Undercutting BMP – Photo #05562
