## Inspection Photos

Location Name: PETTINGER-USX AB-67N64W/35SENE

Location ID: 306362

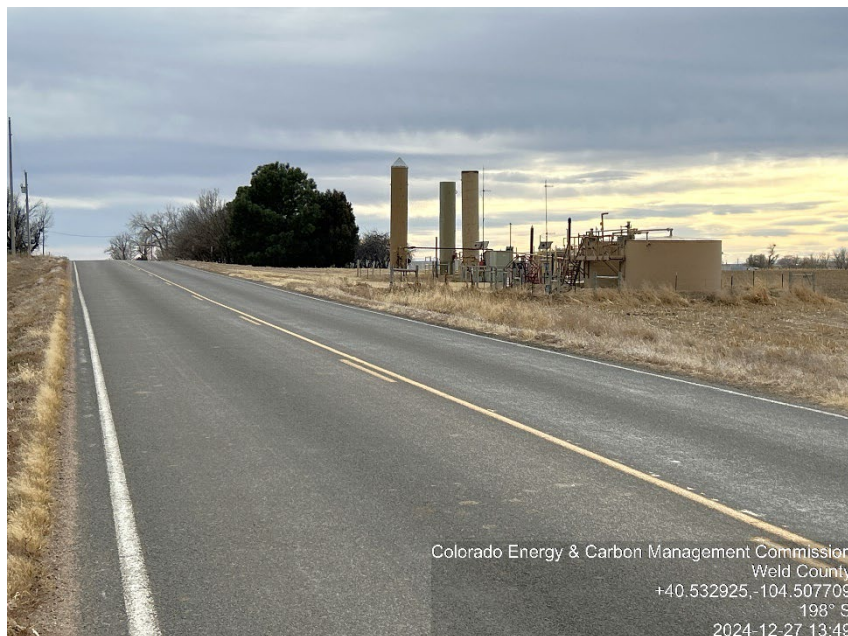
**Photo #1**

**Pettinger USX AB 35-8, 35-01D** Battery site

**Inactive | Shut-down**

*Battery site entrance*

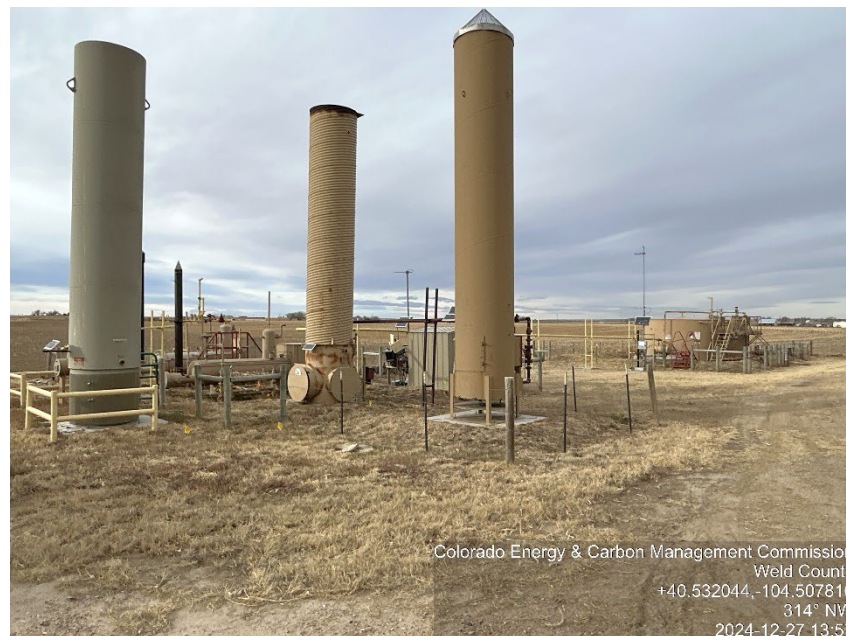
**Photo #2**

**Pettinger USX AB 35-8, 35-01D** Battery site

**Inactive | Shut-down**

*Formerly served:*

*Pettinger USX AB 35-02, 35-7;*

*Plugged & Abandoned | PA*

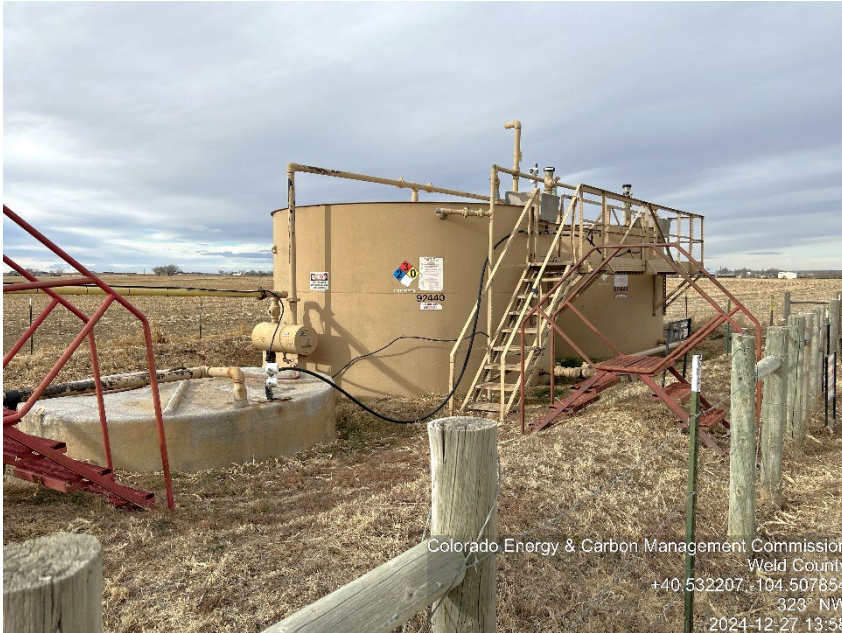
**Photo #3**

**Pettinger USX AB 35-8, 35-01D Battery site**

**Inactive | Shut-down**

*Crude oil, produced H<sub>2</sub>O tank(s): SE corner*

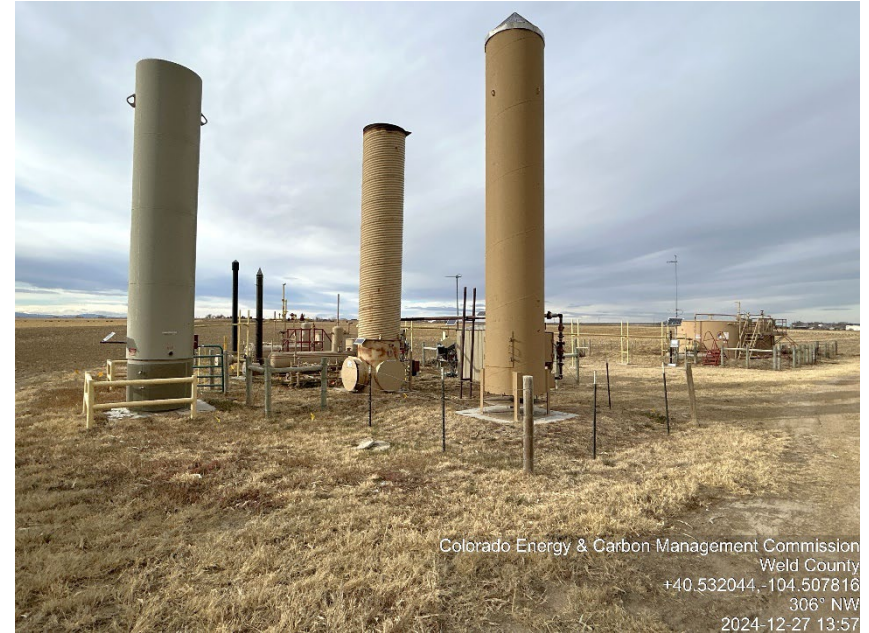
**Photo #4**

**Pettinger USX AB 35-8, 35-01D Battery site**

**Inactive | Shut-down**

*ECD(s), Separator(s)*

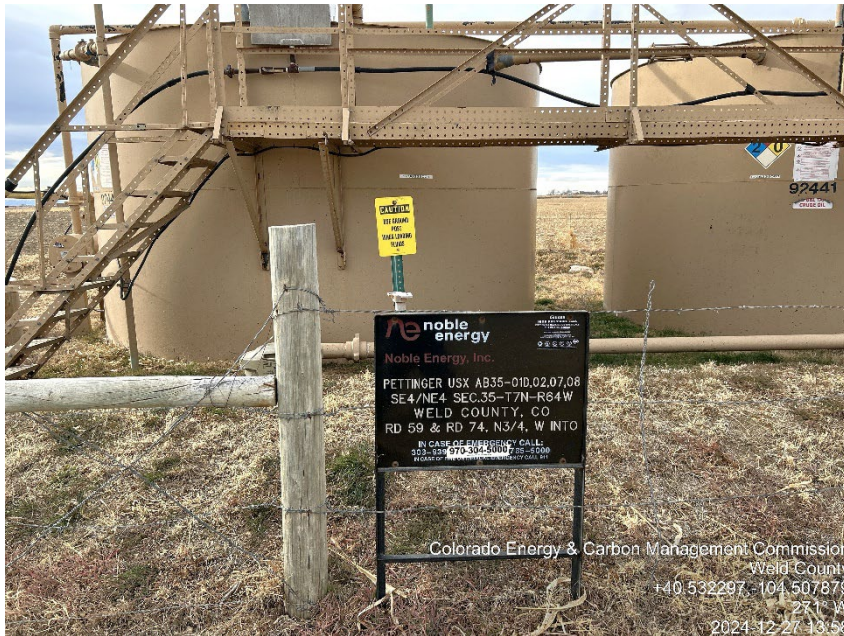
**Photo #5**

**Pettinger USX AB 35-8, 35-01D Battery site**

**Inactive | Shut-down**

*Battery sign*
