# Inspection Photos

API: 061-06876

Operator: PIONEER NATURAL RESOURCES

Inspection Date: 11/20/2024

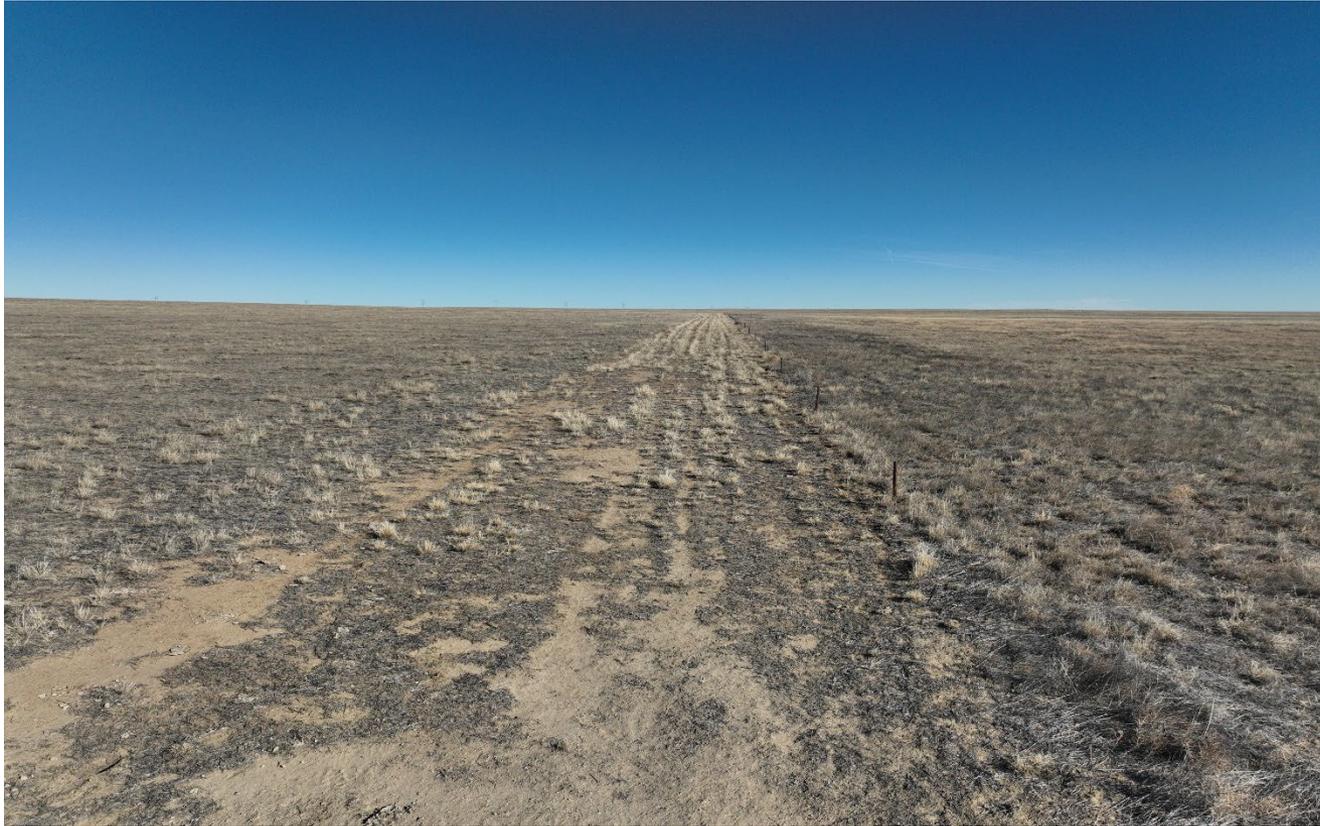
**Photo 3.** Drone aerial photo facing east along the former access road.

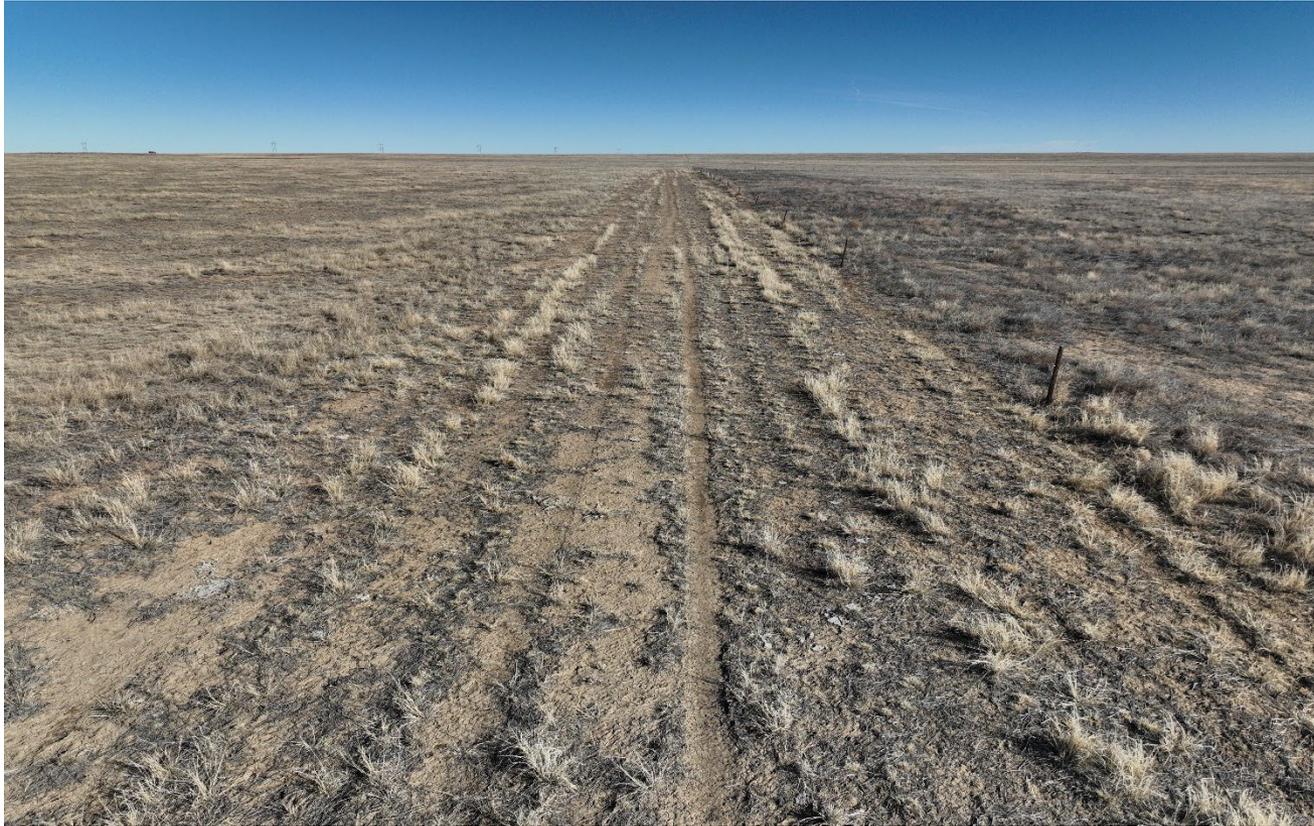
**Photo 2.** Drone aerial photo facing east along the former access road. Areas of the access road have not established perennial vegetation and will need to be reseeded.

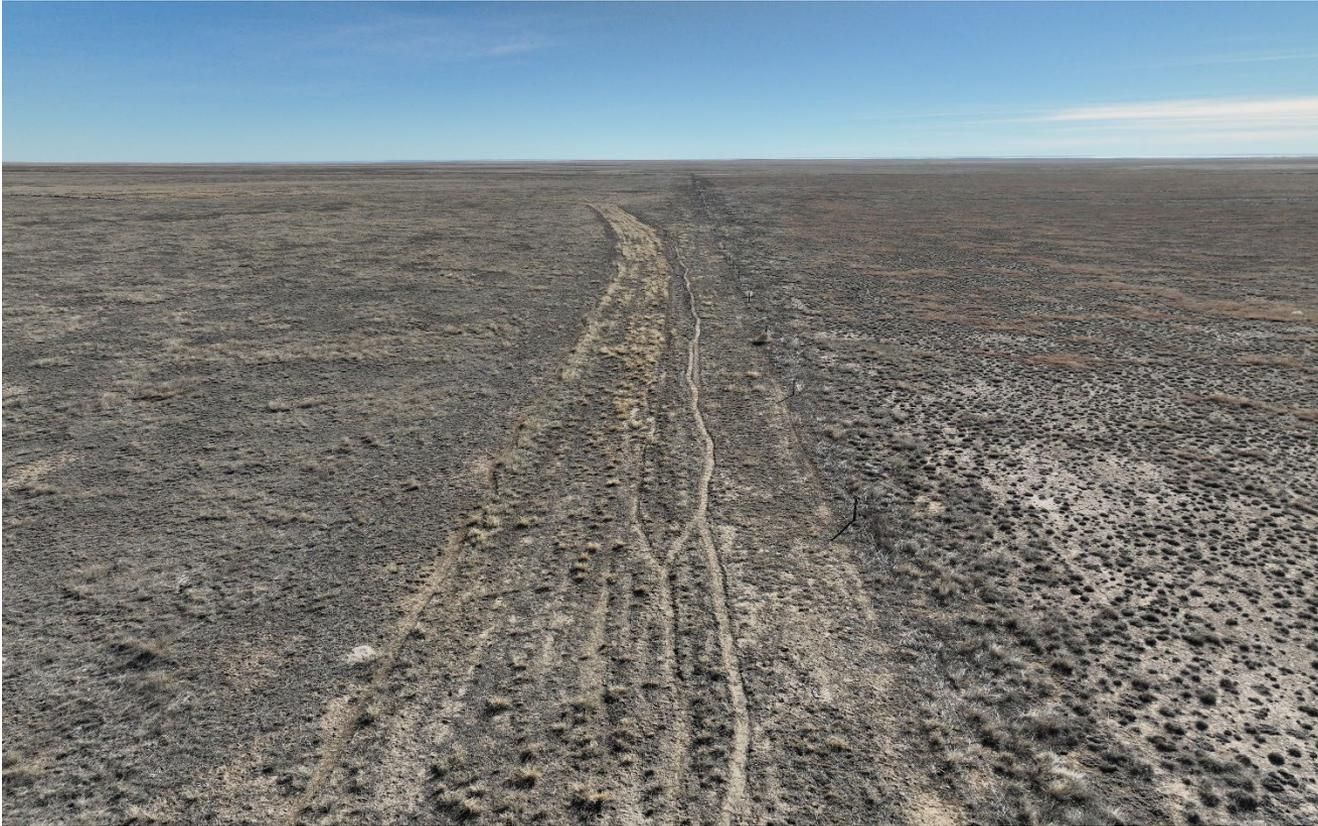
**Photo 3.** Drone aerial photo facing southeast along the former access road.

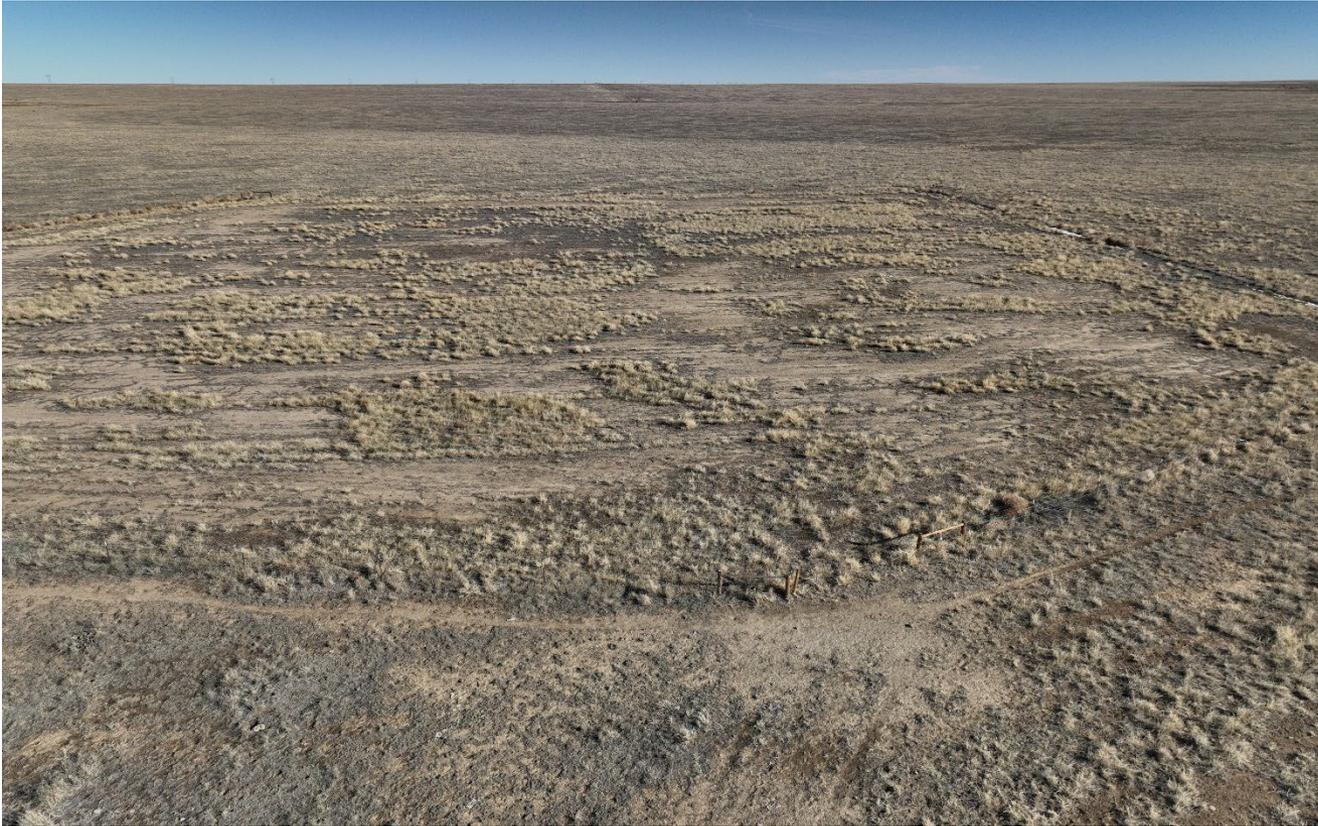
**Photo 4.** Drone aerial photo facing east overlooking the location..

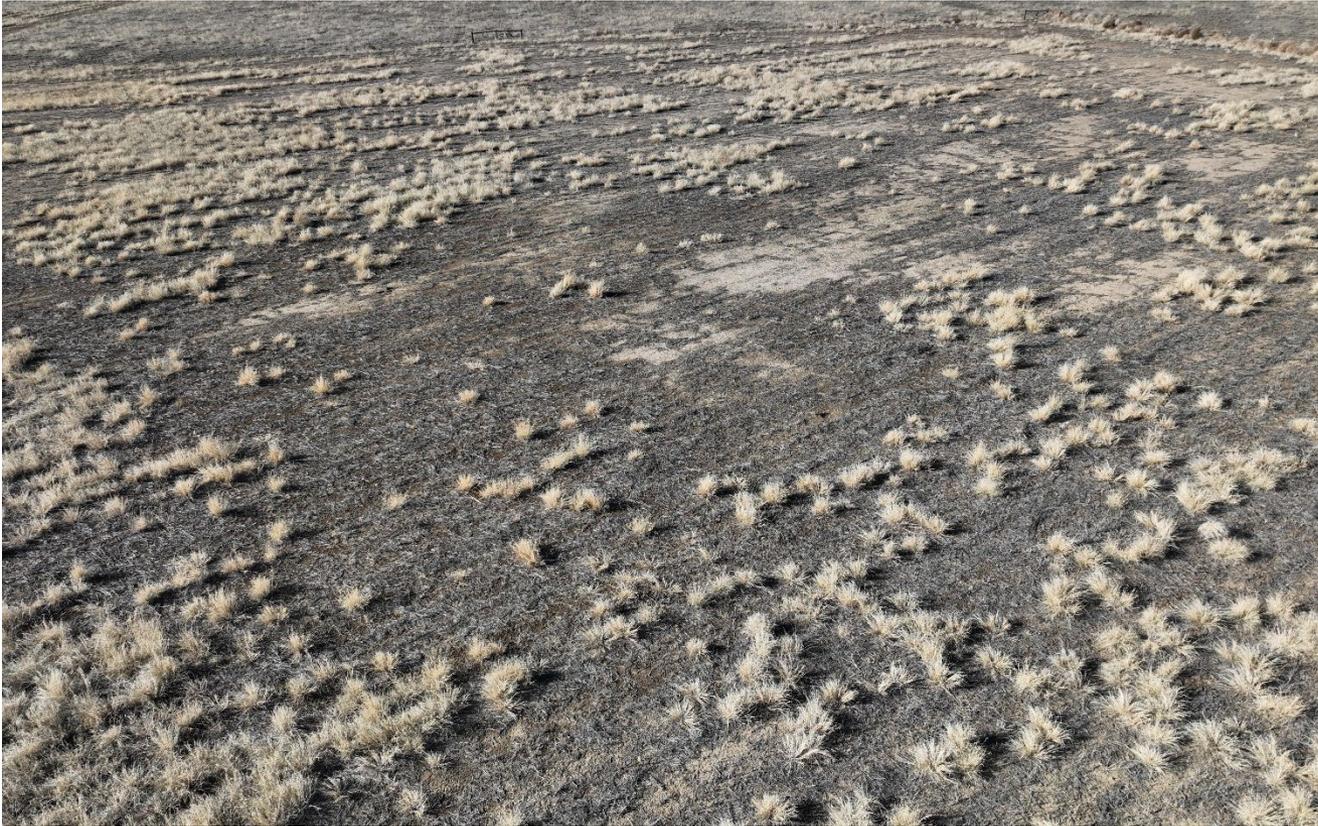
**Photo 5.** Facing down toward the location. Areas of the location have not established perennial vegetation and will need to be reseeded.

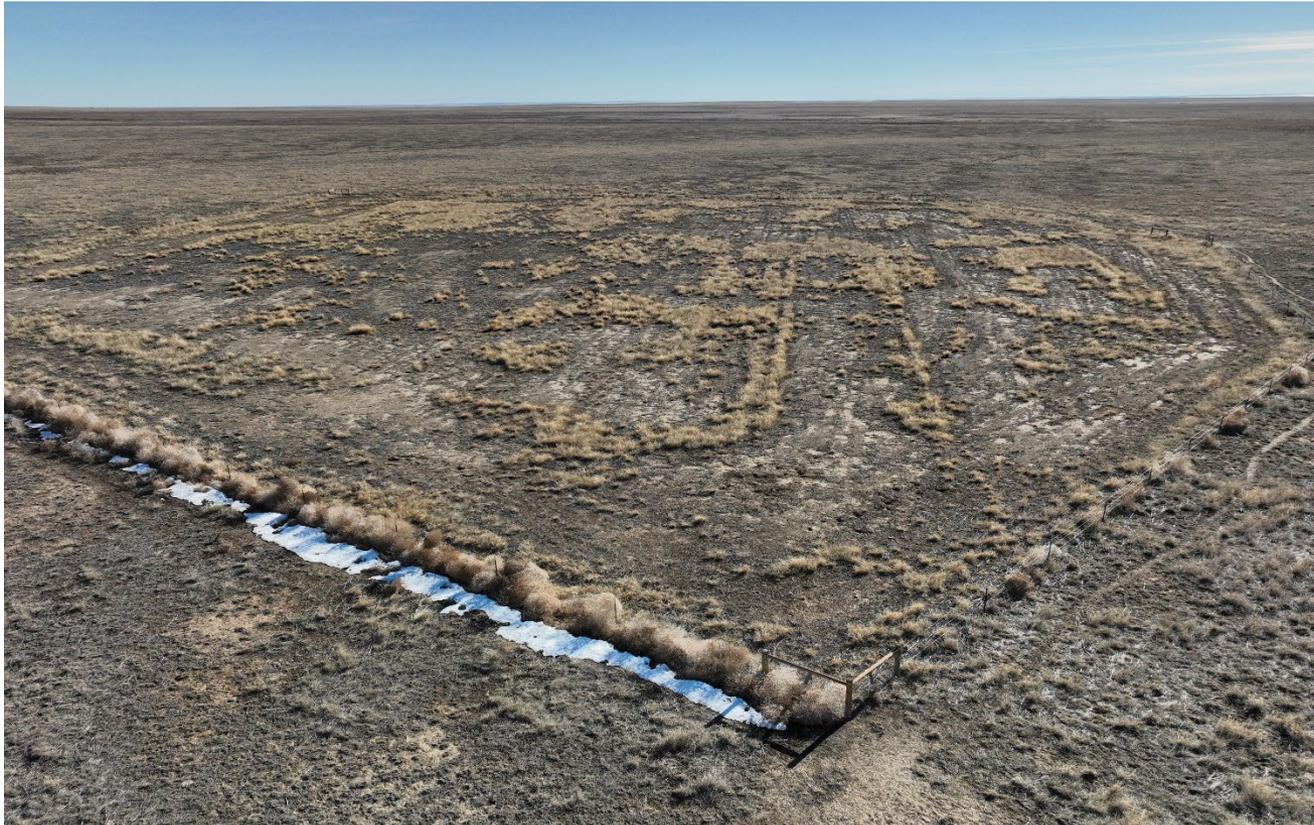
**Photo 6.** Drone aerial photo facing south overlooking the location. The location remains fenced for final reclamation.

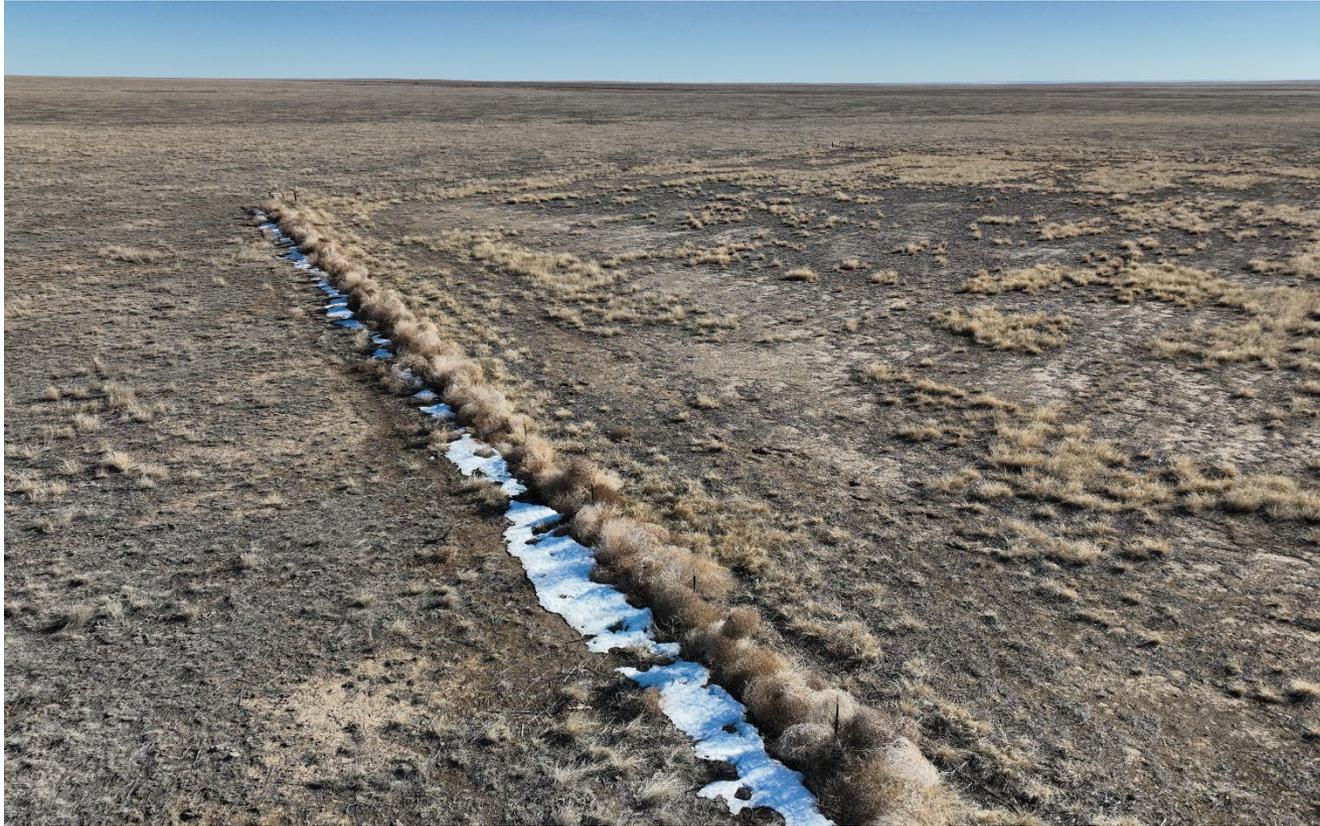
**Photo 7.** View of fence line which has undesirable tumble weeds caught in the fence.

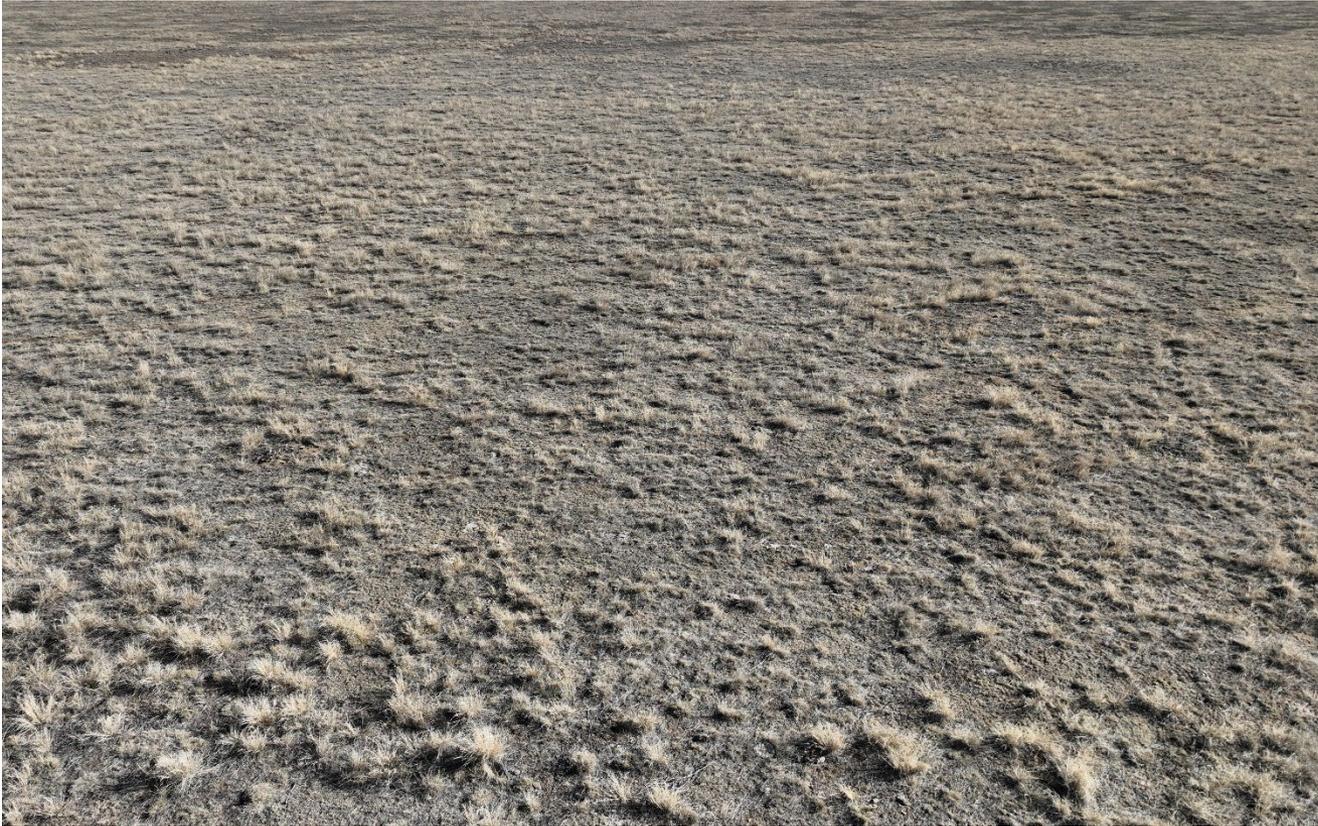
**Photo 8.** View of the surrounding reference area pasture with uniform native vegetation.
