WELL NAME: LYNCH 43-30, API #: 071-08170, INSP. # 716300371

COLORADO
Energy & Carbon Management
Commission
Department of Natural Resources

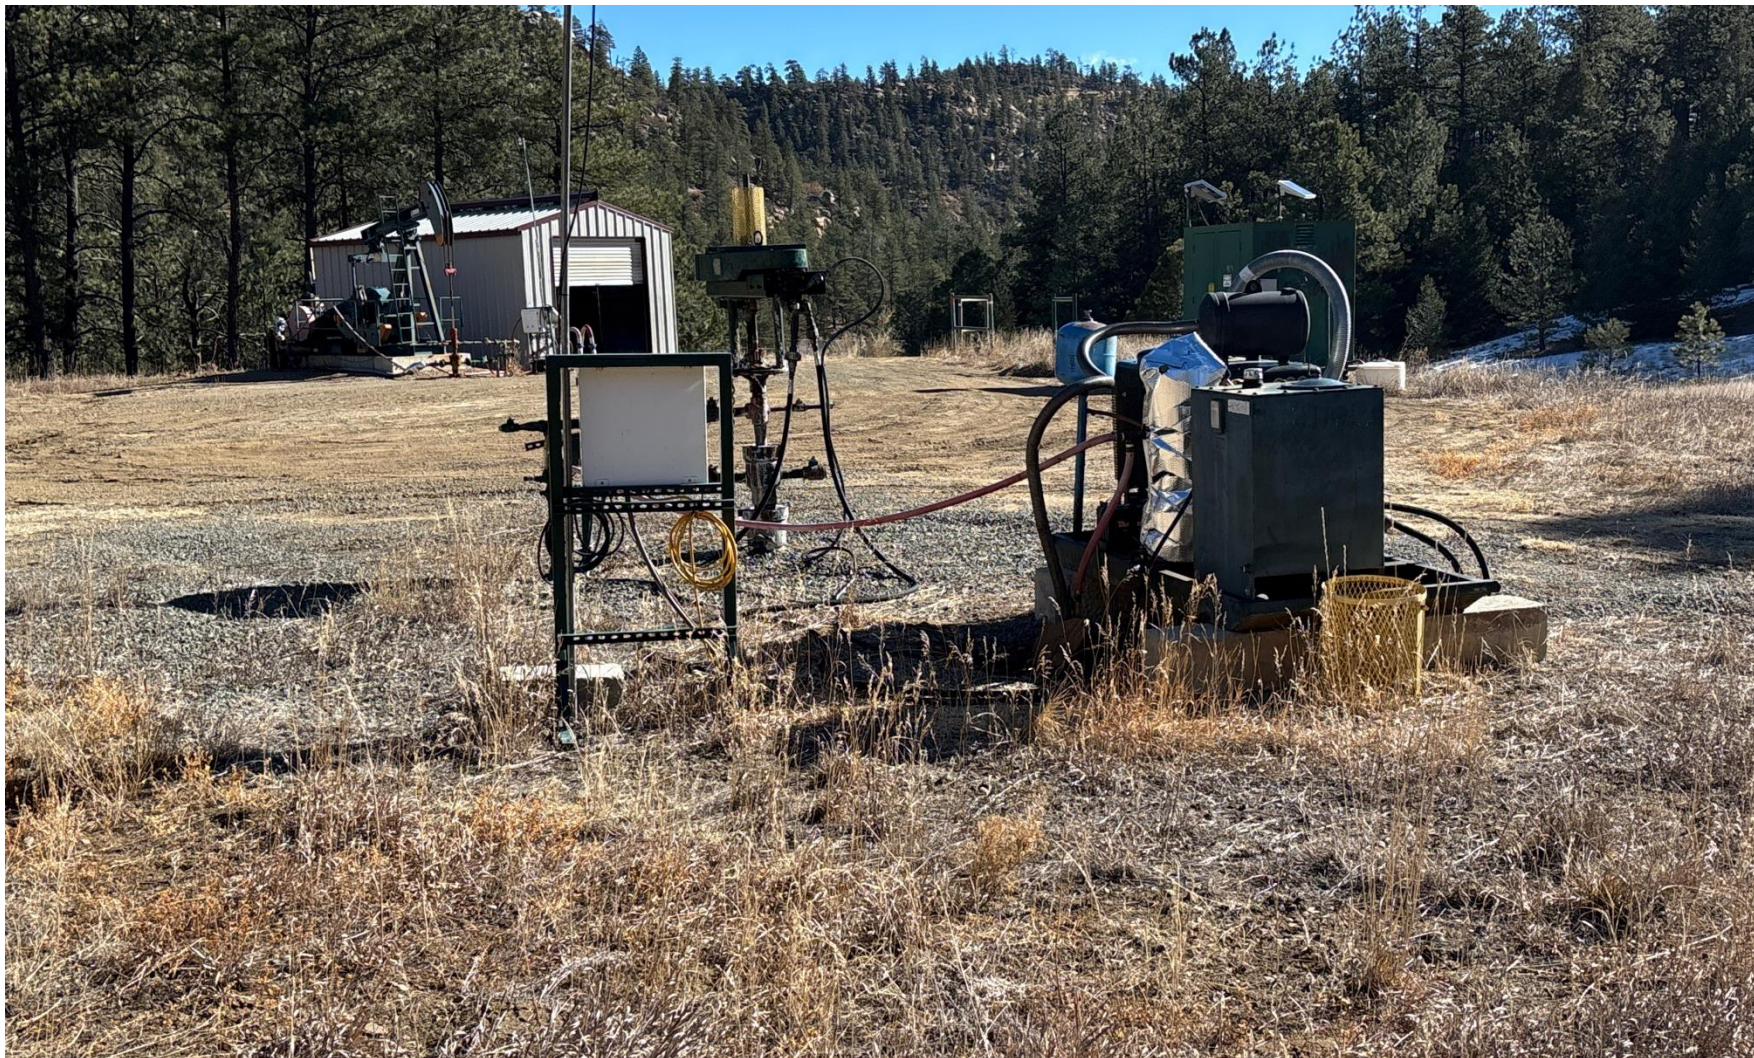
PHOTO 3: ORIG. WELLHEAD AND EQUIPMENT.

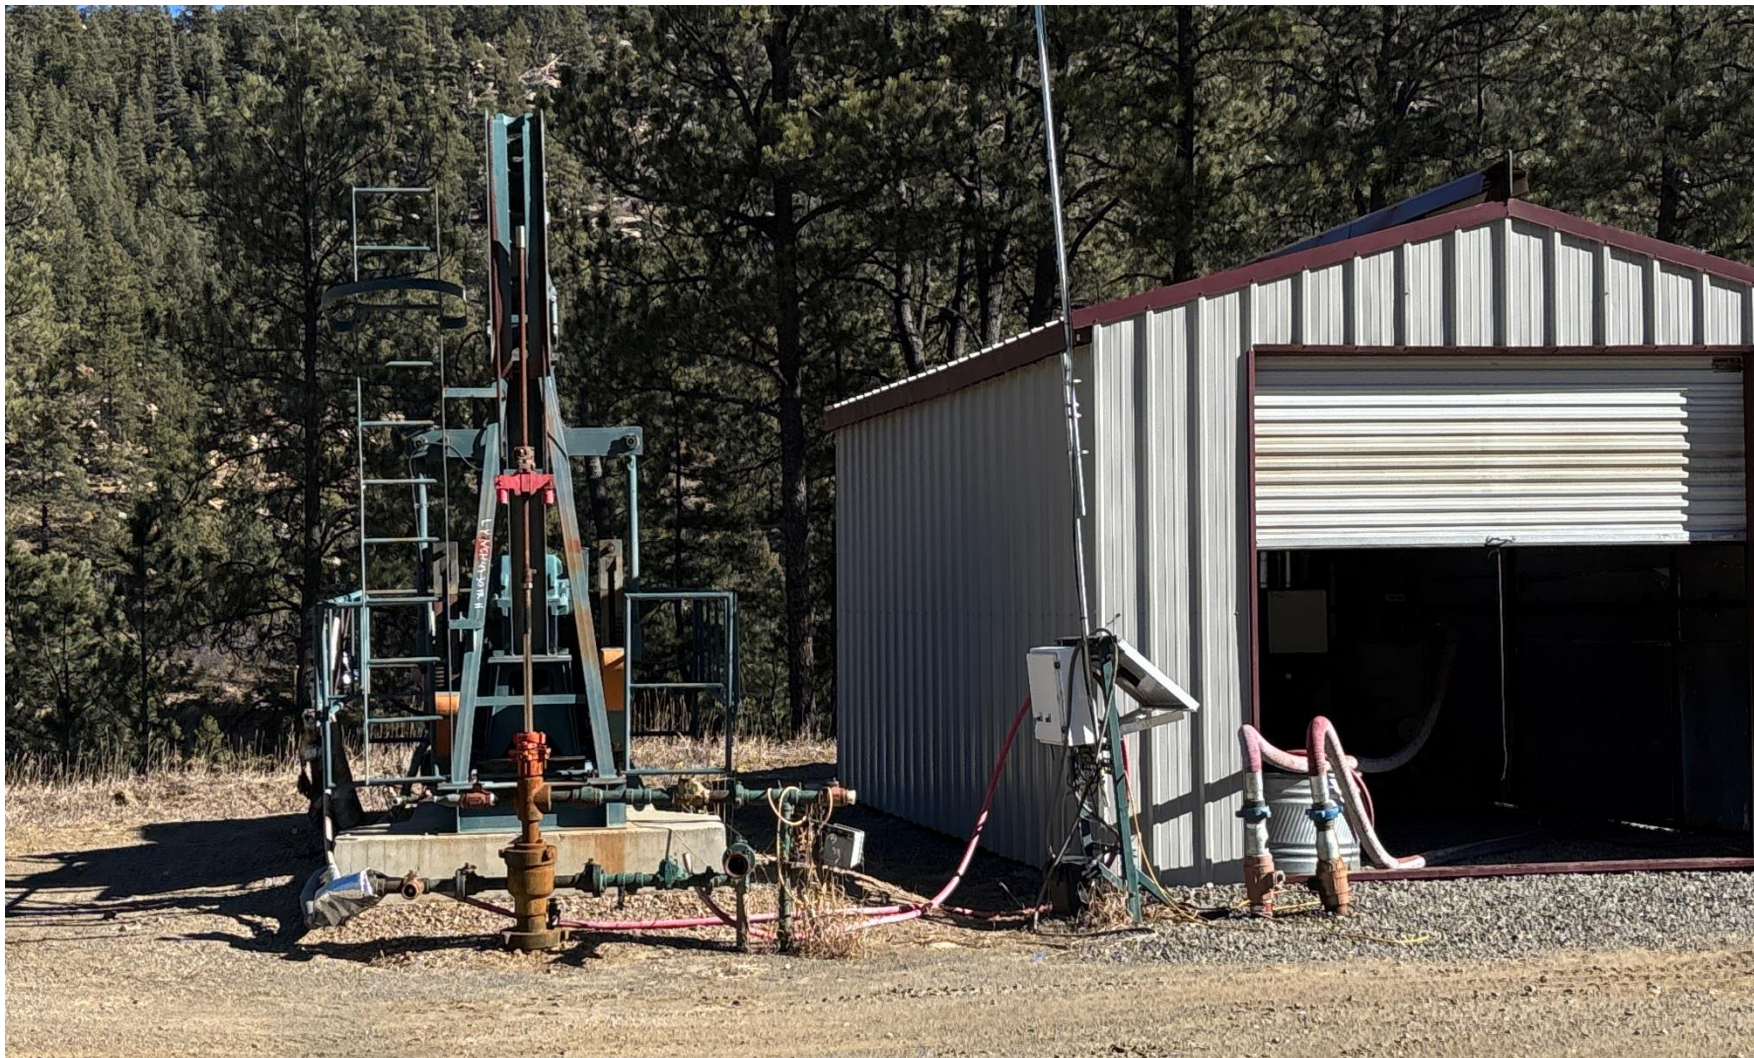
PHOTO 4: TR WELLHEAD AND EQUIPMENT.

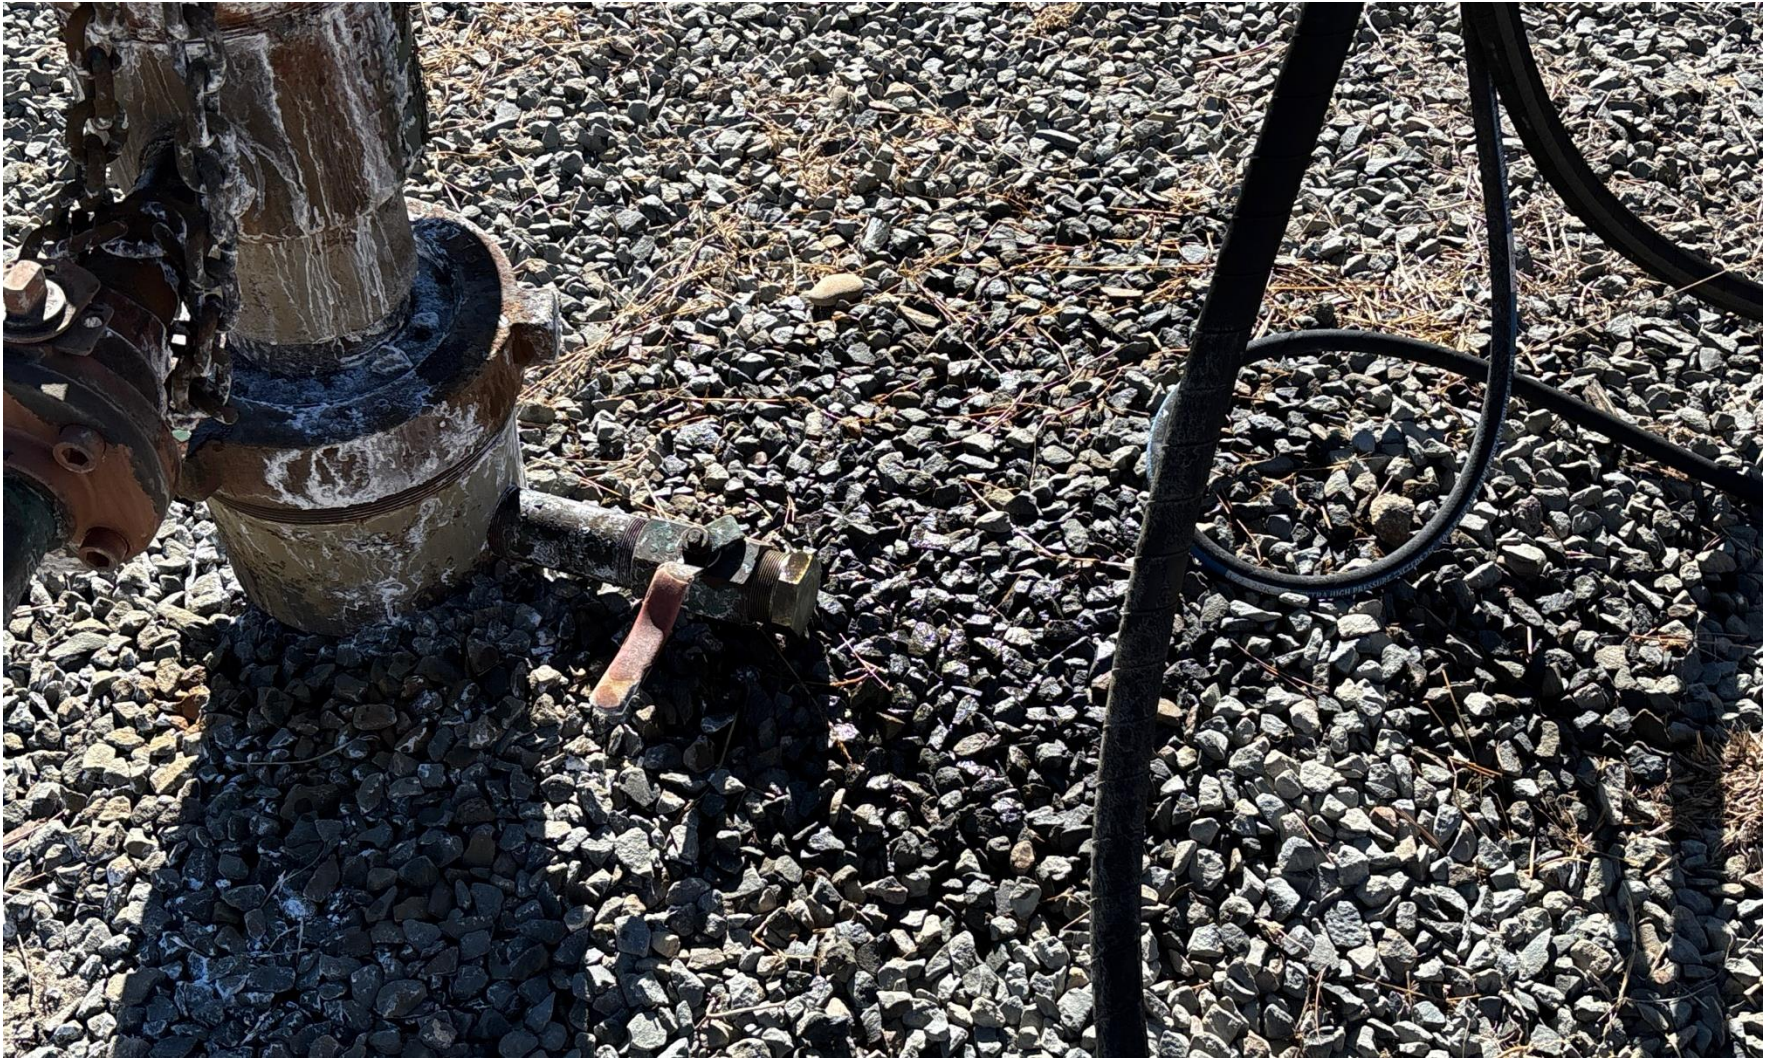
PHOTO 5: AREA OF IMPACTED SOIL UNDER LEAKING DRIVE MOTOR. Conduct maintenance on equipment, cleanup stained material and review self inspection processes. COMPLY WITH RULE 1002,.(2).D. CA DATE 1-9-25

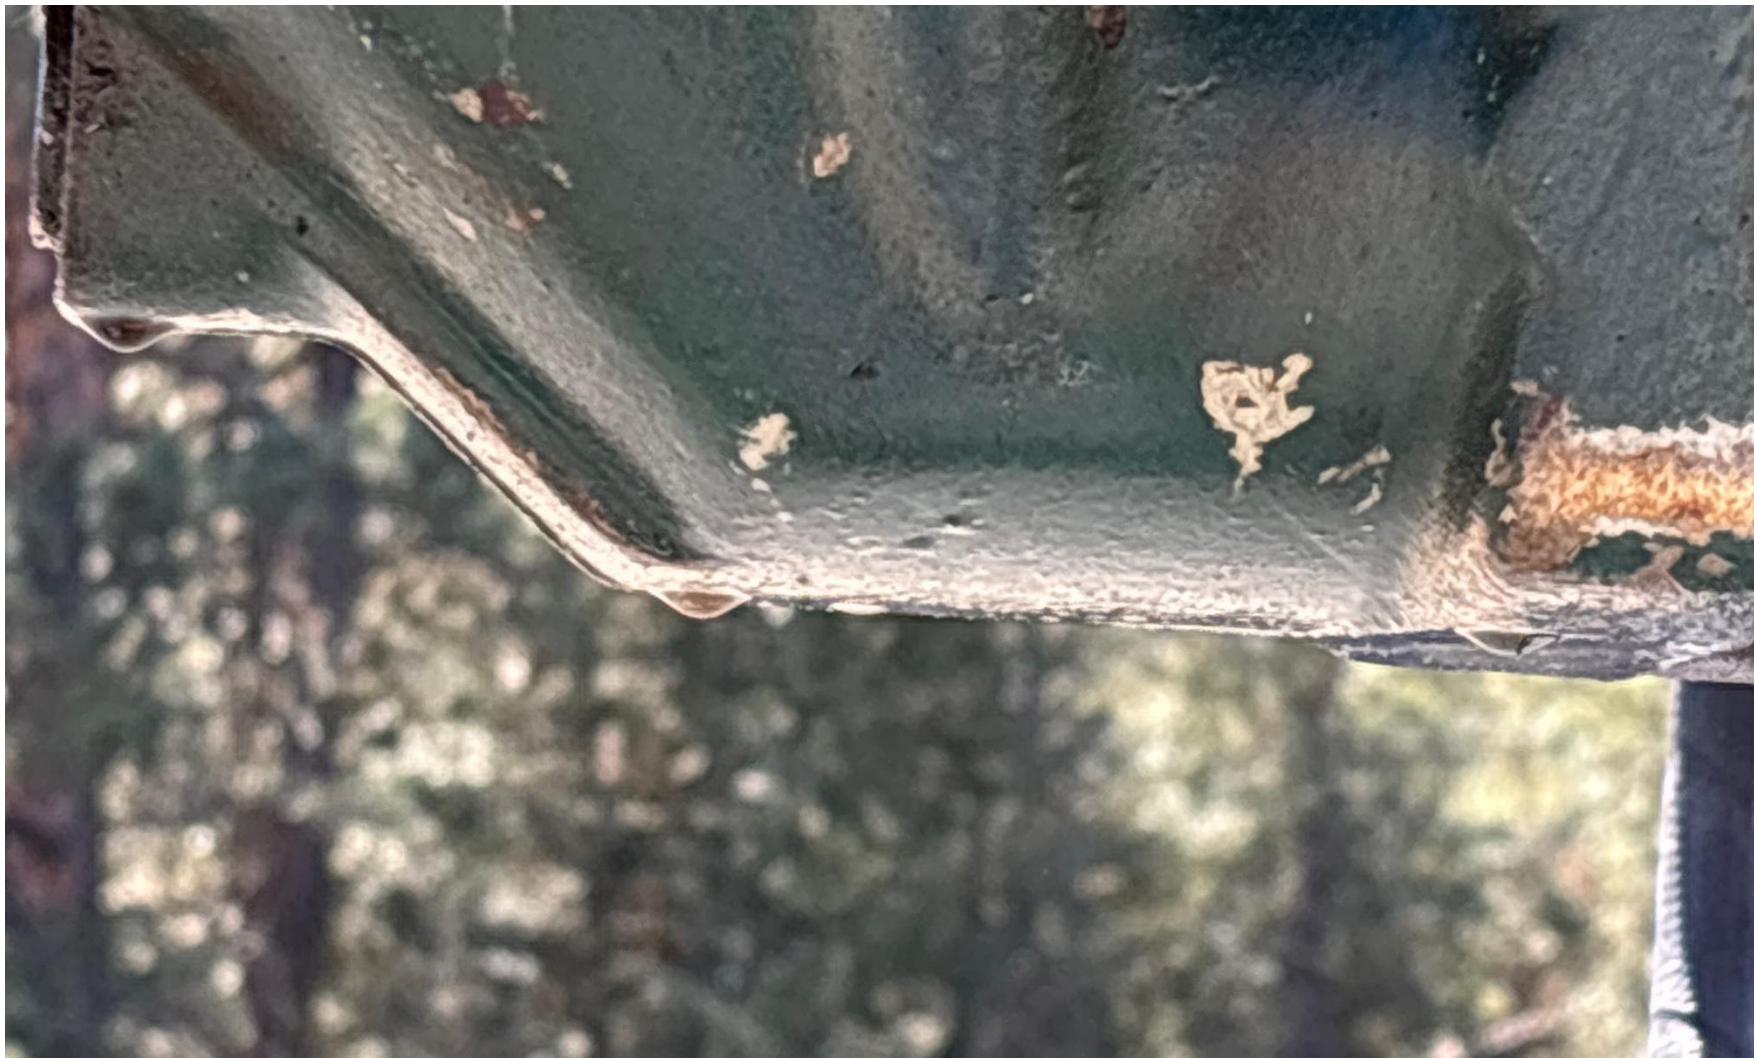
PHOTO 6: DRIVEHEAD MOTOR LEAKING HYDRAULIC OIL. REPAIR EQUIPMENT PER RULE 606. CA DATE 1/9/25.
